National Register of Historic Places  
Registration Form

historic name Williams, Hamp, Building

street & number 500 - 504 Ouachita Avenue

city or town Hot Springs

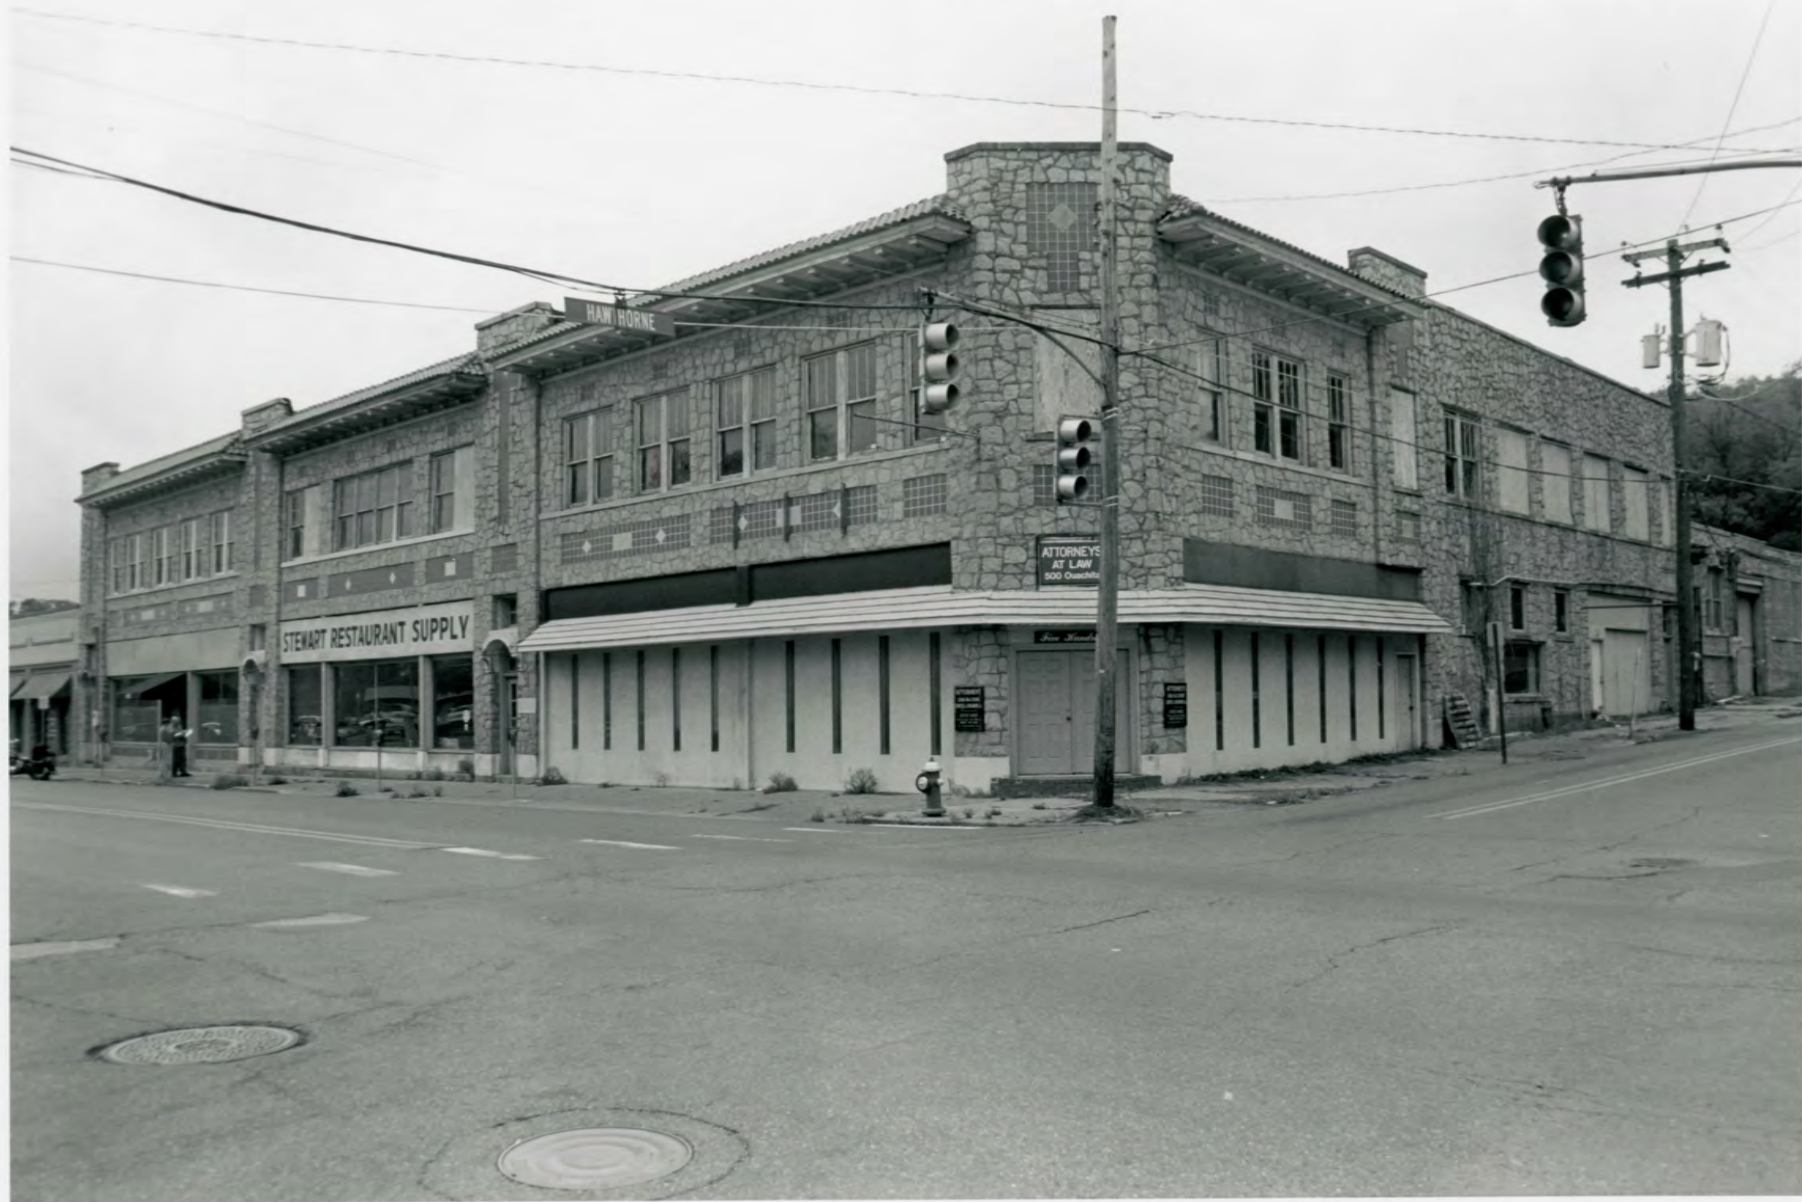
- ① Kemp Williams Building
- ② Garland Co, AR
- ③ Sarah Jampole
- ④ May 3, 2007
- ⑤ AHP
- ⑥ Standing @ East corner, looking west
- ⑦ #1

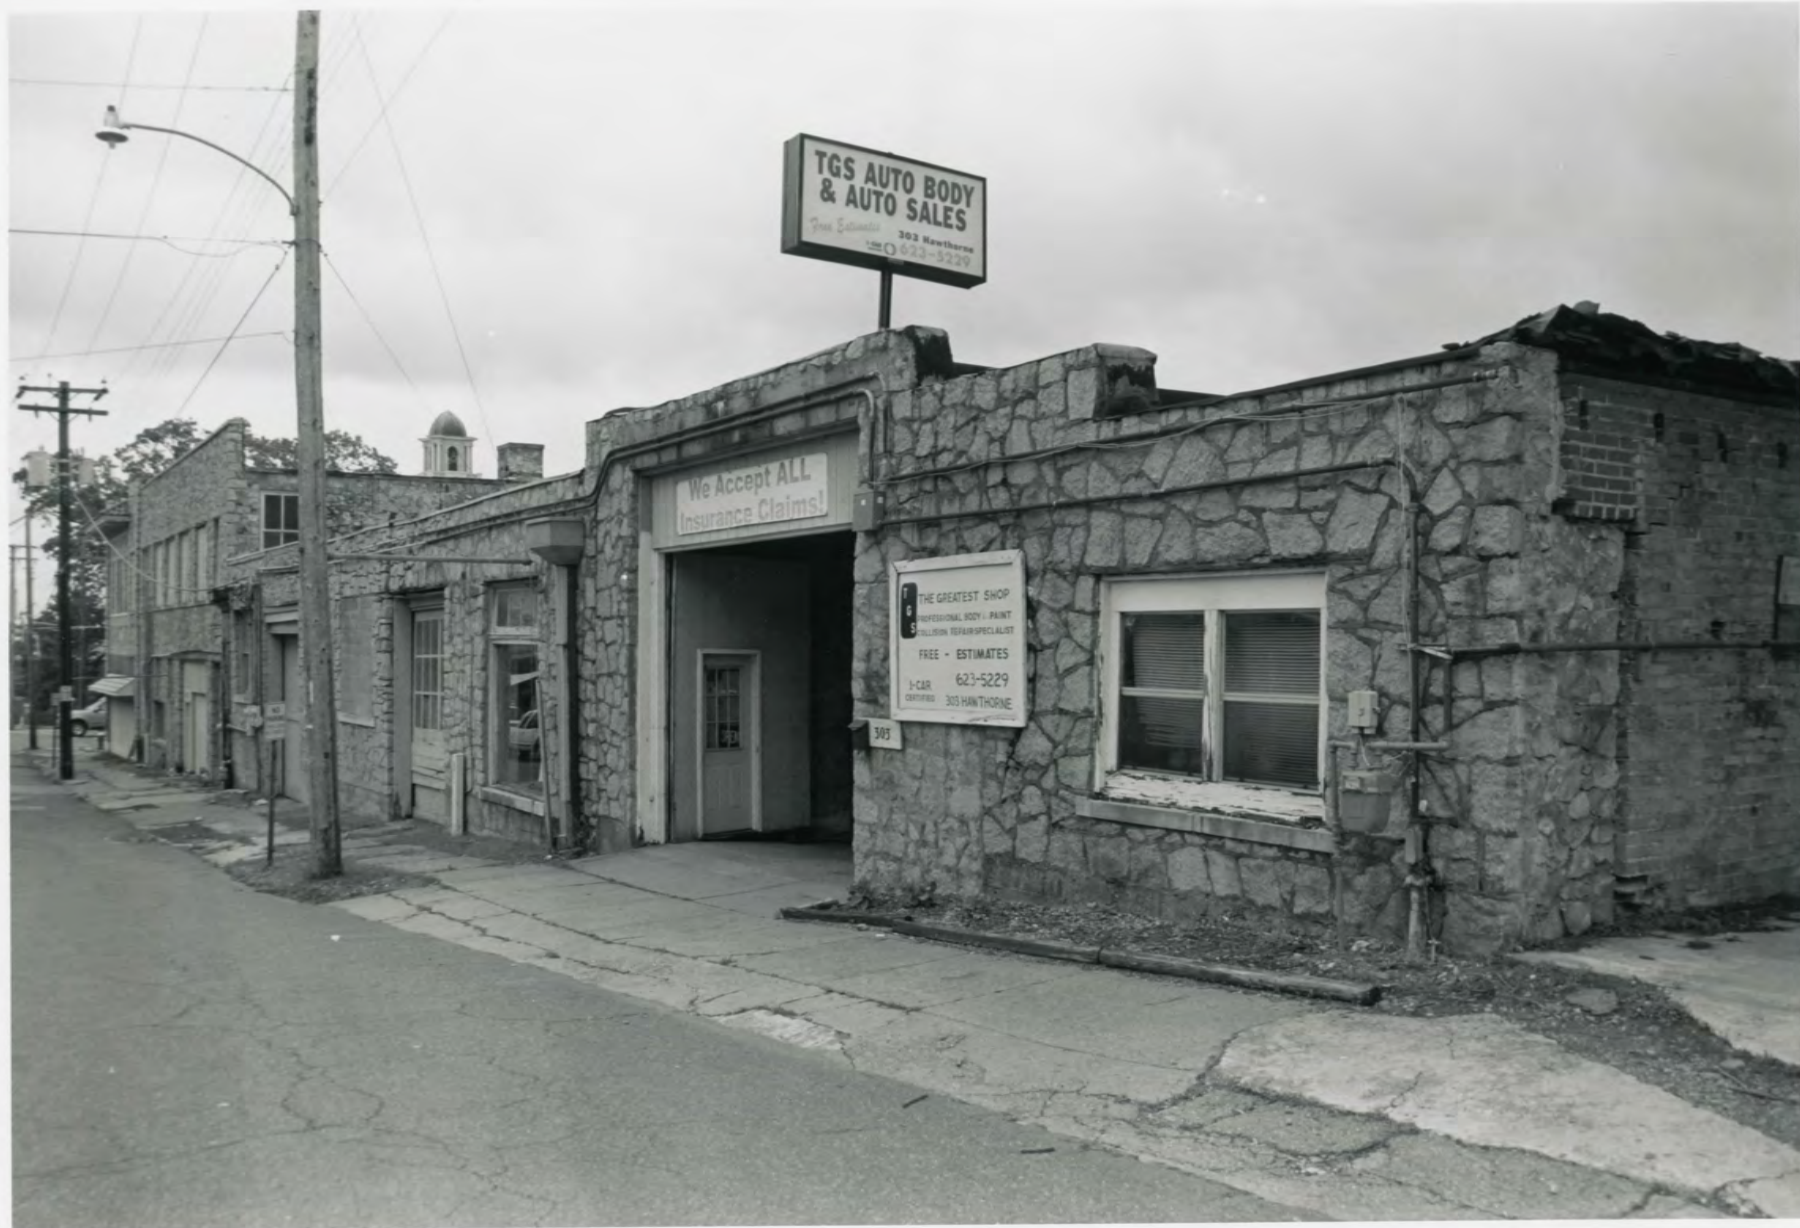
- ① Hamp Williams Building
- ② Garland CO, AR
- ③ Sarah Jampore
- ④ May 3, 2007
- ⑤ AHPP
- ⑥ Standing @ North corner, looking SE along  
NE elevation
- ⑦ #2

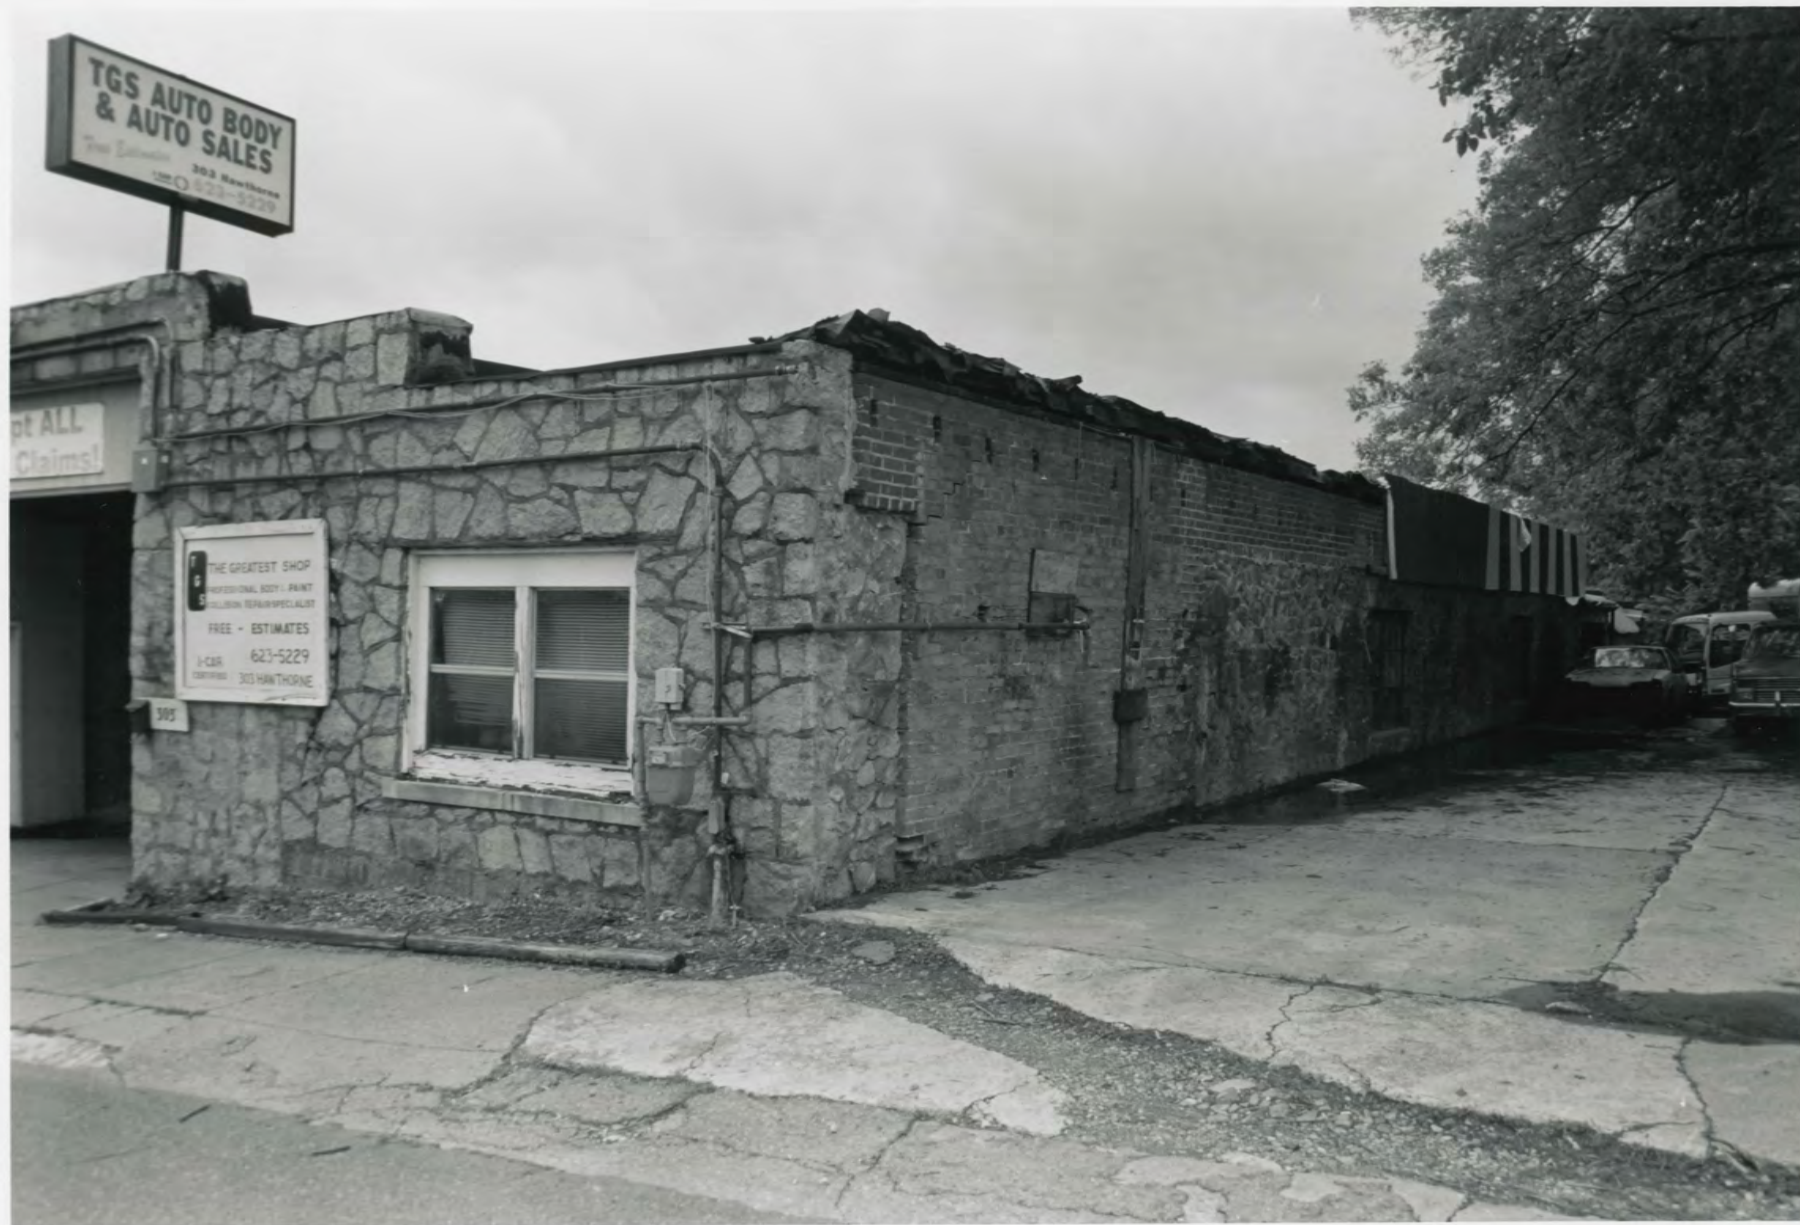
- ① Hamp Williams Building
- ② Garland CO, AR
- ③ Sarah Jampole
- ④ May 3, 2007
- ⑤ ~~ATTP~~
- ⑥ Standing @ NE corner, looking ~~NE~~ along NW elevation
- ⑦ #3

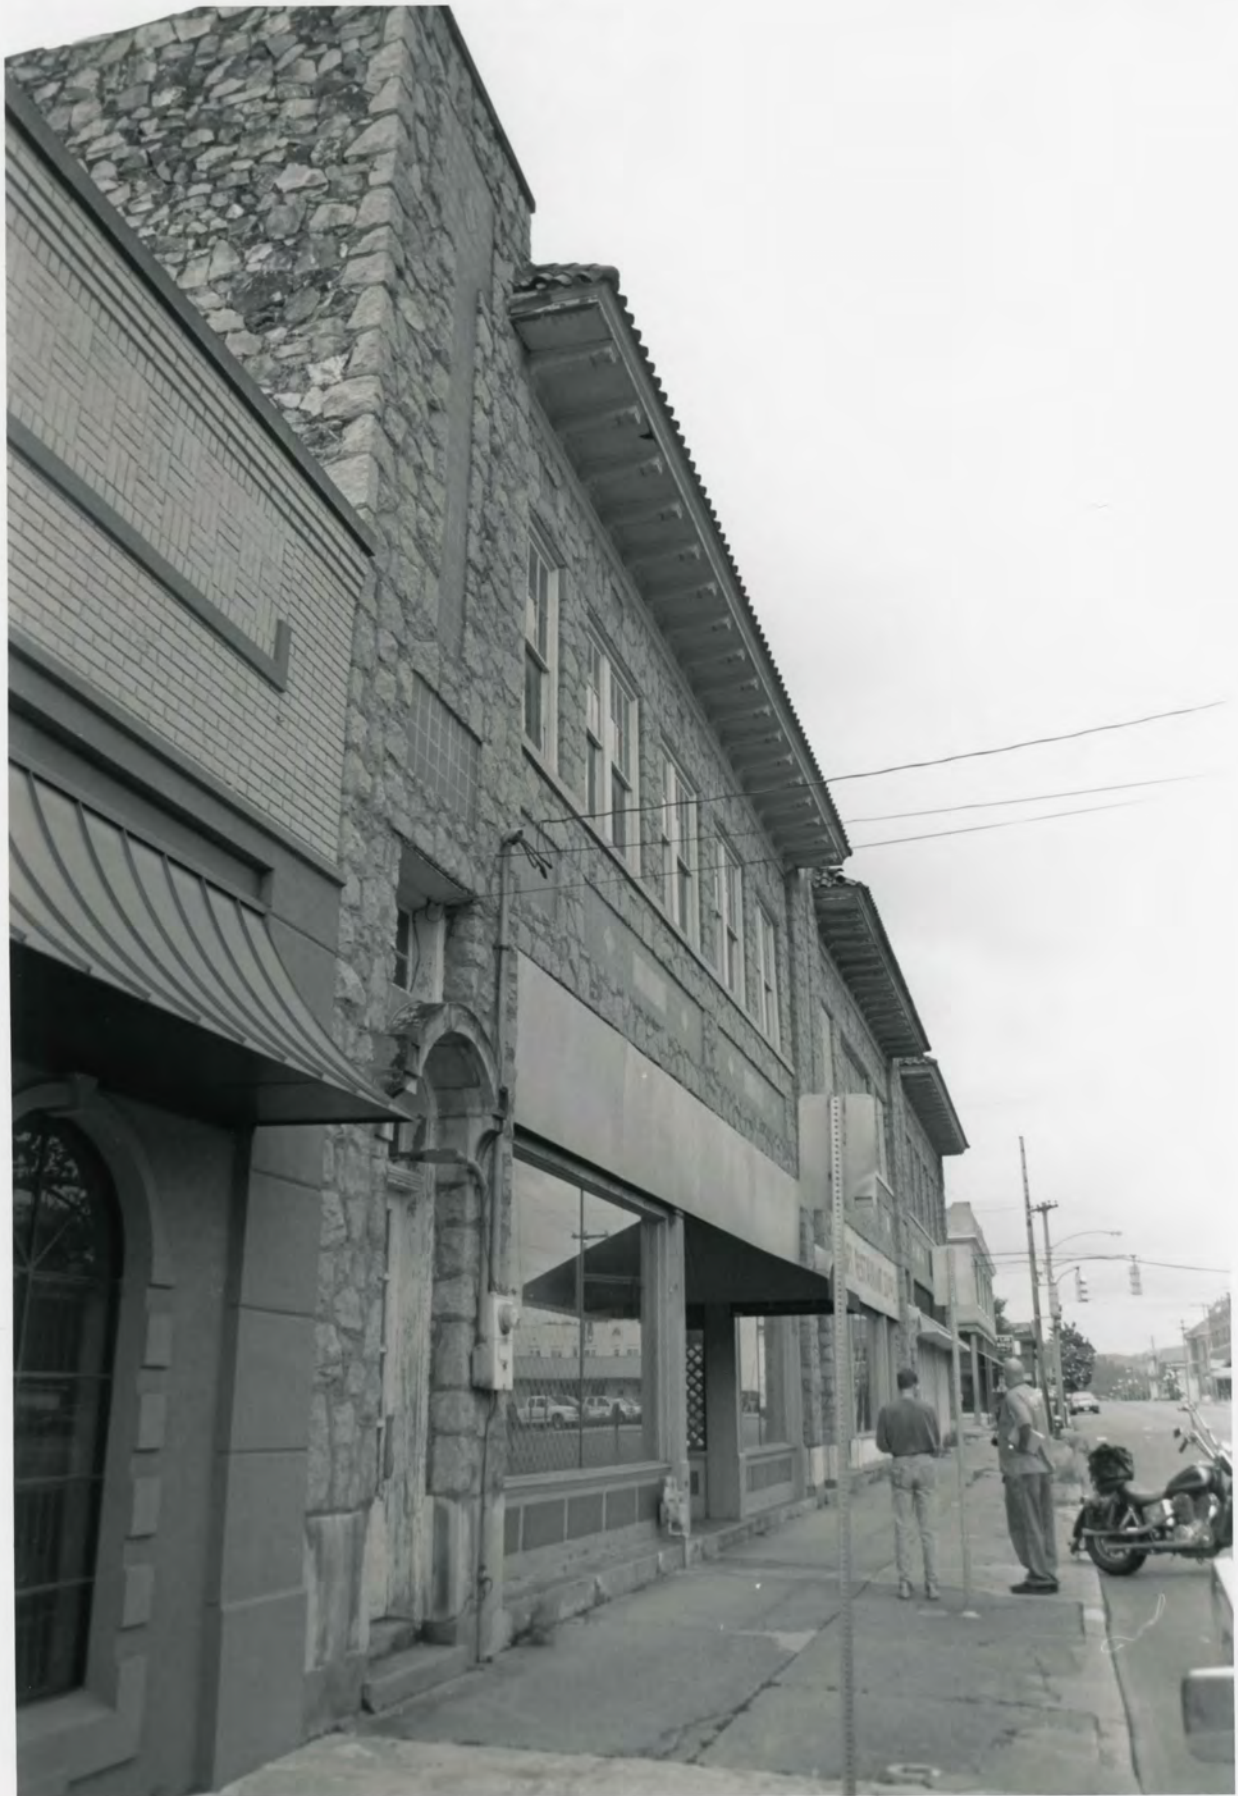
⑦ #4

⑥ Standing @ South Corner, looking east along  
SE elevation

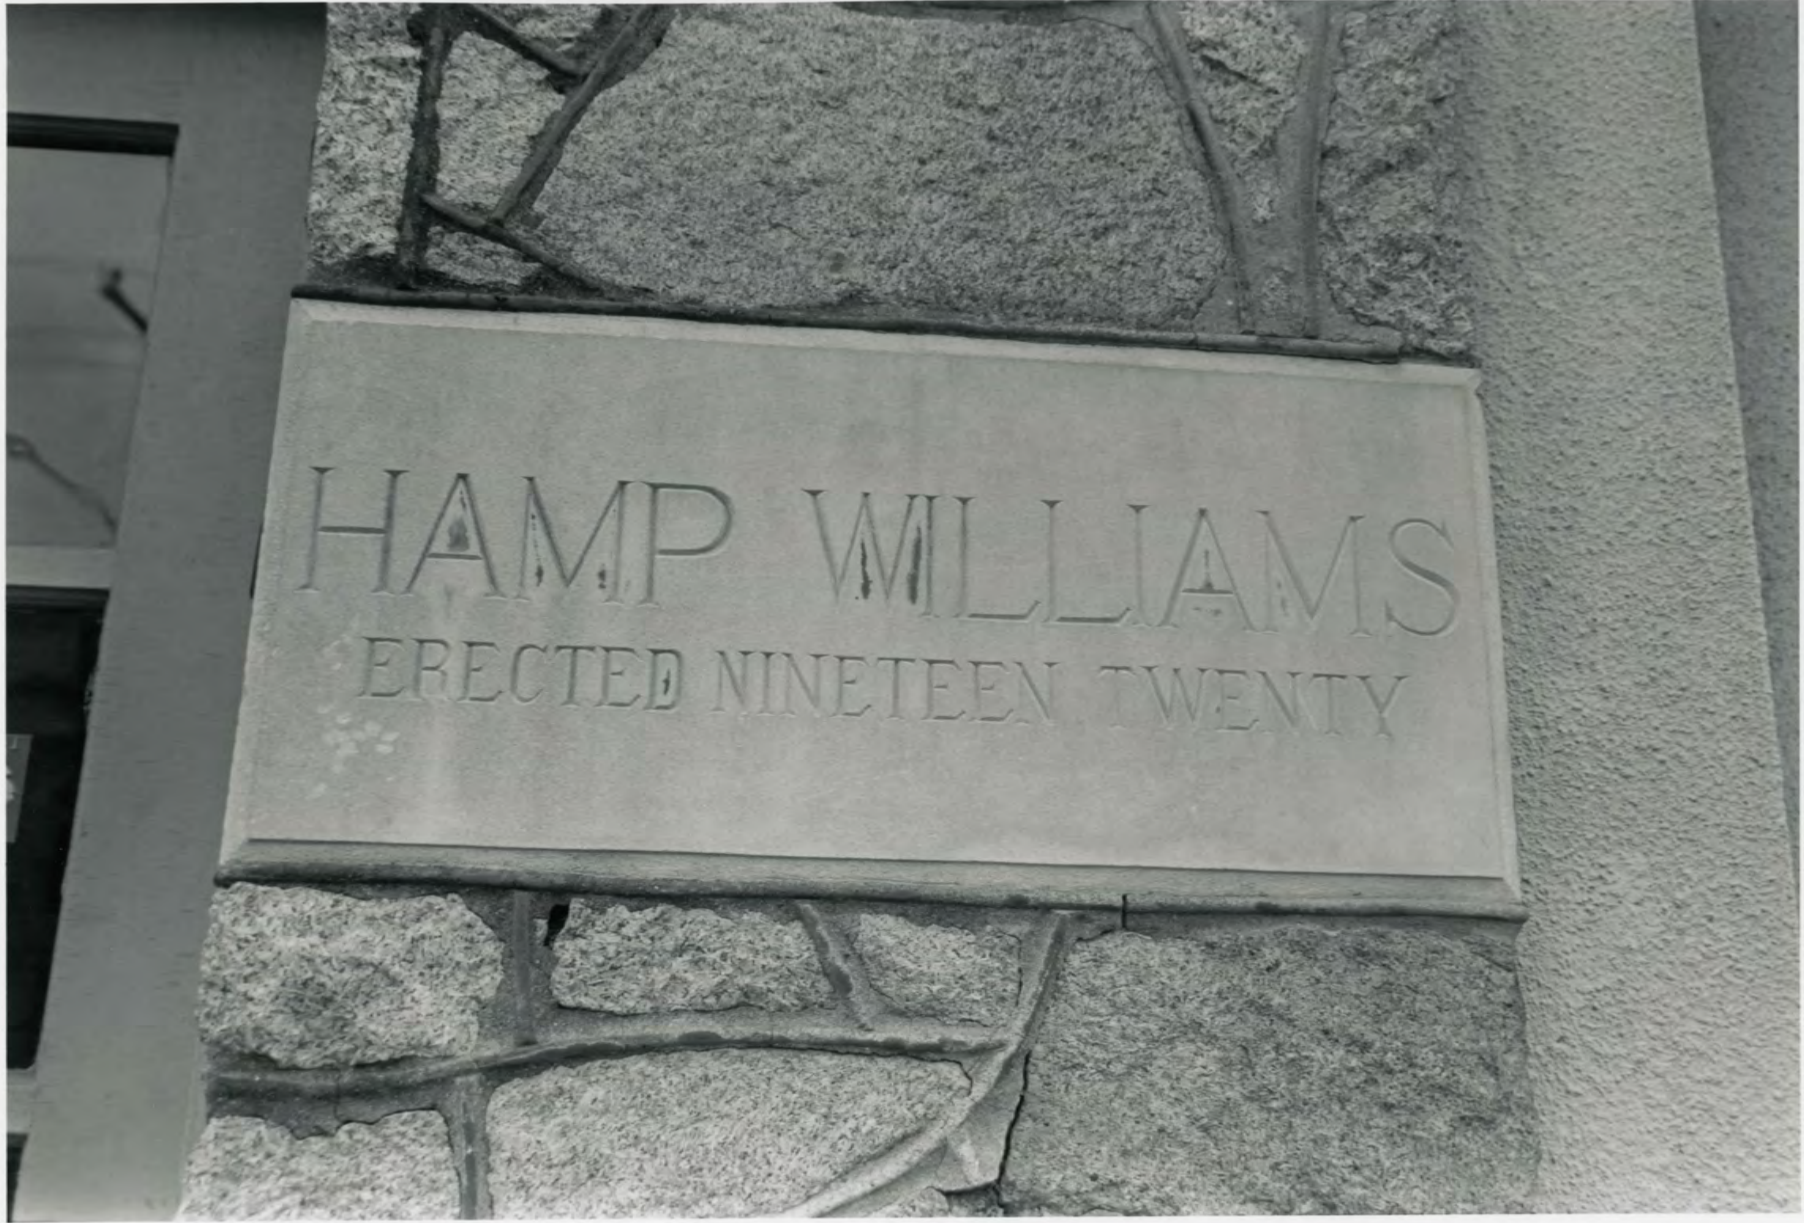
- ① Hamp Williams Building
- ② Garland Co, AR
- ③ Sarah Jampole
- ④ May 3, 2007
- ⑤ ATAP
- ⑥ Nameplate - 1920 - on the SE election
- ⑦ #15

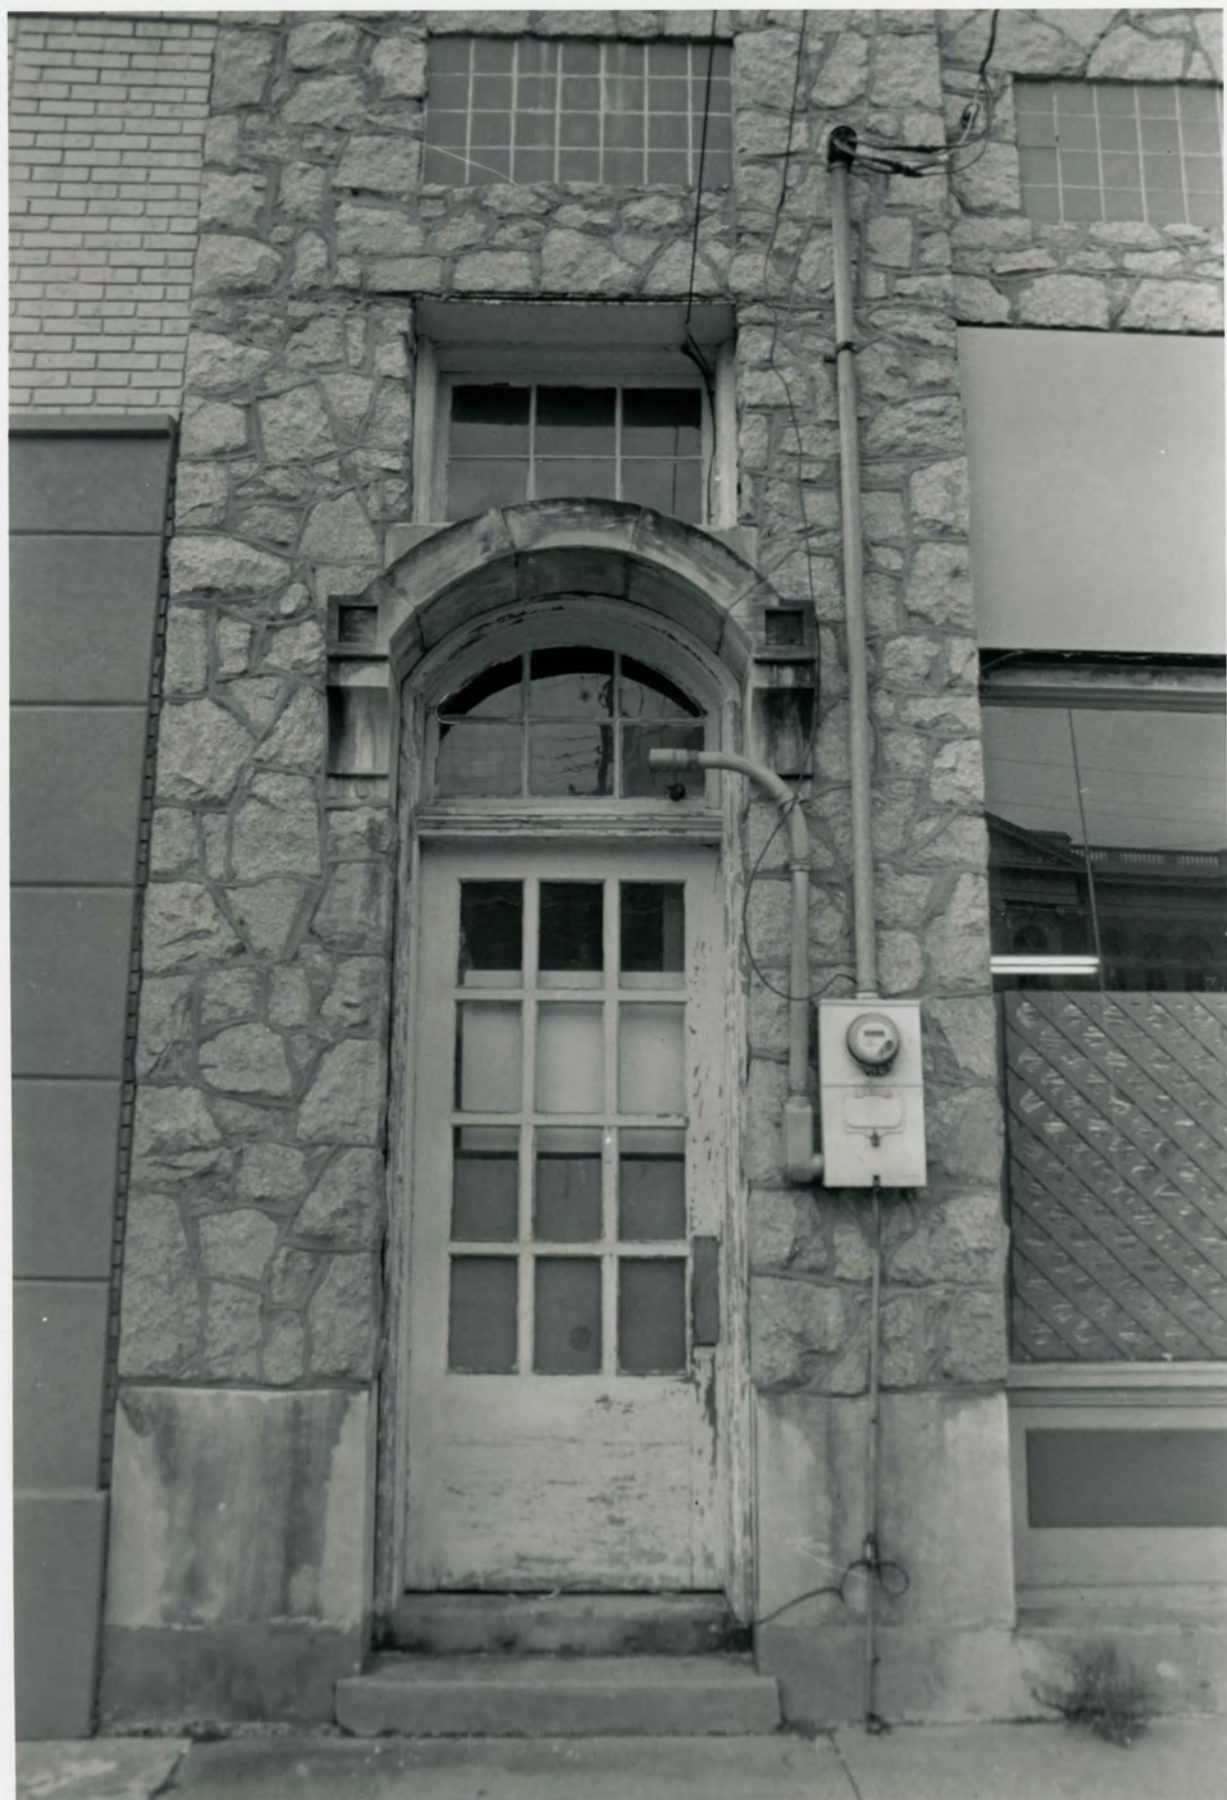
- ① Hamp Williams Building
- ② Garland CO, AR
- ③ Sarah Jampole
- ④ May 3, 2007
- ⑤ ~~AAAP~~
- ⑥ Entry door, far left bay of SE elevation
- ⑦ #7

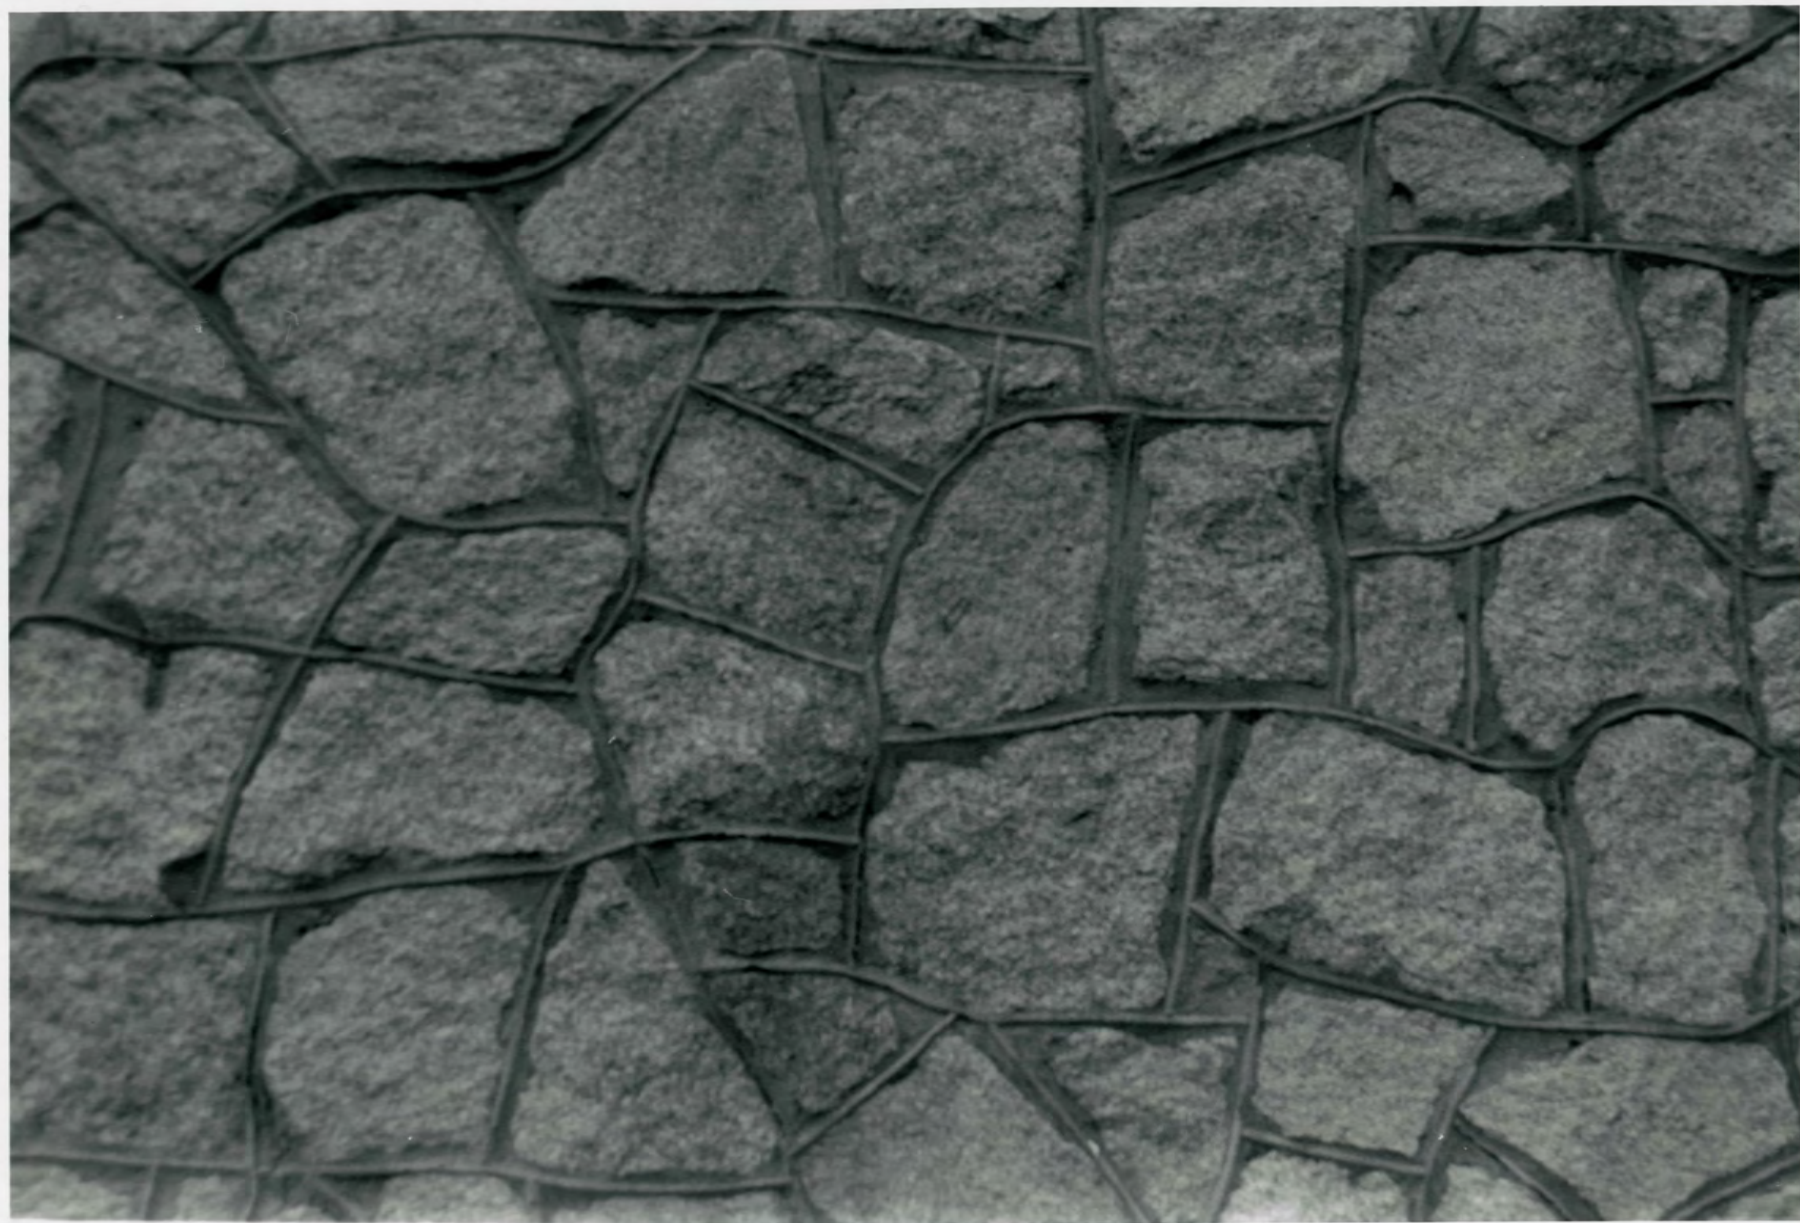
- ① Hamp Williams Building
- ② Garland CO, AR
- ③ Sarah Jampole
- ④ May 3, 2007
- ⑤ AHTP
- ⑥ Exterior wall material close-up, NE elevation
- ⑦ #8

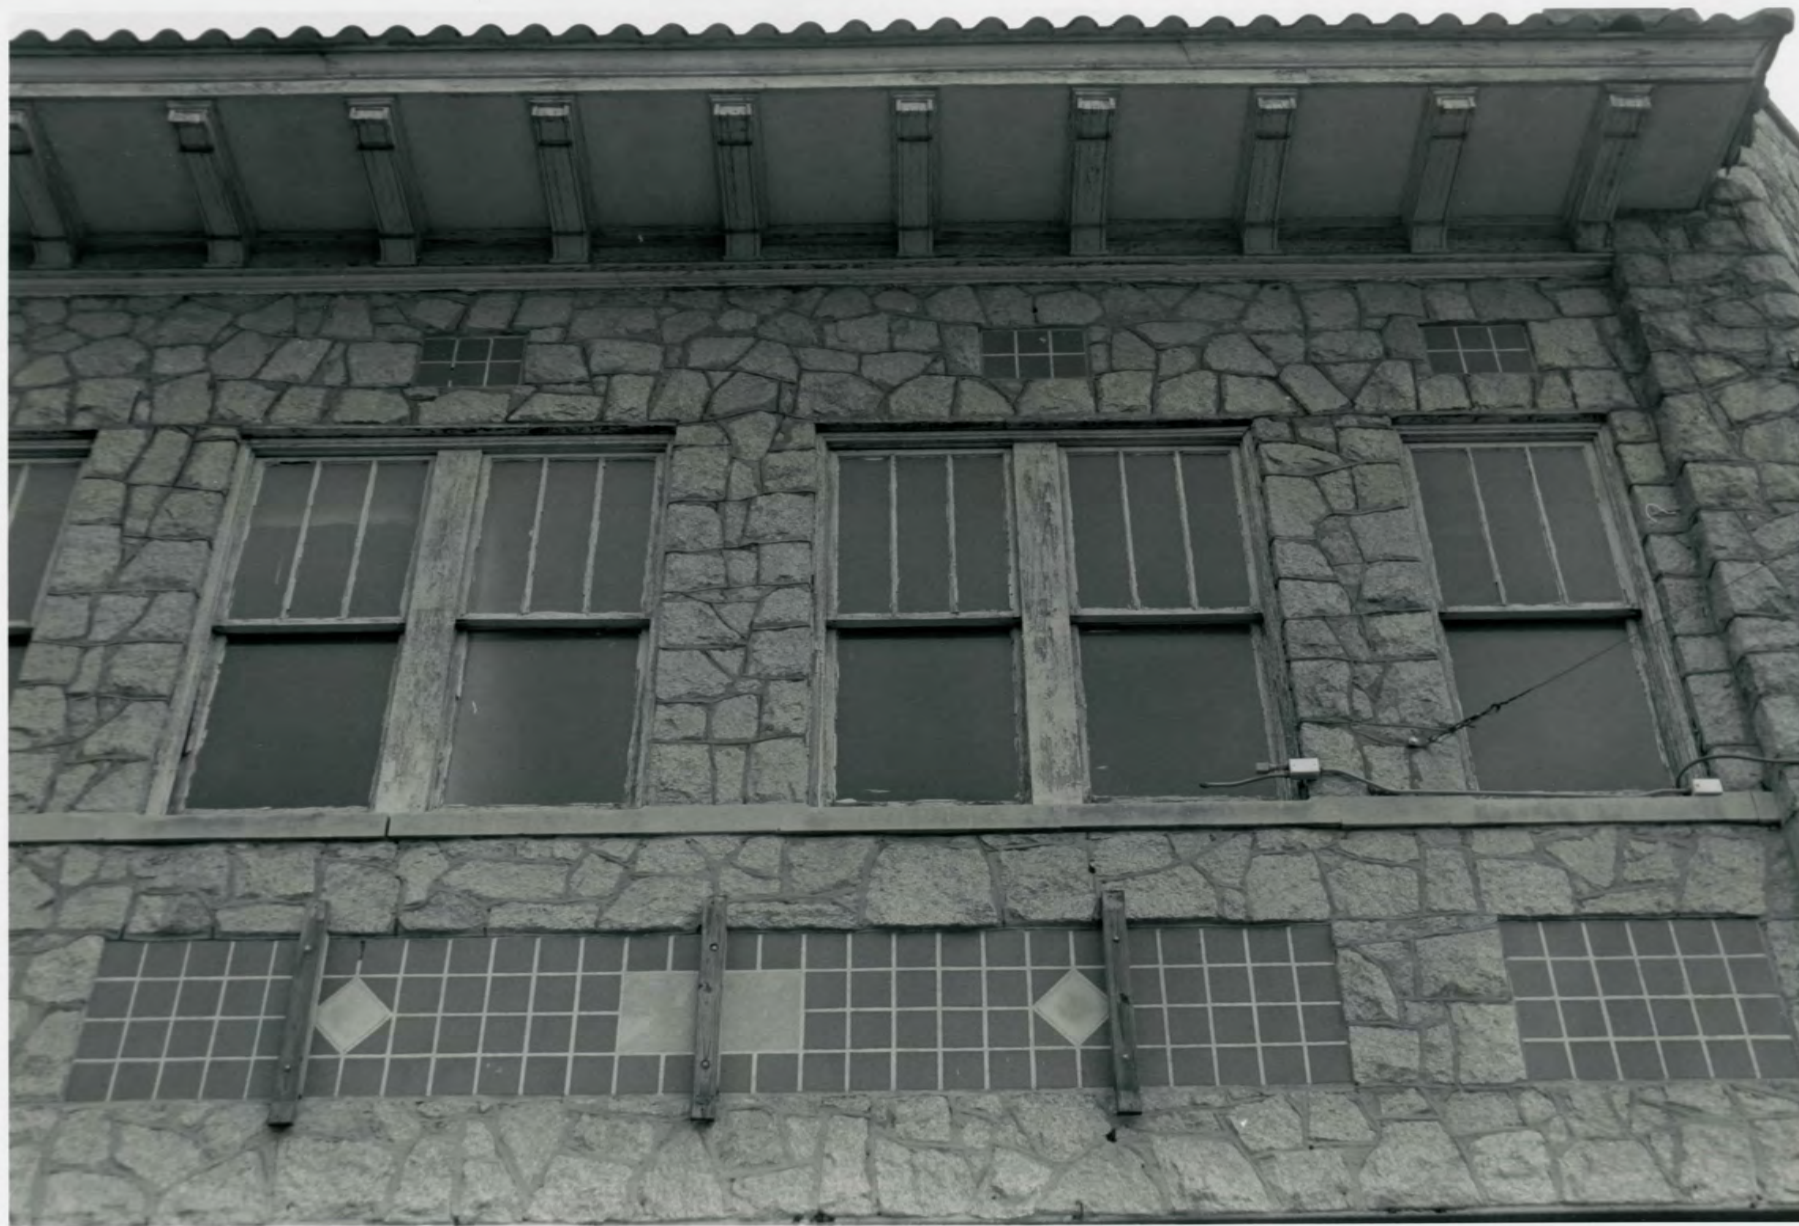
- ① Hamp Williams Building
- ② Garland Co, AR
- ③ Sarah Jampole
- ④ May 3, 2007
- ⑤ ~~WHP~~
- ⑥ Window fenestration, tile detail, eaves detail -  
upper story, SE elevation, far right bay
- ⑦ #9
