National Register of Historic Places Registration Form

historic name Keilman, Francis P., House

street & number 9260 Patterson St.

city or town St. John

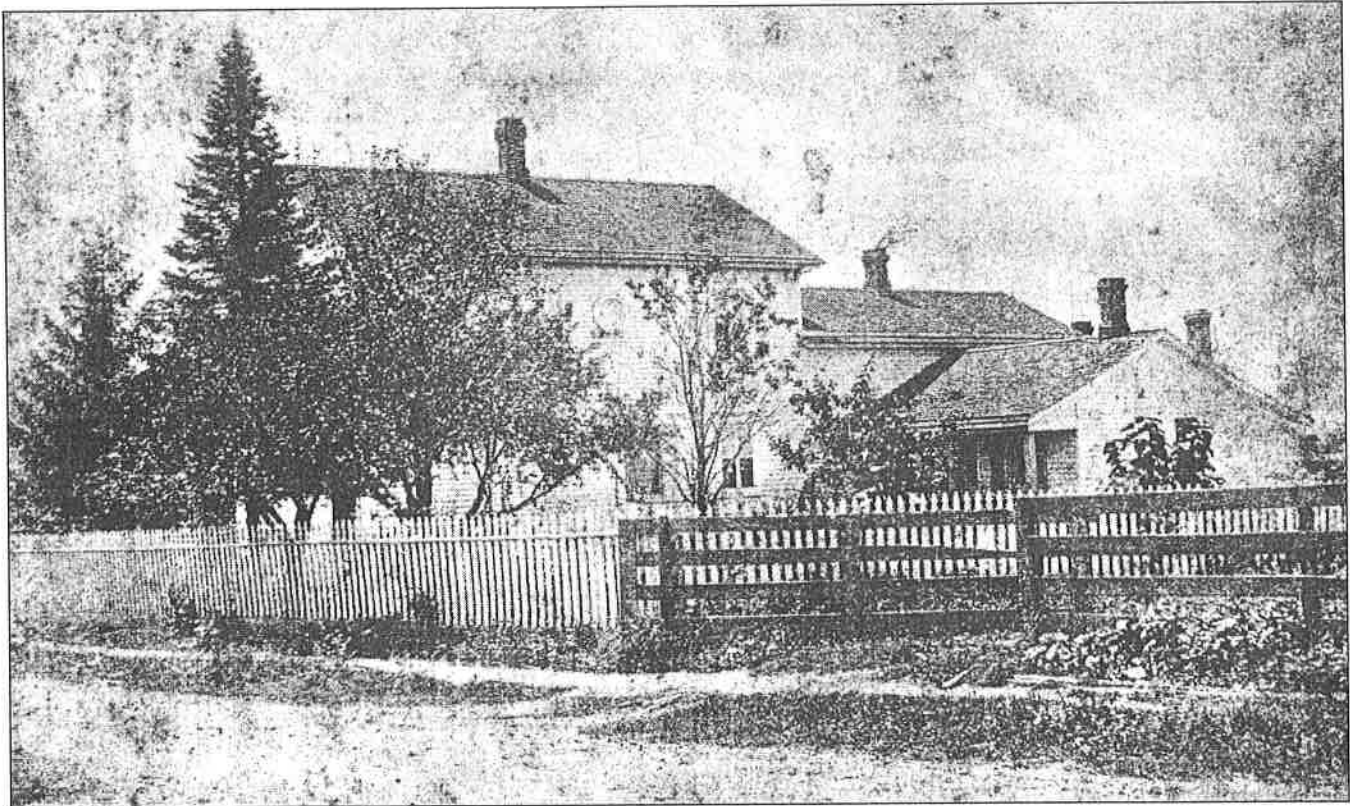
Section number Appendix A

This is a south west perspective of Francis P. Keilman House c. 1900, photographer unknown. This photo shows the addition to the west elevation of the old house showing where it attached to the old summer kitchen. Photo taken from St. John, Indiana : 1837 – 2001 published by St. John Historical Society.

³ A photo of the house c. 1900 showing the summer kitchen is located in Appendix A.
