KENTUCKY HISTORIC RESOURCES
Individual Inventory Form

Resource # SH-134
SHELBY County

1. Name of Resource:
William H. Ballard

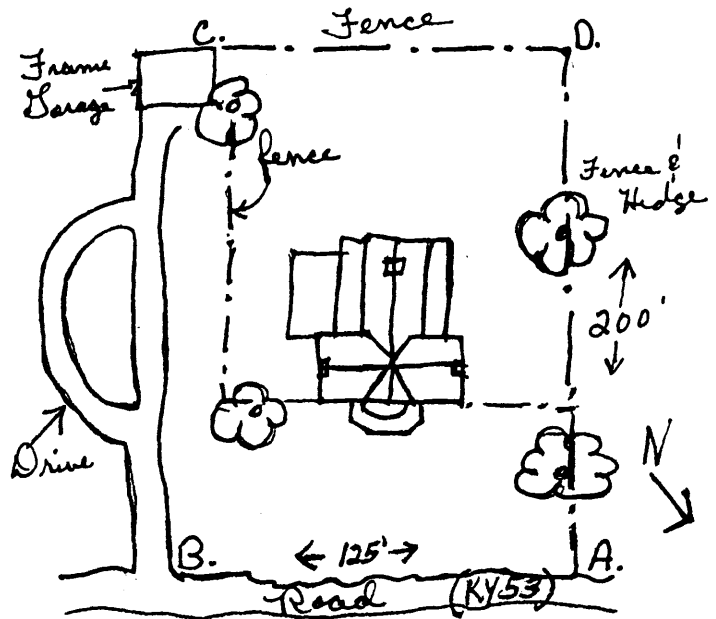
44. Site Plan (and boundary description and justification for N.R. sites):

Beginning at A, which is located in the northern corner of the yard at the intersection of a fenceline with the west edge of KY 53 and is 66 feet north of the northern corner of the dwelling, southeast 125 feet along the west side of KY 53 to B; thence 200 feet southwest along the north side of the drive to C; thence 125 feet northwest along a fence to D; thence 200 feet along a fence and a row of hedges to the point of origin. The boundaries were chosen to include the house its domestic-related space defined by fences, a drive, and KY 53. There are no contributing outbuildings.
