National Register of Historic Places Continuation Sheet

SUPPLEMENTARY LISTING RECORD

Historic name William Harlow CabinOther names/site number Evergreen Bar Mining Claim Cabin

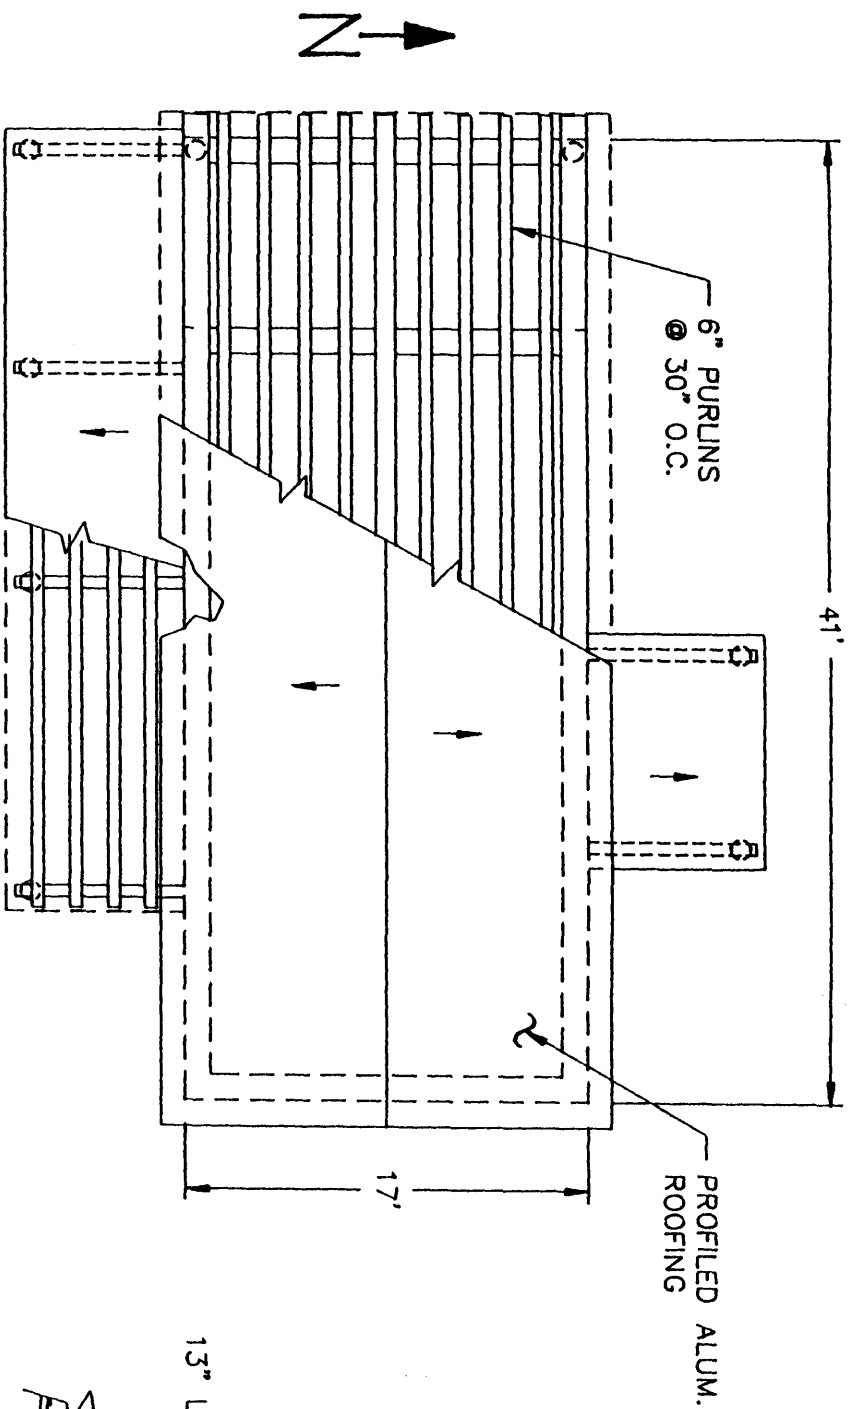
ROOFING PLAN

SCALE: 1/8" = 1'-0"

The attic floor joists are 6" peeled logs laid in the same manner as the first floor joists and set into notches cut to receive them in the exterior logs. The building has a gable roof with the ridge running roughly north-south. Rafters are 3"-4" peeled logs laid on approximate 24" centers. No ridgeboard was evident. Original roofing was 3' split shakes, now covered by a metal standing seam roof.

In the late 1950's a metal standing-seam roof was installed over the original sugar pine shakes. A corrugated metal roof, with a center clear corrugated fiberglass section, was installed over the shake roof of the west porch. In the early 1970's a new wood stove was placed in the living area on the main floor and a metal chimney was installed running straight to the roof. The older chimney, which passed through the floor and then exited the building's upper story through the south wall, was removed at this time. The exterior support for the chimney -- a shelf built of two-inch stock -- remains on the south elevation. Other modifications are minor. The northwest porch stairway was reconstructed following deterioration of the original element. Structural repair to the supporting porch piers was also completed at this time.

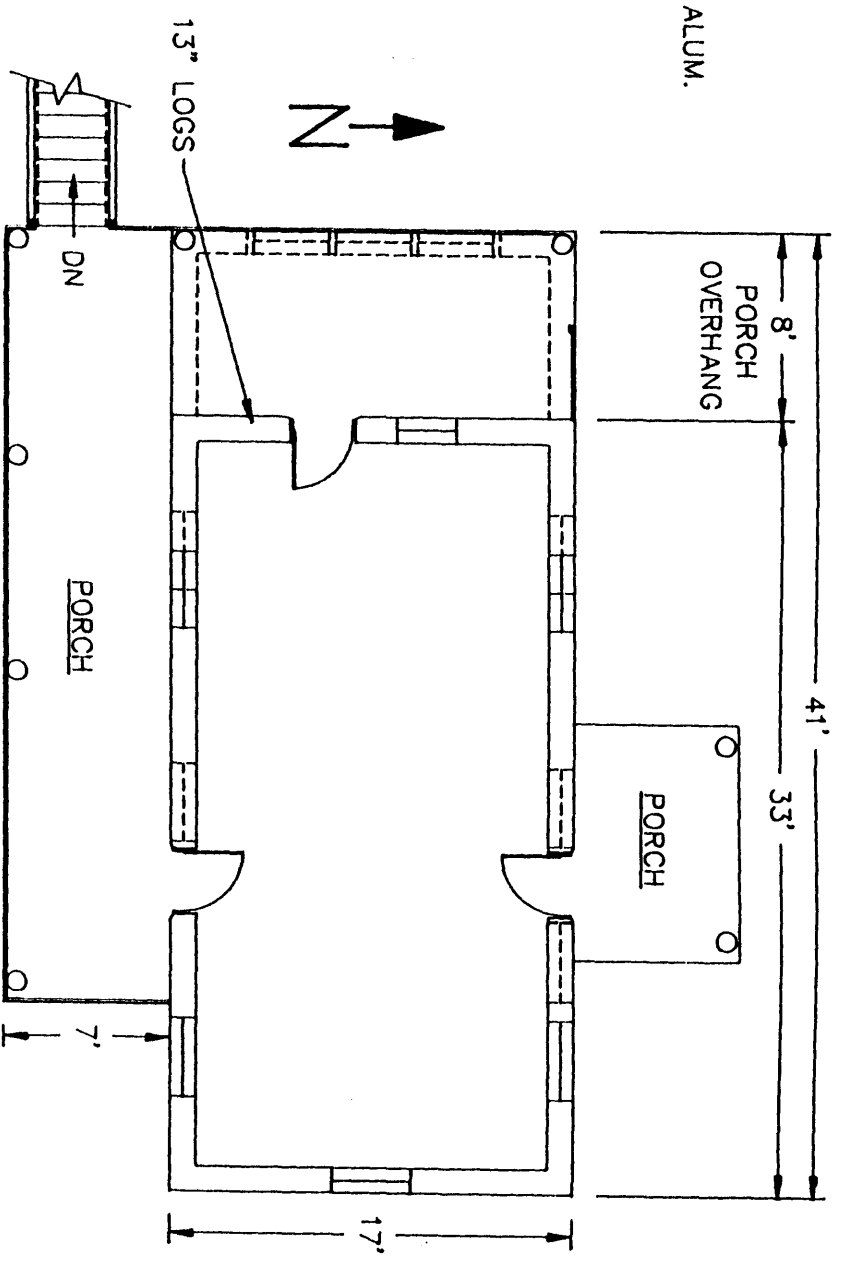
MAIN FLOOR PLAN

SCALE: 1/8" = 1'-0"

The cabin's interior plan is a traditional single-pen, consisting of one enclosed area originally built without interior division. The two spaces on the main floor, resulting from later partitions, serve as a living area and kitchen. A central stairwell gives access to the upper bedroom areas.

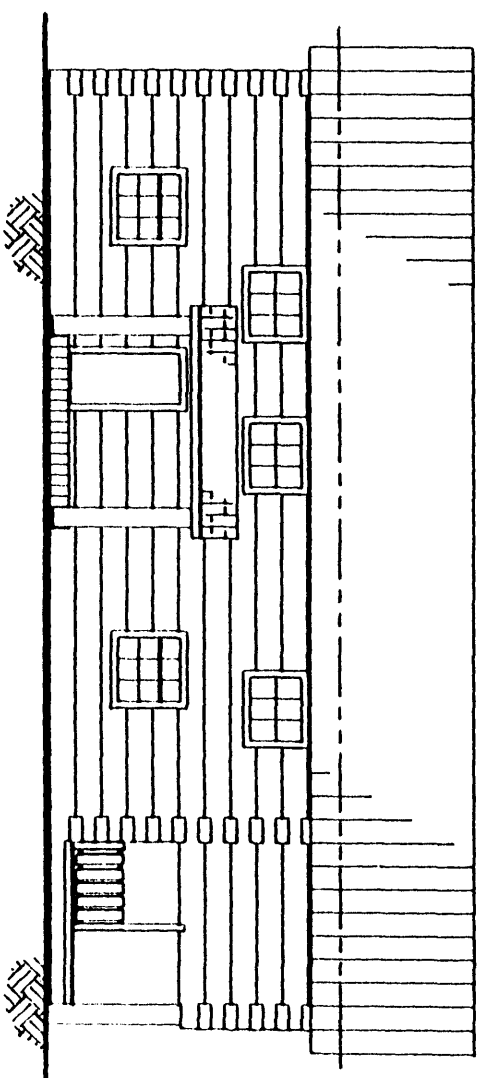
NORTH ELEVATION

SCALE: 1/8" = 1'-0"

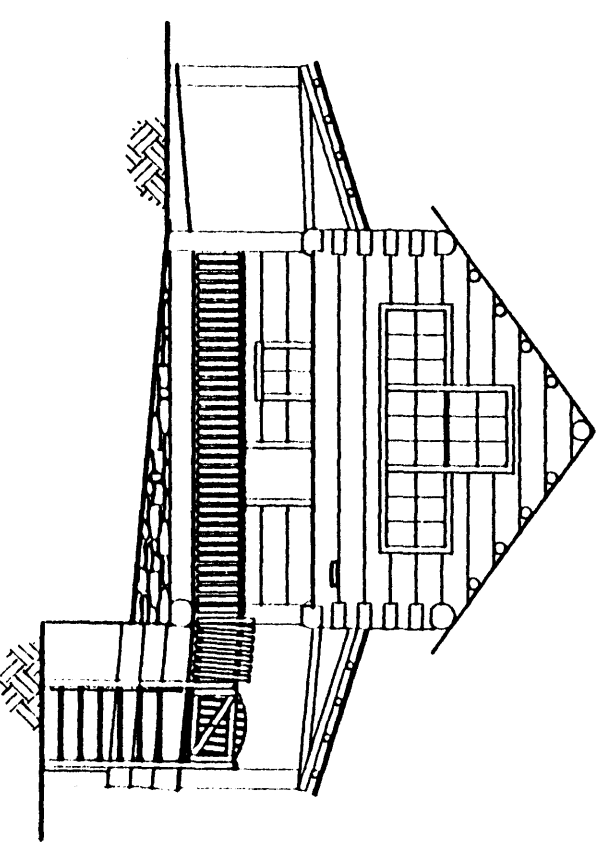
WEST ELEVATION

SCALE: 1/8" = 1'-0"
