KENTUCKY HISTORIC RESOURCES  
Individual Inventory Form

Resource # 208  
Shelby County

1. Name of Resource: Marene Duvall House			16. Date: Original Building ca. 1811 [ 8 ] Addition 1970's [ 2 ]		
2. Original Owner: ? Hall			17. Style: Settlement Vernacular [ 2V ] [ ]

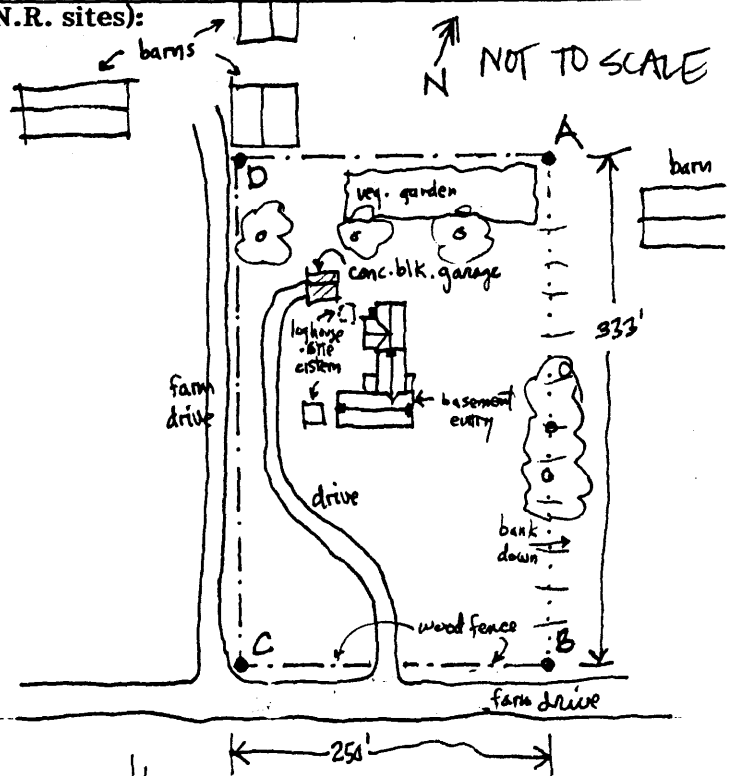
Total Acreage in Present Property: 255.8 43. Acreage included in proposed N.R. boundary: 1.91  
Site Plan (and boundary description and justification for N.R. sites):

Beginning at A, south 333' along an embankment and former tree line to B, thence west 250' along a wood fence to C, thence north 333' along a fence bordering the east side of the drive to D, thence east 250' along a fence to the point of origin. The boundaries were chosen to encompass the house and its domestic-related space as defined by fences and an embankment with remnants of a former tree line. Included is a non-contributing concrete block garage.

Point A is located in the northern corner of the yard and is 173 feet north of the northernmost corner of the ed.

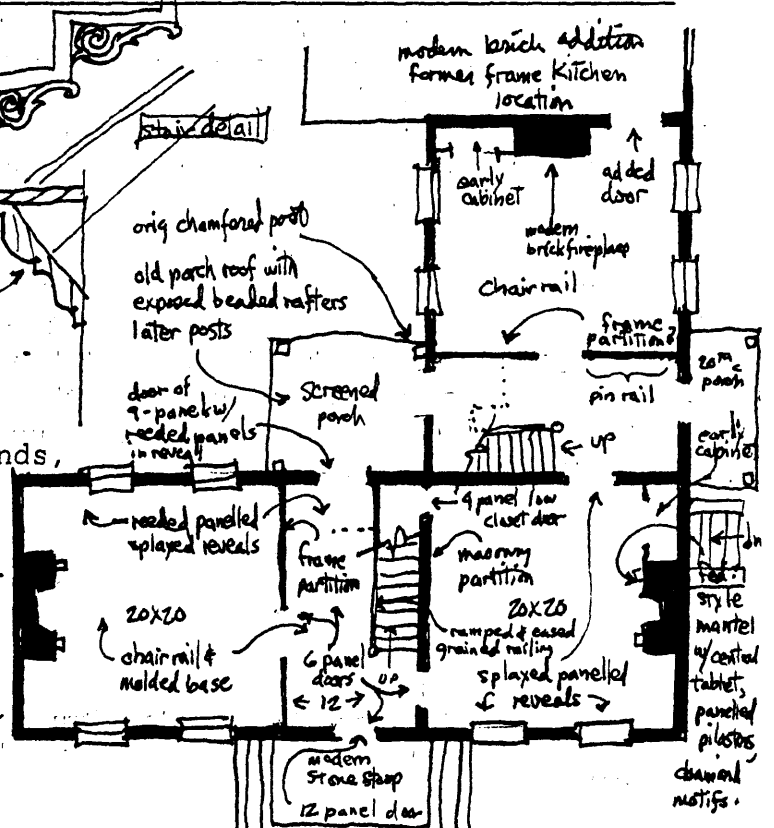
Description and House Plan:

**Exterior:** Two-story five-bay brick center-passage house with a two-story integral ell containing a second passage and a room on each floor. Flemish bond principal (south) facade and 6-course American bond elsewhere. Brickwork pencilled with a grapevine joint. Splayed jack arches and original blinds with pintle hinges and wrought iron shutter dogs (south front only). Segmentally arched basement vents with horizontal bars. 9/6 sash, tapered beaded rakeboards, molded backbands, cornice with plain angled crown and molded bed. Rear porch in angle of ell has old roof with exposed beaded rafters and one original chamfered post (other posts replaced). One-story 3-bay front porch removed (not original) and modern stone stoop added on south front. Interior chimneys.

Basement entry at northeast corner of main house has original stone steps and wings, beaded batten door with brick relieving arch over wood lintel; modern bulkhead over. Modern brick 1-story wing to rear (north) occupies site of earlier frame kitchen. Stone foundation throughout original section.

Interior: Basement: under entire house including ell, no fireplaces, only partitions correspond to masonry partitions on floor above, up and down sawn joists. West room: first floor: molded base and chairrail, enriched Federal mantel with panelled pilasters and central tablet and end blocks, reeded panelled splayed reveals at windows. Passage: doors have reeded reveal panels and 6-panel doors except unusual twelve-panel front door and rear nine-panel door. Ramped and eased stair rail with carved stringer brackets, chair rail. East room: more ornate mantel, similar to west but with incised diamond motifs in tablet and end blocks, and a band of incised dentil or triglyph motifs under the molded shelf. Early cabinet to north of chimney, chairrail and molded base, panelled splayed window reveals, also panelled reveals at doors (not reeded). Rear passage: has closed stringer stair with square balusters, pinrail beside door on east wall. The ell room has been altered, but retains early chairrail throughout and cabinet beside chimney. 2nd floor of ell did not originally connect to main block. 2nd floor mantels are of shelf-and-architrave type.
