National Register of Historic Places Registration Form

historic name Arlington Club

street & number 811 SW Salmon Street

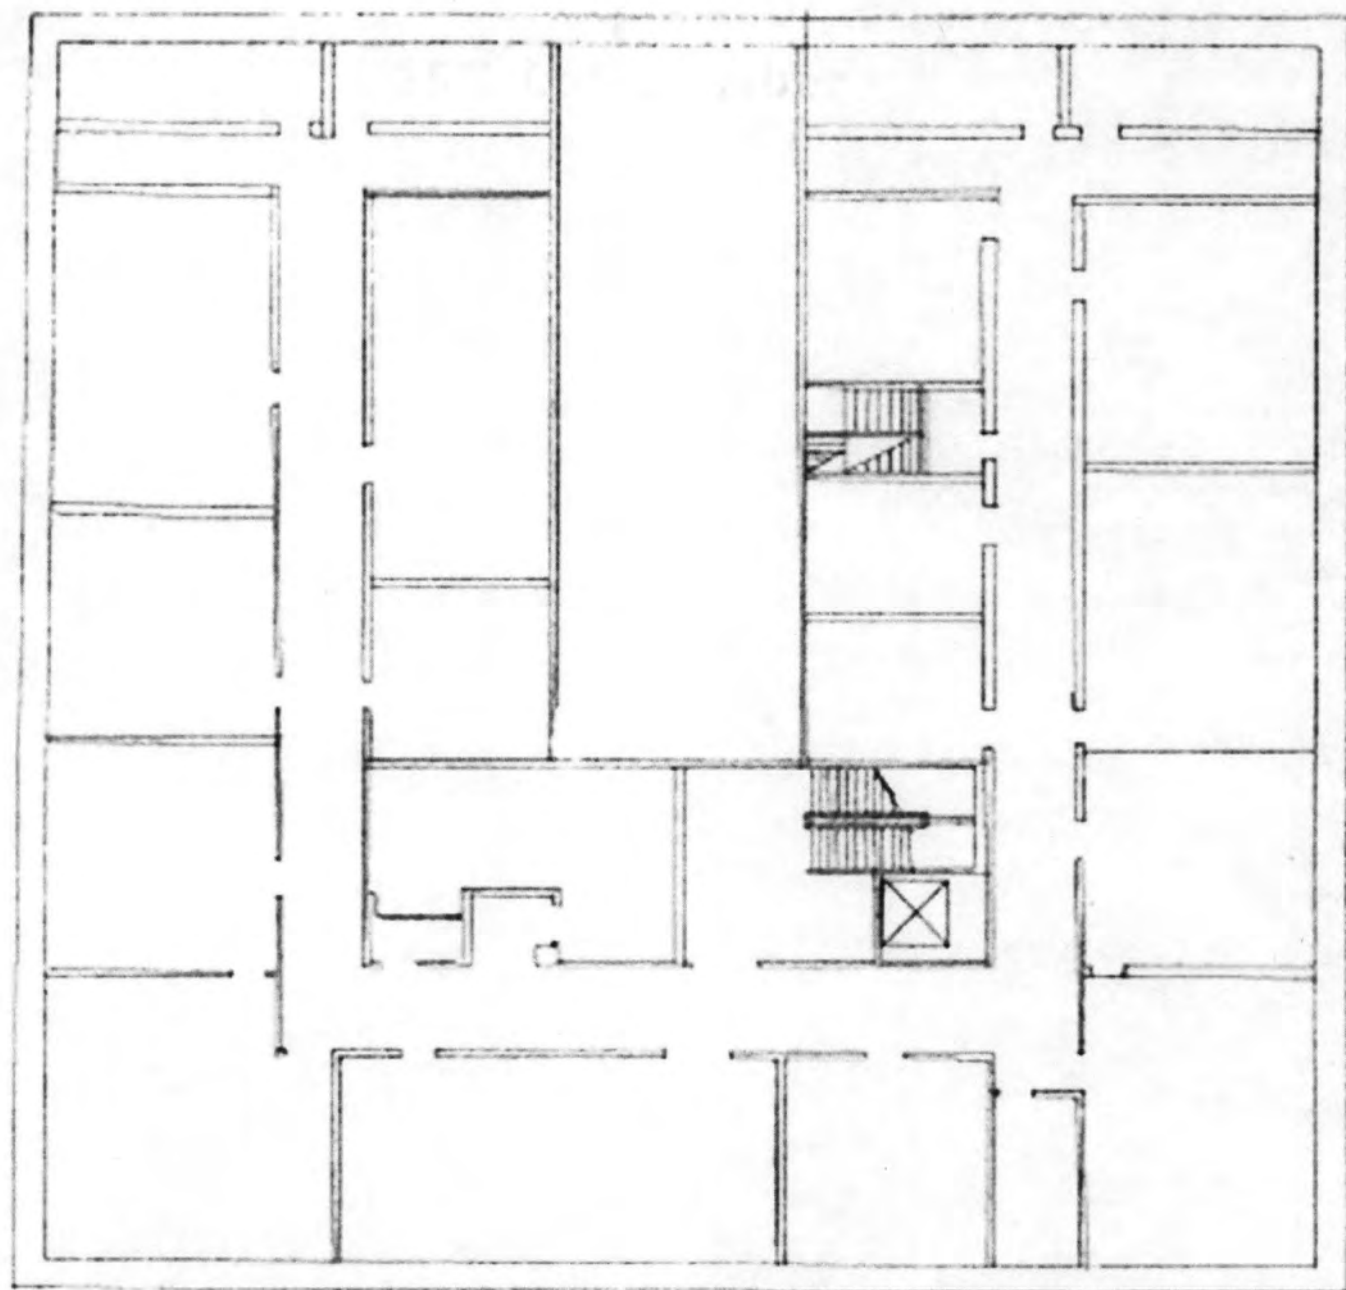
Figure 4

Typical Upper Floor Plan

The third floor, as built, was devoted largely to guest rooms. Today, the third floor has been adapted for use as small meeting rooms accessed by a "U" shaped corridor. The fourth floor is similar to the third except that it remains as guest rooms with a mix of two-room and single room units and club offices at the northwest. In total, the floor has eight units.

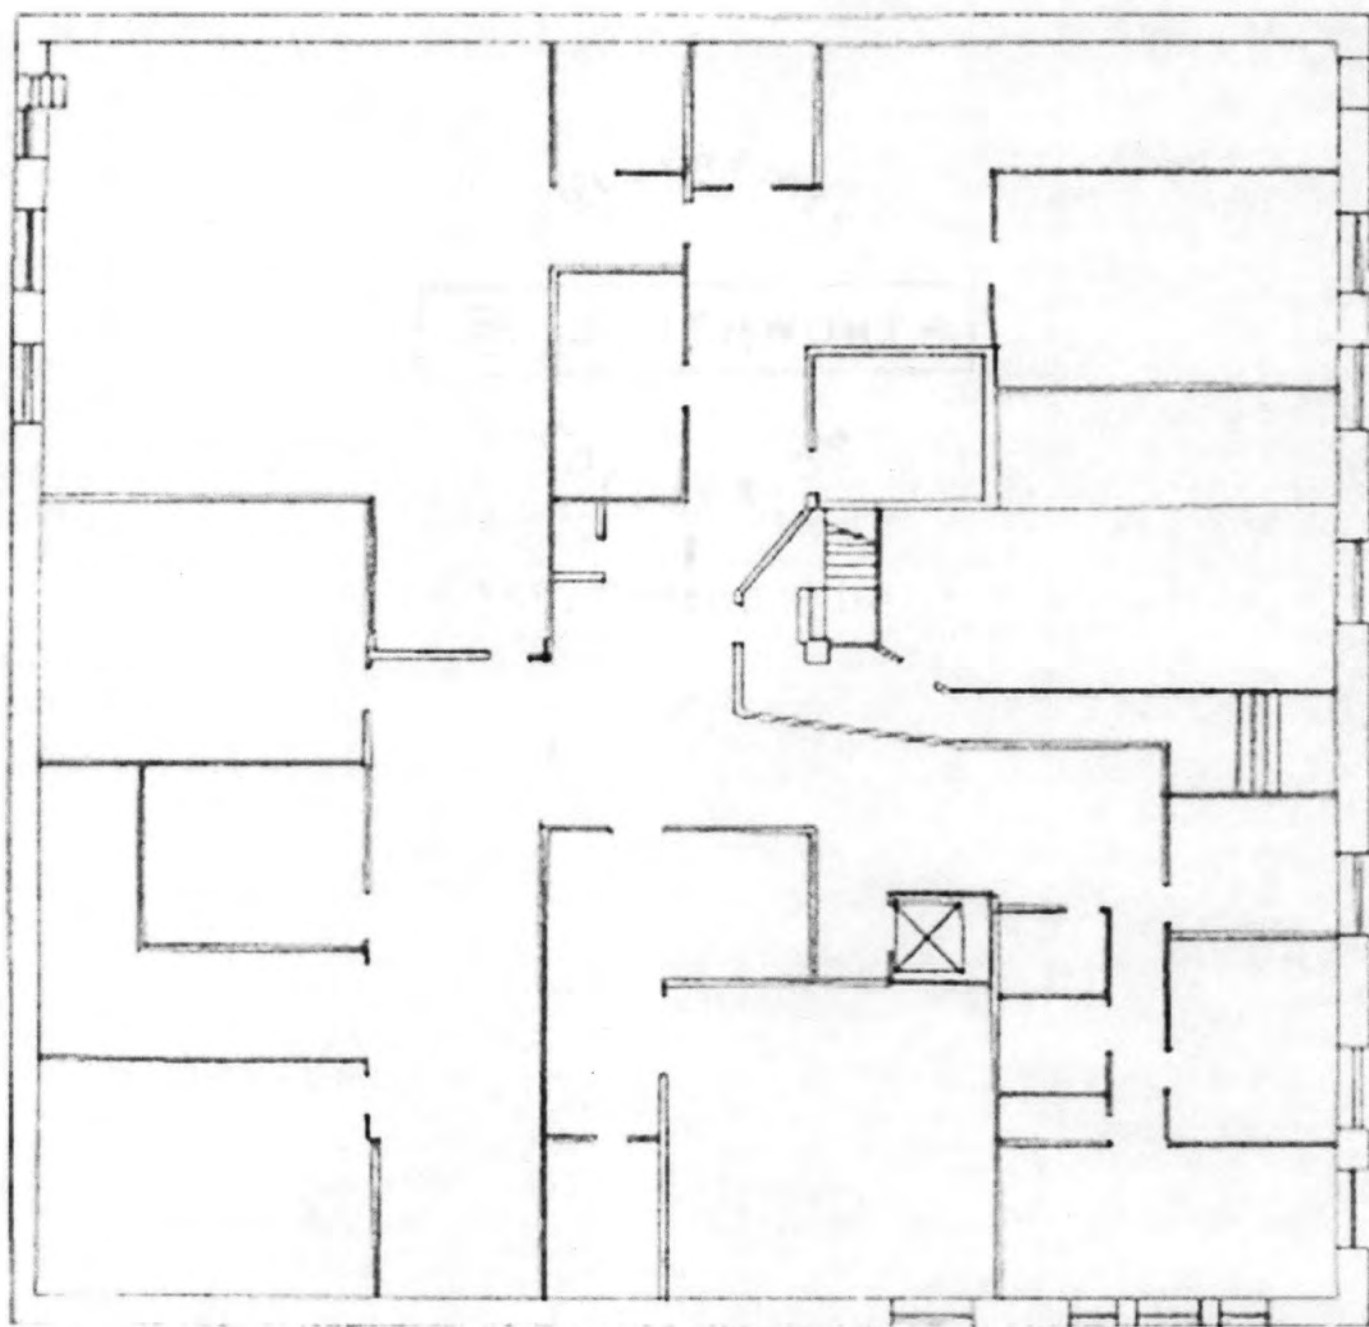
Figure 5

Basement Floor Plan

The basement is dedicated to service uses with utilitarian finishes. These uses include storage and back-of-the-house rooms.
