# HISTORIC PROPERTY INVENTORY FORM

Site No.: 211  
Site Name: Historic J.A. THRONSON HOUSE  
Common Danielson Home  
Field Recorder: NC/ER  
Date Recorded: 10-30-85  
Owner's Name: Inez Longen  
Street: 510 S. Fourth  
City/Town: Dayton  
County: Columbia  
Zip Code: 99328

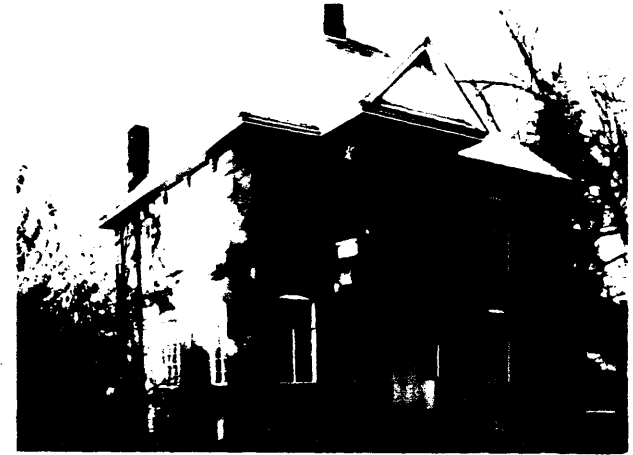
Photography Neg. No.: 2+11 & 2+12  
(Roll No. + Frame No.)  
View: Southwest facade  
Date: 10-30-85

This house is on a large landscaped corner lot. It has a square plan with a gable on hip roof. There is a two story porch and balcony projection with a pedimented roof with full returns on two facades. They are punctuated with horseshoe shaped brick arch openings and decorated brick drop labels. A dentil brick belt course surrounds the house. There is a round vent in gable of roof and a pedimented dormer with half round window on north facade. It has boxed eaves with brick brackets underneath. Roof is aluminum sheets. East pediment is of colored blue and gold glass set in stucco. Ornamental steel reinforcing rods are exposed at first floor porches. Interior is plain except for spindlework frieze at stairway.
