KENTUCKY HISTORIC RESOURCES INVENTORY

2. Present Name
Richardson House

3. Location
547 Lawrence Street

Historic Property Name Richardson House Site # MD-B-16

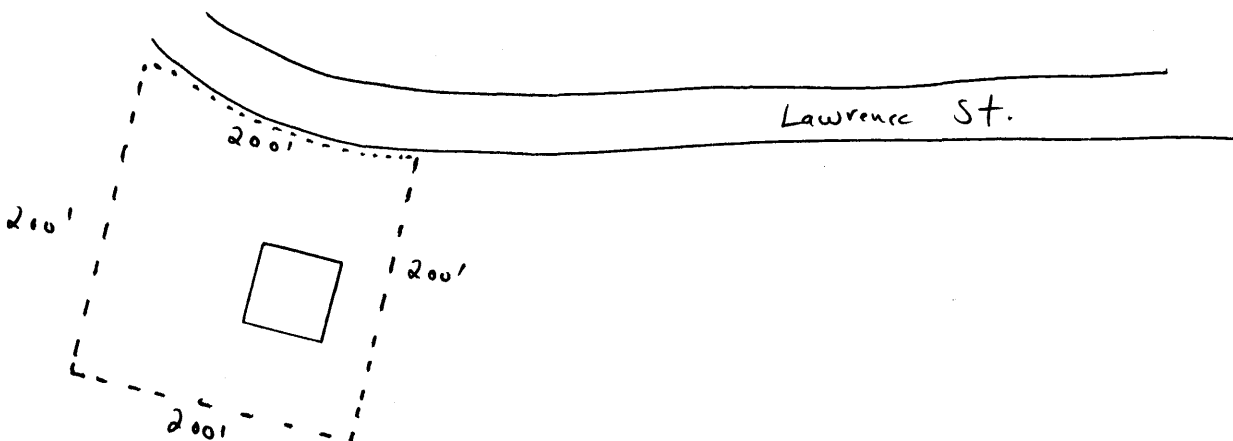
Sketch of Site Plan (Showing outbuildings, structures, landscape features and the site boundary as described above.)

Beginning at a point on the south side of Lawrence Street, approximately 100 feet from the center of the house, proceed 200 feet in a southwestward direction; thence 200 feet in a northwestward direction; thence 200 feet in a northeastward direction; thence 200 feet in a southeastward direction along the south side of Lawrence Street to the point of origin.

Not to scale
