National Register of Historic Places Registration Form

historic name Proctor, William House

street & number 7037 SR 64

city or town Marengo

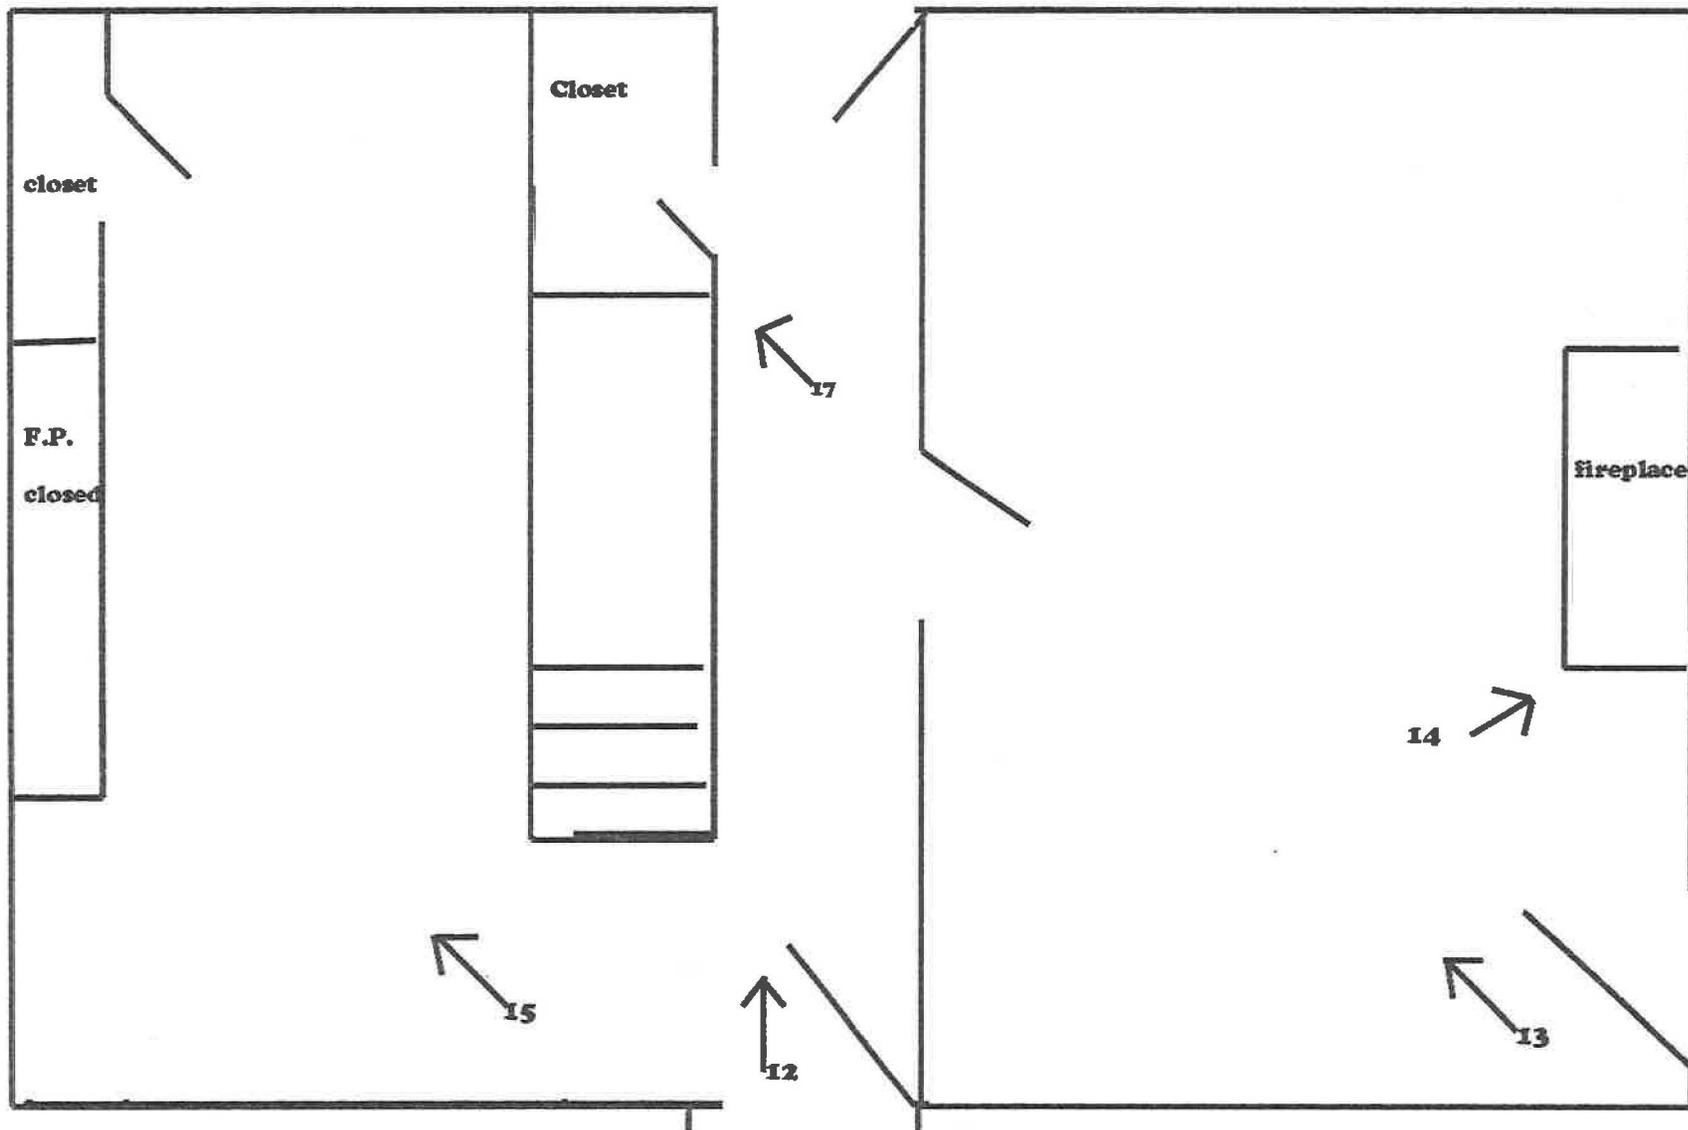
First Story

The interior of the first floor is laid out with a central hall with the brick masonry wall to the right (west) as one enters (Photograph 0012). A stair is within the central hall and a plaster and lath wall abuts the stair and creates the first floor room on the left (east). The western room has the finer details and was probably the public room of the house (Photograph 0013). There is a six-panel door in the opening between the hall and this room. The walls and ceiling are plaster. The floor is the original four-inch wide wood, probably poplar, laid parallel to the front of the house. The woodwork is simple and painted. There is an original fireplace surround and mantle, a nice and somewhat elaborate (for 1830s Indiana) example of Federal design with recessed panels in the surround (Photograph 0014). The rear (southern) wall of this room has new framing for a window that will be replaced into its original location. The window was removed and a door was placed in this wall when the non-historic addition was added. The eastern room has a wider plank floor, plaster walls and a wide bead board ceiling. The simple woodwork is painted. The original fireplace in this room has been enclosed behind a sheetrock wall. A flue cover is visible on the wall above the location of the fireplace. A closet created by the sheetrock addition is to the south of the location of the fireplace (Photograph 0015).

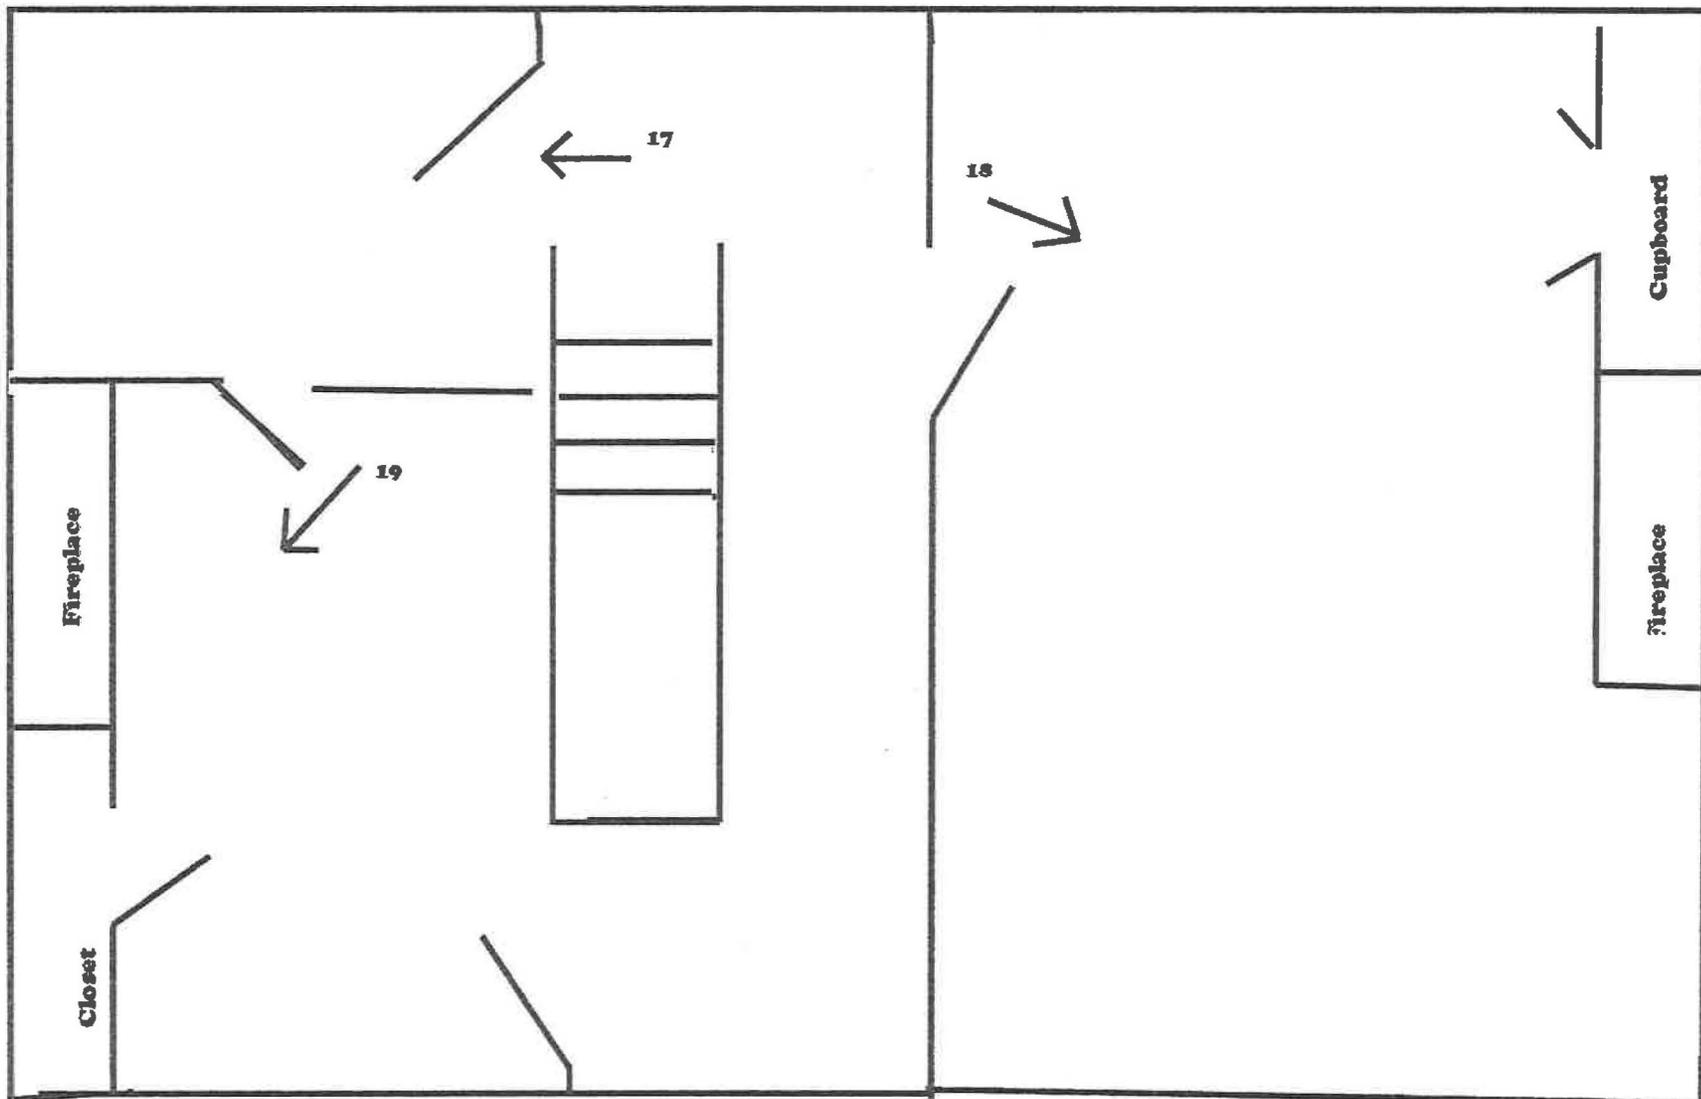
Second Story

At the top of the stairs, the landing opens into rooms on both sides and a hall extends to the south opening into secondary doors to both side rooms. The western room has its original wide wooden floor, bead board ceiling, original simple wood work, and original fireplace with surround and mantel that matches those in the eastern room (Photograph 0018). The eastern room retains its wide wooden floor, bead board ceiling, original fireplace with simple mantel and surround, original
