# National Register of Historic Places Registration Form

historic name Casa Vives

street & number 88 Calle Paseo Atocha, corner Calle Castillo

**Casa Vives** is an 1860, L-shaped layout, brick and masonry, two-story, Neoclassical, flat-roofed with parapet building located at 88 Paseo Atocha, corner of Castillo Street, two blocks north from the main plaza of the traditional urban center in the municipality of Ponce. The residence occupies a lot of one thousand one hundred and seventy-four (1,174) square meters. Possibly designed by architect Juan Bértoly Carderoni, as stated by many, and built by Carlos Milán, **Casa Vives'** elegance, details, materials and quality of craftsmanship, it's one of the best preserved nineteenth century houses in the island. The building epitomizes the quintessential architecture associated with the 19<sup>th</sup> century upper classes that projected their class vision upon the built landscape of the major urban centers in the island, been the city of Ponce probably its best example.

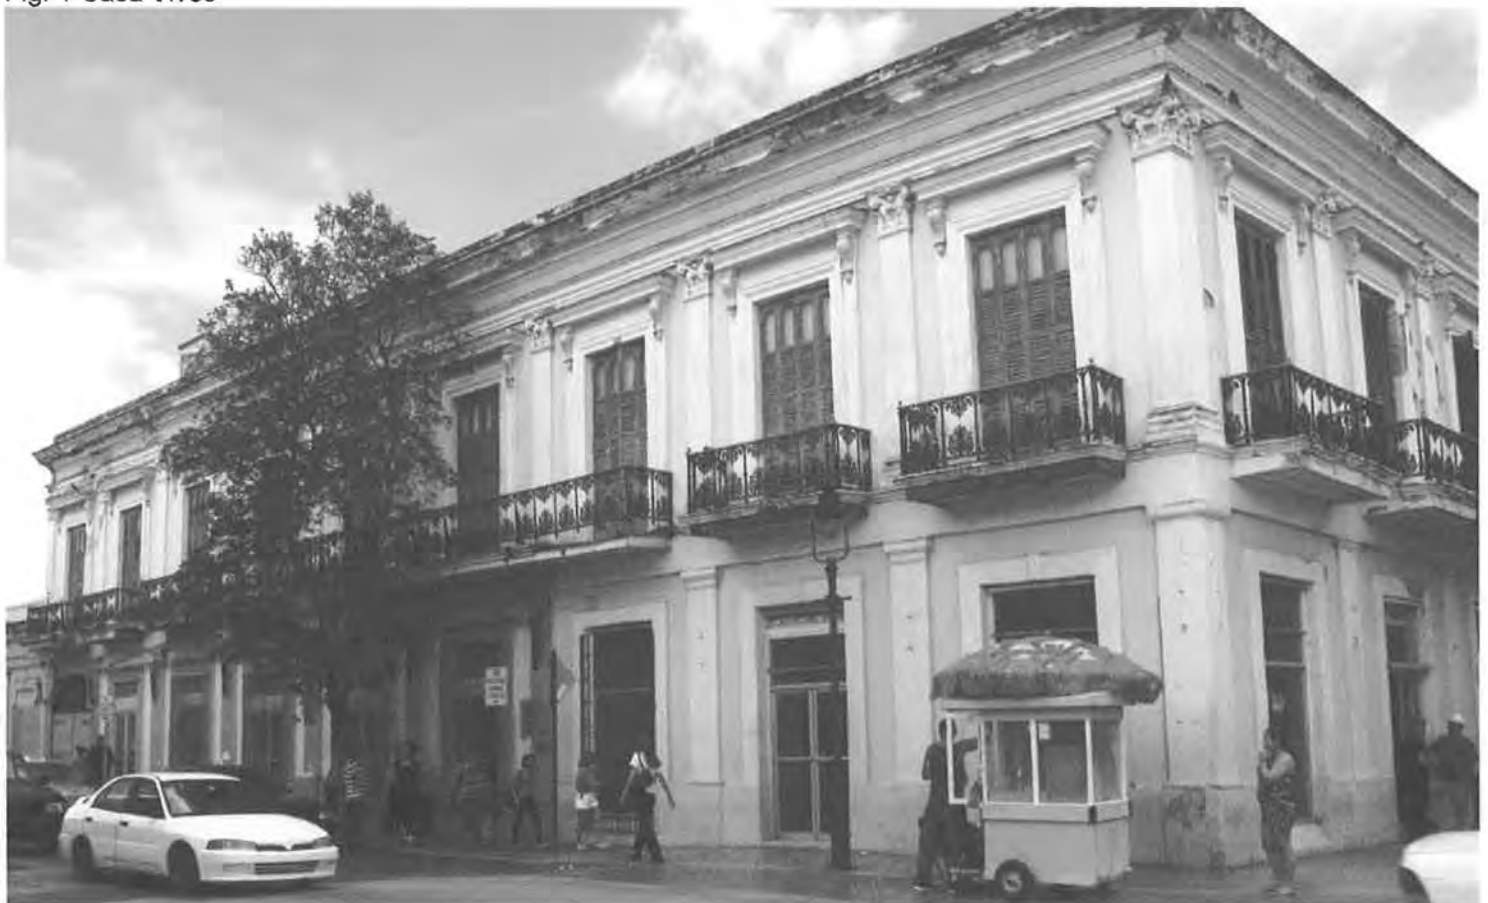
Fig. 1 Casa Vives

The second level received a more complex treatment, to emphasize its social significance. The upper level façade is completely articulated around its many openings. There are thirteen sets of wooden double doors with adjustable louvers, nine facing *Calle Castillo* and four overlooking *Paseo Atocha*. Each doorway is accentuated by a combination of balconies, plaster moldings and pediments, all framed by a rhythmic articulation of Corinthian pilasters. The balconies have the original nineteenth century wrought iron grilles. The façade is crowned with a sober, but strong

entablature. The Tuscan and Corinthian pilaster accented the buildings verticality, against its massive and dominating horizontality (**Fig. 1**).

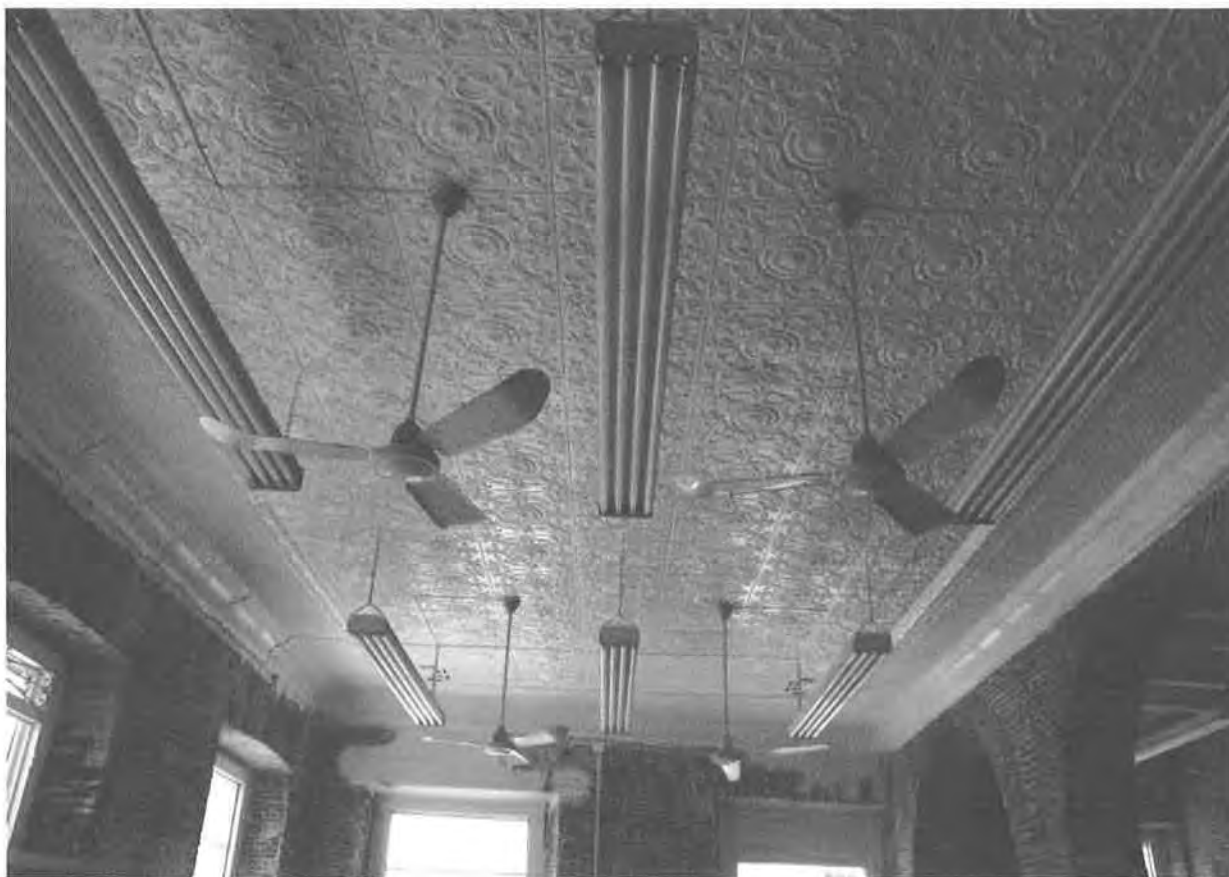
Fig. 2. Decorative tin panels, first floor.

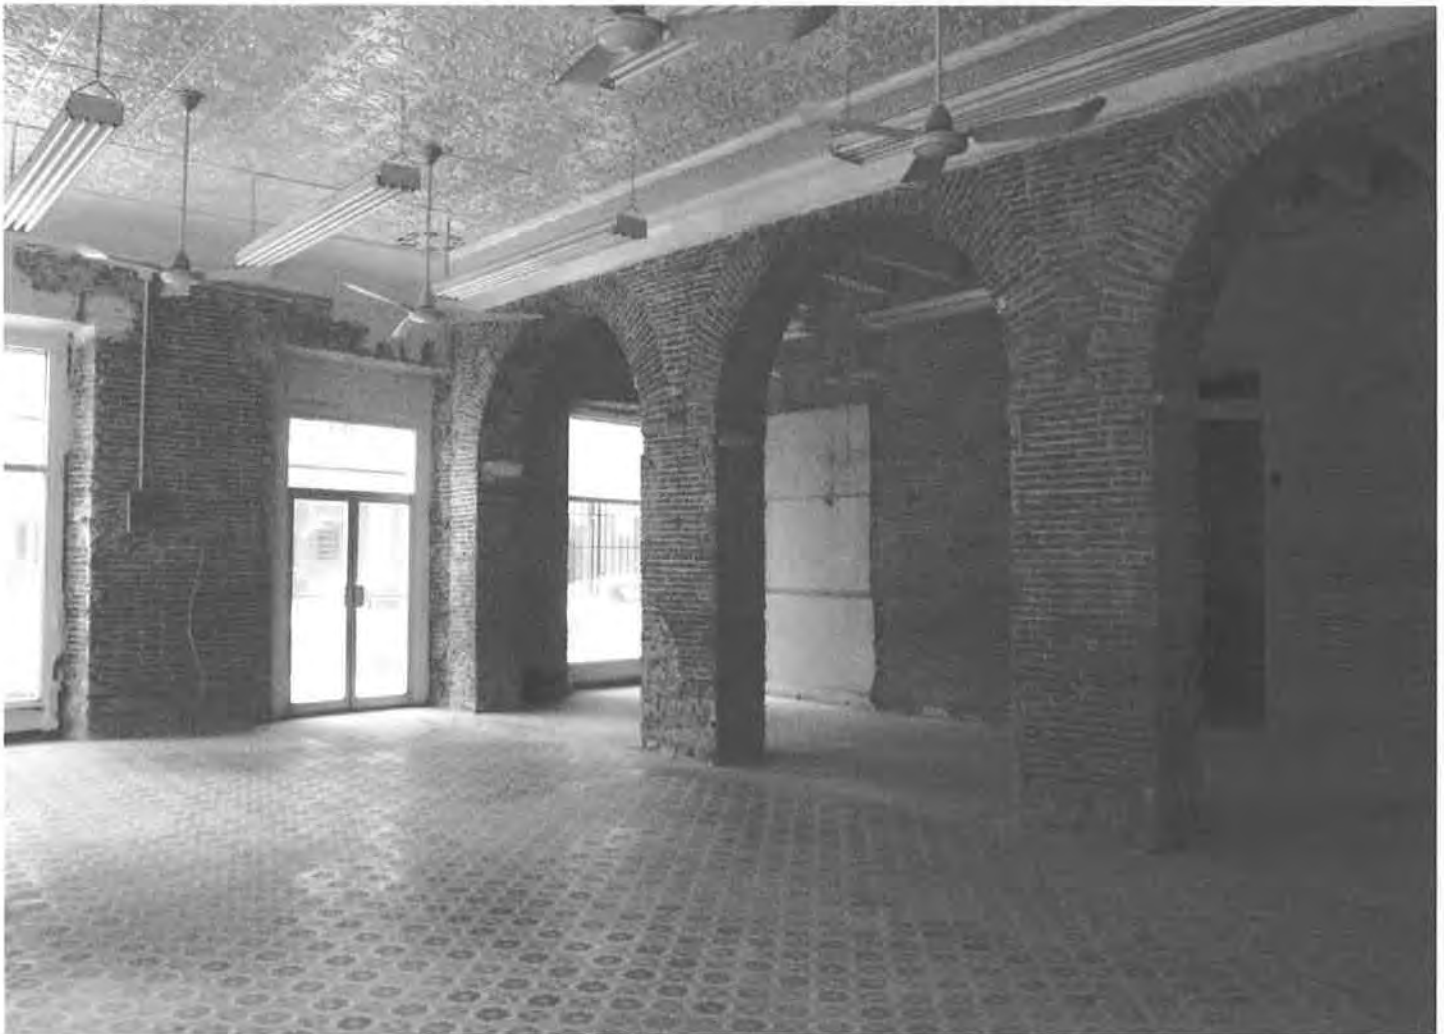
Fig. 3 Exposed brick walls, first floor.

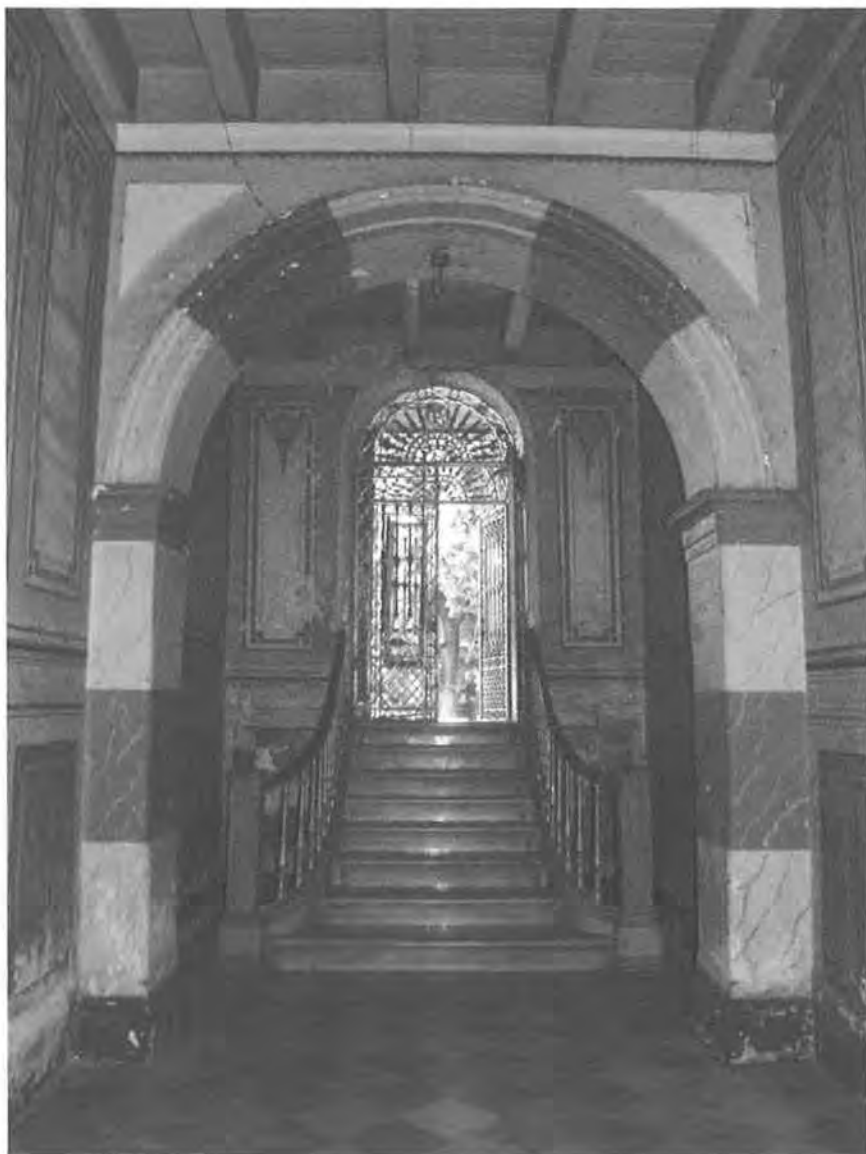
Fig. 4 Detail of zaguan, towards marble flared stair.

The residential second-story is access thorough an original double-door wooden gate facing Paseo Atocha. Pass the entrance, an imposing *zaguán* (hallway), with seventeen-foot high with exposed beams and rafters ceiling and richly stenciled decorated walls, surprised the visitor. Mid-point in the *zaguán*, a Roman arch, painted to simulated marble, creates a transition point and serves to visually frame a magnificent eight risers, bronze handrails, marble flared stair (**Fig. 4**). At the stair's landing, there are two identical richly crafted iron grilled gates. One guards the entrance to the second floor, while the other one do the same to and from the patio. At the gate's upper portion that faces the *zaguán*, within a golden painted circle, the metal is curved to form the letters CV, the initials

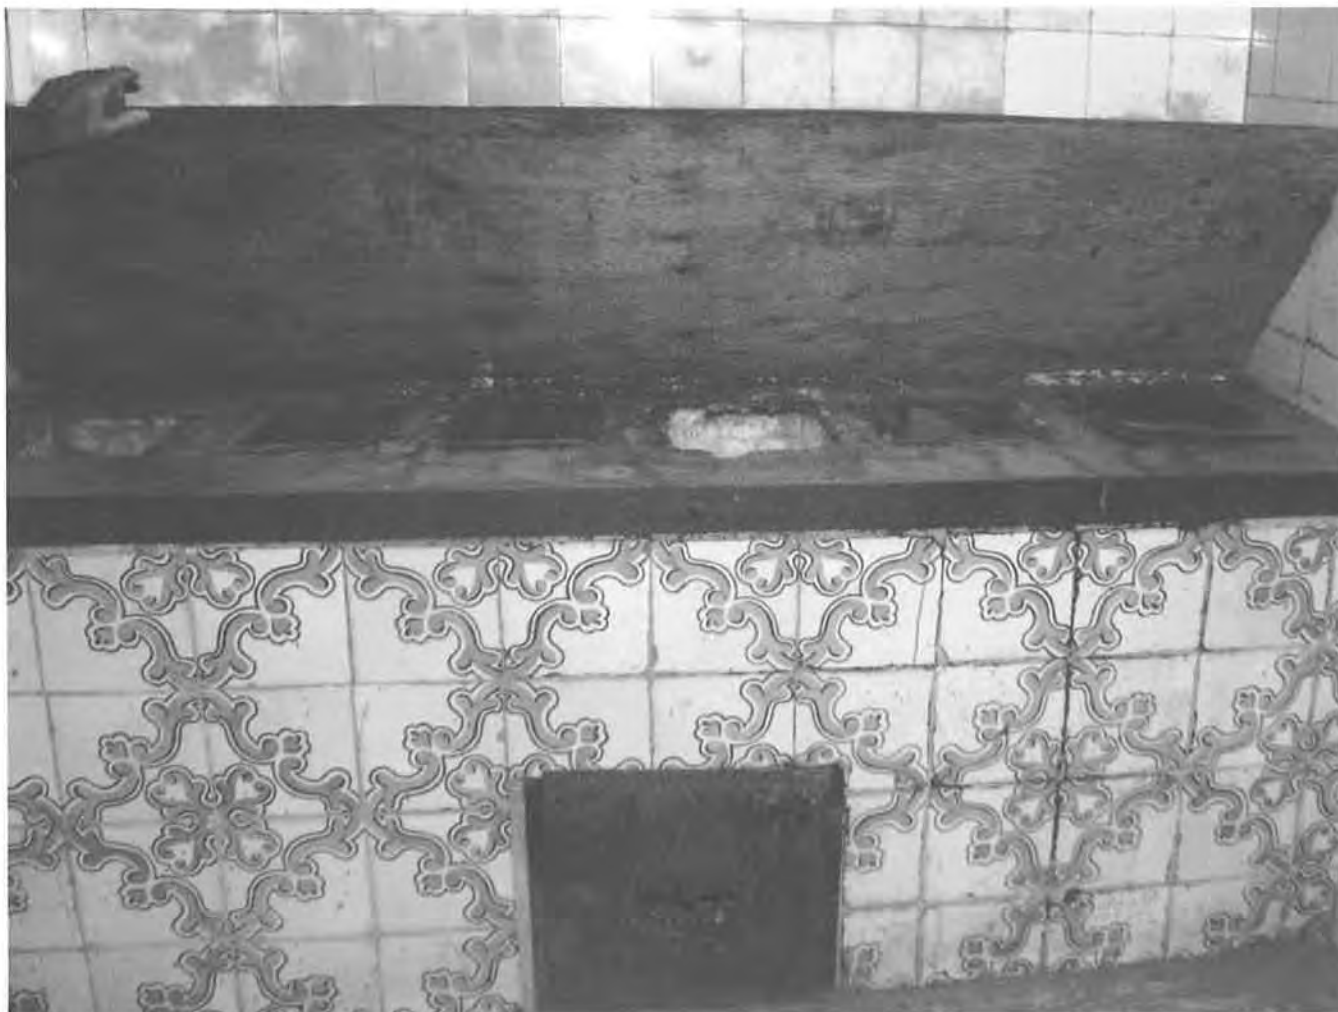
Fig. 5 Original stove

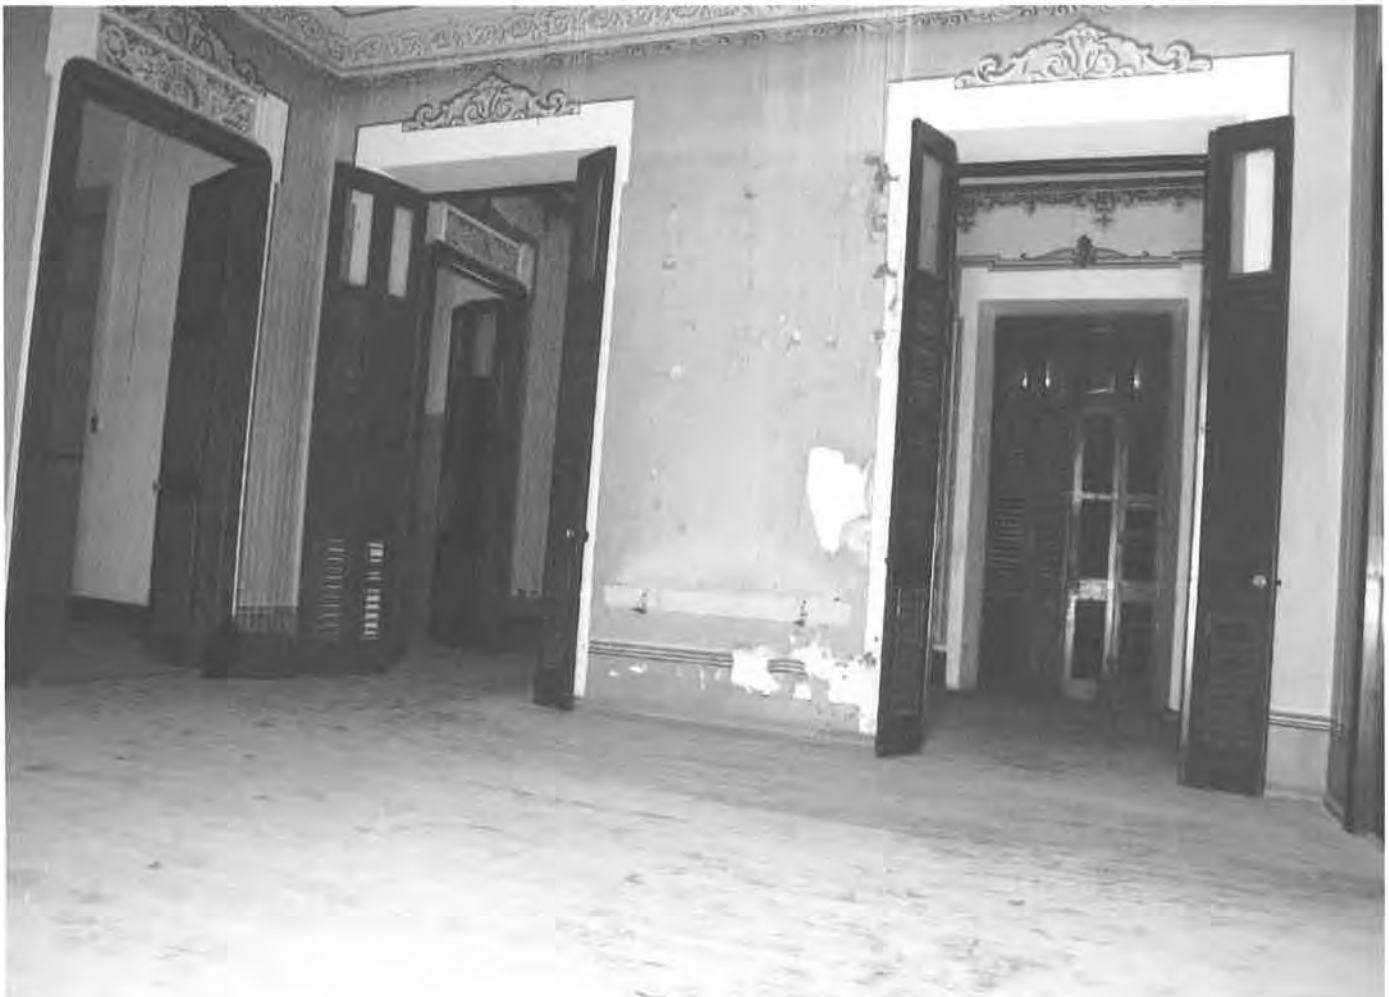
Fig. 6 Detail of living room, towards antesala.

In the second story, the living quarters consist of fifteen rooms divided among sleeping quarters, living room, *antesala*, dining room, kitchen (with the original 19<sup>th</sup> century stove)(**Fig. 5**) bathroom and studio/library. The layout responds to the L-shaped arrangement. A massive rectangular volume, divided in three spacious rooms with fifteen-foot high ceilings, faces west overseeing Paseo Atocha (**Fig. 6**). The bedrooms, kitchen, bathroom and dining room are lined-up along the longitudinal axis, facing north overlooking Calle Castillo. This section of the quarters, the most private section of the house, also faces south, towards the interior courtyard. The entrance to each room in the longitudinal axis is accentuated by the use of a classical pediment framing each doorway. Each room facing the patio, with the exception of the dining room at the eastern end, has a distinguishable feature of a double door system. First a double wooden door with adjustable louvers, crowned with a wooden fixed transom with frosted glass panel. Another solid mahogany double door is added, which covers the entire doorway.

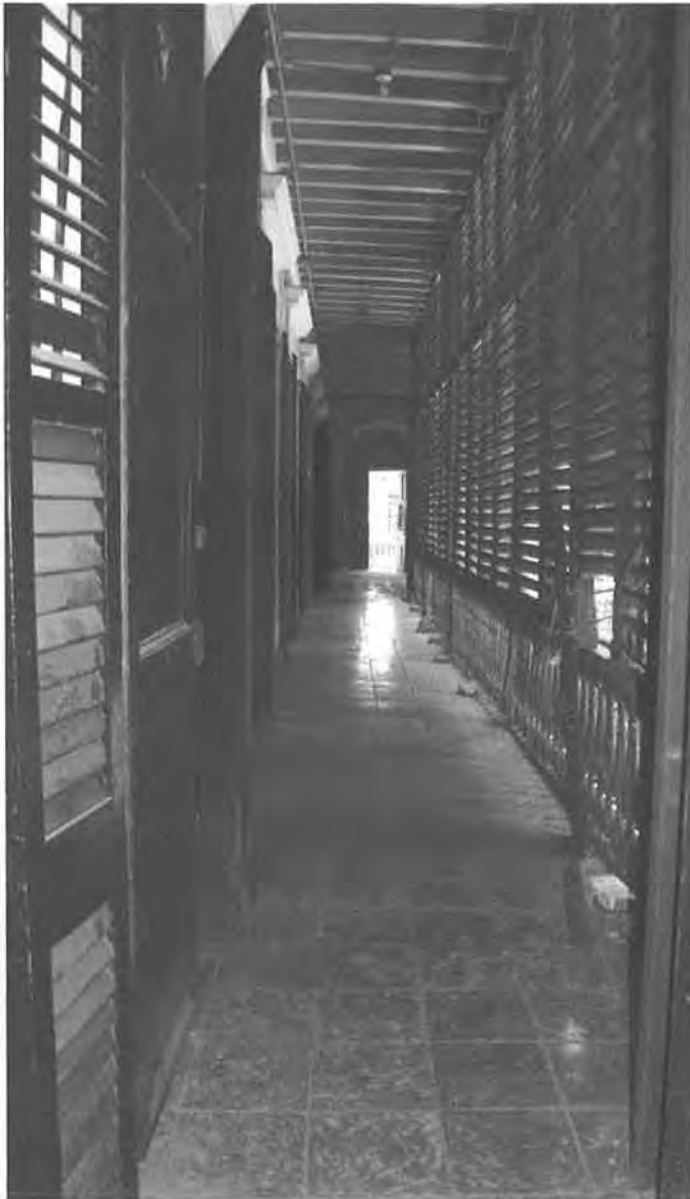
Fig. 7 Gallery

The rooms within the elongation are access through a forty-eight-foot long, six-foot wide gallery. The gallery is enclosed in its full length through the use of an original row of wooden balustrade, supporting operable wooden transoms, movable wooden louvers and wooden shutters, simultaneously providing shade and air, two important design considerations, as Ponce is known for its heat and its implacable sun (**Fig. 7**). Another significant design in **Casa Vives**, related to Ponce's climate, is the treatment given to the air circulation within the living quarters. The house has high ceilings, ranging from fourteen to fifteen feet, to give hot air more space to rise. Adorned ventilation holes are strategically located at the four corners of every room's ceiling, allowing for the heat to exit through the roof and letting the cool air circulate throughout the entire house (**Fig. 8**). The fresh air is captured at the roof through a set of brick and masonry ventilation structures, oriented in an east-to-west direction (the usual direction of the wind currents), and channelized to the house interior (**Fig. 9**). Every single room in the house connects to the adjacent room through wooden double doors (some with louvers and shutters, other of solid construction), allowing air to circulate from one space to another. Furthermore, many of the interior doors are crowned with wooden transoms, facilitating the air conduit even with the doors close. In addition, every single room has, at least, one wooden double door that open toward the exterior.

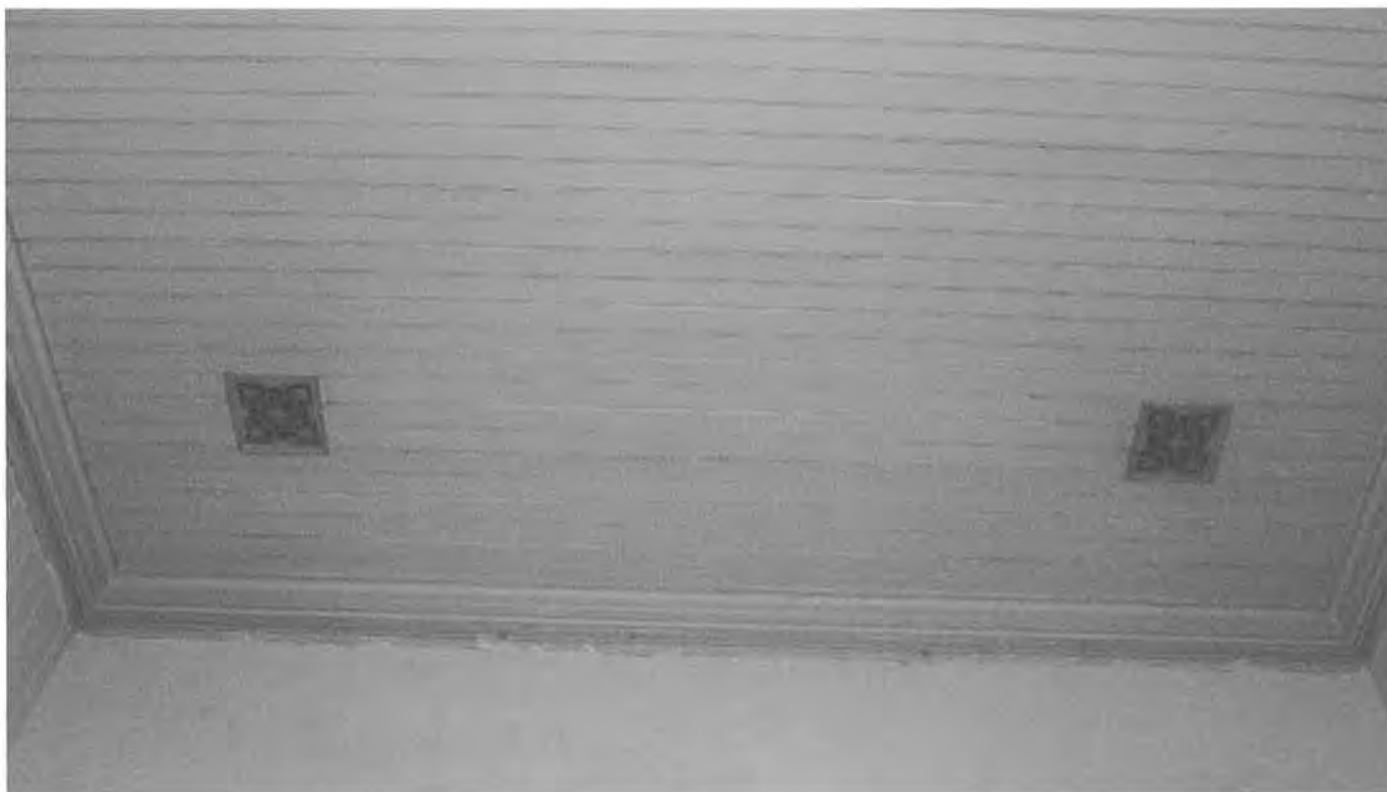
Fig. 8 Ventilation holes.

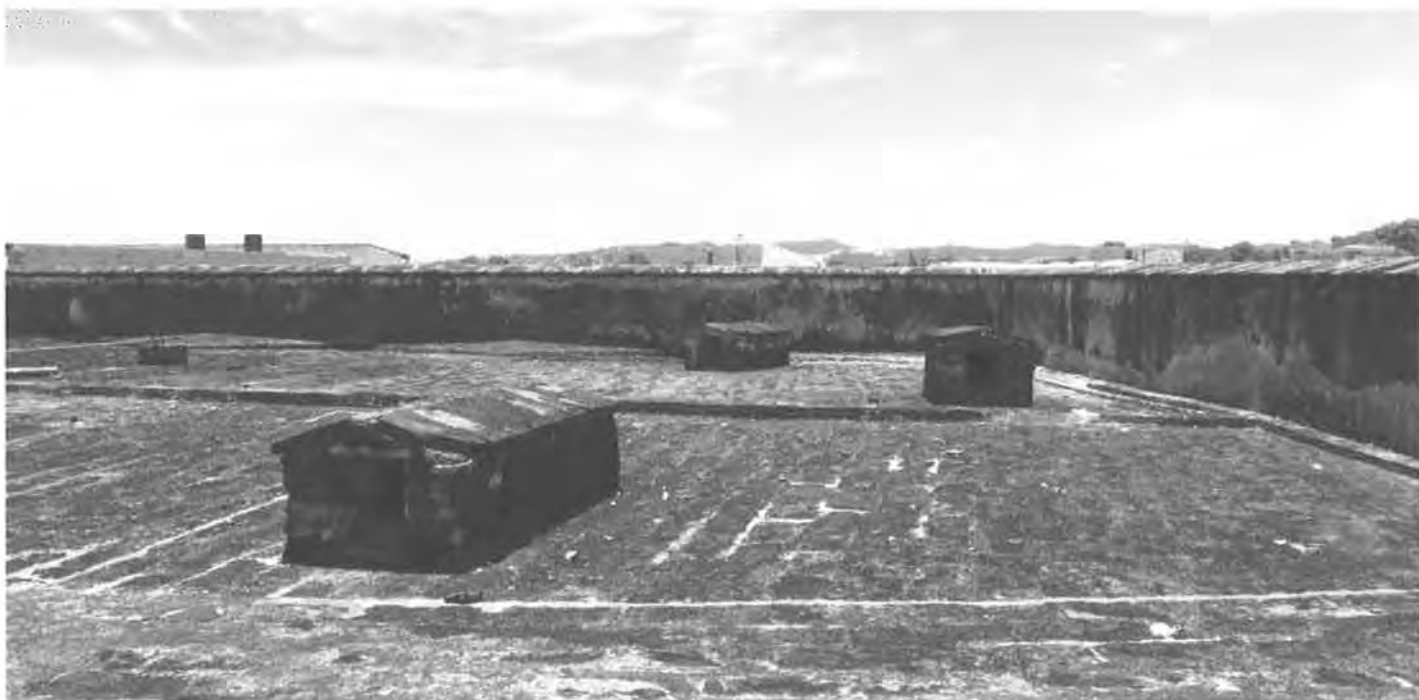
Fig. 9 Ventilation structures at the roof.

The building's roof is access through an interior wooden stair. Made of thin bricks three layers deep, as it was the practice by the 1860s, and surrounded by a three-foot high parapet, the roof contains certain elements of architectural interest. First of all, there are the previously described ventilation structures. In addition, the engineering techniques applied in the design of the roof's drainage speaks well of the craftsman quality at the time. The flat roof slopes slightly towards the western edge, pushing any rainfall into that direction, while, at the same time, at the foot of the parapet, the deck was slightly raise in an arrow shape, dividing the incoming water current and forcing it directly into the drainage holes (**Fig. 12**). The rain fall capture at the roof, according to historic documentation, finds its ways into a well located at the patio.

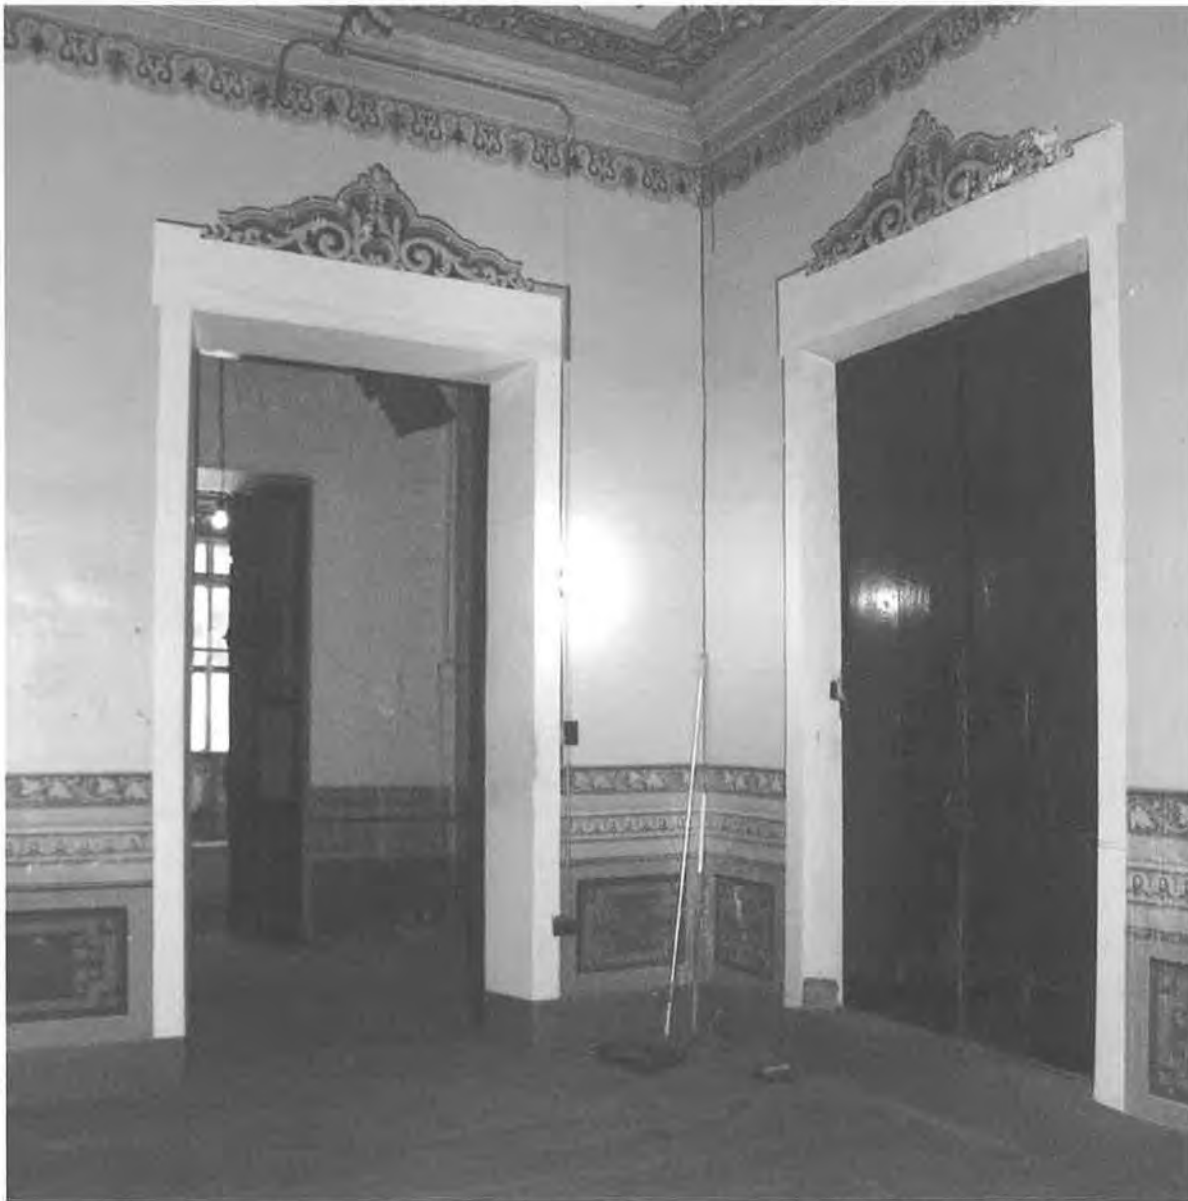
With the exception of the bathroom, the walls in the house featured diverse surface treatment. Almost every wall is decorated with hand painted and stenciled art recreating geometric patterns and

classic motifs: garlands, pilasters, columns and linear designs to accentuate corners (**Fig. 10**). All floors are of wooden planks made out of *tabloncillo* (*sideroxylon portoricense*), with the exception of the gallery's floor, which consist of hydraulic cement tiles, result of an early twentieth century intervention. The ceiling consists also of wooden planks, mostly decorated with hand painted geometric motifs and stenciled designs.

Fig. 10 Example of stenciled art.

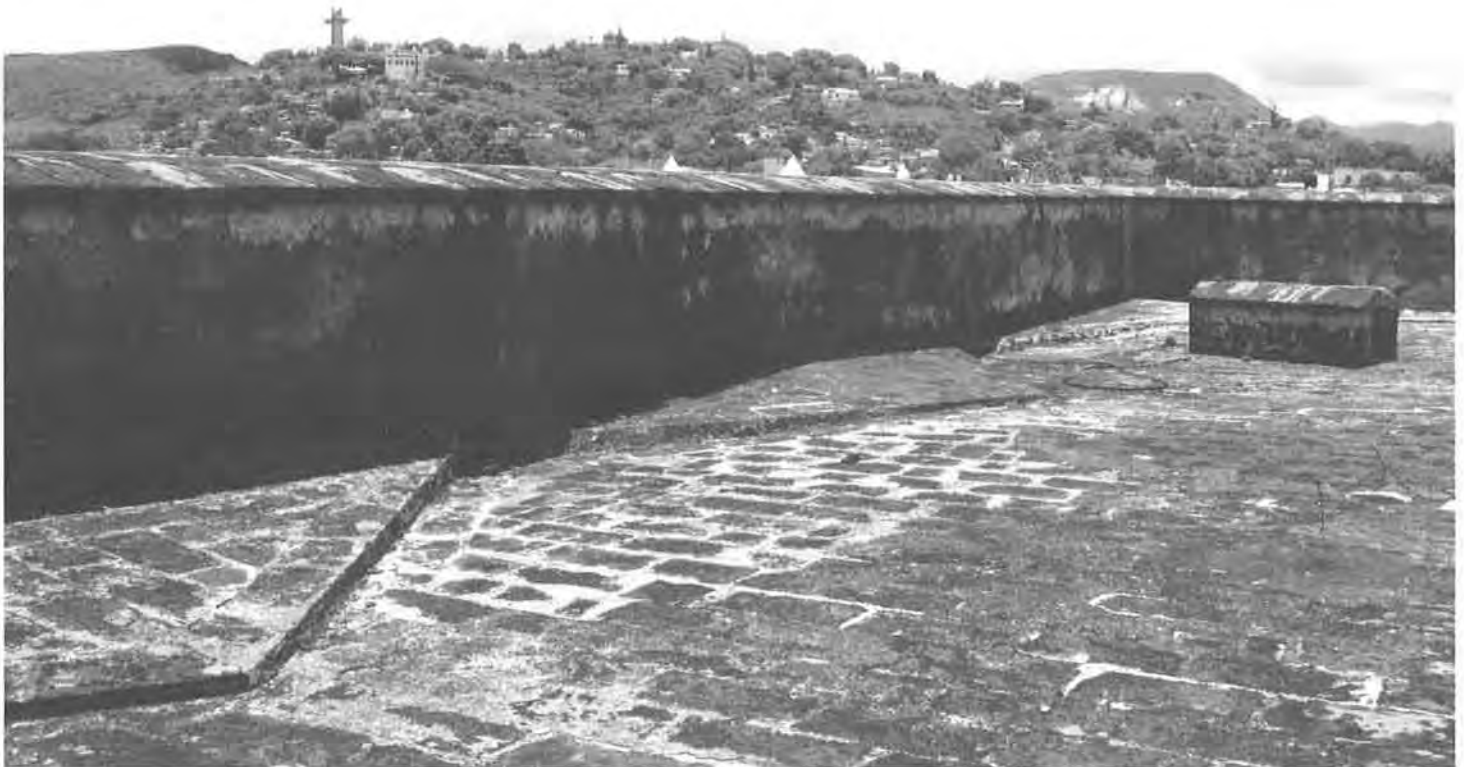
Fig. 12 Drainage design at the roof.
