National Register of Historic Places Registration Form

historic name BUILDING AT 44 CENTRAL AVENUE
other names/site number J.R. PETER'S & SONS

street & number 44 CENTRAL AVENUE not for publication
city or town ALBANY vicinity
state NEW YORK code NY county ALBANY code 001 zip code 12206

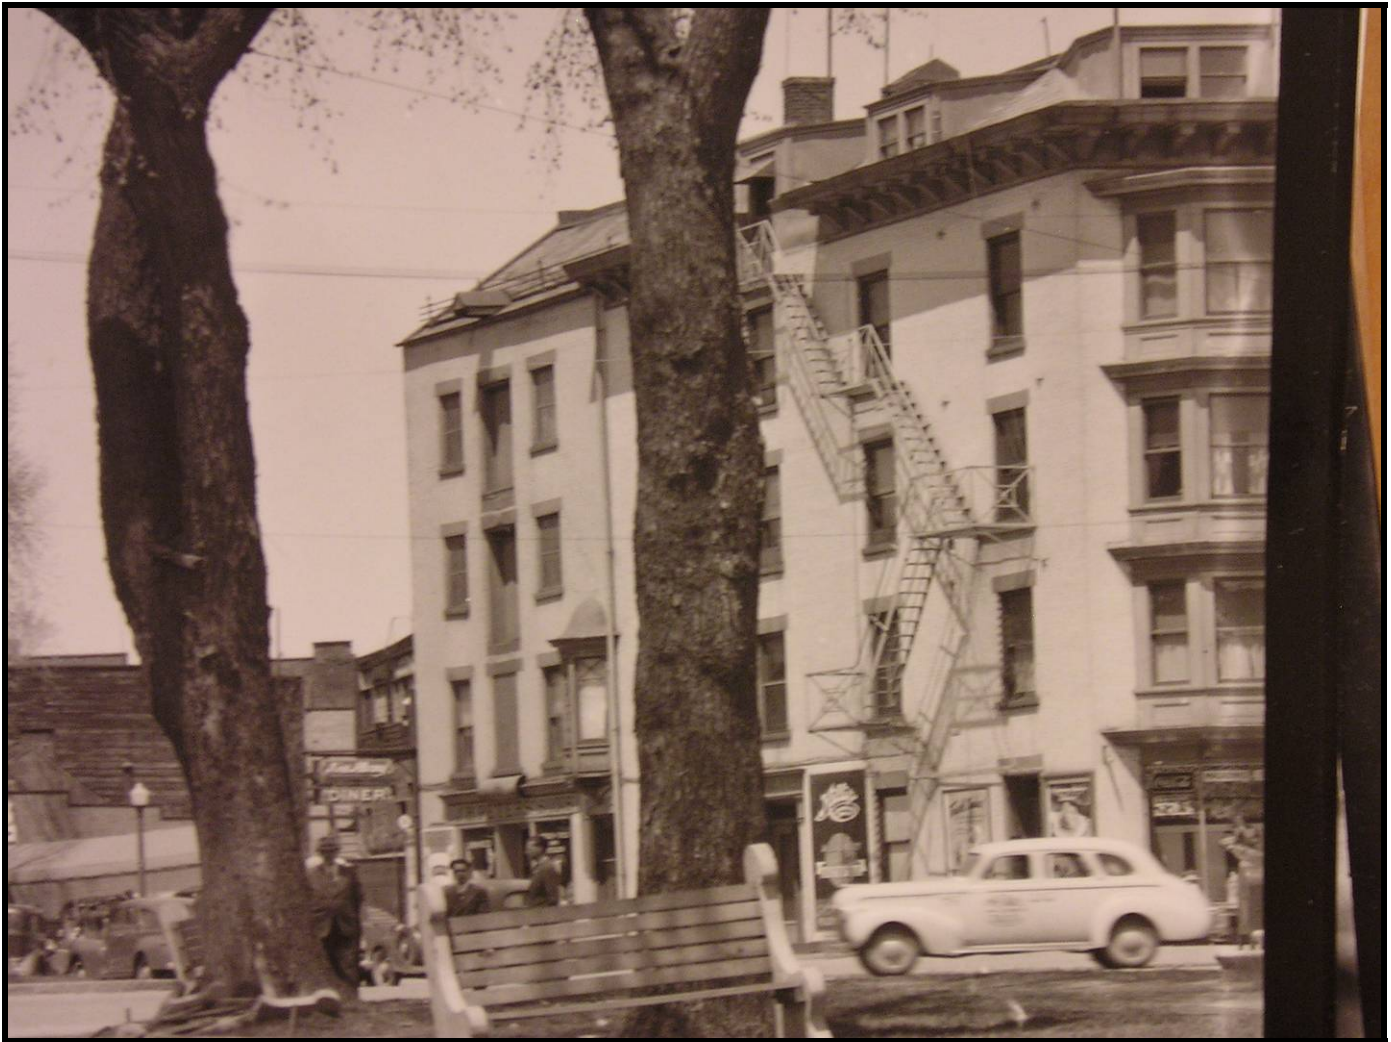
Above, historic image, ca. 1940, showing 40 and 44 Central Avenue; the nominated building, 44 Central, is at the left.
