KENTUCKY HISTORIC RESOURCES  
Individual Inventory Form

Resource # 133  
Shelby County

1. Name of Resource: Martin House

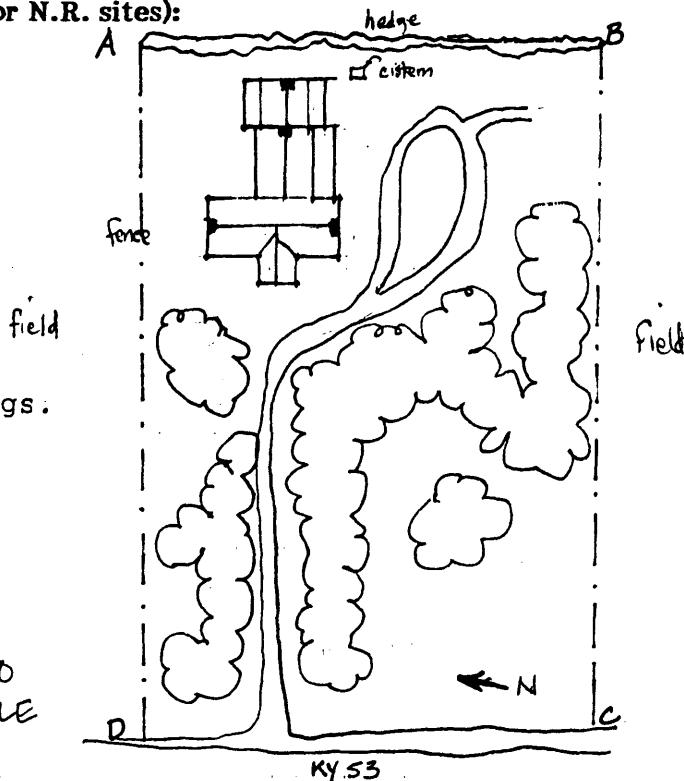
4. Site Plan (and boundary description and justification for N.R. sites):

Beginning at A, south 200' along a hedge to B, thence west 450' along a fence to C, thence north 200' along the east side of KY53 to D, thence 450' east along a fence to the point of origin. The boundaries were chosen to encompass the house and domestic-related space as defined by fences and hedges and distinct from surrounding fields. The front lane is lined with mature trees which enhance the setting. There are no contributing outbuildings.

Point A is 42 feet northeast of the northeast corner of the dwelling at the rear of the ell.

NOT TO SCALE

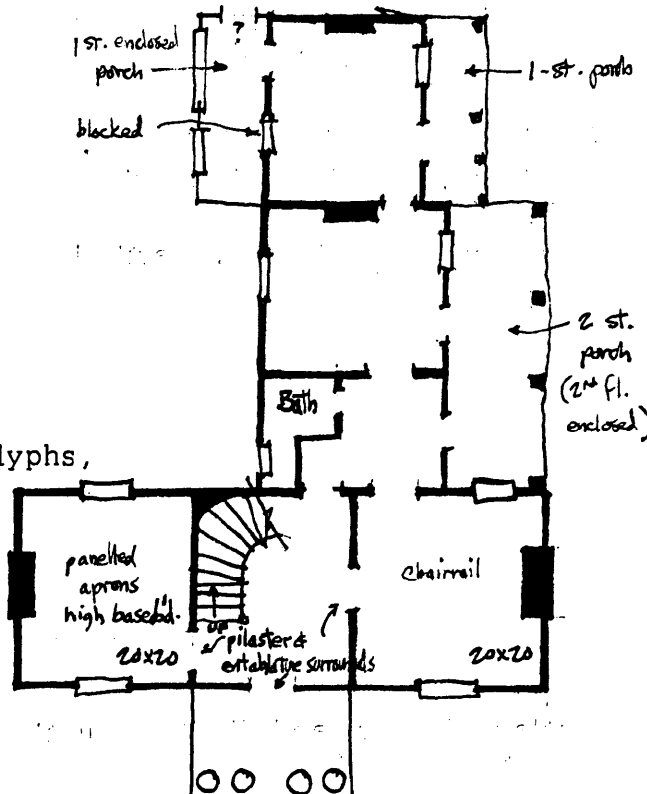
5. Description and House Plan:

2-story, 3-bay, brick, center-passage, single-pile plan, double-stretcher bond on principal (west) facade and south gable end, common bond on rear (east) facade with Flemish bonding course every 7th row, pilasters divide bays, 8/8 sash, wood sills and lintels with cornices, gabled roof, full Greek Doric entablature, monumental Greek Revival portico supported by Doric columns of molded brick, Doric entablature, flushboard in tympanum with triglyphs, 2-panel front door with 2-pane transom flanked by recessed, panelled pilasters, cornice above, second floor has window with panelled apron and identical pilasters and surround, partially exterior end chimneys, cut stone foundation, 2-story offset ell with added porch on south

side supported by concrete blocks and enclosed on second floor, window openings altered to segmental arches in ell, 1-story, 1-room brick kitchen on east end of ell with porch on south side and enclosed porch on north side, ell and kitchen have interior end chimneys, entire structure has standing seam metal roof.

Curved stair in passage, door surrounds in passage consist of pilasters and plain cornices, north room has high baseboards and panelled aprons under windows, south room has chair rail, low baseboards, and no aprons under windows, bathroom added in west room of ell, west window in north wall of kitchen blocked.
