KENTUCKY HISTORIC RESOURCES INVENTORY

Site No. BC-70

Historic Property Name Oglesby-Conrad House Site # BC-70

Multiple Resource/Thematic Nomination Title Historic Resources of Cloverport

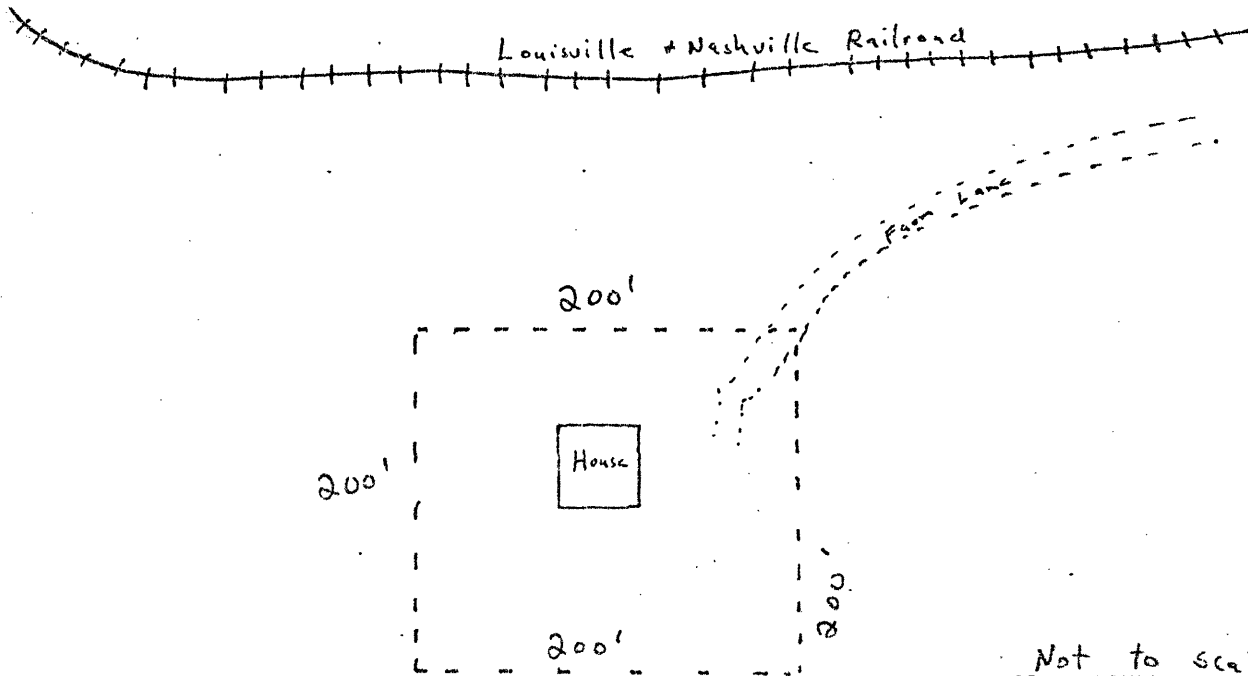
Sketch of Site Plan (Showing outbuildings, structures, landscape features and the site boundary as described above.)

Beginning at a point 100 feet northeast of the house proceed 200 feet in a southward direction; thence 200 feet in a westward direction; thence 200 feet in a northward direction; thence 200 feet in an eastward direction to the point of origin.

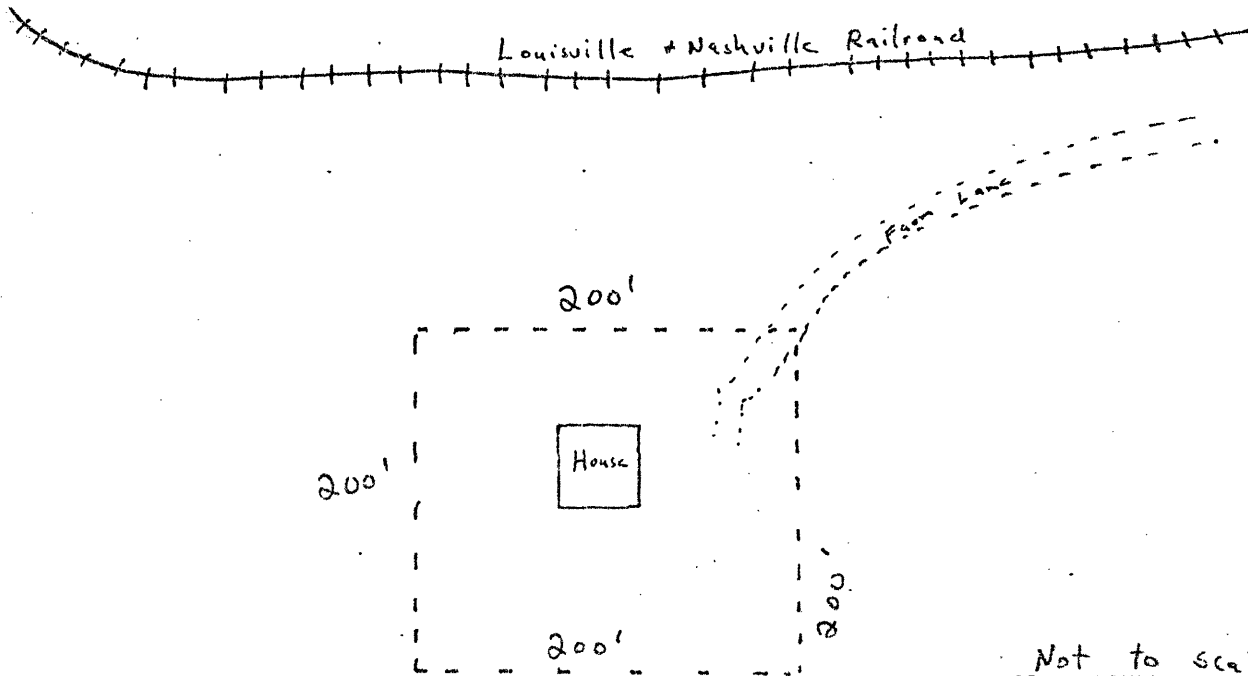
Sketch of Site Plan (Showing outbuildings, structures, landscape features and the site boundary as described above.)

Beginning at a point 100 feet northeast of the house proceed 200 feet in a southward direction; thence 200 feet in a westward direction; thence 200 feet in a northward direction; thence 200 feet in an eastward direction to the point of origin.
