ARIZONA STATE HISTORIC PROPERTY INVENTORY

SURVEY AREA NAME: Safford, Arizona
 HISTORIC NAME: Talley, William, House
 ADDRESS/LOCATION: 219 11th St.
 CITY/TOWN: Safford
 TAX PARCEL NUMBER: 101-07-054 / <1 ACRE(S)
 OWNER: Talley, Alfred & Linda
 OWNER ADDRESS: 219 11th St.
Safford, Arizona 85546
 HISTORIC USE: Residence
 PRESENT USE: Residence
 BUILDING TYPE: House
 STYLE: Spanish Colonial Revival
 CONSTRUCTION DATE: 1928
 ARCHITECT/BUILDER: Talley
 INTEGRITY: Major alterations
 CONDITION: Good

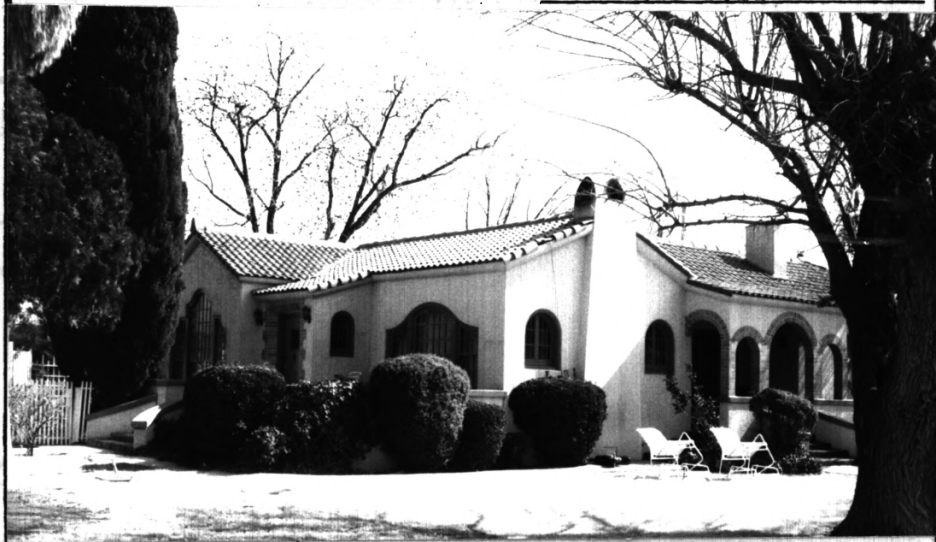
PHOTOGRAPH

ROOF TYPE: Gable roof with cross gables,.
 ROOF SHEATHING: Red spanish tile
 EAVES TREATMENT: Flush, curved cornice
 WINDOWS: Focal windows are triple arched, parabolic in shape, many paned; other..
 ENTRY: Main door is heavy plank, single light, with brick surround
 PORCHES: Shed roof porch with triple round arch; two stringer course brick..
 STOREFRONTS: Not Applicable

STORIES: 1 DIMENSIONS: (1) 40'(w) 30'
 STRUCTURAL MATERIAL: Wood frame
 FOUNDATION MATERIAL: Concrete
 WALL SHEATHING: Stucco
 APPLIED ORNAMENT: Brick detailing surrounds main entry and arches

PHOTOGRAPHER: Linda Laird & Associates
 DATE: Jan, 1987 VIEW: N, 3/4
 NEGATIVE NUMBER: R:DD F:11

ADDITIONAL DESCRIPTION/ANALYSIS (annotated form): Roof type contd: exterior stucco over brick chimney. Windows contd: windows are round arched nine by nine light casement. Porches contd: surround. Distrt str contd: residential area.
