National Register of Historic Places Registration Form

historic name McNee Barns

other names/site number KHRI # 017-454

OTHER: Gable-Roof Barn, Boxcar Barn, Windmill,
and Stone Fence

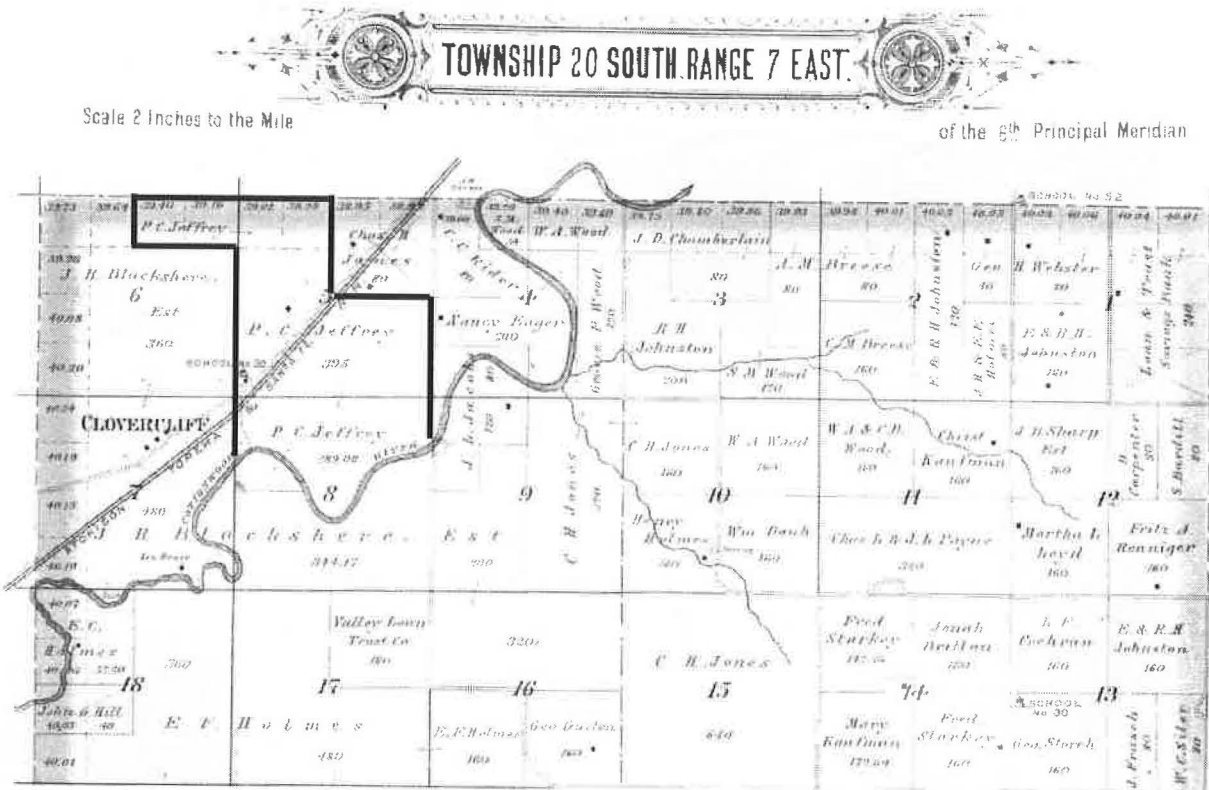
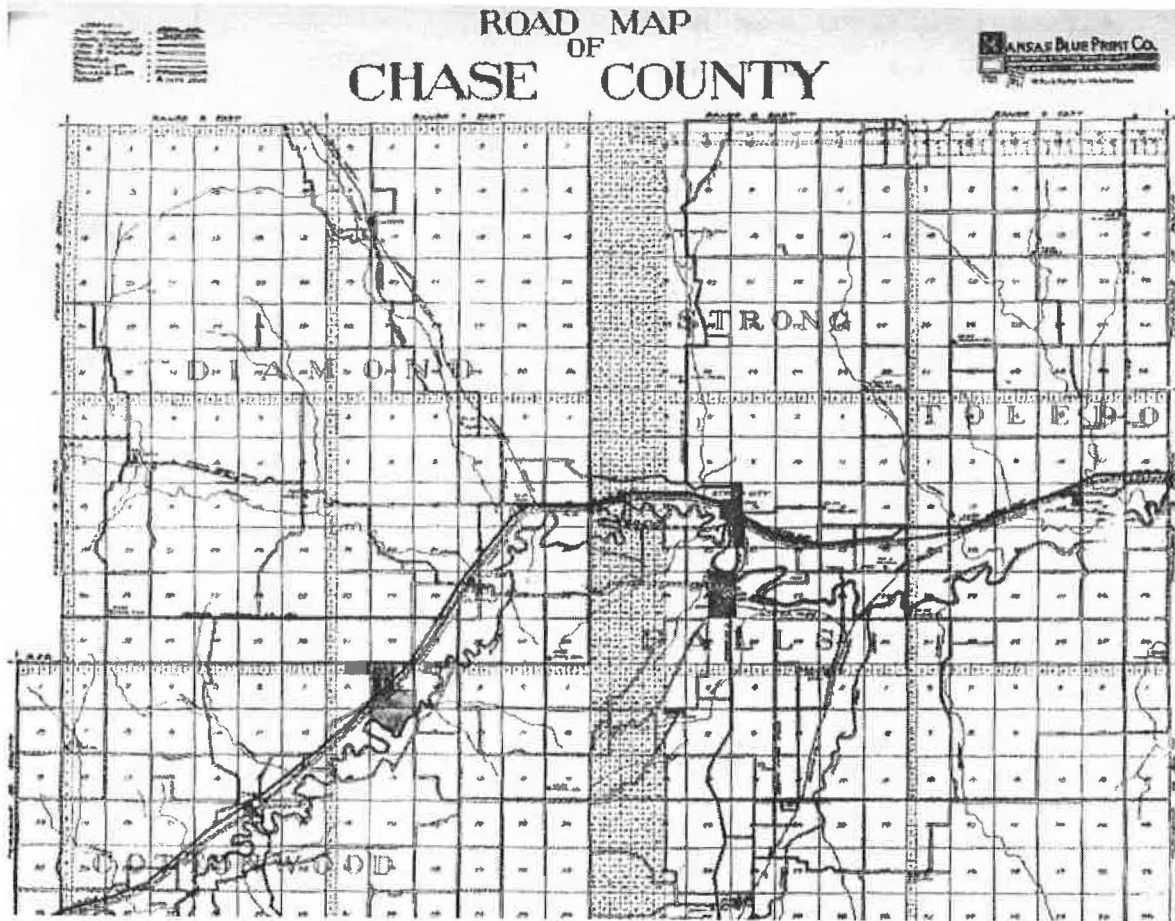
Figure 1-McNee Farm

Top: 1901 Plat Book of Chase County illustrating boundary of P. C. Jeffrey's farm (1882 - 1908)

Lower: Map from Abstract of Title illustrating current McNee Farm with identical boundaries

⁵ See Figure 1 under Additional Documentation at the end of this document. A 1901 Chase County Plat Book illustrates Jeffrey's land, matching the boundary of the existing Campbell/McNee Family Farm.

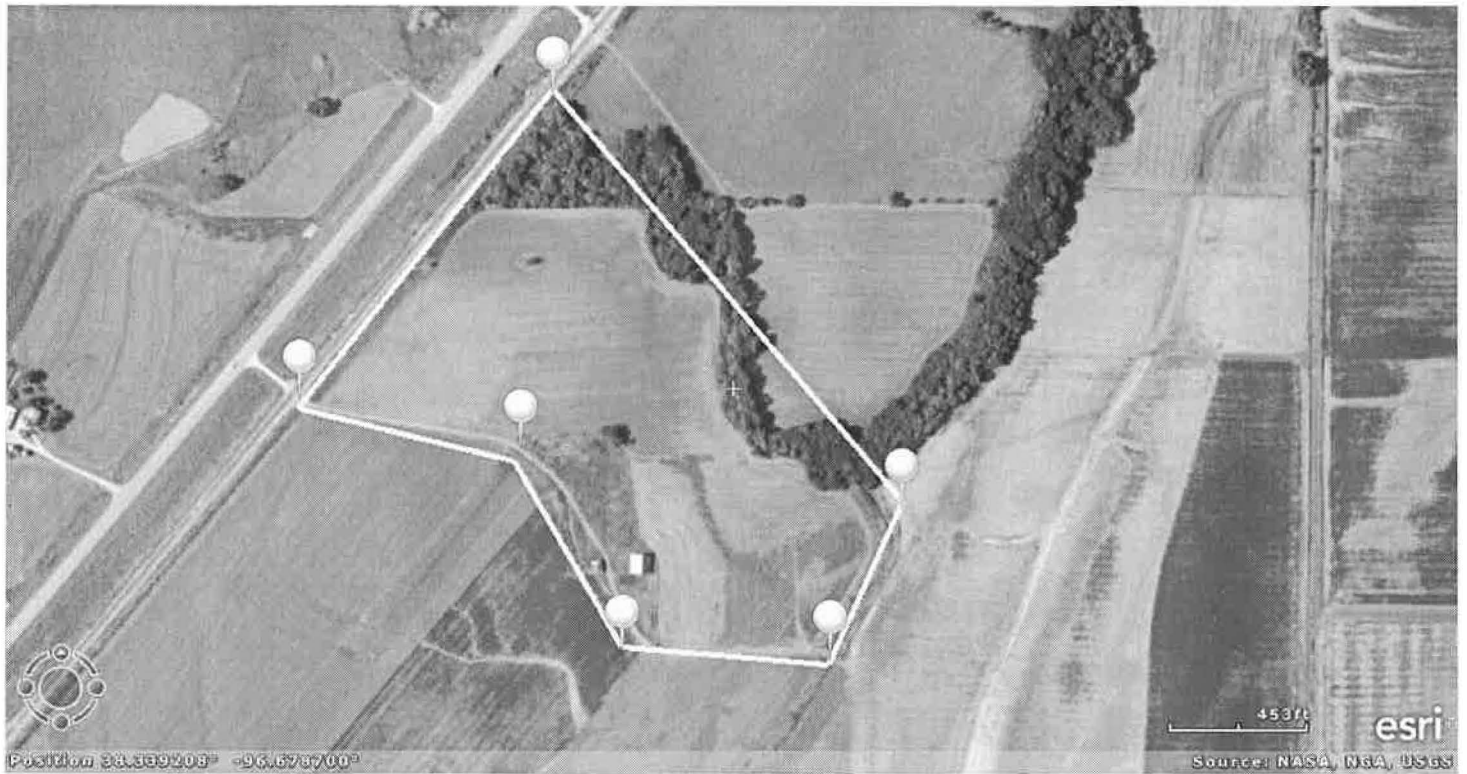
Figure 2 – Aerial Photo illustrating site boundary using ArcGIS Explorer

UTM Coordinates starting at north point, going clockwise

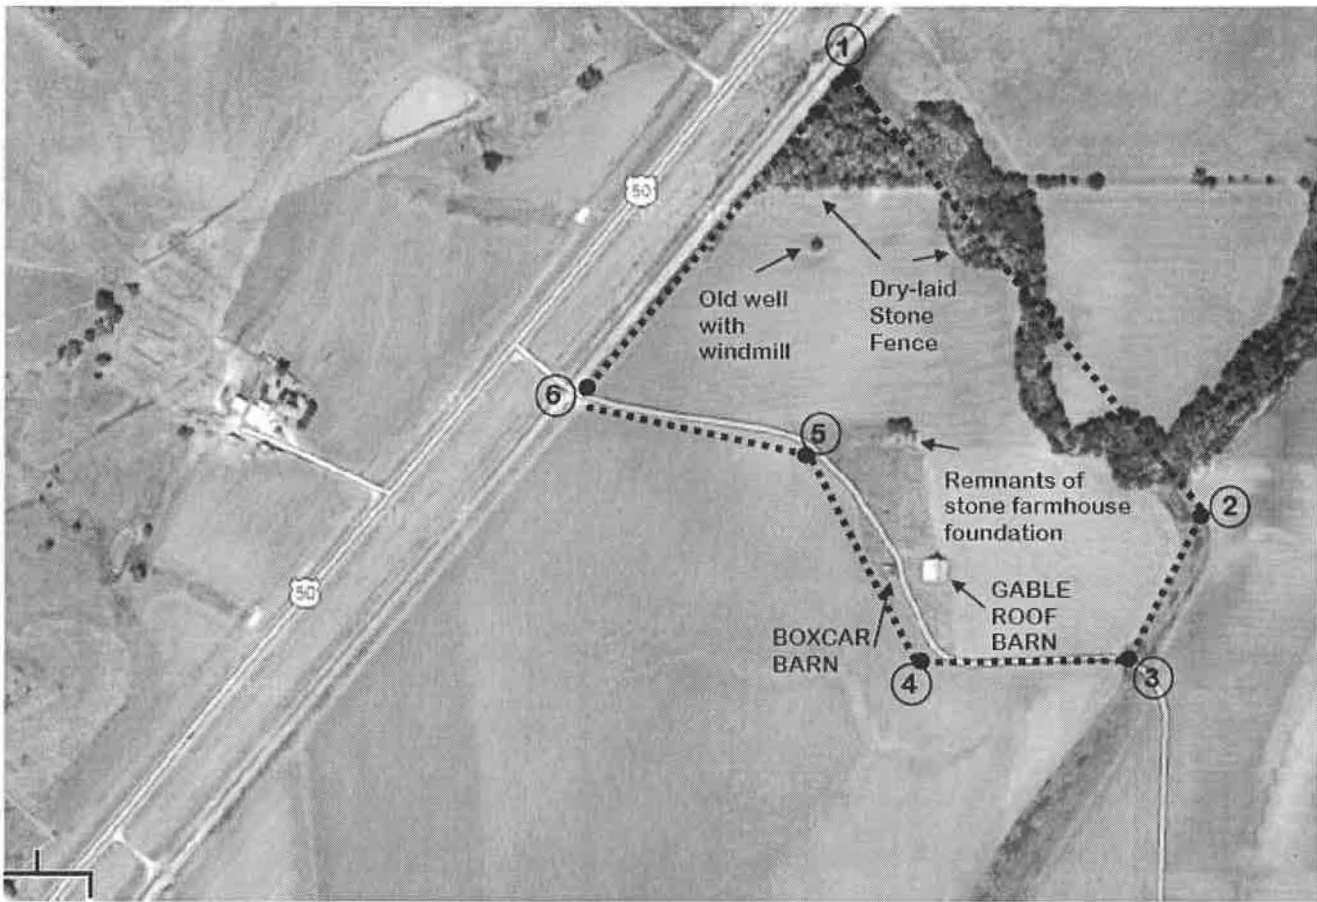
Figure 3 (above) - Aerial photo downloaded at Google Maps identifying resources on the site (© 2012 Digital Globe, Geo Eye, USDA Farm Service Agency, Map date © 2012 Google)

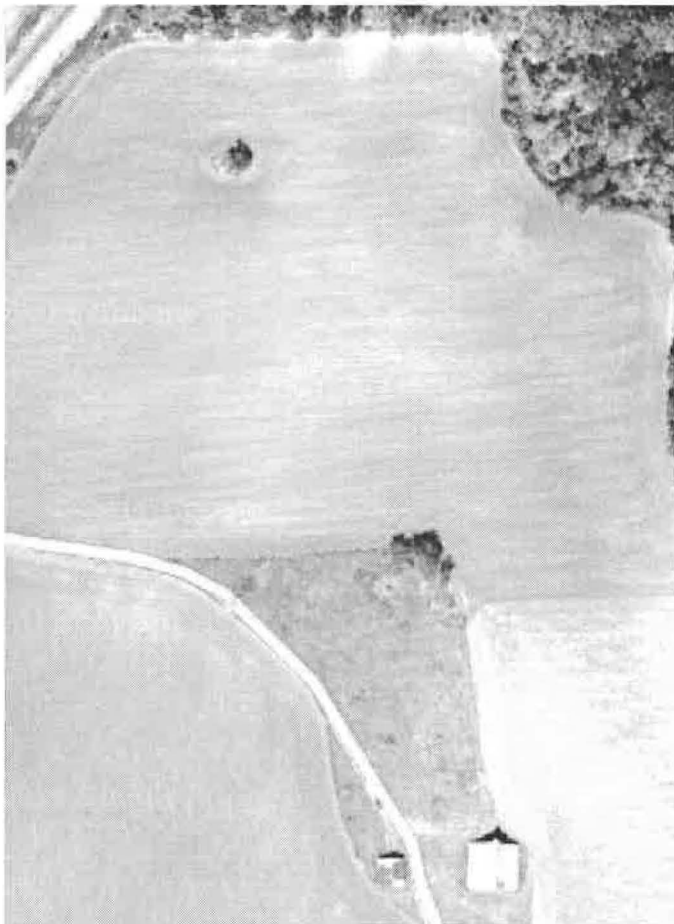
Figure 4 (left) – Enlarged map showing major resources

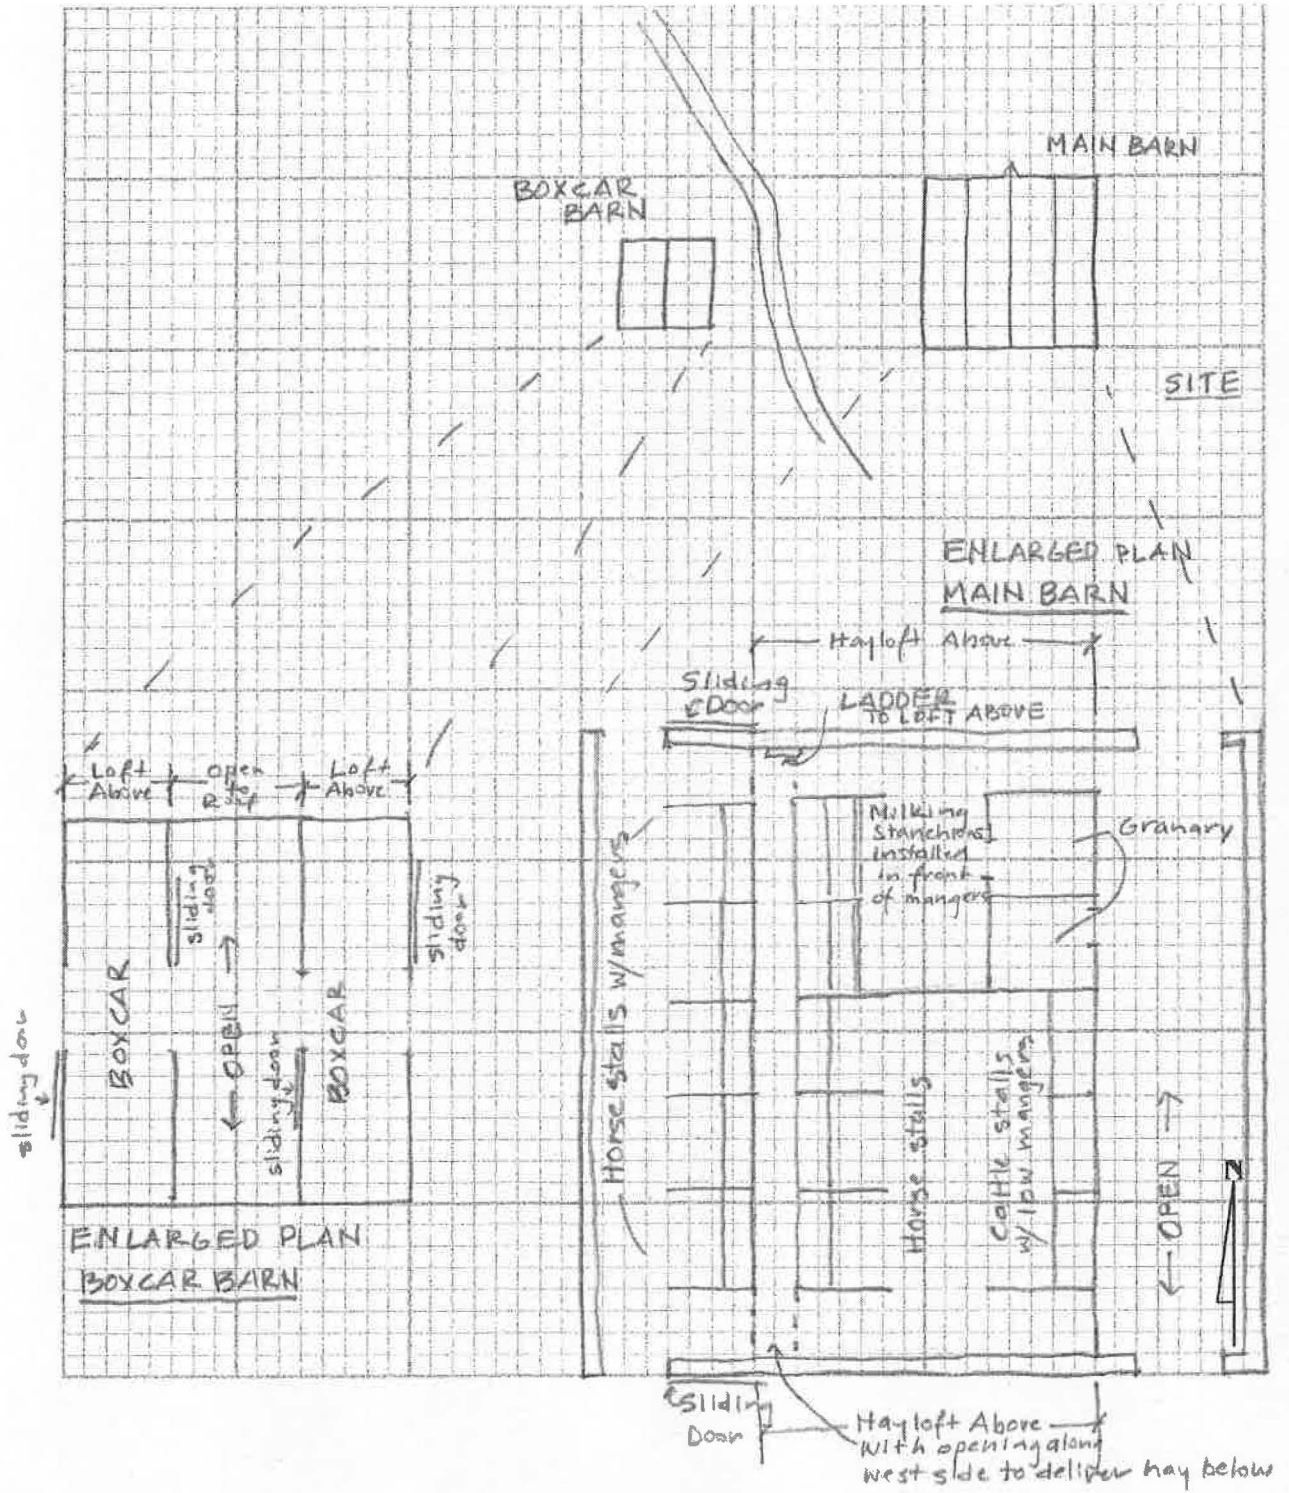
Figure 5 – Sketch Plan of barn configuration, Spencer October 2012

The interior of the barn continues to reflect its original design with minimal changes. The interior configuration is based on a grid of wood columns with stone footings that frame the stalls on the ground level and supporting the hay loft above. The center bay is generally comprised of horse stalls on the west and cattle stalls on the east with a wide open center aisle accessed at the north and south ends from the west bay and the north end of the east bay. This configuration is atypical in that the center aisle does not correspond to exterior openings to allow direct passage through the center of the barn. The horse stalls are distinguished by a tall manger and sturdy partitions between stalls. The cattle stalls have a smaller, low manger with no partitions between stalls. Two granaries are located at the northeast corner of the center section of the barn. The north granary is accessed from the center bay; the south granary is accessed from the east outer bay. Horse stalls are located along the east side of the west outer bay with a narrow passage between the west stalls and the stalls on the west side of the center bay. The passage is open to the hayloft above to allow throwing hay from the loft, to the ground-level stalls below. The openings on each end of the west bay provide the primary circulation to access to the stalls in the west and center bays. The east bay is an open space with no partitions, likely used as a loafing shed for livestock shelter with openings on the north and south ends of the bay.
