# National Register of Historic Places Registration Form

historic name Oltjenbruns Farm  
other names/site number Welper Farm / 5PL.163

Historic Resources of Phillips County,  
Colorado 1889 - 1965

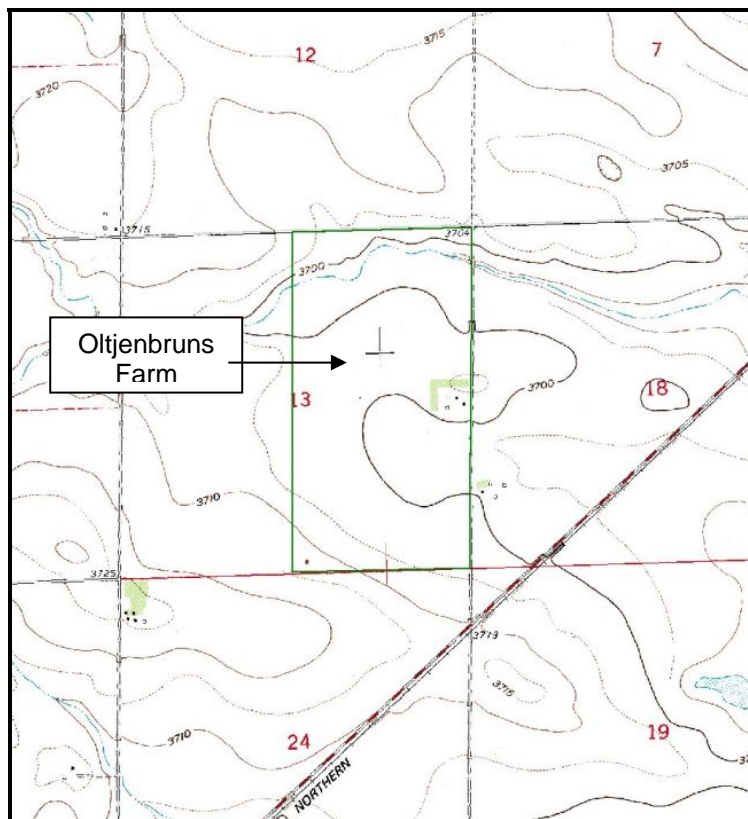
**USGS Topographic Map – Regional Perspective**

Amherst quadrangle, 7.5 minute series
