**HISTORIC RESOURCES INVENTORY**  
**BUILDING AND STRUCTURES**  
 HIST-6 NEW 5.77

IDENTIFICATION	1. BUILDING NAME (Common) <span style="float: right;">(Historic)</span>		John Hoadley House	
	2. TOWN CITY		VILLAGE	COUNTY
	Branford		Stony Creek	New Haven

3. STREET AND NUMBER (and/or location)			
	213 Leetes Island Rd. Map J6, Block 1, Lot 7; .46 acres			
	4. OWNER(S)			
	Richard W. & Leocadia Sullivan <input type="checkbox"/> Public <input checked="" type="checkbox"/> Private

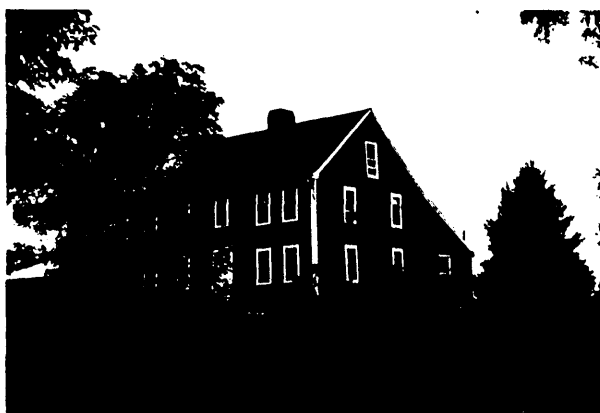
PHOTO

Constructed on a rectangular plan with its ridge parallel to the street, this structure has a steeply pitched roof with no overhangs. Its brick center chimney straddles the ridge. It has a nine-window facade and a five window gable. Windows have six-over-six sash apparently replacing some nineteenth-century replacements (WPA survey form shows two-over-two windows). Its center entry door is flanked by wide head and jamb trim.

VIEW East & North Elevations
