**NATIONAL REGISTER OF HISTORIC PLACES  
INVENTORY -- NOMINATION FORM**

Grand Canyon National Park North Rim Headquarters

Grand Canyon National Park  
North Rim Headquarters  
Site Plan

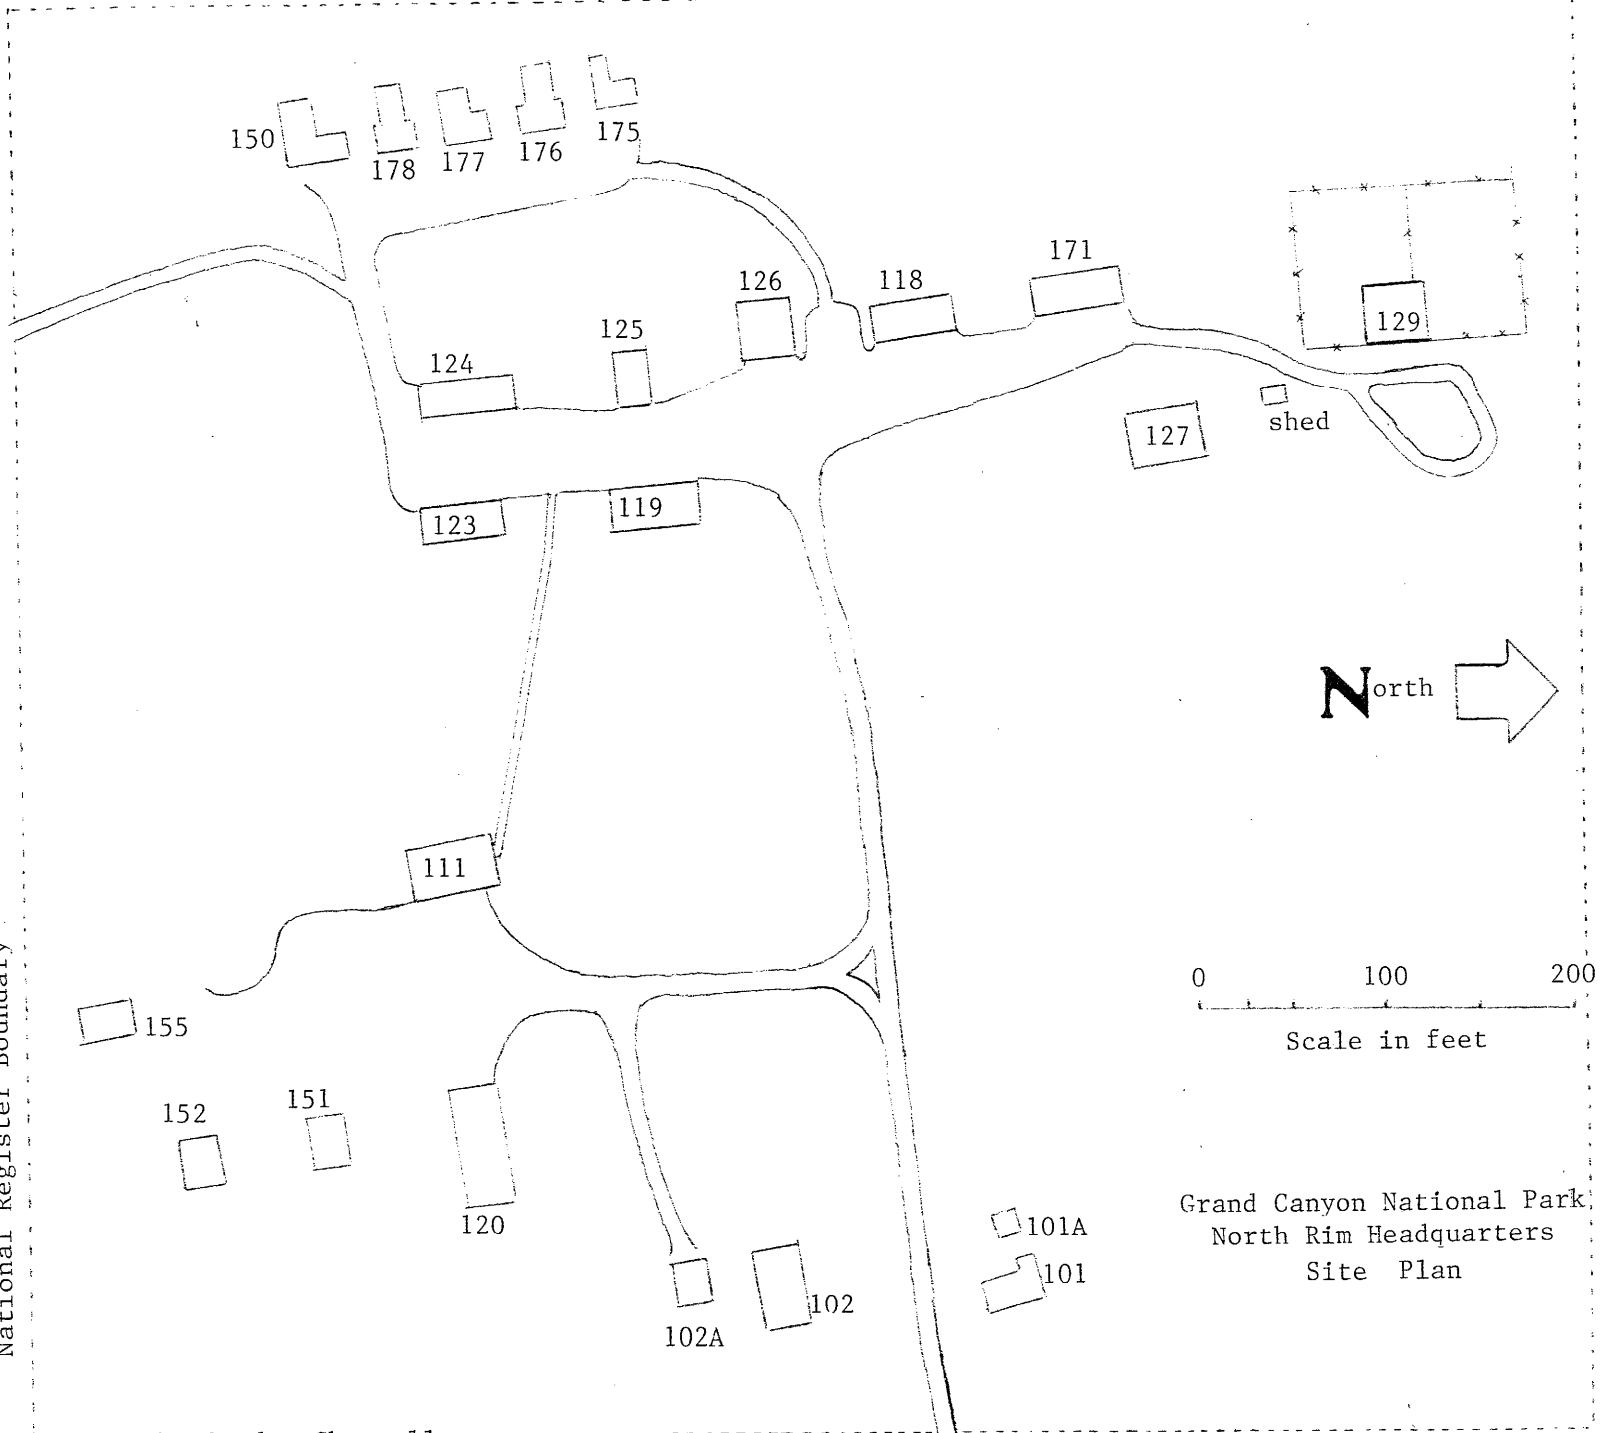
National Register Boundary

0 100 200  
Scale in feet

The boundary is a rectangle composed of a north-south line which is 50 feet east of the easternmost corner of Building No. 102, an east-west line 25 feet south of the southernmost corner of Building No. 155, a north-south line 25 feet west of the westernmost corner of Building No. 175, and an east-west line 25 feet north of the northernmost corner of the corrals adjacent to Building 129; the boundary is entered by road from the east past Buildings 101 and 102, hence the added buffer on that side.

The 12.2 acres contained in the boundary is not a large area in view of the fact that the buildings are scattered across a rural landscape, not compressed into urban city blocks. The boundary, perhaps seemingly large to those accustomed to urban National Register properties, is justified on the basis that it is needed to include the various buildings.
