National Register of Historic Places Registration Form

historic name Roseburg Veterans Administration Hospital Historic District

street & number 913 Northwest Garden Valley Boulevard

city or town Roseburg

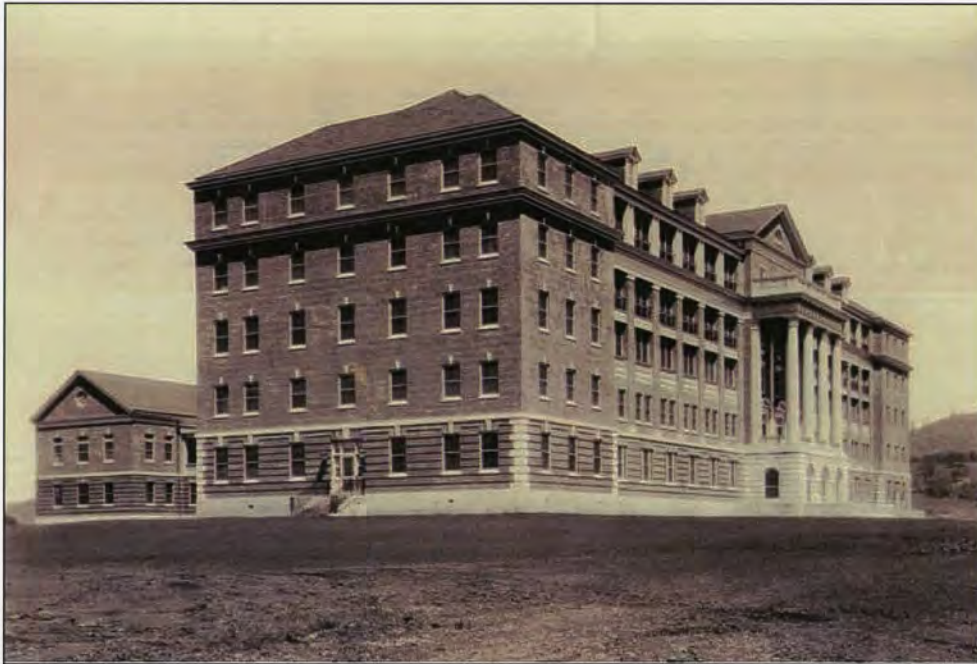
Figure 5: South and facade (east) elevations of Resource 1 (Main Building). Photograph dated May 27, 1933. Located in a scrapbook in the Public Affairs Office of the Veterans Affairs Roseburg Healthcare System, Roseburg, Oregon.

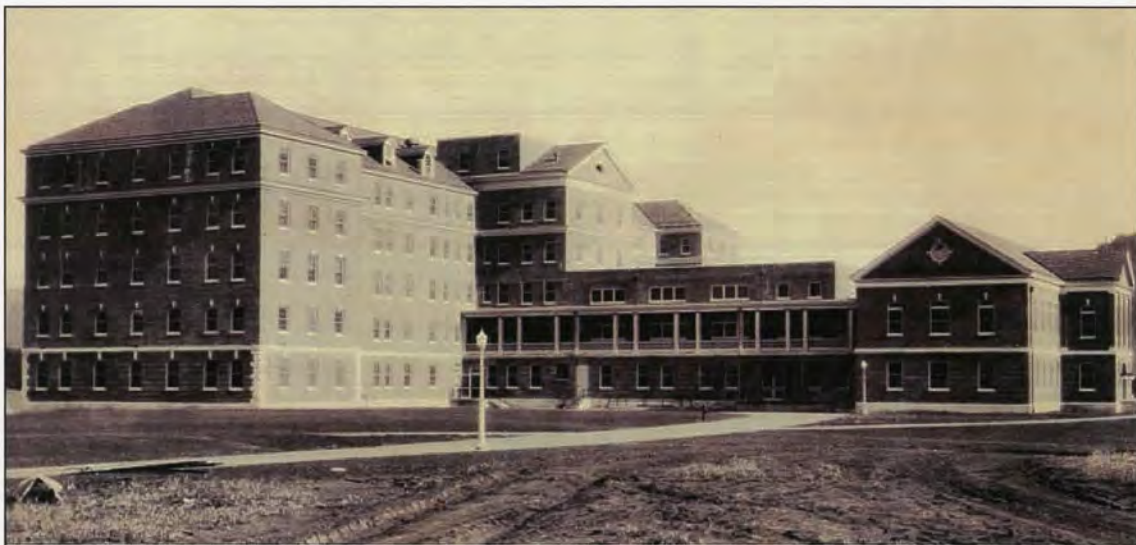
Figure 6: North and rear (west) elevations of Resource 1 (Main Building). Photograph dated May 27, 1933. Located in a scrapbook in the Public Affairs Office of the Veterans Affairs Roseburg Healthcare System, Roseburg, Oregon.

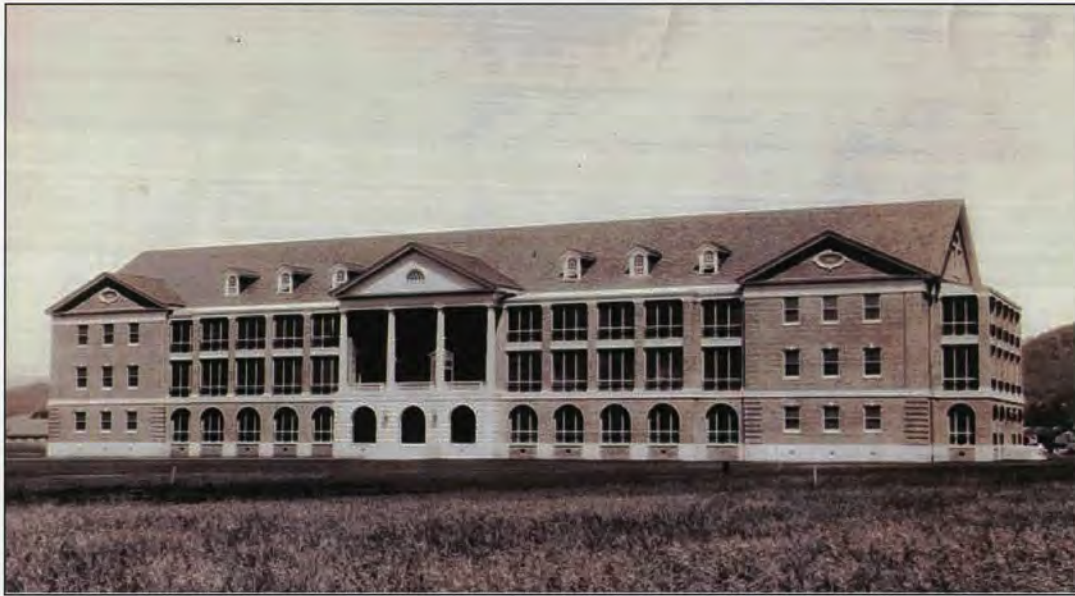
Figure 7: Facade (southeast) and northeast elevations of Resource 2 (Convalescent Building). Photograph dated May 27, 1933. Located in a scrapbook in the Public Affairs Office of the Veterans Affairs Roseburg Healthcare System, Roseburg, Oregon.

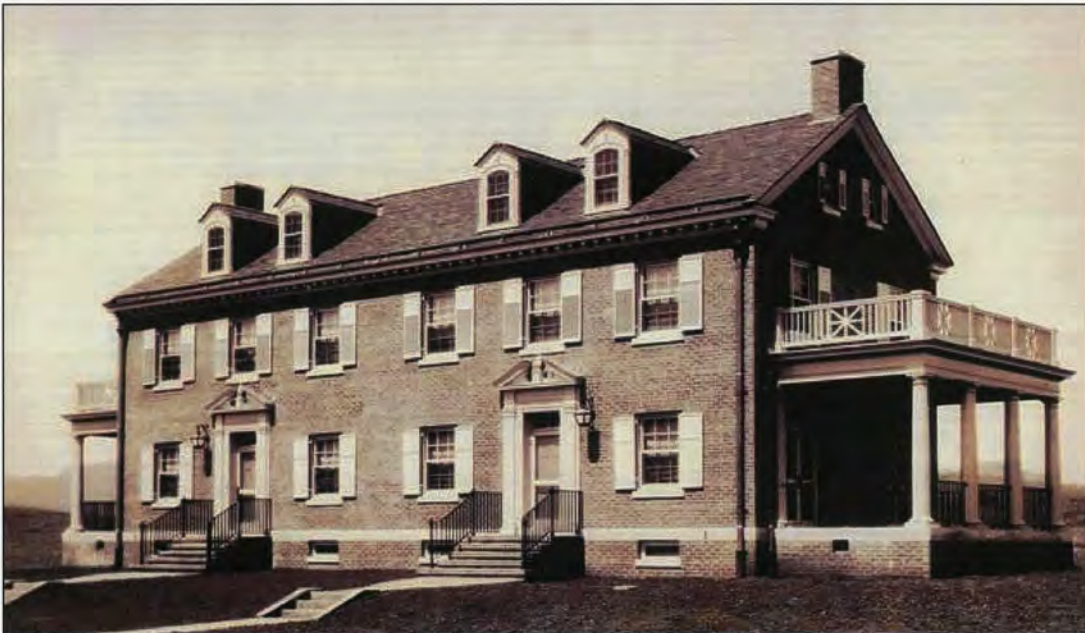
Figure 8: Facade (southeast) and northeast elevations of Resource 6 (Officers' Duplex Quarters). Photograph dated May 29, 1933. Located in a scrapbook in the Public Affairs Office of the Veterans Affairs Roseburg Healthcare System, Roseburg, Oregon.

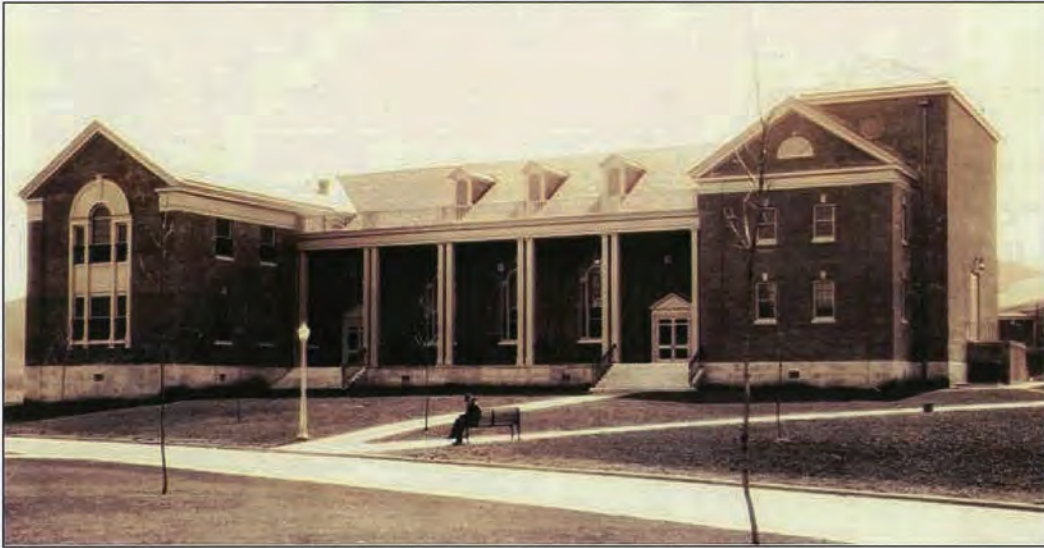
Figure 9: Northeast and rear (northwest) elevations of Resource 16 (Recreation Building). Photograph dated April 10, 1936. Located in a scrapbook in the Public Affairs Office of the Veterans Affairs Roseburg Healthcare System, Roseburg, Oregon.

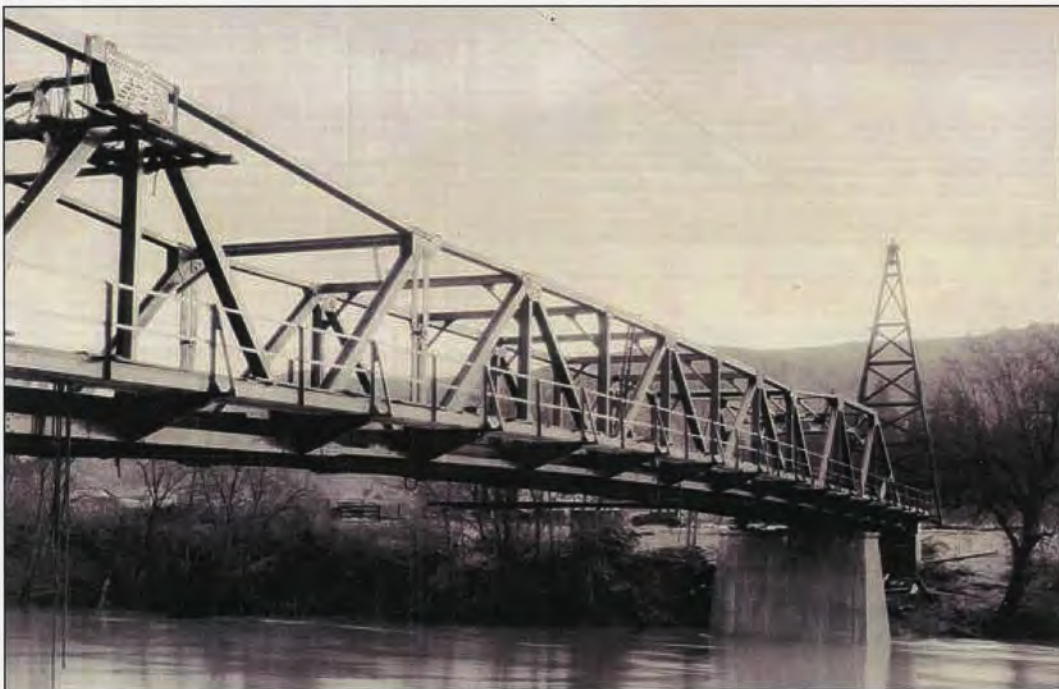
Figure 10: Bridge (Resource G) under construction spanning the South Umpqua River. Photograph dated December 12, 1932. Located in a scrapbook in the Public Affairs Office of the Veterans Affairs Roseburg Healthcare System, Roseburg, Oregon.

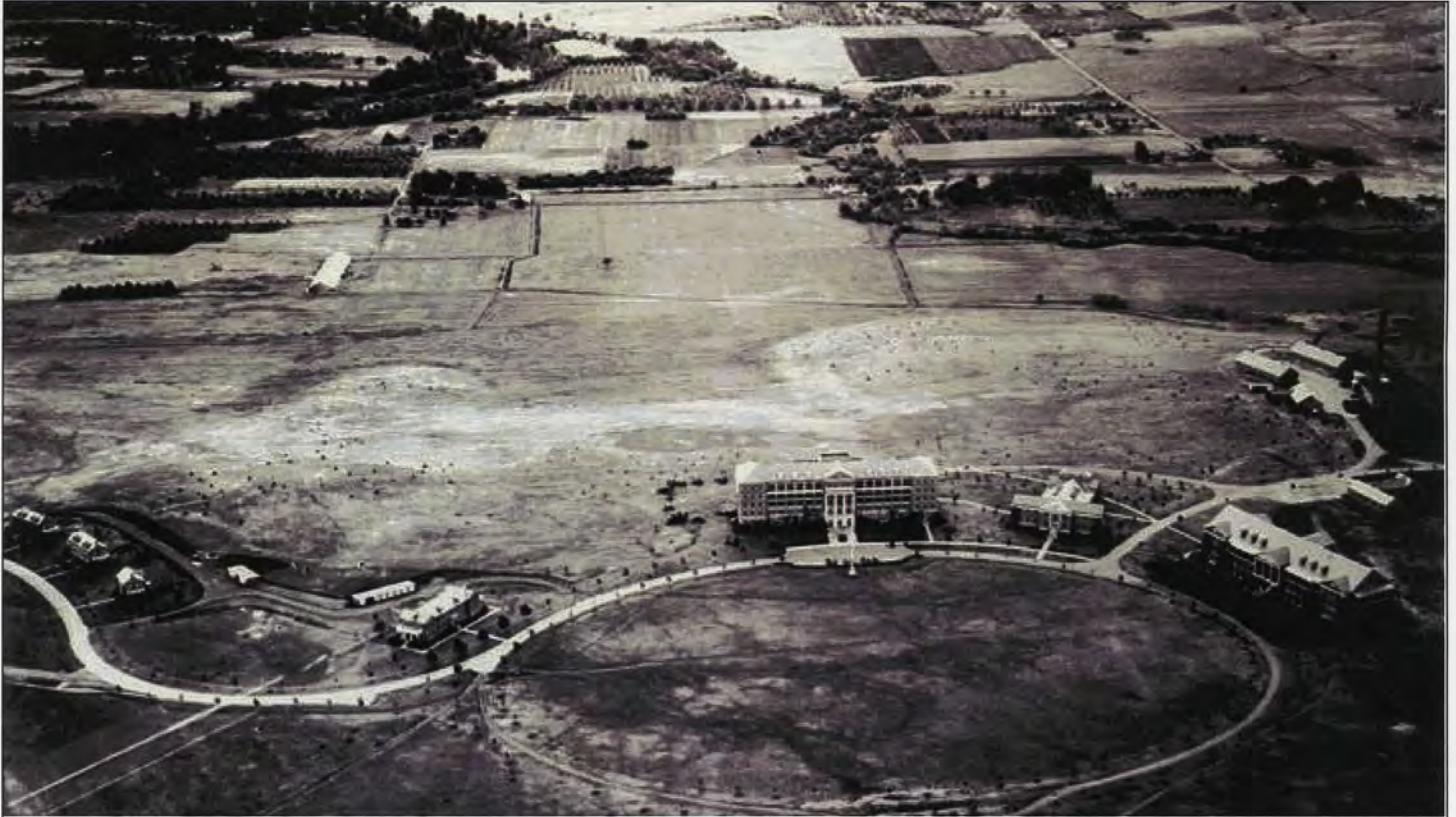
Figure 11: Aerial overview of the Roseburg VA Hospital. Undated photograph (post-1938). Located in a scrapbook in the Public Affairs Office of the Veterans Affairs Roseburg Healthcare System, Roseburg, Oregon.

- Figure 11: Aerial overview of the Roseburg VA Hospital. Undated photograph (post-1938). Located in a scrapbook in the Public Affairs Office of the Veterans Affairs Roseburg Healthcare System, Roseburg, Oregon.

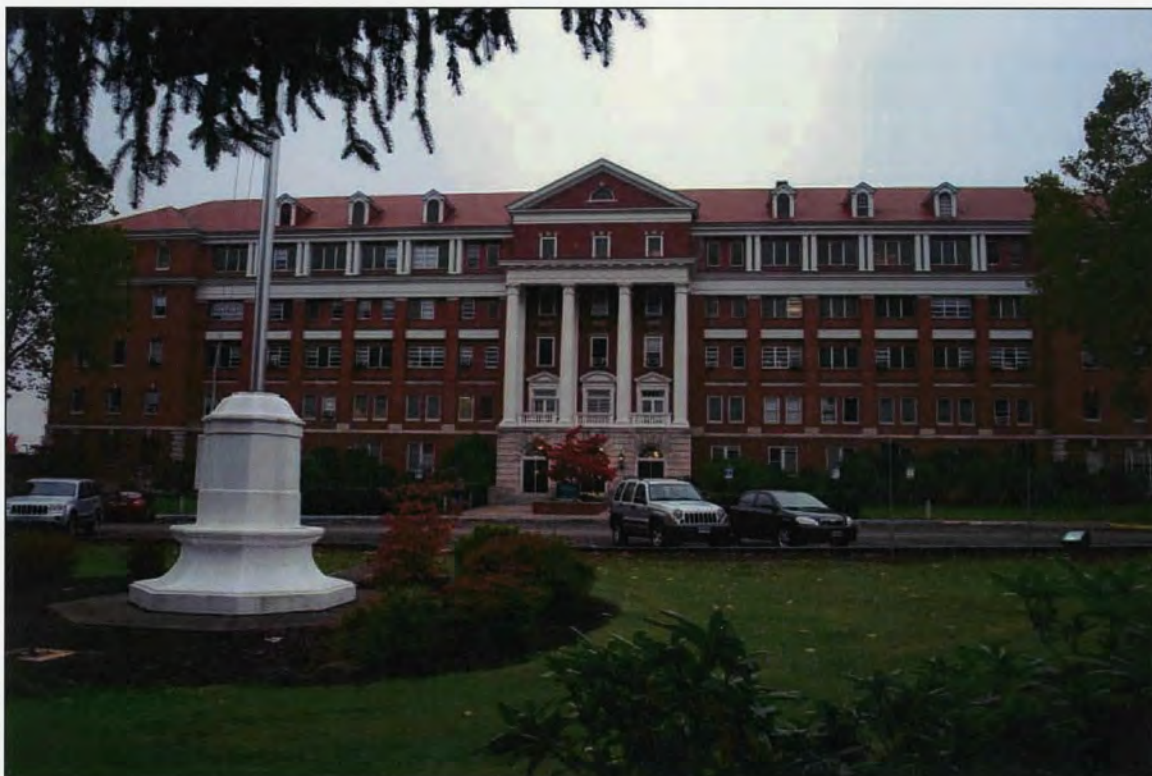
Photo 1 of 16: View to the west to the façade of Resource 1 and base of Resource K.

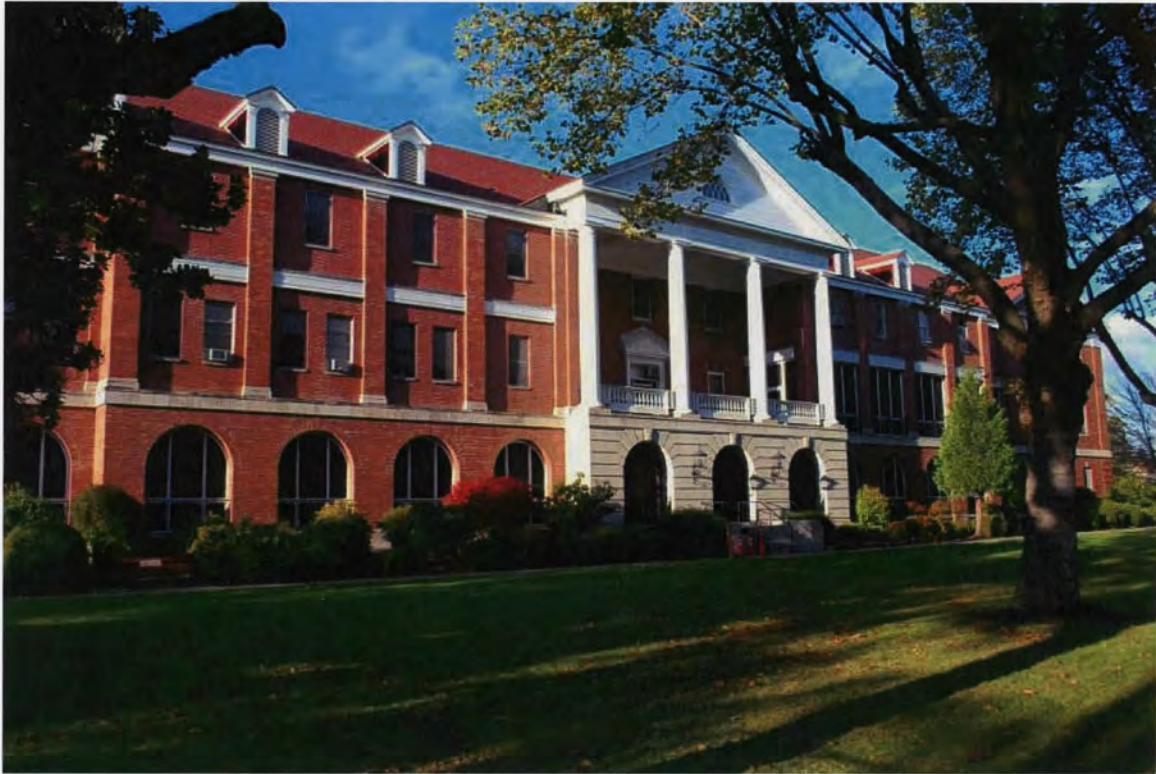
Photo 3 of 16: Façade of Resource 2. View looking to the northeast.

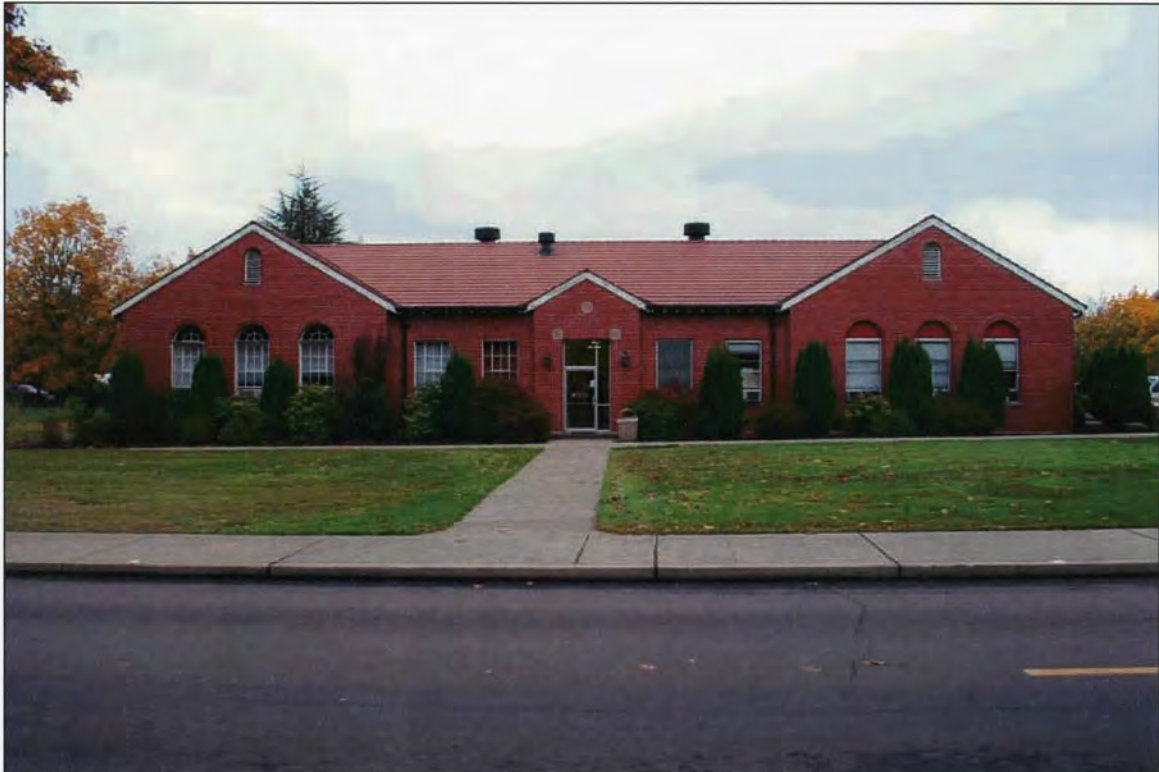
Photo 4 of 16: Façade of Resource 17. View looking to the northeast.

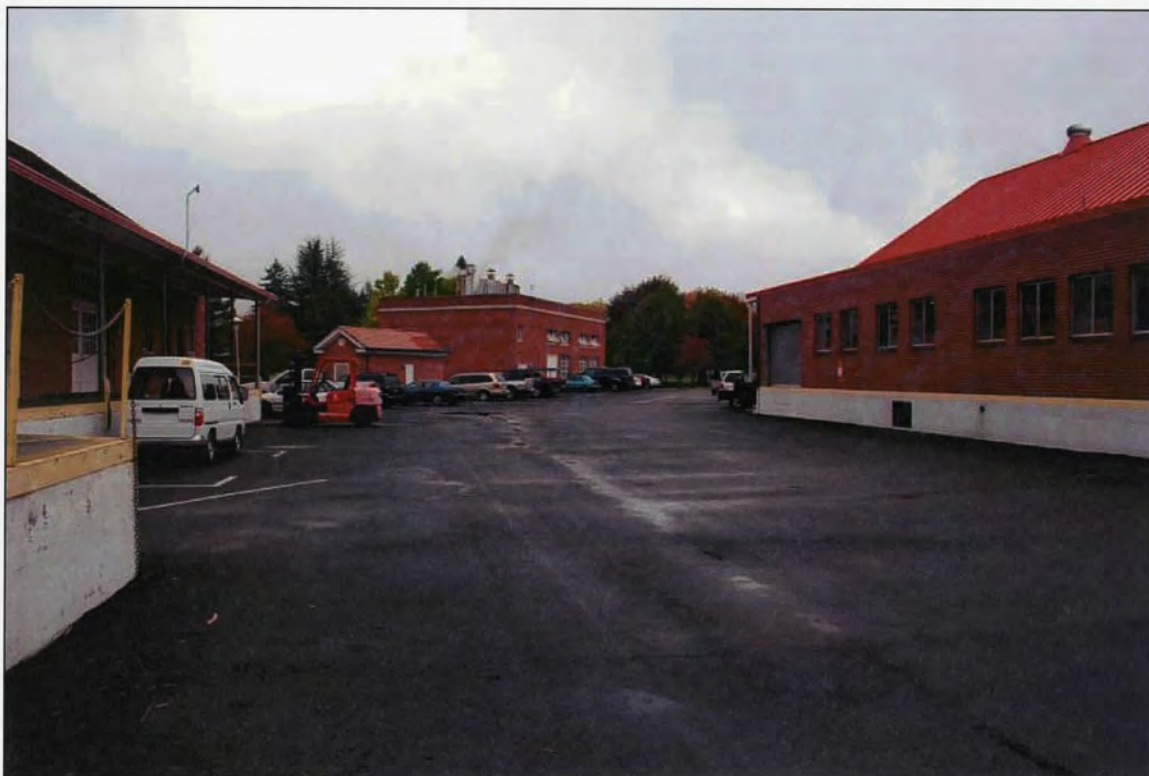
Photo 5 of 16: View looking to the northeast to Resources 13, 9, 7, and 11.

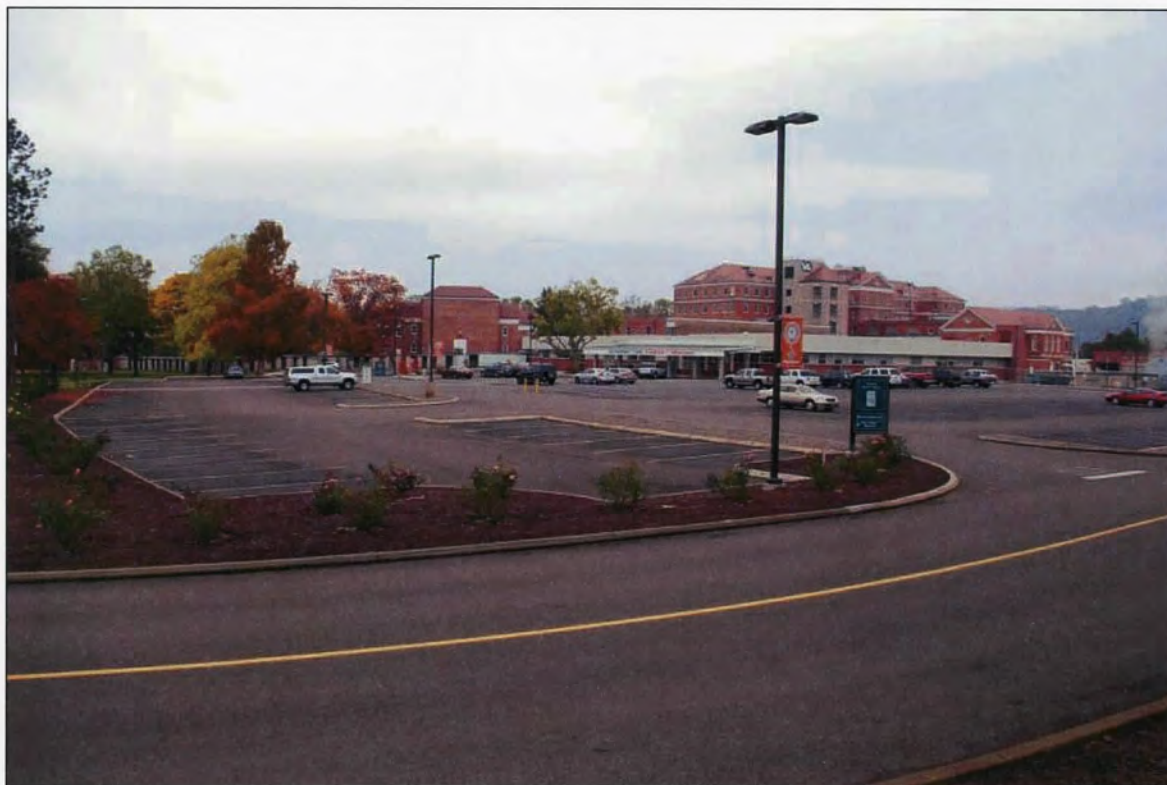
Photo 6 of 16: View looking to the southeast to Resources D, 16, 1-AC, 1, and 71.

- Photo 6 of 16: OR_DouglasCounty_2nd_Generation_Veterans_Hospitals_RoseburgVAHospital_0006
View looking to the southeast to Resources D, 16, 1-AC, 1, and 71.

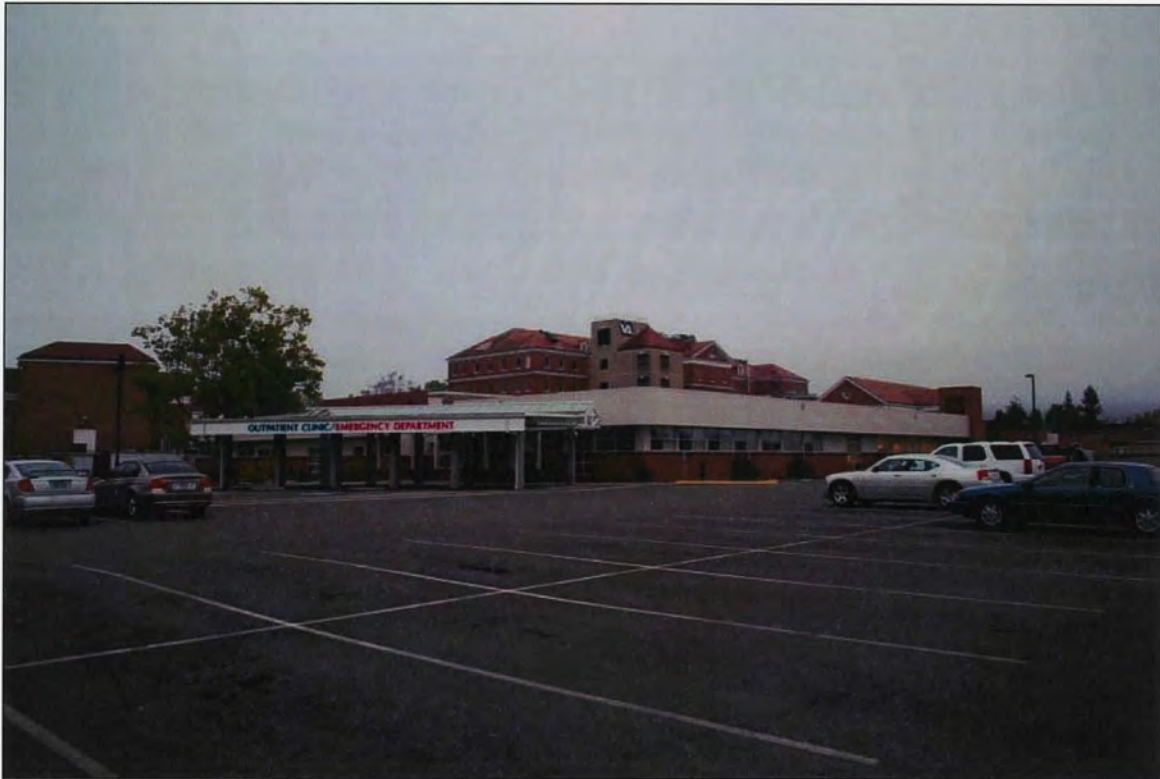
Photo 7 of 16: View looking to the southeast to Resources 16, 1-AC, and 1.

- Photo 7 of 16: OR_DouglasCounty_2nd_Generation_Veterans_Hospitals_RoseburgVAHospital_0007
View looking to the southeast to Resources 16, 1-AC, and 1.
- Photo 8 of 16: OR_DouglasCounty_2nd_Generation_Veterans_Hospitals_RoseburgVAHospital_0008
North elevation of Resource 71. View looking south.

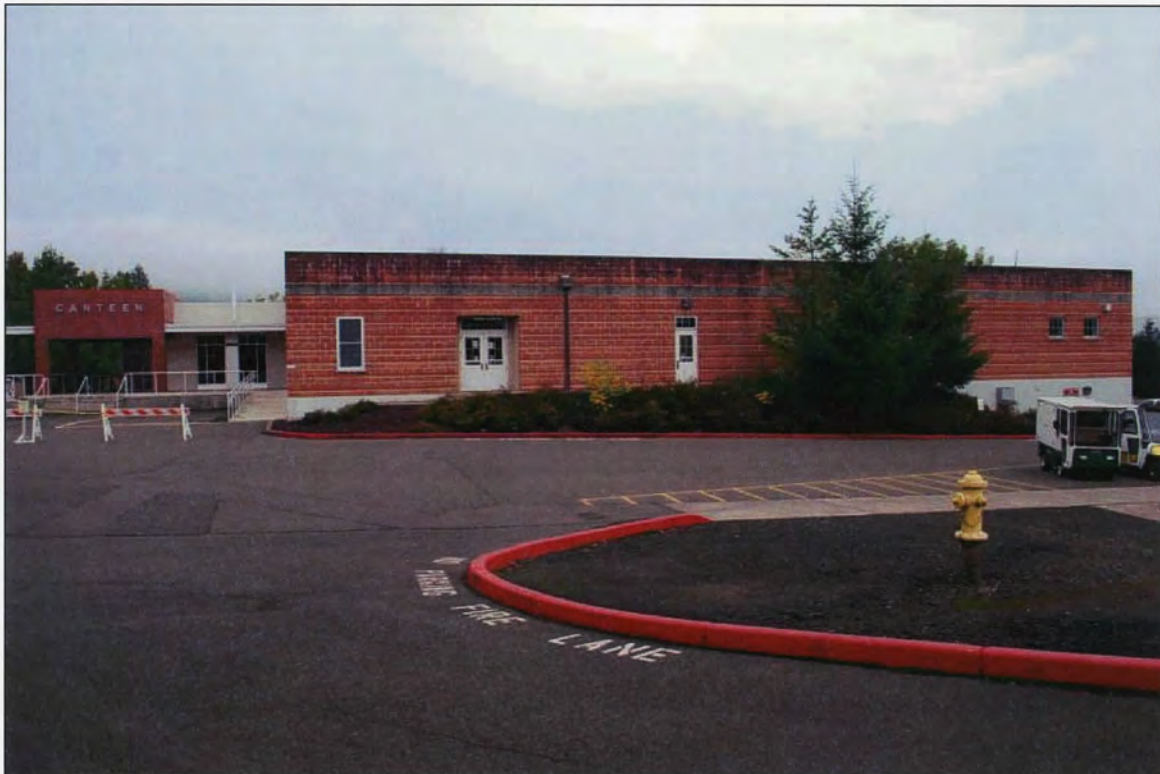
Photo 8 of 16: North elevation of Resource 71. View looking south.

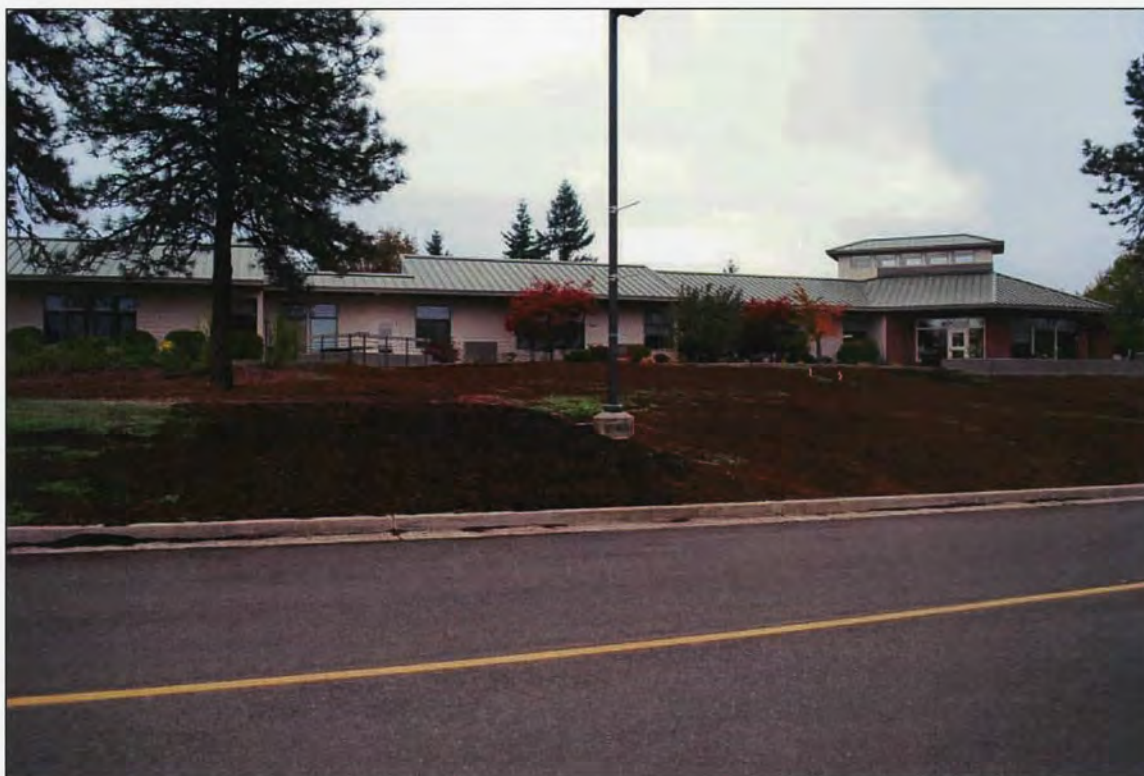
Photo 9 of 16: West elevation of Resource 81. View looking east-southeast.

- Photo 9 of 16: OR_DouglasCounty_2nd_Generation_Veterans_Hospitals_RoseburgVAHospital_0009
West elevation of Resource 81. View looking east-southeast.
- Photo 10 of 16: OR_DouglasCounty_2nd_Generation_Veterans_Hospitals_RoseburgVAHospital_0010
Façade (southeast) elevation of Resource 6. View looking north-northeast.

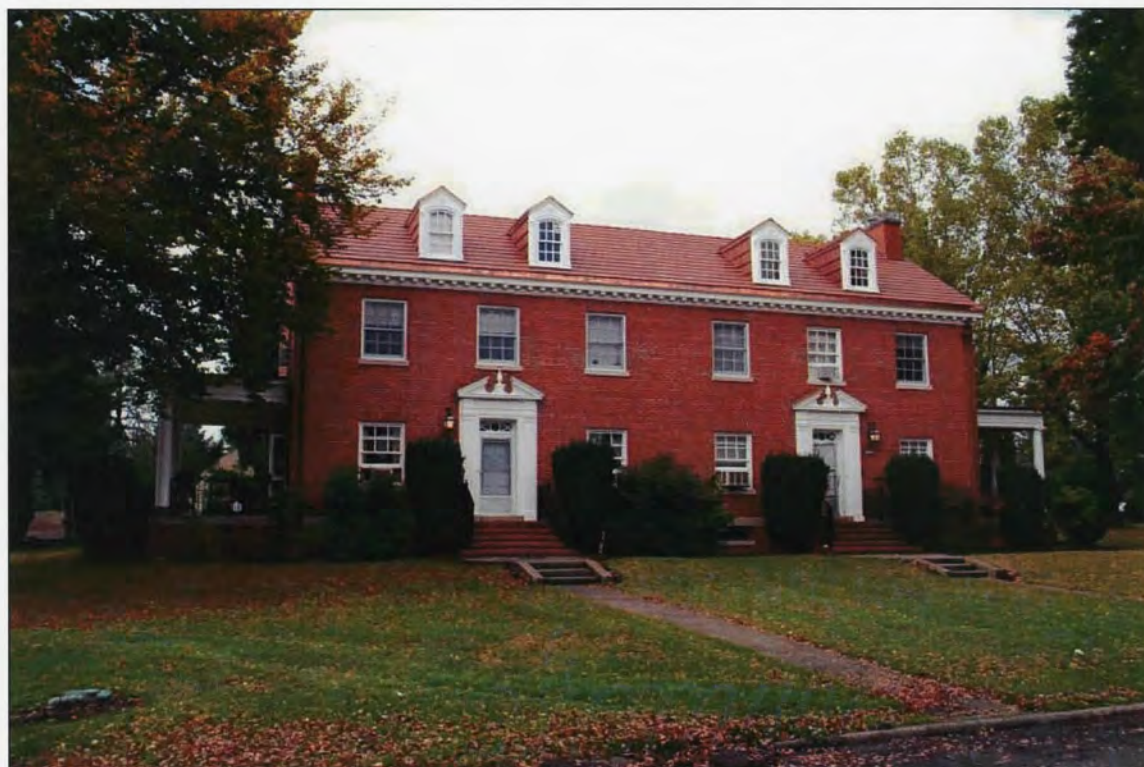
Photo 10 of 16: Façade (southeast) elevation of Resource 6. View looking north-northeast.

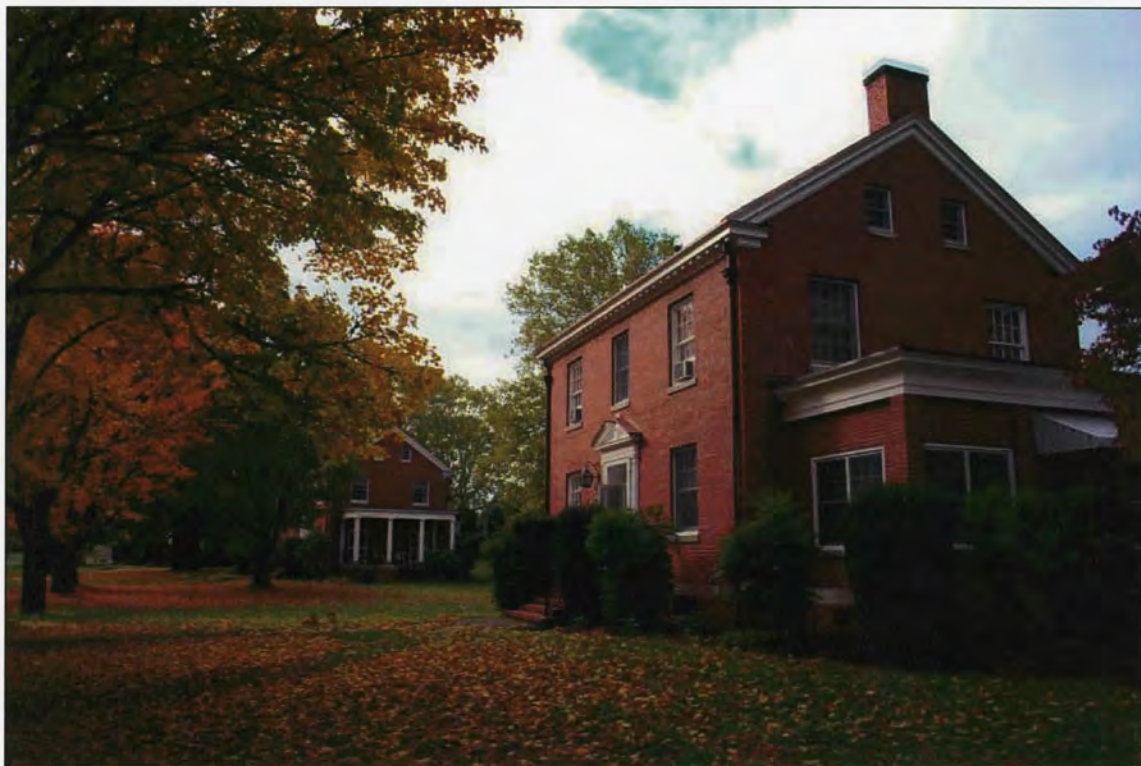
Photo 11 of 16: Façades (southeast) and northeast elevations of Resources 5 and 6. View looking southwest.

- Photo 11 of 16: OR_DouglasCounty_2nd_Generation_Veterans_Hospitals_RoseburgVAHospital_0011
Façades (southeast) and northeast elevations of Resources 5 and 6. View looking southwest.

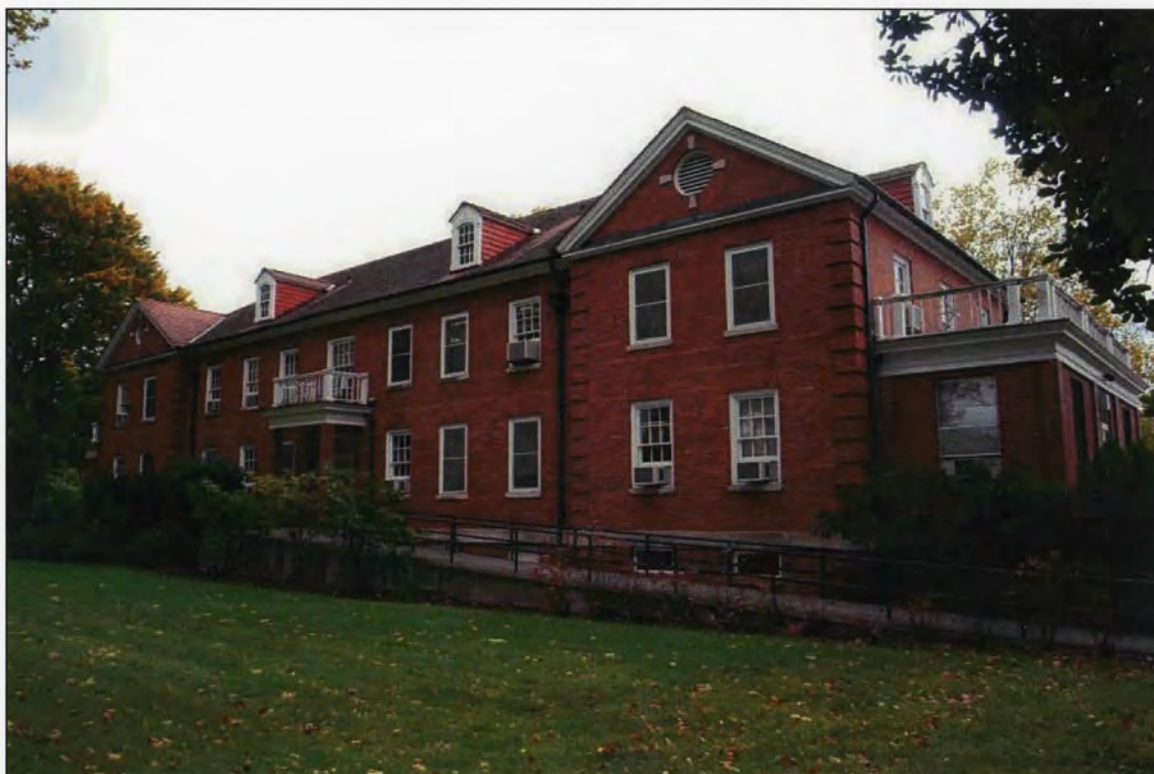
Photo 12 of 16: Façade (northeast) and northwest elevations of Resource 3. View looking south-southeast.

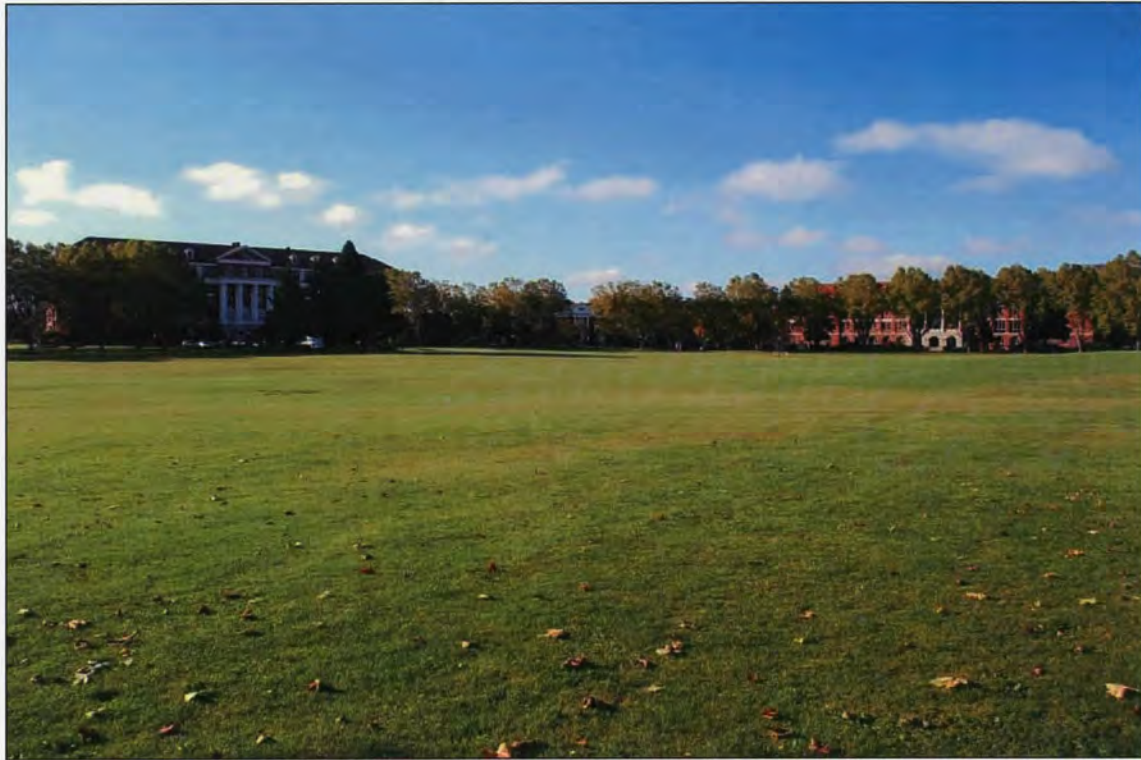
Photo 13 of 16: View across ellipse (Resource L) looking to Resources 1, 16, and 2. View looking northwest.

- Photo 13 of 16: OR_DouglasCounty_2nd_Generation_Veterans_Hospitals_RoseburgVAHospital_0013
View across ellipse (Resource L) looking to Resources 1, 16, and 2. View looking northwest.

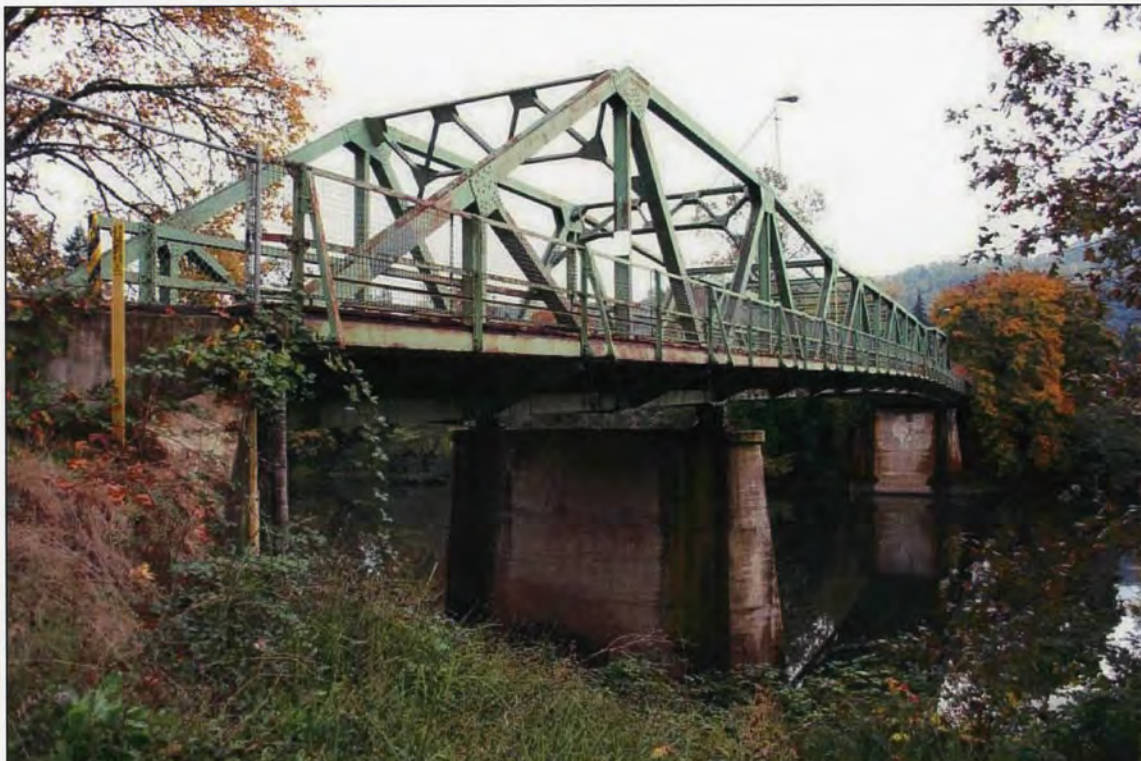
Photo 14 of 16: View to the southeast of the southwest elevation of the bridge (Resource G) over the South Umpqua River.

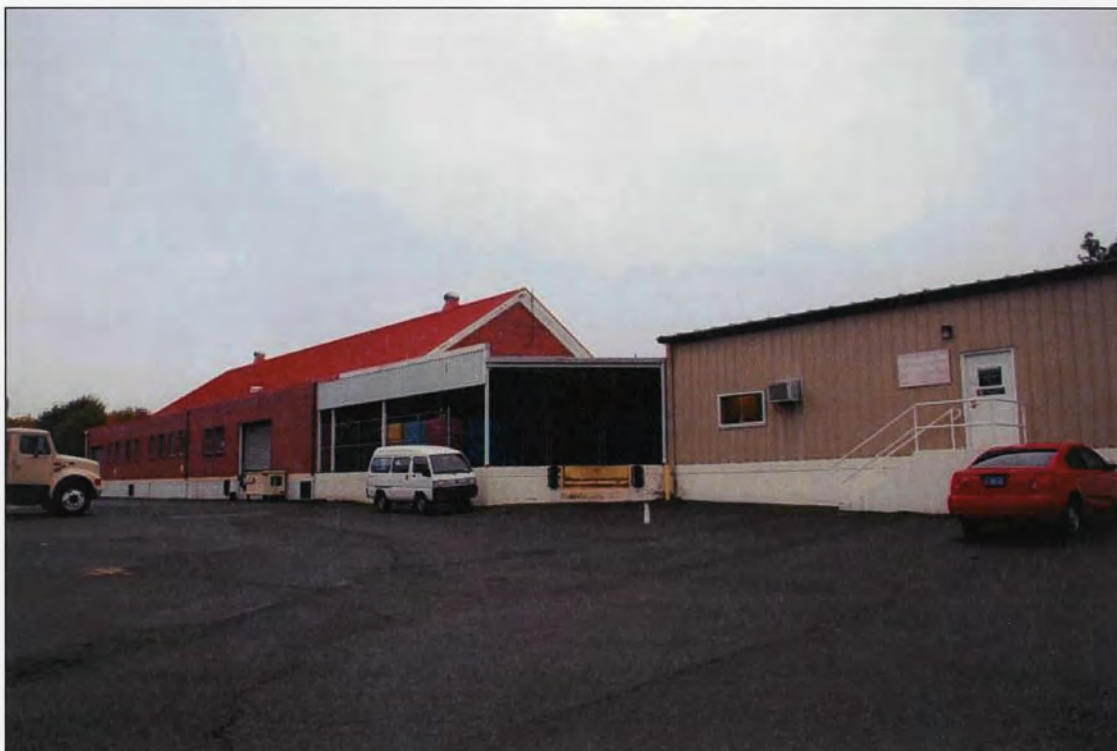
Photo 16 of 16: View looking to the east-southeast along the façade (northwest elevation) of Resource 11 and 11A.

Resource 11A was constructed circa 1985–2000 as an addition to the laundry building (Resource 11, 1933). It is oriented to the northwest and is located adjacent to the southwest elevation of Resource 11. The two-bay (d/w) single-story addition is supported by a concrete slab foundation and exhibits a ribbed-metal exterior and a ribbed-metal gable roof. The facade and rear elevations both exhibit single-leaf entries containing metal doors and windows filled by two single-light, horizontal sliding sashes. A circular vent projects from the right side (southwest elevation), and another projects from the roof in the southeast corner of the building. A loading dock sheltered by a flat roof located on the left side (northeast elevation) of this resource connects it with the laundry building (Resource 11, 1933).
