# National Register of Historic Places Registration Form

Section No. 7 Page 1 Martin Hofherr Farm 🕬

The farm, which is located on 650 West, consists of four buildings. These are the house, completed in 1905; a large round barn, built in 1904; an English barn, built in 1913; and a garage, a contemporary intrusion, built in the 1980s. Northeast of the round barn is a one-story, wood barn, constructed after the period of significance (far right in photo 1). The boundaries have been drawn to exclude this barn.

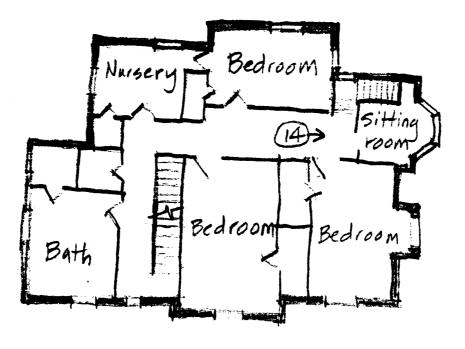
Second Floor Plan

Hofherr House North Delaware Co. V

Upstairs, there is a main, east-west hallway through the center of the house, and a rear hallway adjacent to the rear stair. There are three bedrooms, a small sitting room, a nursery which is connected to the south bedroom, and a bathroom in the northeast corner of this floor. The entrance to the sitting room has a Corinthian column (photo 14) similar to those on the first floor. Original fixtures in the bathroom, including a claw-foot bathtub, have been retained.
