National Register of Historic Places
Registration Form

historic name Loucks Grove Church

state Iowa code IA county Adair code 001 zip code 50849

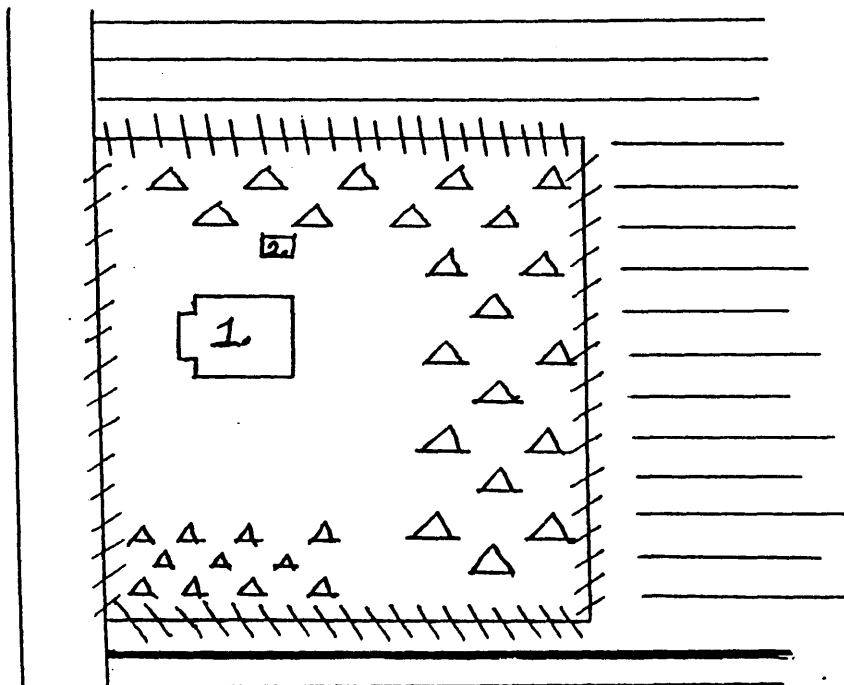
SKETCH MAP

#1 is the only contributing resource.

#2 is the only non-contributing resource. It is a three-hole out house located approximately twenty feet from northeast corner of church. Date of construction is not known.

County rock road is not numbered. See accompanying plat map for location.

Approximate scale is 1 inch = 80 feet.

The only outbuilding on the Loucks Grove Church property is a wooden frame three-hole out house. It is located approximately 20 feet from the northeast corner of the church. The date of construction is not known.

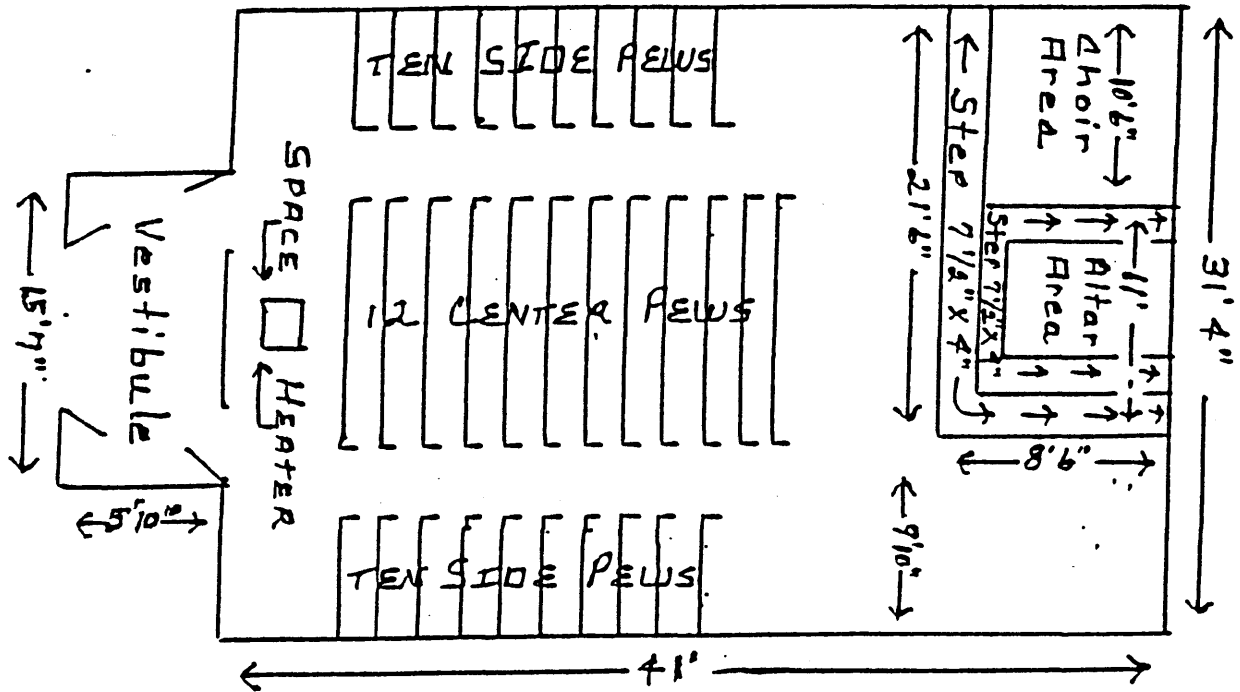
FLOOR PLAN

Interior measurements. Not drawn to scale.

The rectangular structure measures 42 feet 4 inches long by 32 feet 3 inches wide and 31 feet 4½ inches high and sits on a native limestone foundation. The stones are laid together to provide a support which is 22 inches wide and 33 inches tall at the highest point. The cornerstone at the southeast corner bears the date 1895 and a name which is no longer legible. The only entrance is through a vestibule on the west side. The vestibule is 16 feet 3 inches long by 6 feet 6 inches wide and 31 feet 4½ inches high. The 24 foot steep roof of the main structure and the vestibule fall from the 31 foot 4½ inch high peak to the 16 foot sidewalls. Over the original wooden shingles, two layers of composition shingles have been applied. Currently a re-roofing project is underway to remove all the shingles. New wooden shingles are being laid, entirely by hand, to the specifications of the original shingles. The exterior walls are sided with 4 inch lap siding which has been painted white. A re-painting project is now in progress. There are three Gothic style windows on both the north and south sides of the church. Over the double doors in the vestibule is an ogee arch window with ten panes. It is presently being repaired.

In the northeast part of the church is the altar and choir section. The total area is 21 feet 6 inches long by 8 feet 6 inches wide. The choir area accounts for 10 feet 6 inches of the length on the north side. It is reached from the main floor by a $7\frac{1}{2}$ inch riser. The other 11 feet is the altar area which is in the middle of the east wall. The altar area is reached by a $7\frac{1}{2}$ inch riser from the choir section or by two $7\frac{1}{2}$ inch risers from the main part of the church. The remaining 9 feet 10 inches in the overall area is on the south end. There are no interior walls other than the one which divides the sanctuary and the vestibule.
