National Register of Historic Places Registration Form

historic name Harry Keith Barn
other names/site number KHRI # 065-199

Other: Gambrel-Roof Barn; Bank Barn

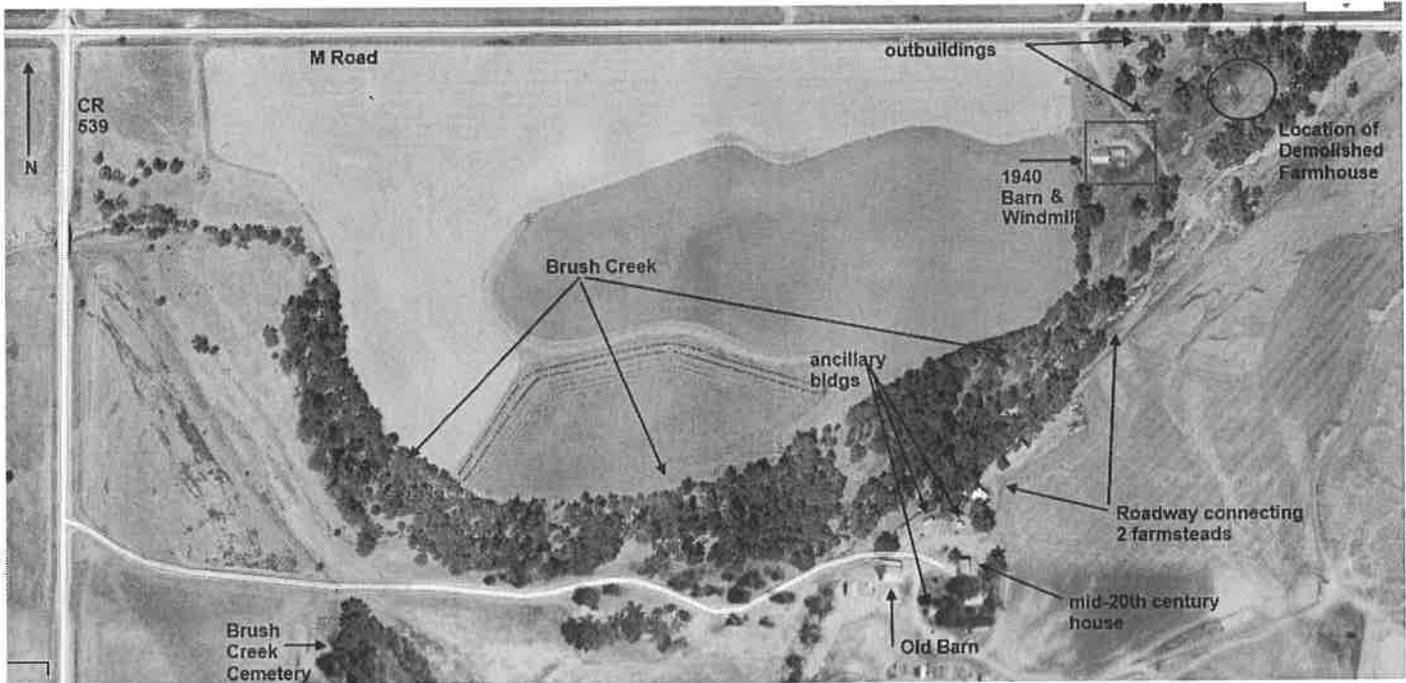
Figure 1:

Aerial Image (Google.com, 2012)
Box indicates nominated barn & windmill.

The Harry Keith Barn is located south of Penokee in Millbrook Township, Graham County, Kansas. It is situated in the northeast quarter of Section 2, Township 9S, Range 24W and is southeast of the junction of 200th Avenue and M Road. It was constructed in October 1940 on Harry Keith's farmstead, which he had owned since purchasing it from F.G. Brumage in 1920. The impressive gambrel-roof bank barn and adjacent windmill can be seen from the main county road (200th Avenue). The environs of the barn include rolling agricultural fields, century-old cottonwood trees along nearby Brush Creek, and hedge trees. Aside from the barn and windmill, the site of the associated farmstead includes a few remaining outbuildings, but they are not within the boundaries being nominated. The two-story stone farmhouse has been gone for many years, and the barn and remaining outbuildings are now associated with the farmstead located in the northwest quarter of Section 2. (Figure 1)

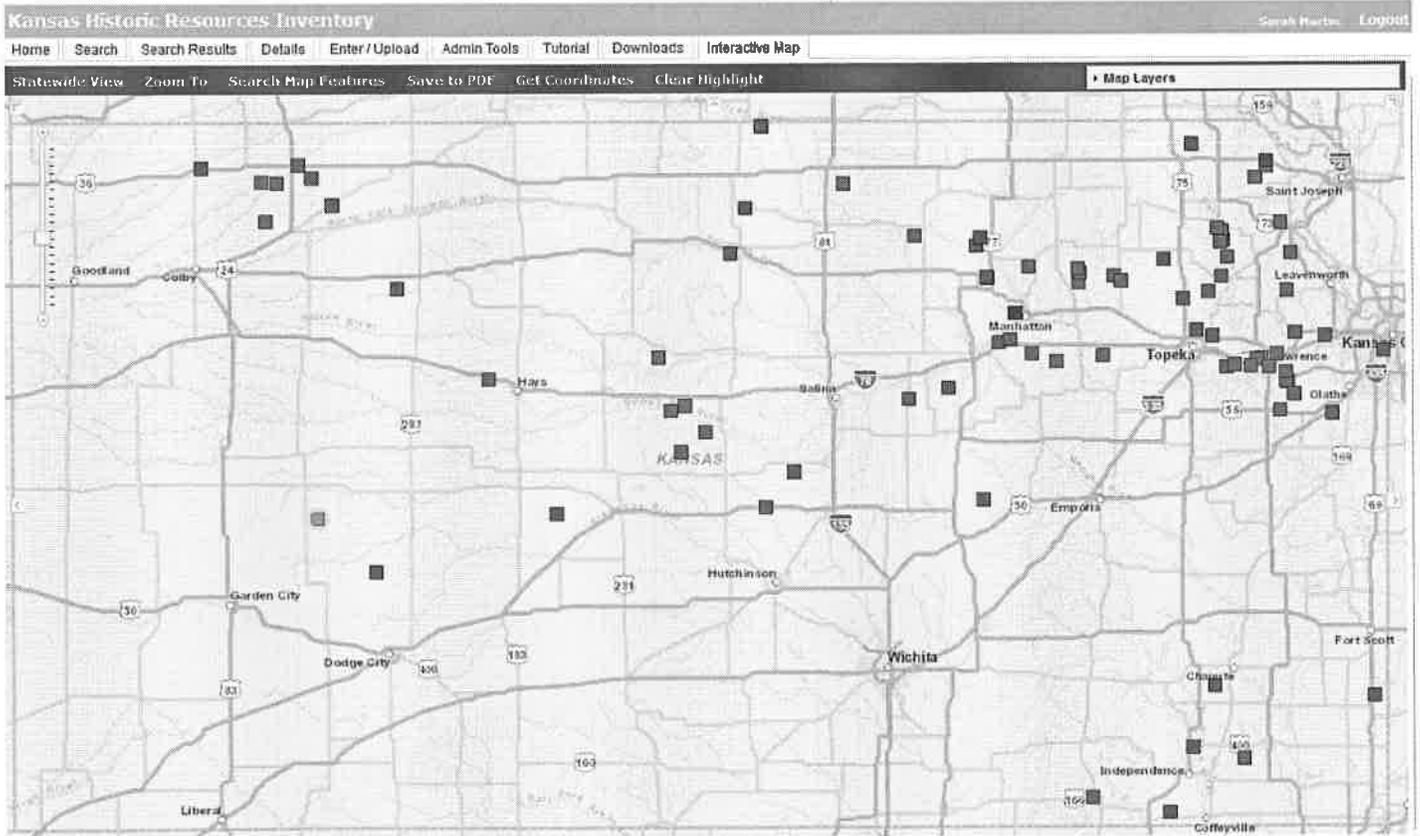
Figure 2: Map of Bank Barns Surveyed in Kansas
Kansas Historic Resources Inventory, Kansas Historical Society
Online Database accessed 19 November 2012: <http://khri.kansasgis.org>

Eighty-five Bank Barns are noted in the Kansas Historic Resources Inventory (Figure 2), 53 of which were recorded during a 2007 survey of 300 agricultural properties in Kansas. Although the survey determined that Bank Barns are common throughout Kansas, "they predominate in the early-settled counties of Eastern Kansas."²³ There are sixteen of these barns in Doniphan County listed in the National Register as part of the "Byre and Bluff Barns of Doniphan County" multiple property nomination. Many early Kansas Bank Barns were built by settlers of Pennsylvania-German heritage, but "the bank design gained favor with farmers of all ethnic backgrounds," and remained popular into the mid-20th century.²⁴
