# National Register of Historic Places Registration Form

1. Name of Property	
historic name Clearfield School, District #58	
other names/site number KHRI # 045-0000-00313	
2. Location	
street & number 2162 N 600 Road	not for publication
city or town Baldwin City	Vicinity
state Kansas code KS county Douglas code	045 zip code 66006

Name of Property:	Clearfield School #58
City or Vicinity:	Baldwin City, Palmyra Township
County/State:	Douglas County, Kansas
Photographer:	Sarah Martin
Date of Photos:	6 September 2013

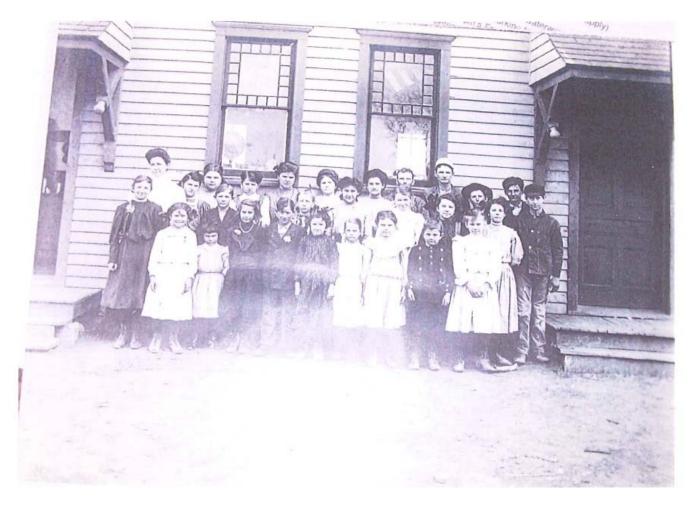
# Figure 7: Historic Photograph, front elevation, approximately 1903.

The front, south-facing elevation includes two separate entrances; former students said one entrance was for the boys and the other for the girls. A concrete pad extends the width of this front elevation. Each entrance is comprised of a concrete stoop with a single, paneled wood door topped by a curved shed roof porch supported by brackets. Between the two entrances are two double-hung wood windows, each with a decorative upper sash containing a surrounding band of 20 three-inch square panes. Centered above these windows within the gable is a flush triangular panel below which is a now-covered opening where two fixed decorative windows were installed.<sup>1</sup> Fishscale shingle siding clads the area within the gable.

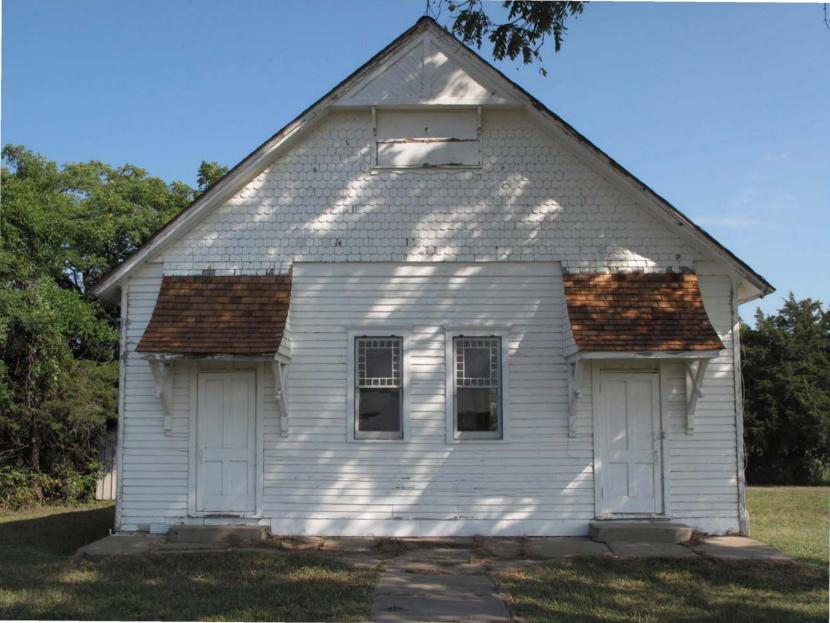
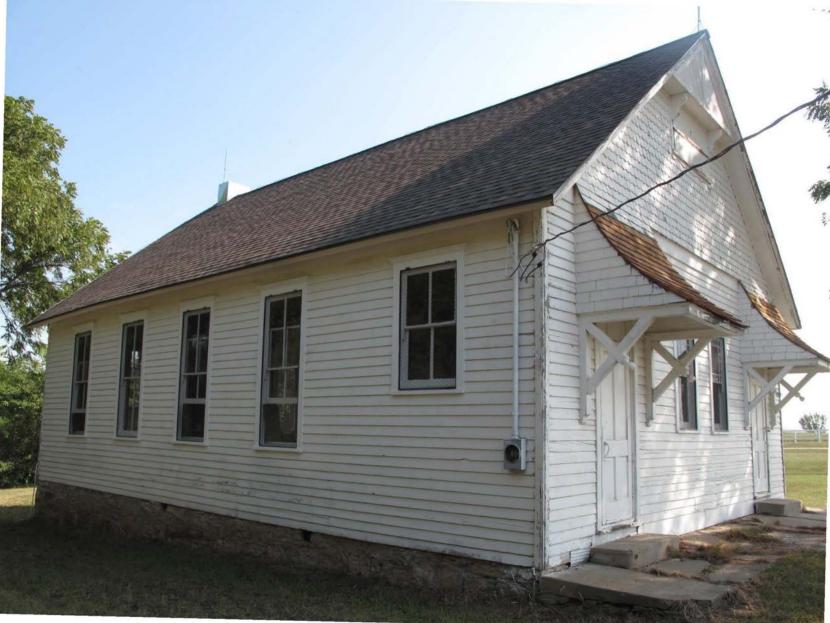
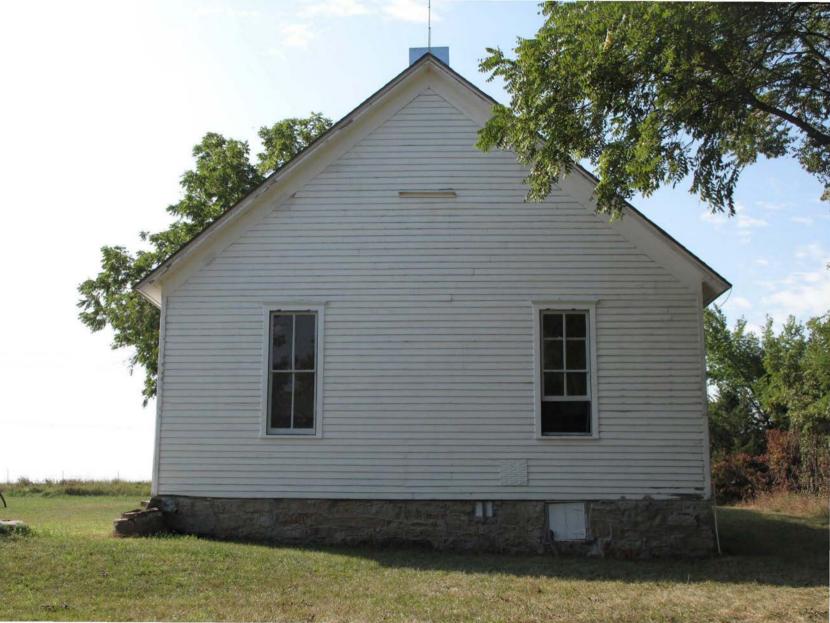
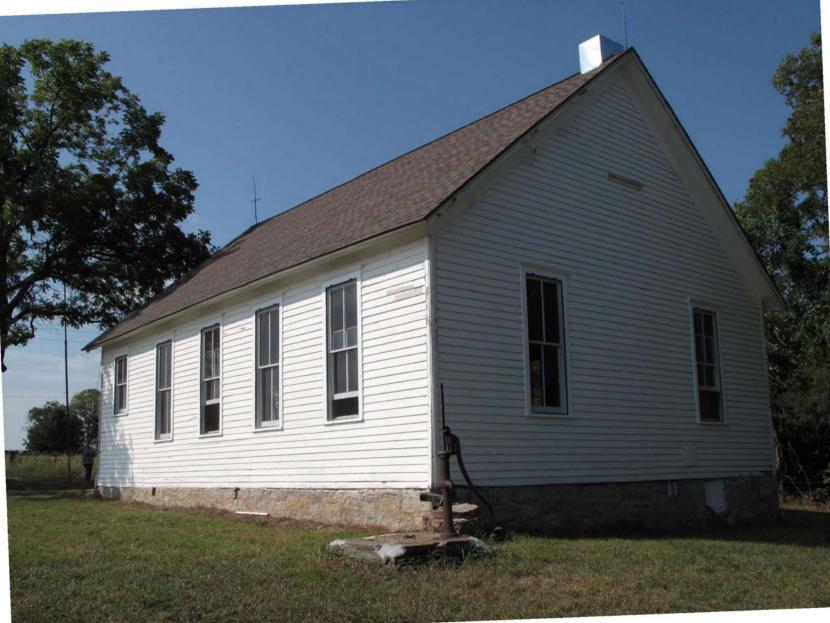
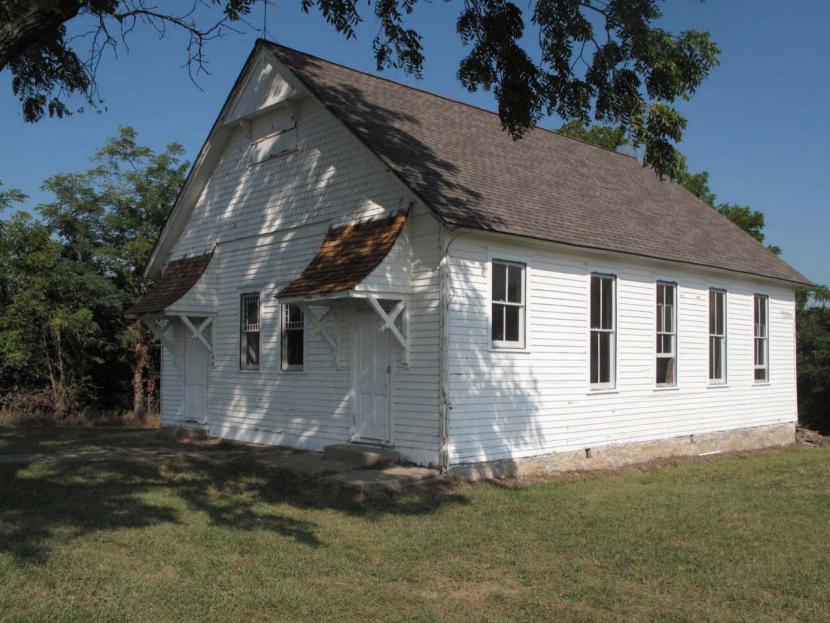
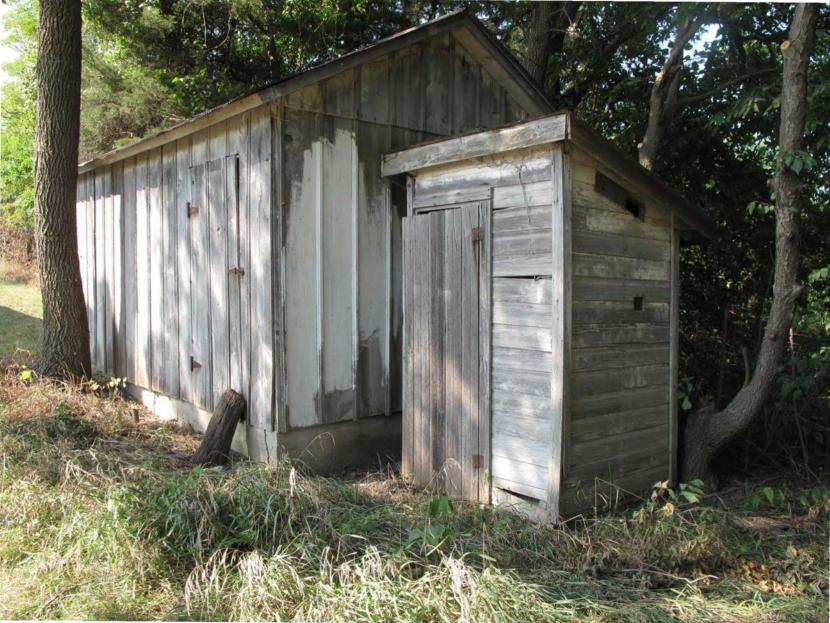
- 1 of 12 Front (south) elevation, facing N
- 2 of 12 Side (west) elevation, facing NE
- 3 of 12 Rear (north) elevation, facing S
- 4 of 12 Rear (north) and side (east) elevations, facing SW
- 5 of 12 Front (south) and side (east) elevations, facing NW
- 6 of 12 South outhouse and shed, facing SW
- 7 of 12 North outhouse, facing W
- 8 of 12 Interior, east cloakroom/vestibule, facing NW
- 9 of 12 Interior, west cloakroom/vestibule, facing NE
- 10 of 12 Interior, entrances into classroom at south end of building, facing SW
- 11 of 12 Interior, overall classroom space, facing SW
- 12 of 12 Interior, overall classroom space, facing N

Clearfield School is a wood-frame, rectangular building with wood clapboard siding. It features a front gable roof and is built on a stone foundation. The building has one interior brick end chimney at the peak of the north end gable. The corners of the building feature corner boards and the roofline is finished with a simple cornice. All of the windows have matching exterior trim.

The east (side) elevation features five 2-over-2, double-hung wood sash windows. The southernmost window is smaller than the others and measures 3'x3', and the others measure 4'x6'. This elevation includes a rain water runoff well and pump at the north end.

The north (rear) elevation includes two 2-over-2, double-hung wood sash windows, which flank an interior brick chimney. A rectangular metal vent at the roof peak denotes the location of the chimney, which remains brick below the roofline. Just above the foundation and west of the center of the wall, is an opening that has been sealed shut that it is believed this may have been used to deliver coal or wood into the building. Nearer the west corner and set within the stone foundation is an opening with a wood door allowing access to the crawlspace.

The west (side) elevation mirrors the east side, with five 2-over-2, double-hung wood sash windows.
