**National Register of Historic Places
Inventory—Nomination Form**

historic Whitinsville Historic District

7. Description Whitinsville Historic District, Northbridge

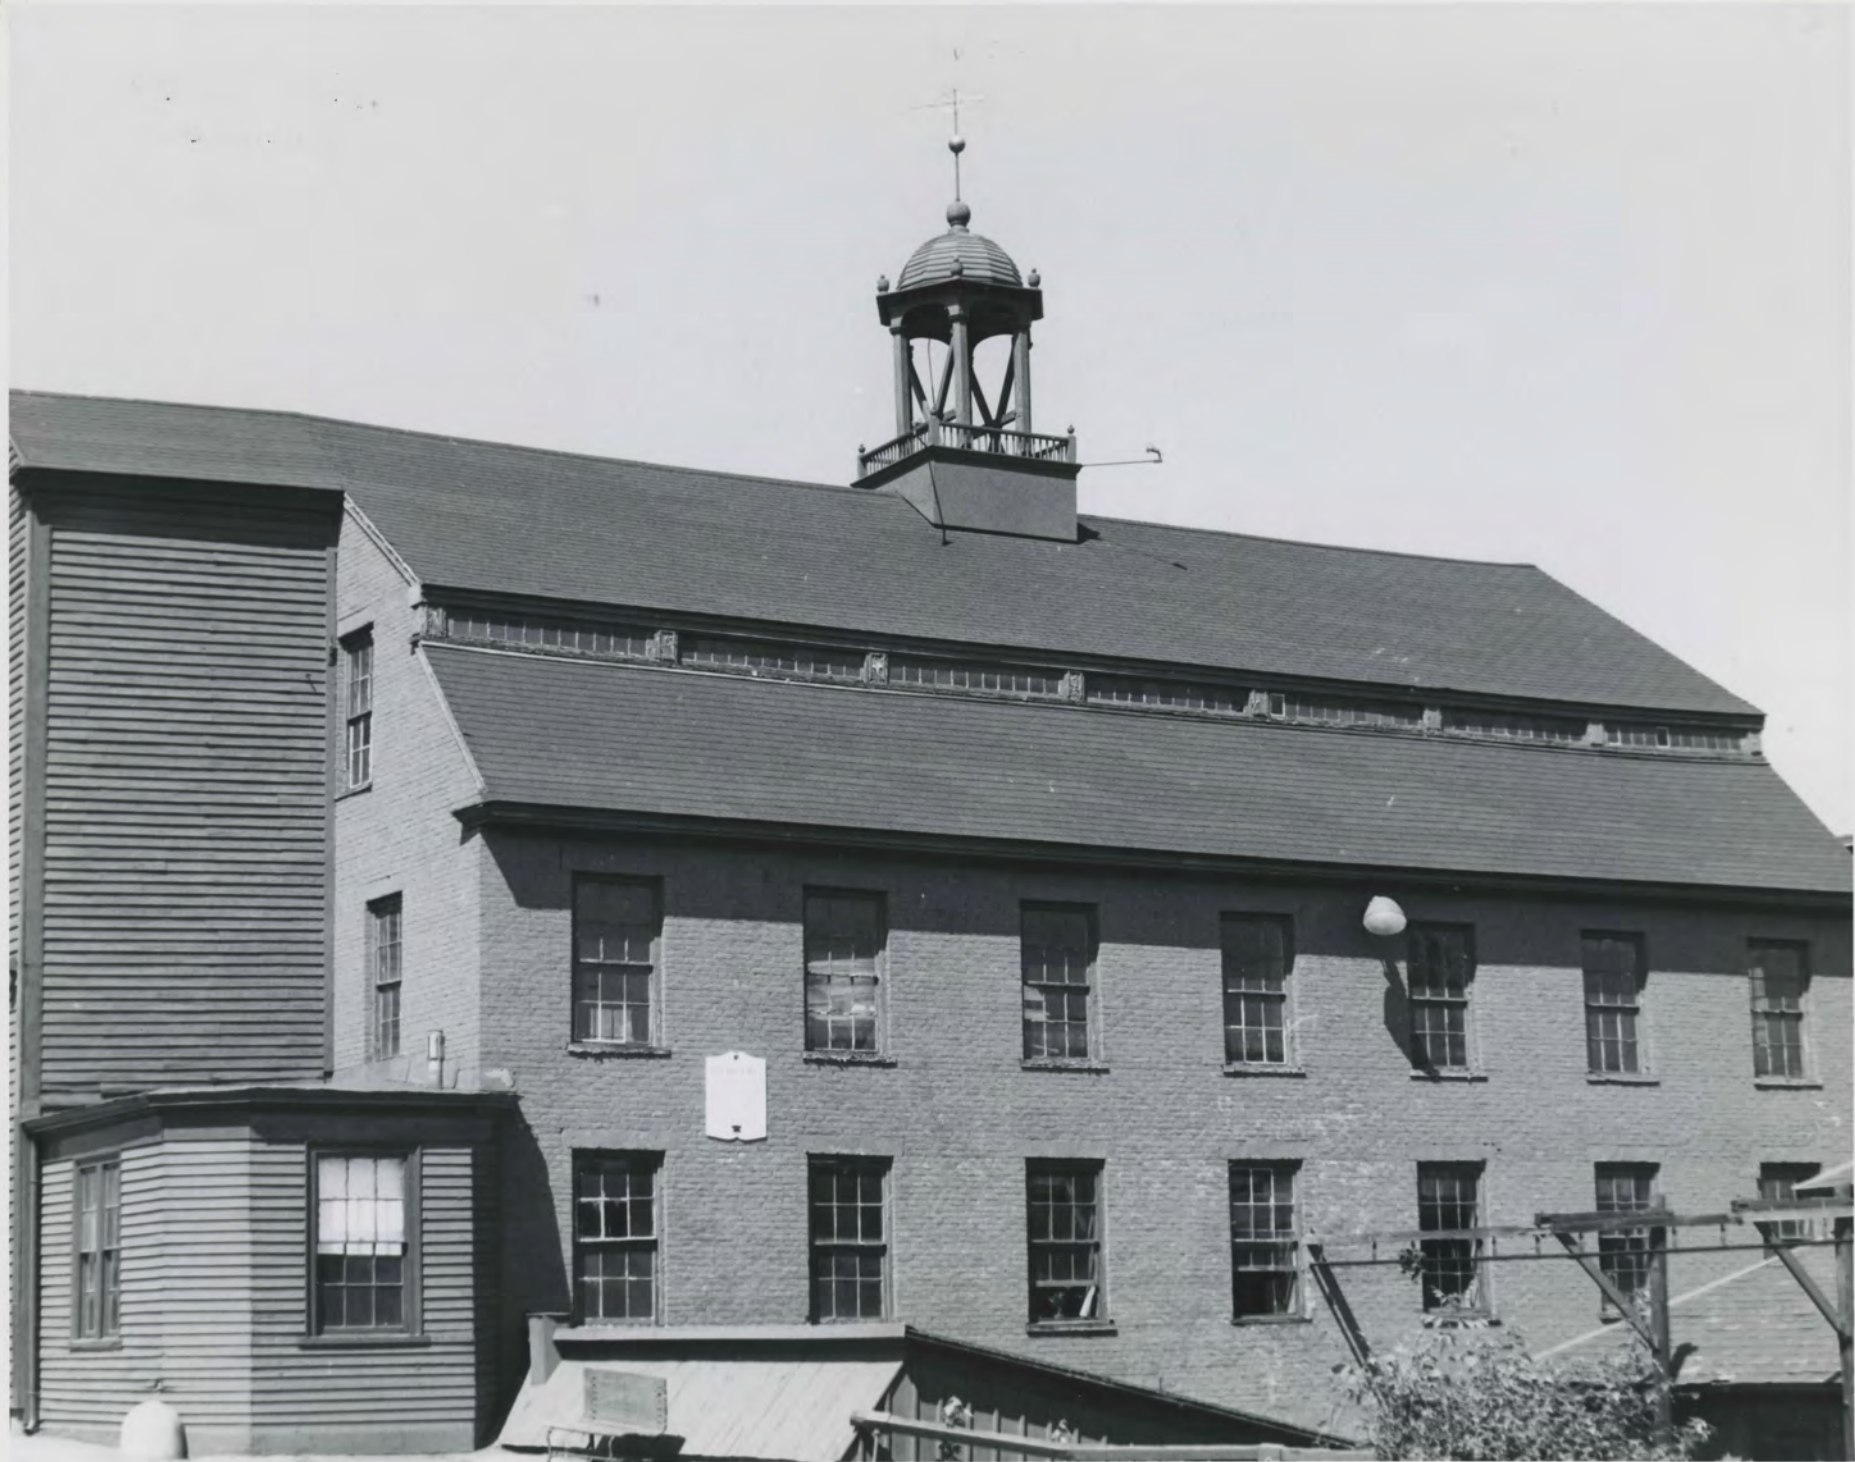
Photo 1 of 20

The Brick Mill
Douglas Rd.
NORTHBRIDGE, Mass. 01588
Whitinsville Historic-
District.

Grouped in three complexes along the Mumford River, Whitinsville's factories reflect a century's development in industrial architecture, from the 1820s through the 1920s. The earliest, the "Brick Mill" (1826; Photo #1, Map #17) was built by Col. Paul Whitin and Sons as a cotton factory. It is a prototypical mill of the 1820s, with a clerestory monitor, undecorated end stair-tower, small rectangular windows, and an open, Federal-style belfry sitting on the middle of the roof ridge. In a nearly perfect state of preservation (with only its west facade marred by a 3-story brick addition of 1905), the "Brick Mill" is one of the most significant examples of its type and period of factory construction still standing in New England.

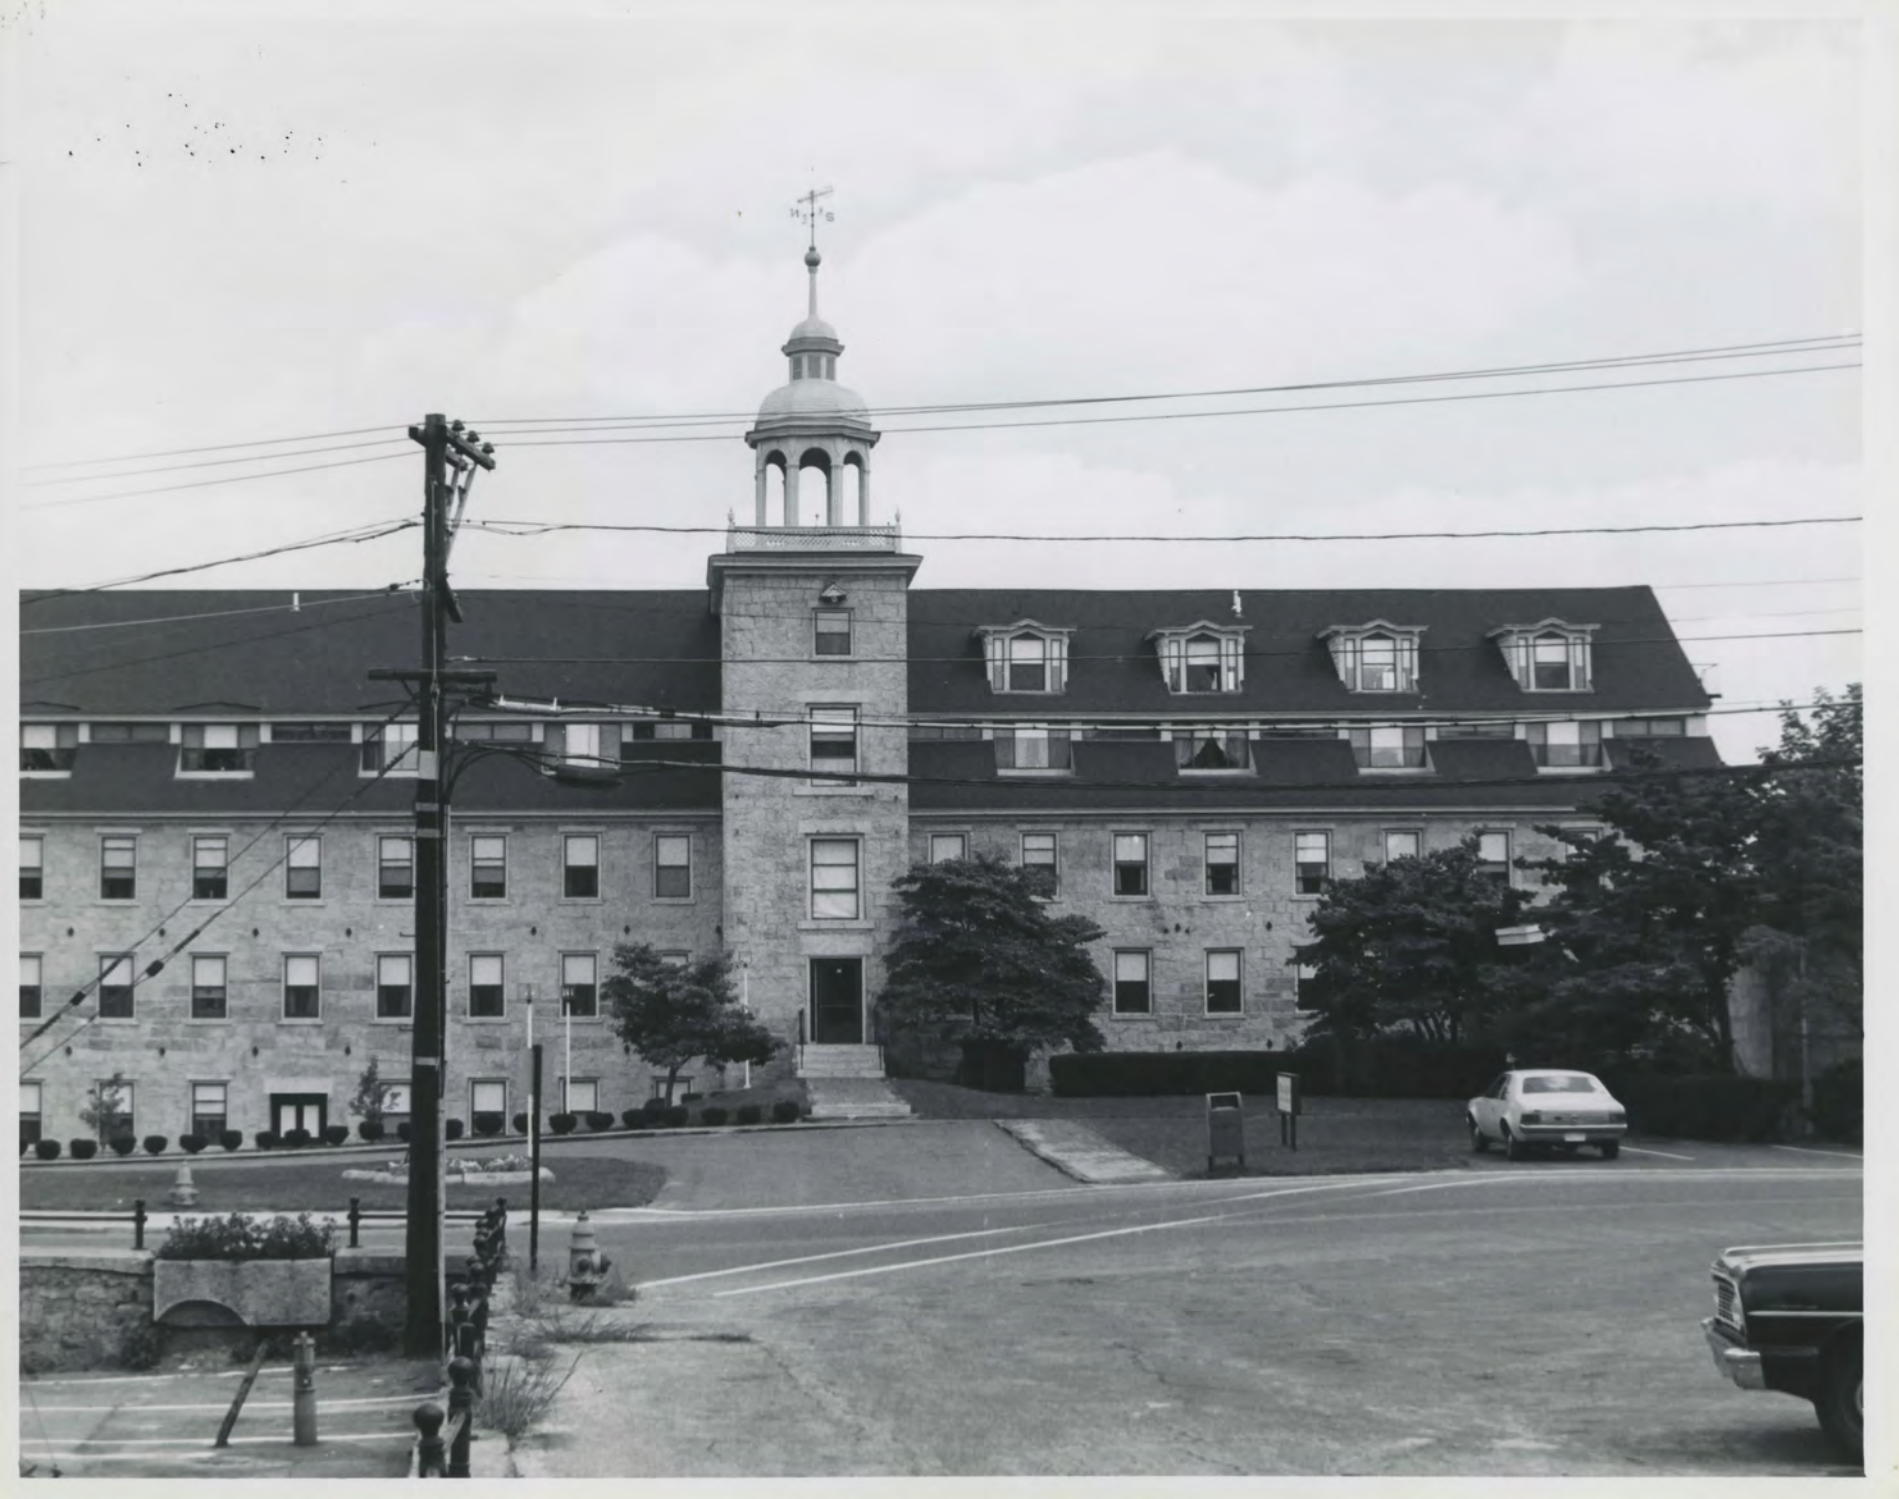
#14 Direction of View:
Looking East
year 1979
Photographer: *Ken Worchol*
Negative at: *photographer*
Photo 2 of *20*

#14 Whitinsville Cotton
Mills
Douglas Road
NORTHBRIDGE Mass.
01588
Whitinsville Historic
District

Across Hill St. from the "Brick Mill" stands the Whitinsville Cotton Mills complex (Photo #2, Map #49), built by P. Whitin & Sons in 1845, with a rear ell added in 1864. It is an outstanding example of 1840s mill construction, with its smooth-faced ashlar walls, clerestory monitor, and open Federal-style belfry sitting on a central, projecting stair-tower. In 1976, the mill experienced a generally sympathetic conversion to apartments (Cotton Mill Apartments), with the greatest changes occurring in fenestration (e.g., recessed dormers cut into the clerestory).

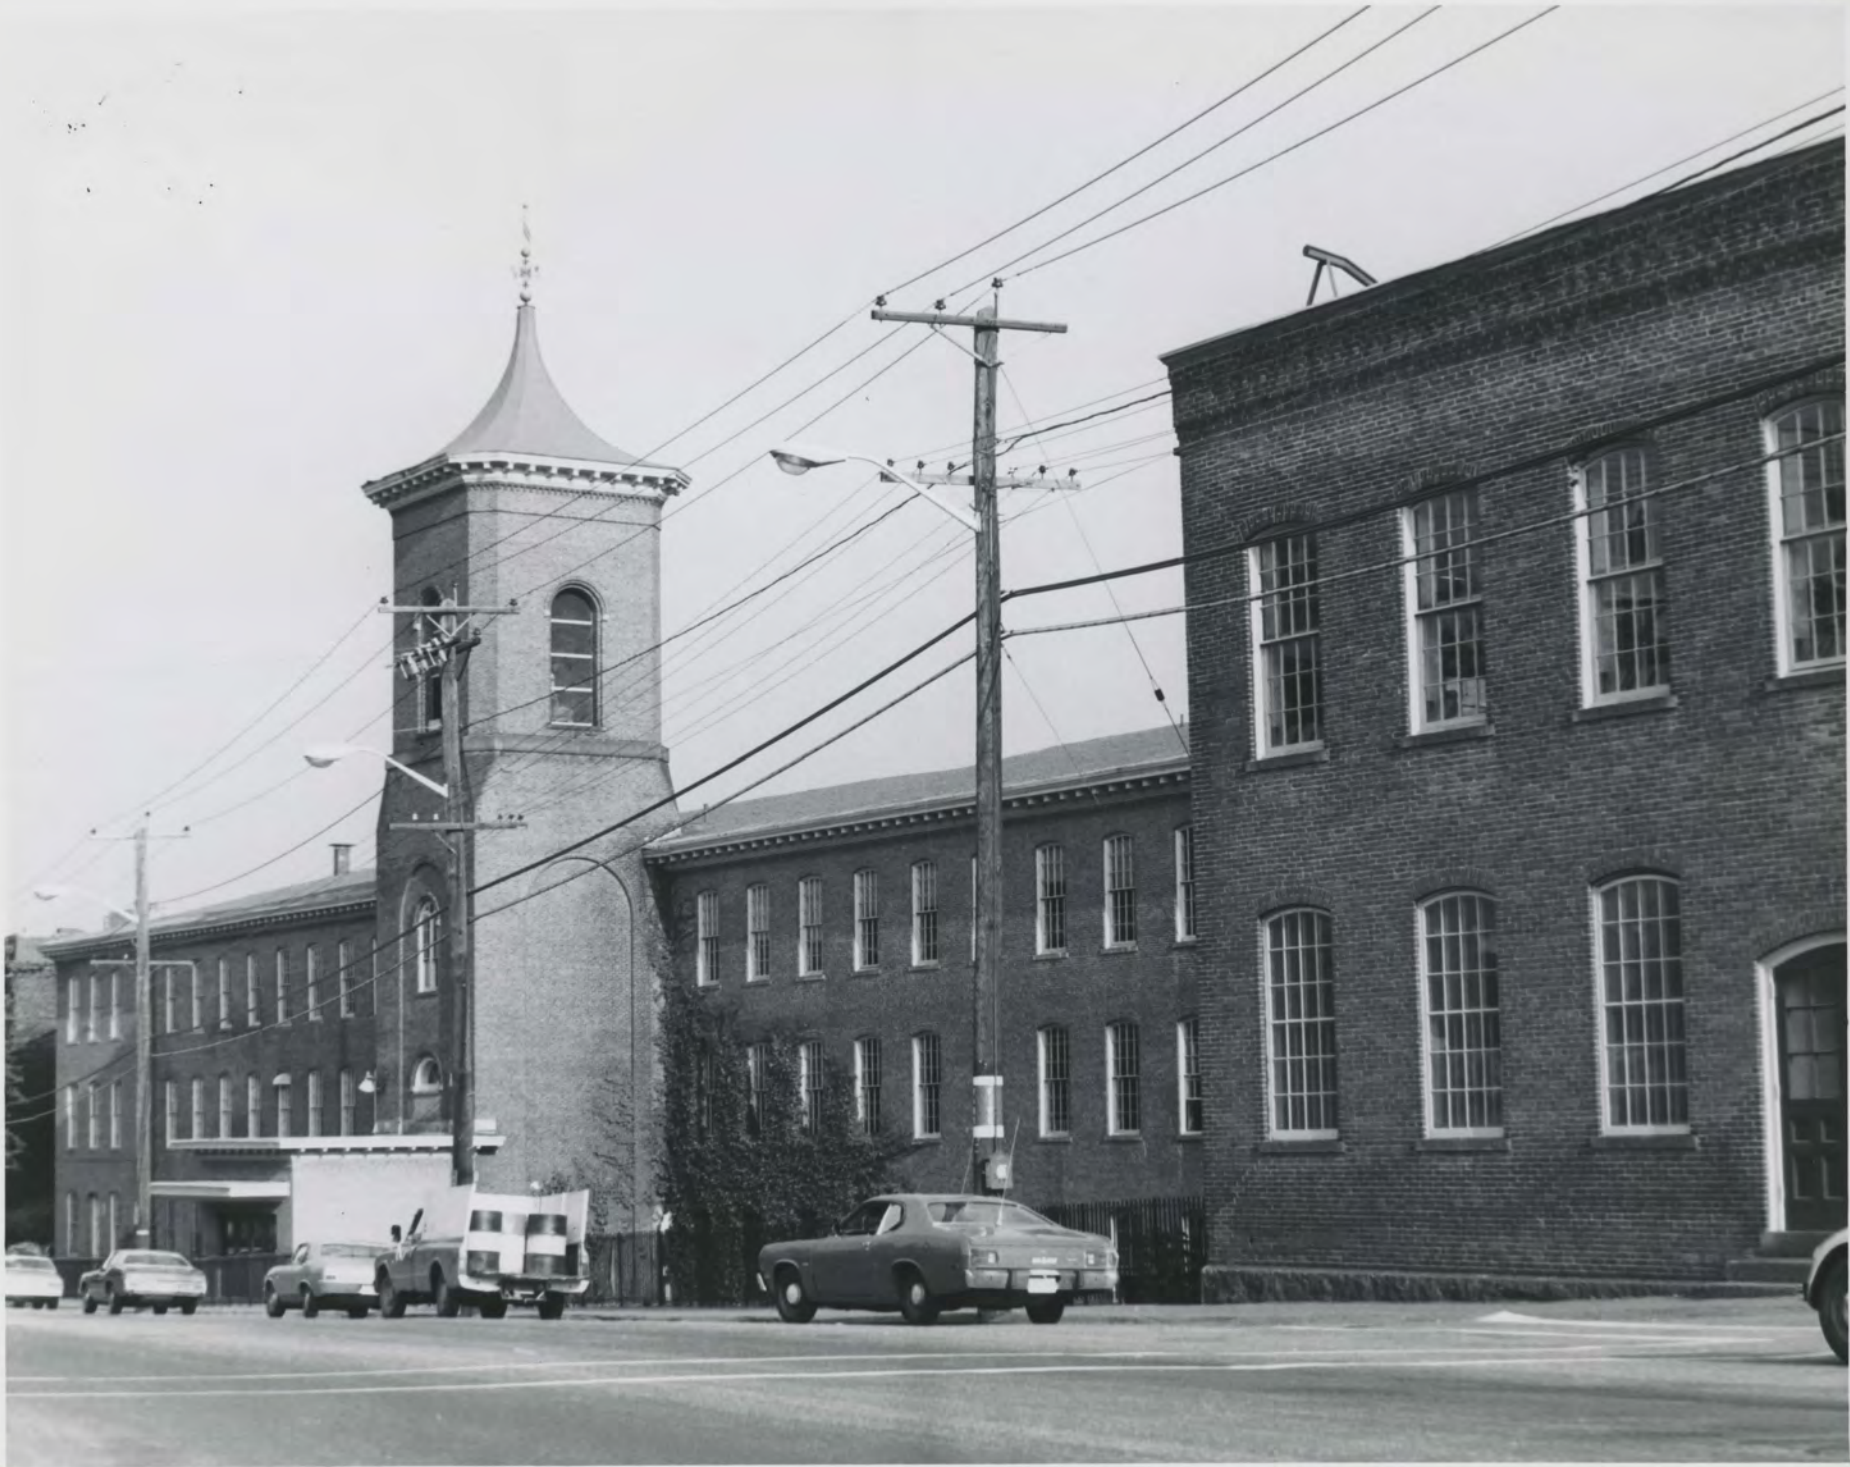
#10 Direction of View:
Looking east
year 1979
Photographer: *Ken Warchol*
Negative at: *photographer*
photo *3* of *20*

#10 Whitin Machine Work
Shop 1864 addition
Main Street
NORTHBRIDGE, Mass.
01588
Whitinsville Historic
District

Overshadowing these cotton mills is the vast complex of the Whitin Machine Works (1847-1923; Photo #3, Map #251). It represents the growth of a major ancillary industry that emerged in New England to service the needs of the cotton and woolen manufacturers -- the production of textile machinery. Like the proprietors of many pioneer cotton mills, the Whitins maintained a small machine shop to build and repair machinery (in the 1820s, it was housed in part of the "Brick Mill"). What separated the Whitins and set them on their significant course was the inventive genius of one of the founder's sons, John C. Whitin. In 1831, he patented a cotton picker machine that was such an improvement over its predecessors that it generated a great and lasting demand. It was on the basis of this and succeeding inventions that the Whitin Machine Works was founded and grew into an industrial giant.

Similarly, construction of the 1864 addition to the Machine Works caused the Whitins to build the seven multi-family tenements at 2-6 to 56-62 High St. (Photo #7, Map #276-283), as well as the four Italianate row-houses at 168-178, 190, and 220-230 Main St. (Map #236, 235, 240) and at 7-17 High St. (Photo #18, Map #284). A major expansion of the Whitin Machine Works in the late 1880s was accompanied by the erection of 37 Queen Anne duplexes at 5-7 and 10-12 Linden St. (Map #293, 295), 211-213 to 270-272 Main St. (Map #241-248, 31), 1-3 to 26-28 Maple St. (Map #298-311), 1-3 to 13-15 Oak St. (Map #325-331), and 1-3 to 9-11 West St. (Map #314-317).

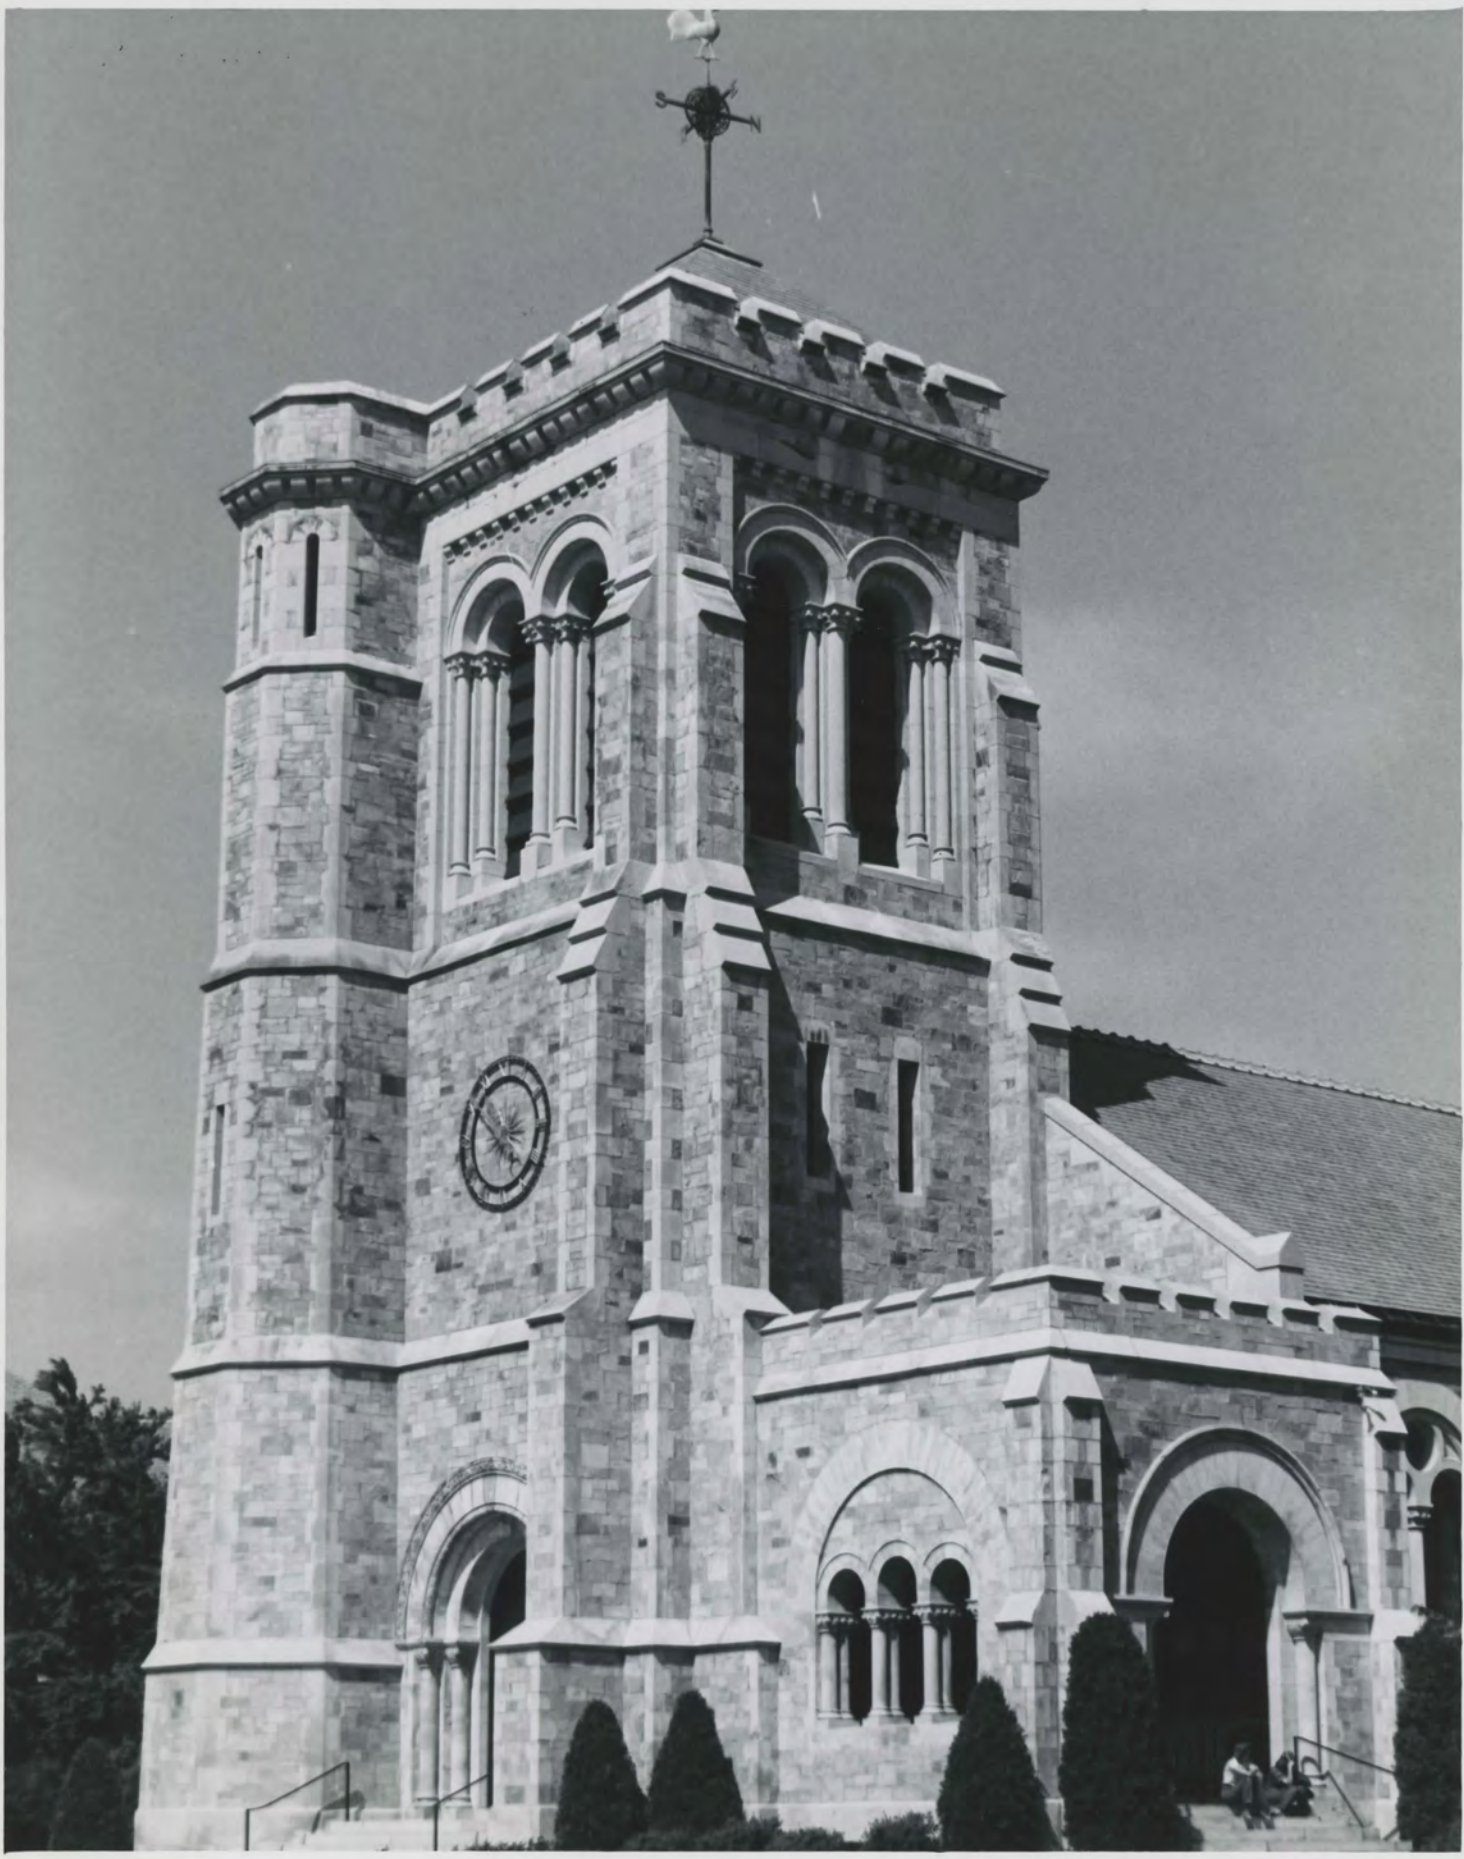
#12 Direction of View:
Looking North
year 1979
Photographer: *Ken Werschol*
Negative at: *photographer*
photo 4 of 20 *5*

#12 Village Congregation
church
Church Street
NORTHERIDGE, Mass.
01588
Whitinsville Historic
District

The District also contains three notable churches. The Village Congregational Church (Photo #4, Map #213) was built with Whitin family funds in 1898 on the Memorial Square site of an earlier church building. Designed by Boston architects Shepley, Ruten and Coolidge, it is an extremely fine example of an academic Romanesque Revival structure. Built of light-brown sandstone, its most outstanding feature is a massive 3-story entrance tower projecting from the front of its gabled auditorium. The tower features crenelated battlements, wall buttresses, round arches cut into its upper story for a belfry, and a polygonal projection on its southeast corner. Its main entrance has recessed, grouped round arches, while adjoining the tower is a 1-story side-entrance pavilion decorated with a blind arch containing a trio of open round arches supported by Medieval columns.

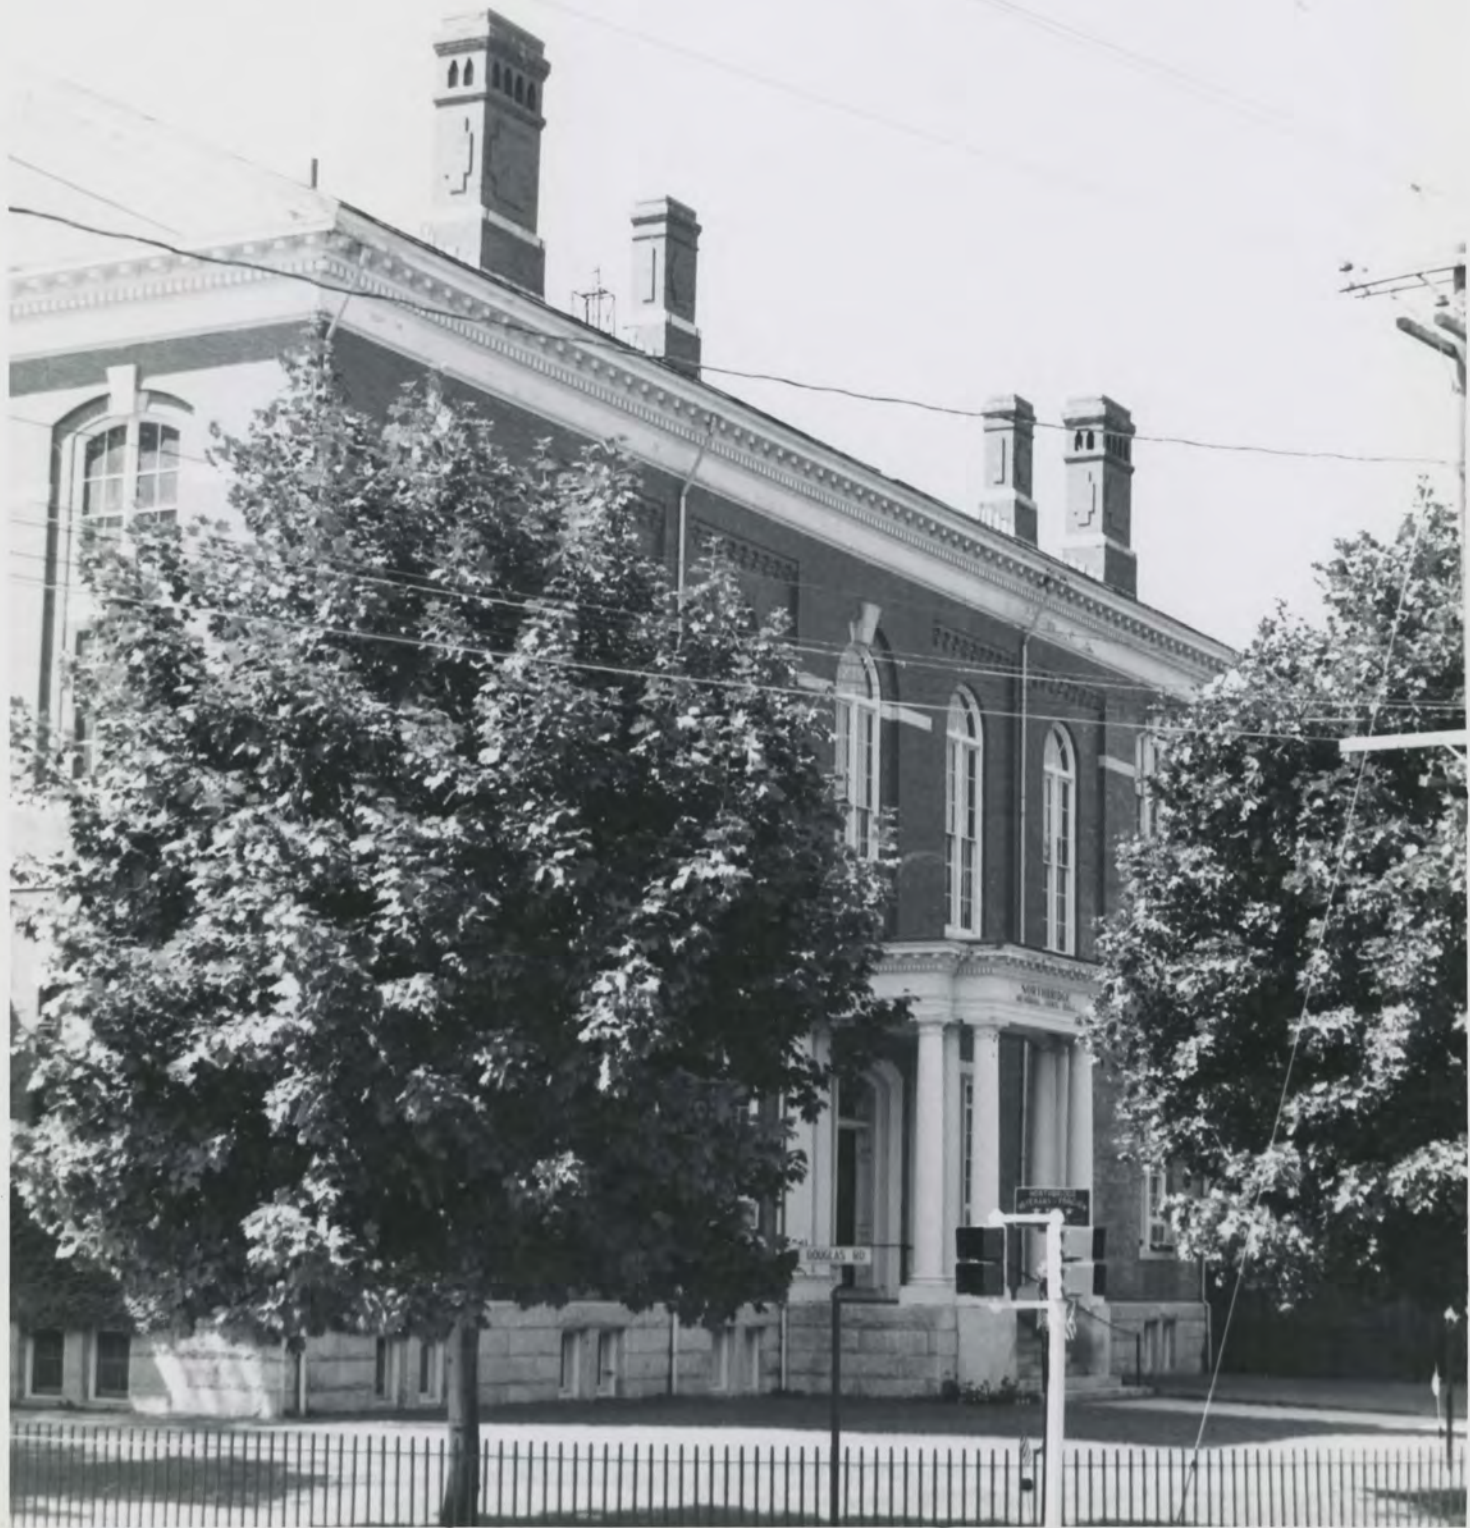
Photo 5 of 20

Town Hall
Douglas Rd. & Main St.
NORTHBRIDGE, Mass. 01588
Whitinsville Historic-
District.

Whitinsville's civic buildings from this period include a town hall, a bank/post office building, a Civil War memorial, a library, and a gymnasium. Oldest of all is the Town Hall (Photo #5, Map #48), built in 1872 by John C. and Charles P. Whitin on the site of the old family homestead, adjacent to the Whitin Machine Works. It is an imposing, 2-story brick building with chaste Italianate detailing. It has a pedimented gable end with oculus facing Memorial Square, a bracketed cornice, large round-arched windows in the upper (auditorium) floor, string courses, and one-story entrance porches on its north and west sides, with clustered, unfluted columns.

Finally, the mill-owners underwrote many aspects of local government: in 1872, they built the Town Hall (Photo # 5, Map #48) as a memorial to their dynastic founders (which structure came to symbolize the mills' pervasive influence over town affairs); in 1922, the Whitin Machine Works built and equipped a fire station, on the corner of Main St. and West Water St., to serve both its own needs and those of the whole community; and the Whitins were also responsible for transforming Memorial Square into a focal point for civic ceremonies, with its Civil War Monument (1905; Map #74), World War I Memorial (1922), and its park-like landscaping.

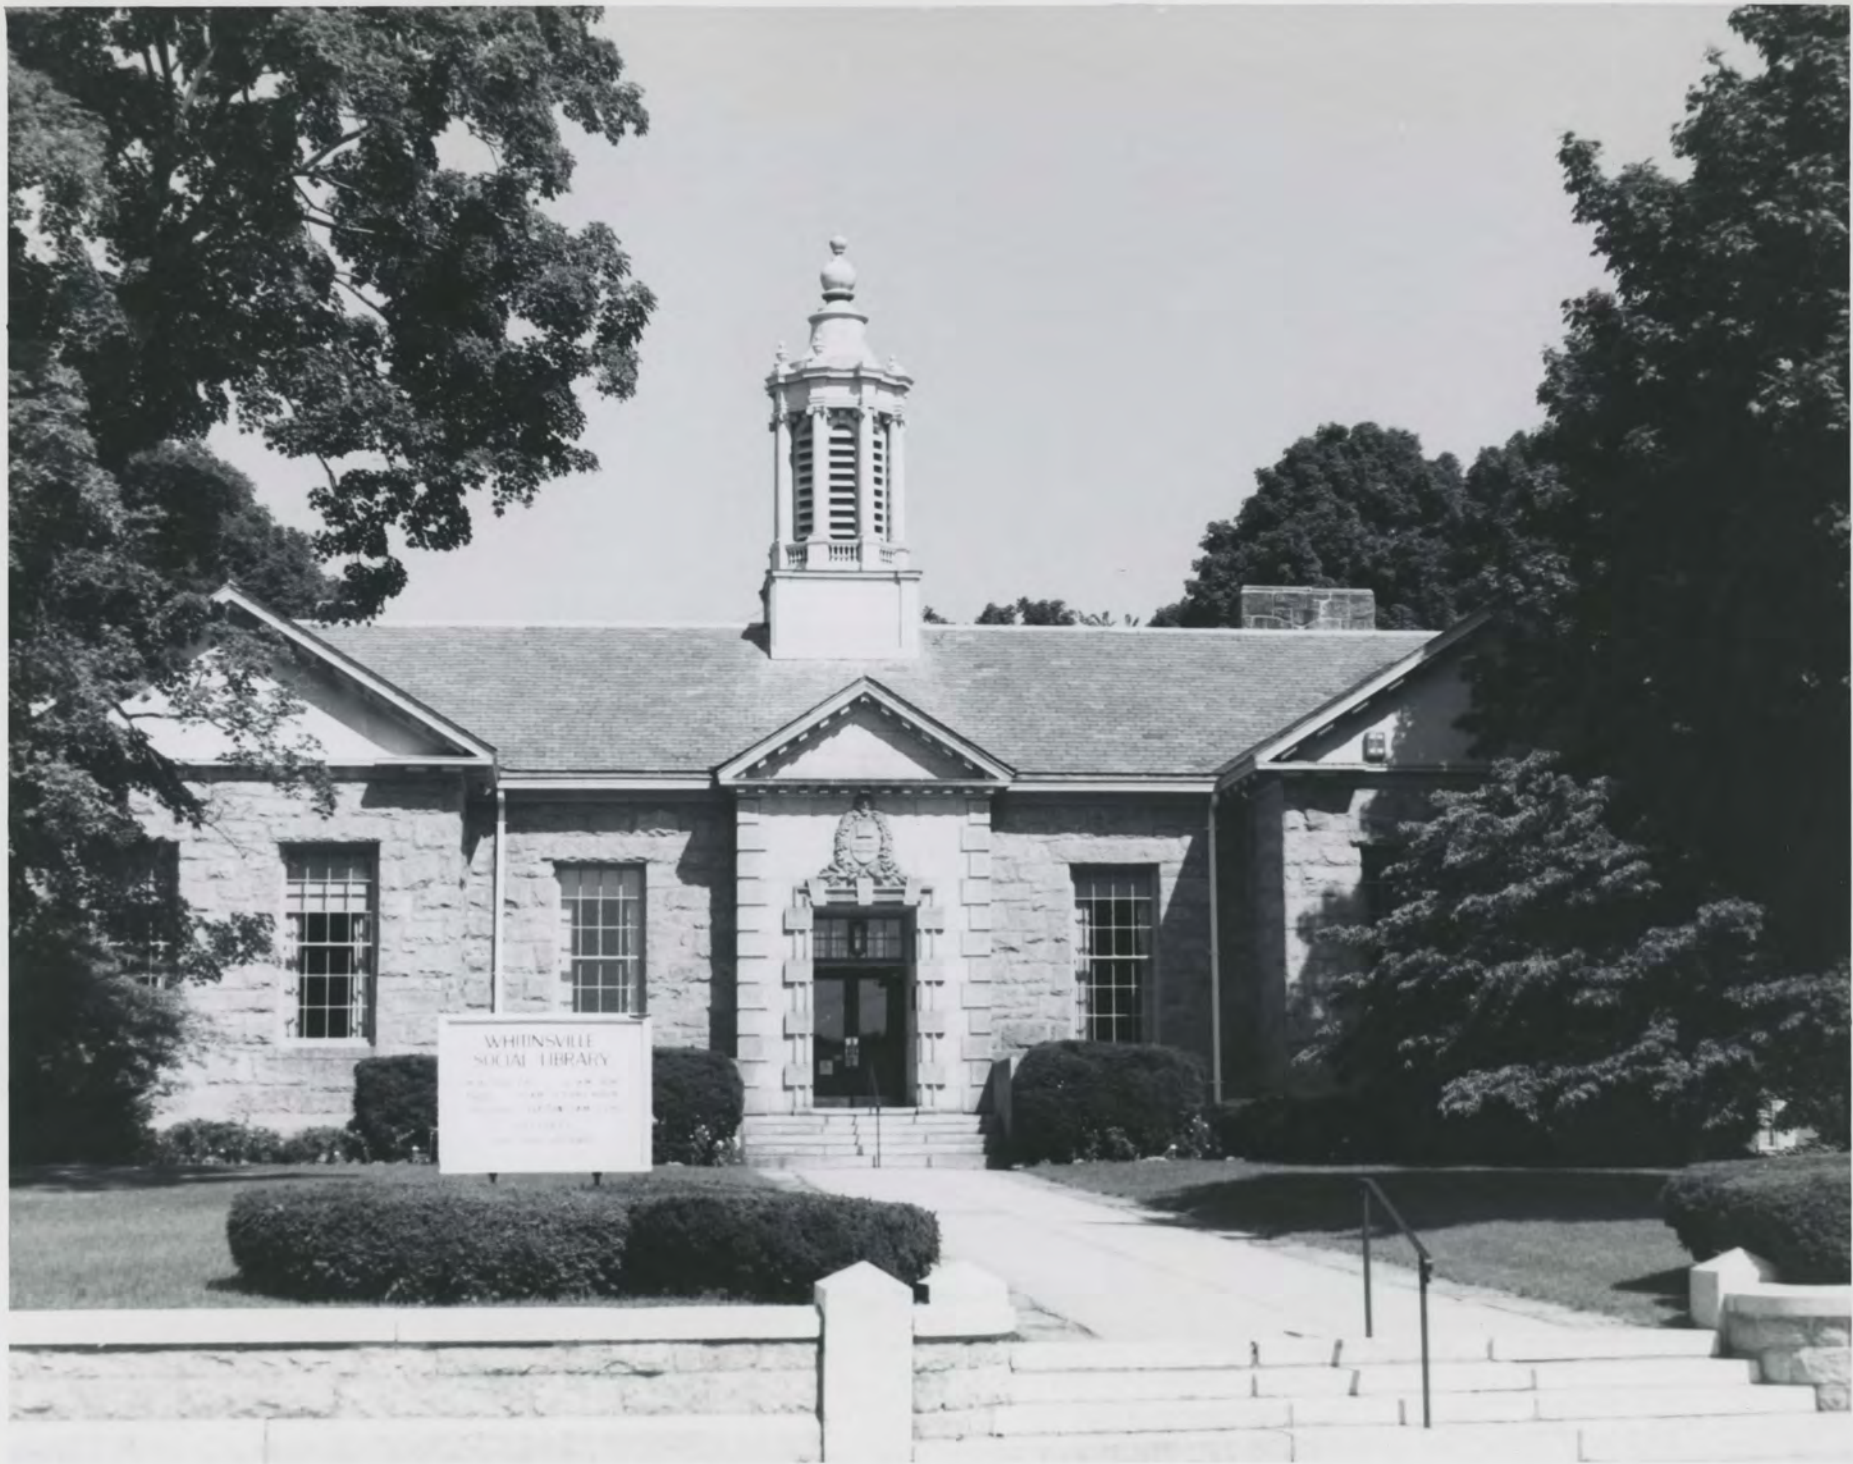
Photo 6 of 20

20 whitinsville Social Library
Church ST
NORTHBRIDGE, Mass. 01588
Whitinsville Historic District
Direction of view Looking
North

Perhaps the single most elaborate civic building in the District is the Whitinsville Social Library (Photo #6, Map #212), which Arthur Whitin gave to the town in 1913. Designed by Boston architect R. Clipston Sturgis, it is a 1-story, granite Neo-Classical building located on Church St., near Memorial Square. Hipped-roofed, with its broad side facing the street, it has slightly protruding pavilions at each end of the facade topped by cross-gables with returning eaves. Its central doorway is ensconced in a smaller projecting pavilion, decorated with a pediment, vermiculated quoins, and a vermiculated Gibbsian surround around the door itself surmounted with a cartouche. Rising from the center of the roof is a circular belfry, with Ionic columns interspersed between louvered round arches supporting an urn-encrusted entablature that is capped with a massive copper finial.

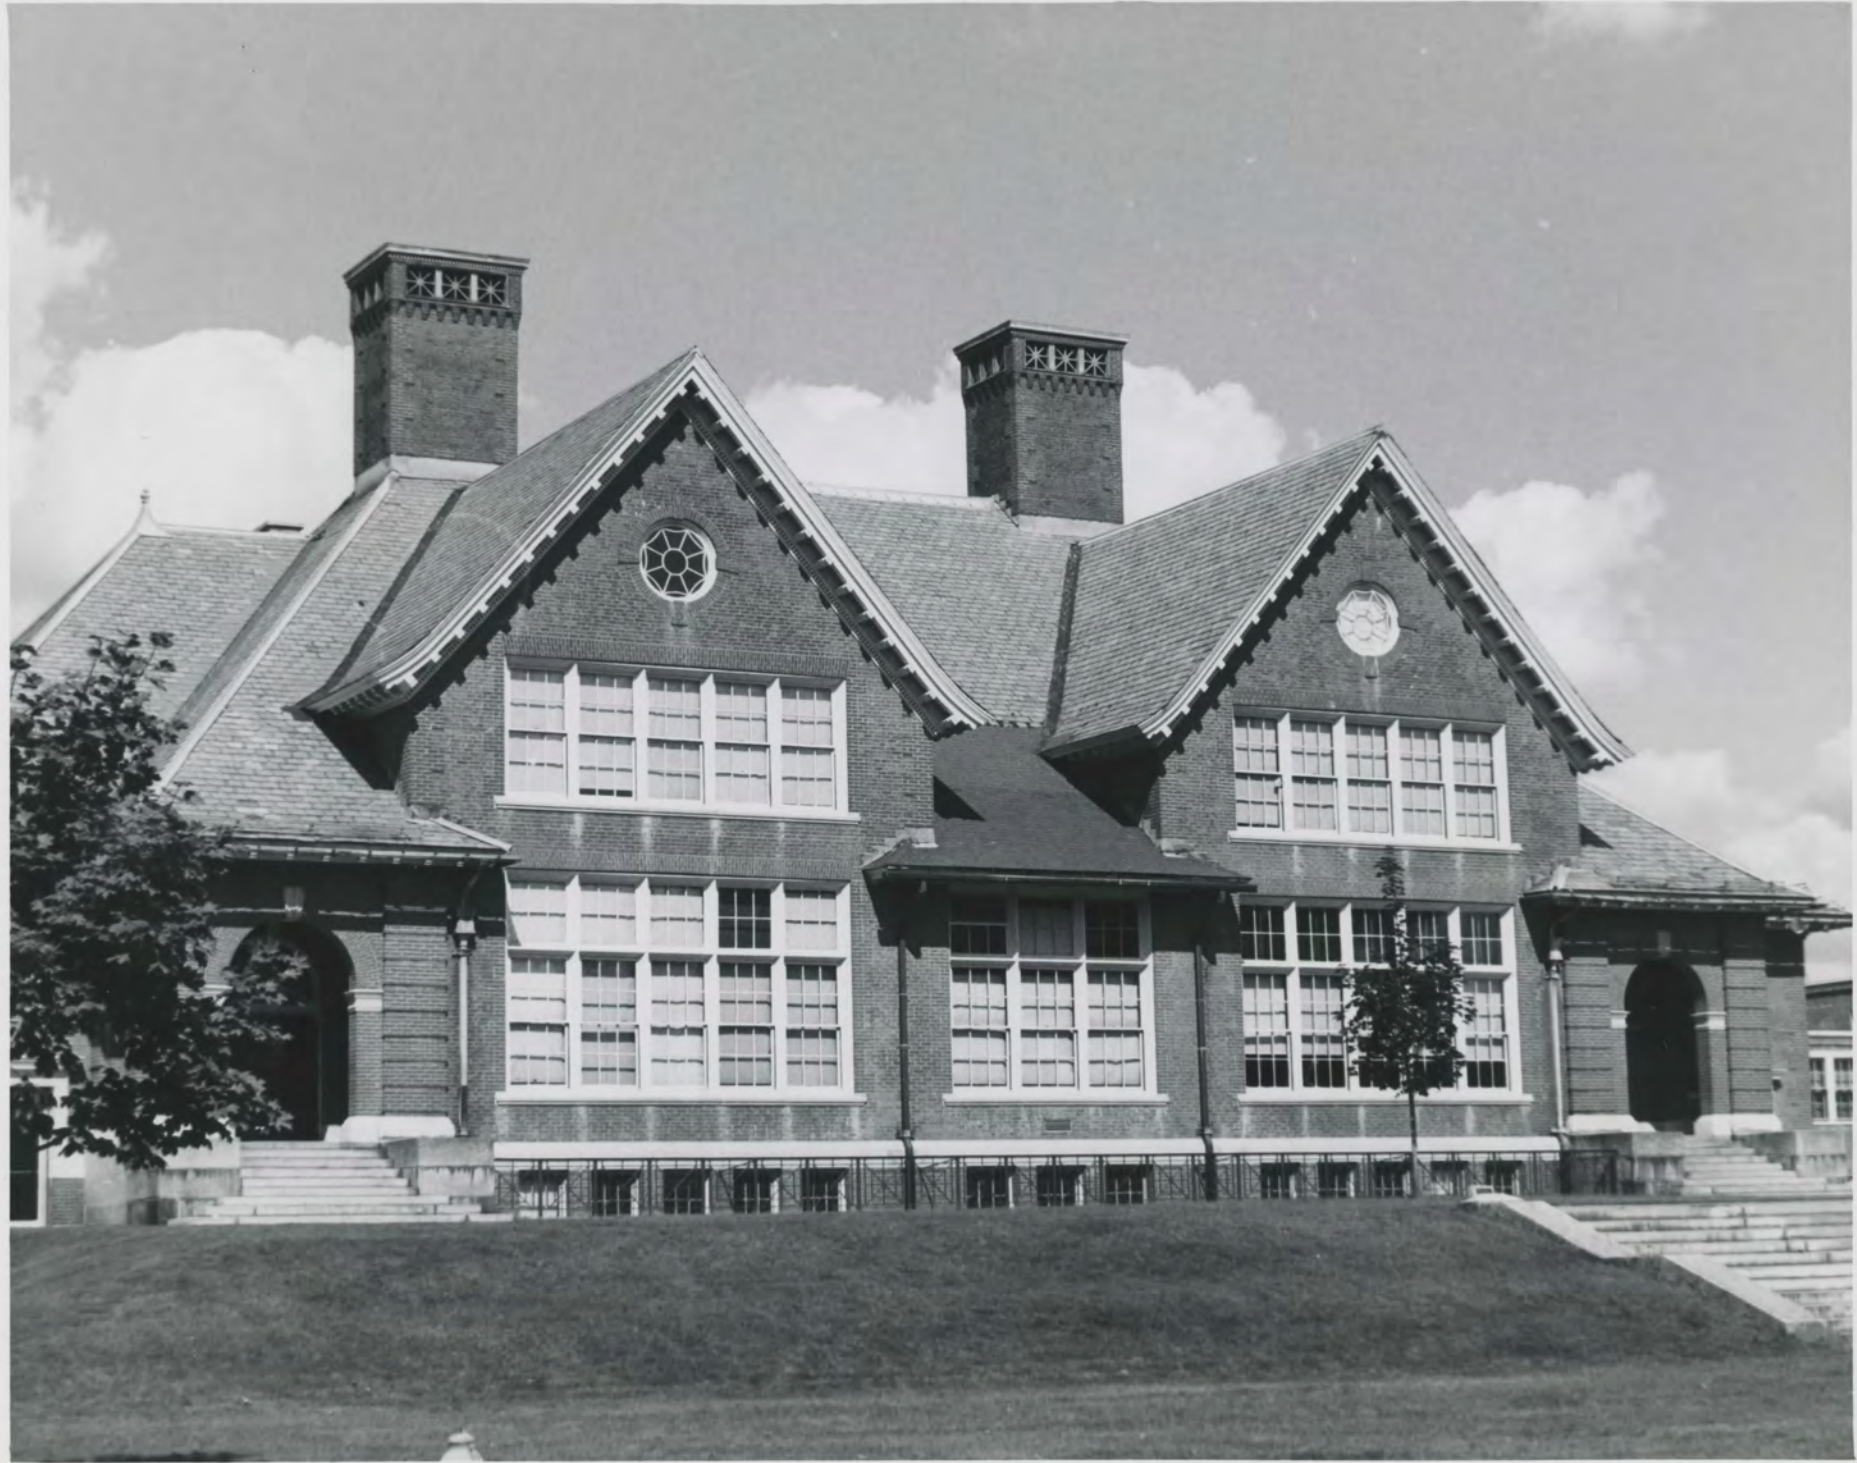
Photo 7 of 20

Whitin-Lasell High School
119 Linwood Ave.
NORTHBRIDGE, Mass. 01588
Whitinsville Historic-
District

Finally, on Linwood Ave. sits the Whitin-Lasell High School (Photo #7, Map #64), built in 1906 with funds donated by Arthur Whitin and Josiah Lasell. Designed by leading Boston architects Peabody & Stearns, it is

a 1½-story brick building with a variety of Neo-Classical, symmetrically-arranged details. It has a high hipped roof with two large cross-gables grouped towards the center of its broad facade. Each gable end has bracketed, slightly-flared eaves and a decorative oculus. There are two round-arch, keystone, recessed entrances on either end of the building's front.
