**National Register of Historic Places
Inventory—Nomination Form**

historic Whitinsville Historic District

7. Description Whitinsville Historic District, Northbridge

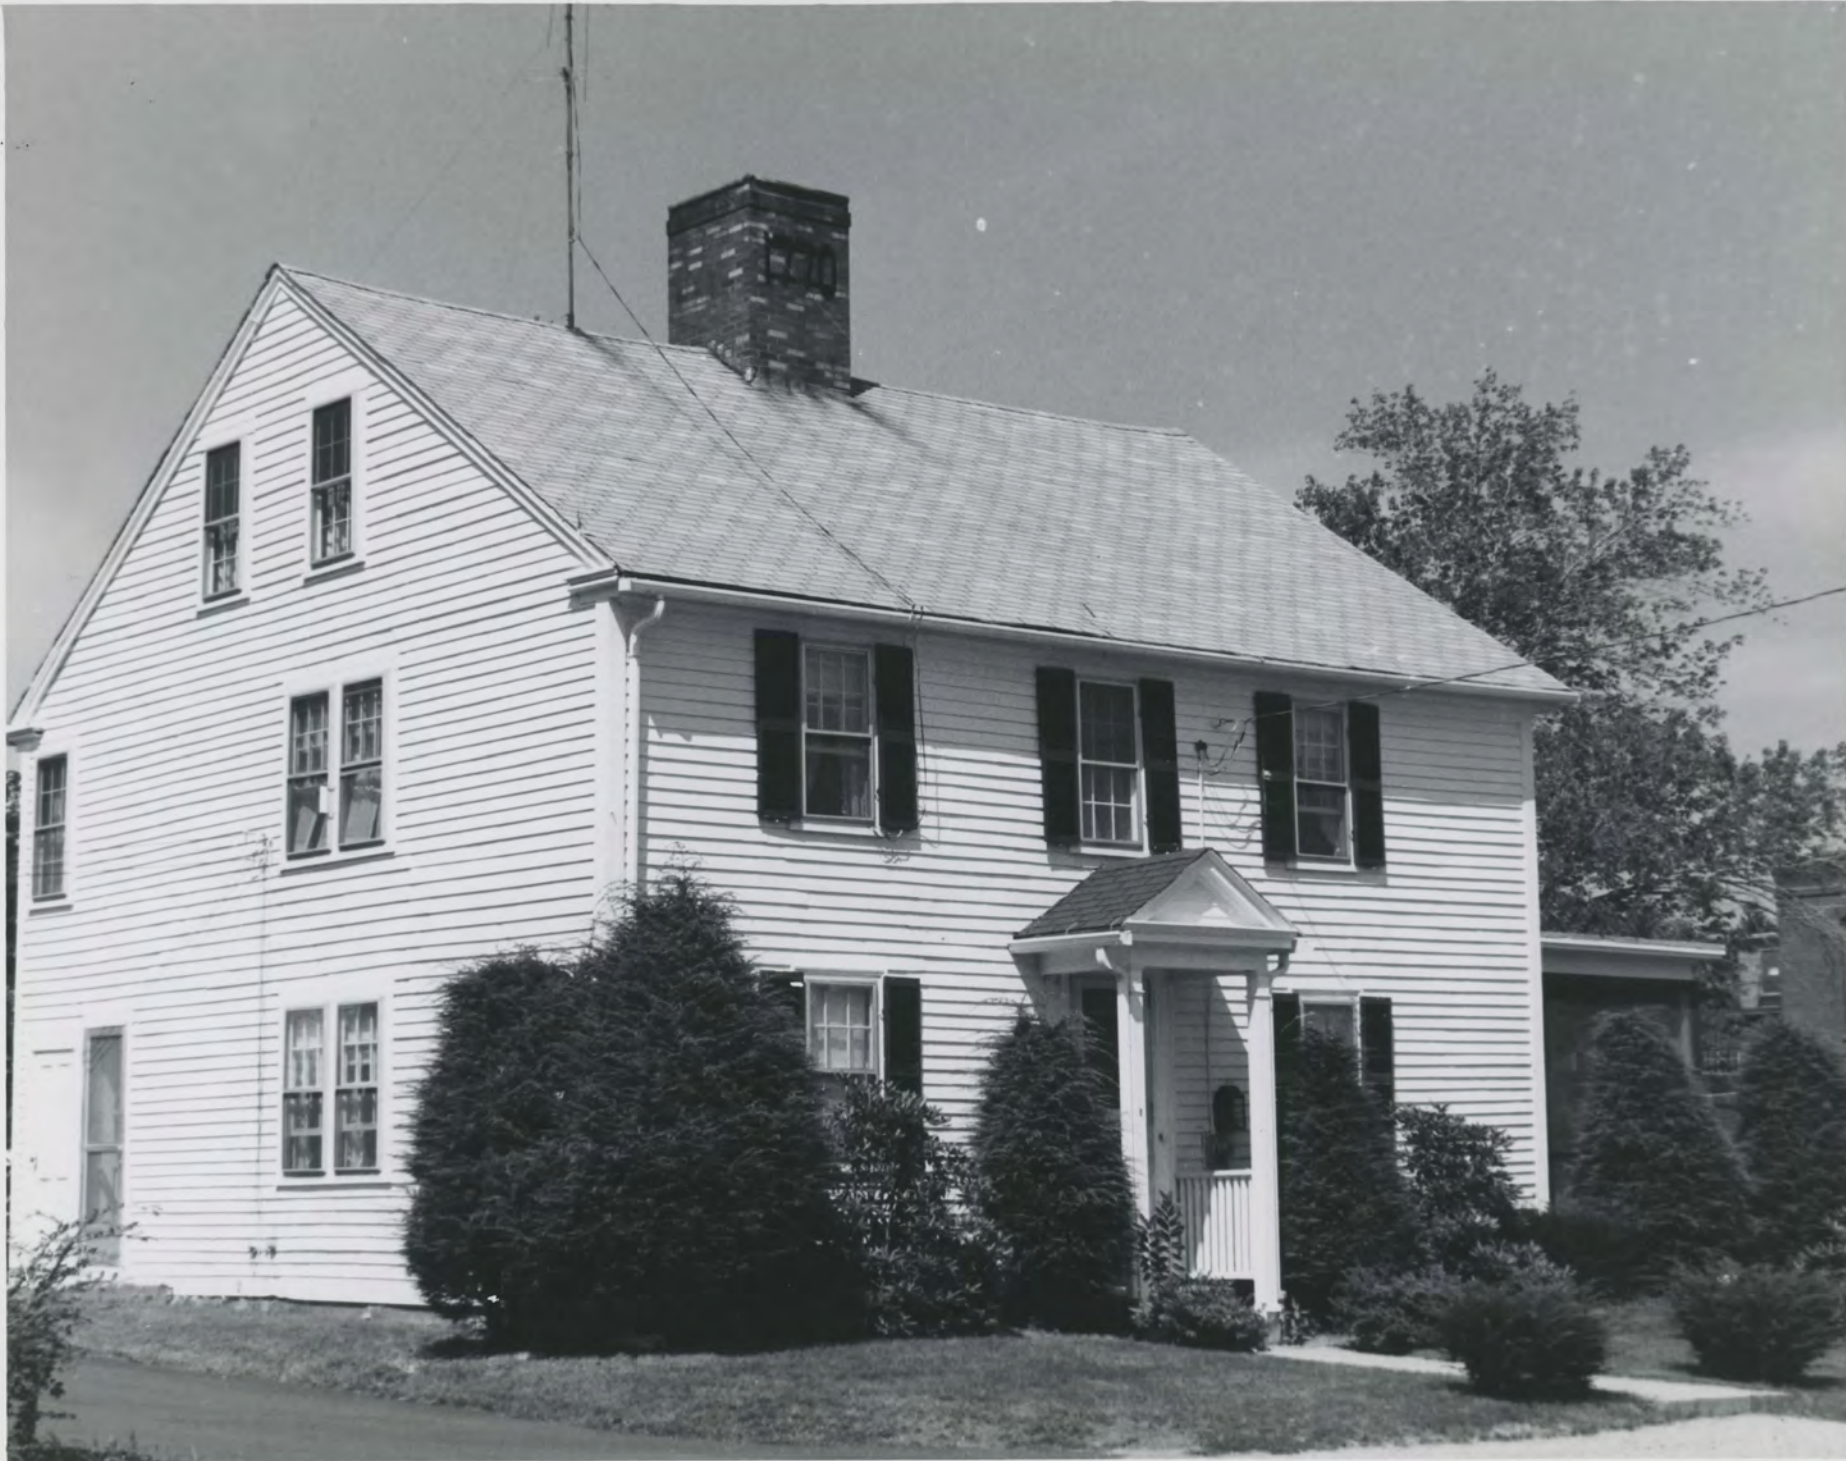
Photographer: Ken Warcholl
Negative at: same as above
Photo 9 of 20

James Fletcher House
1 Elm Place
NORTHBRIDGE, Mass. 01588

The District contains only one 18th century structure, the James Fletcher House, 1 Elm Place (Photo #9, Map #347), built in 1770 by the proprietor of an iron forge on the nearby Mumford River (now the site of the "Brick Mill"). Two and a half stories tall and end-gabled, the James Fletcher House has such Georgian vernacular features as a large central chimney, flush eaves on the gable ends, and a slightly-asymmetrical three-bay facade. More recent additions include a pedimented entrance porch and a sun porch on the side.

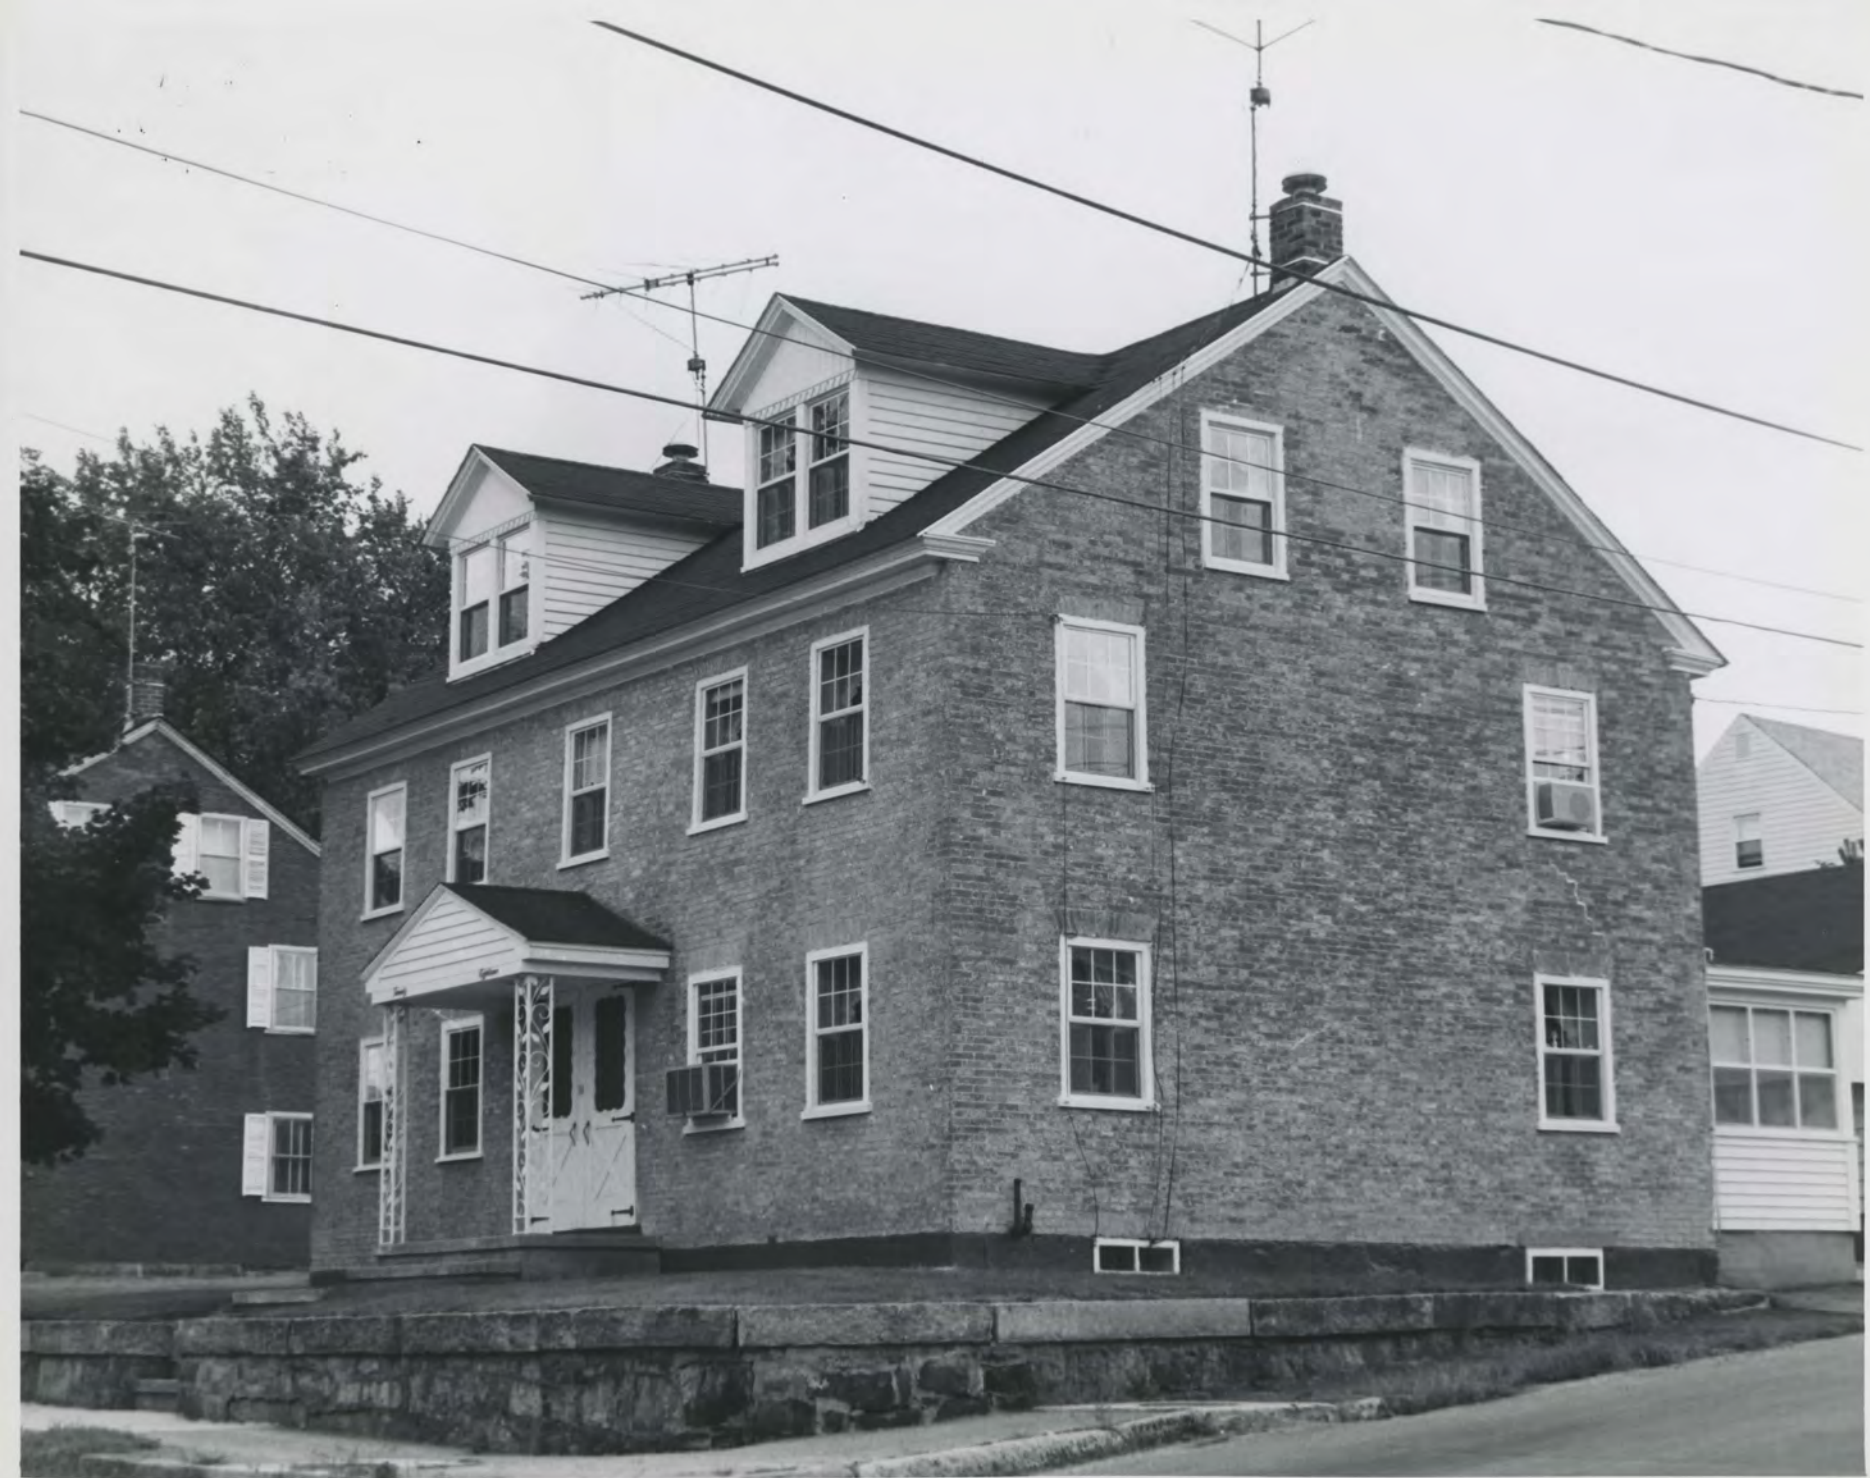
Direction of view:
Looking South East
Year 1979
Photographer Ken Warcholl
Negative #: same as above
Photo 16 of 20

Fletcher Street Tenements
(Street View)
20-22, 26-28, 36-38
Fletcher Street
NORTHBRIDGE, Mass. 01588
Whitinsville Historic
District

On Fletcher St. stand several types of worker housing that have survived from the late Federal period. 20-22, 26-28, and 36-38 Fletcher St. (c. 1826; Photo #16, Map #20, 21, 22) are 2½-story, end-gabled brick tenements, with flared lintels in the brick-work over the windows and 5-bay facades. 70 and 76 Fletcher St. (c. 1830; Map #26, 27) are 1½-story, end-gabled capes, with Federal vernacular doorways featuring attenuated, fluted Doric pilasters and rectangular transoms surmounted by projecting cornices.
