National Register of Historic Places  
Registration Form

historic name Argos Downtown Historic District

city or town Argos N/A  vicinity

state Indiana code IN county Marshall code 099 zip code 46501

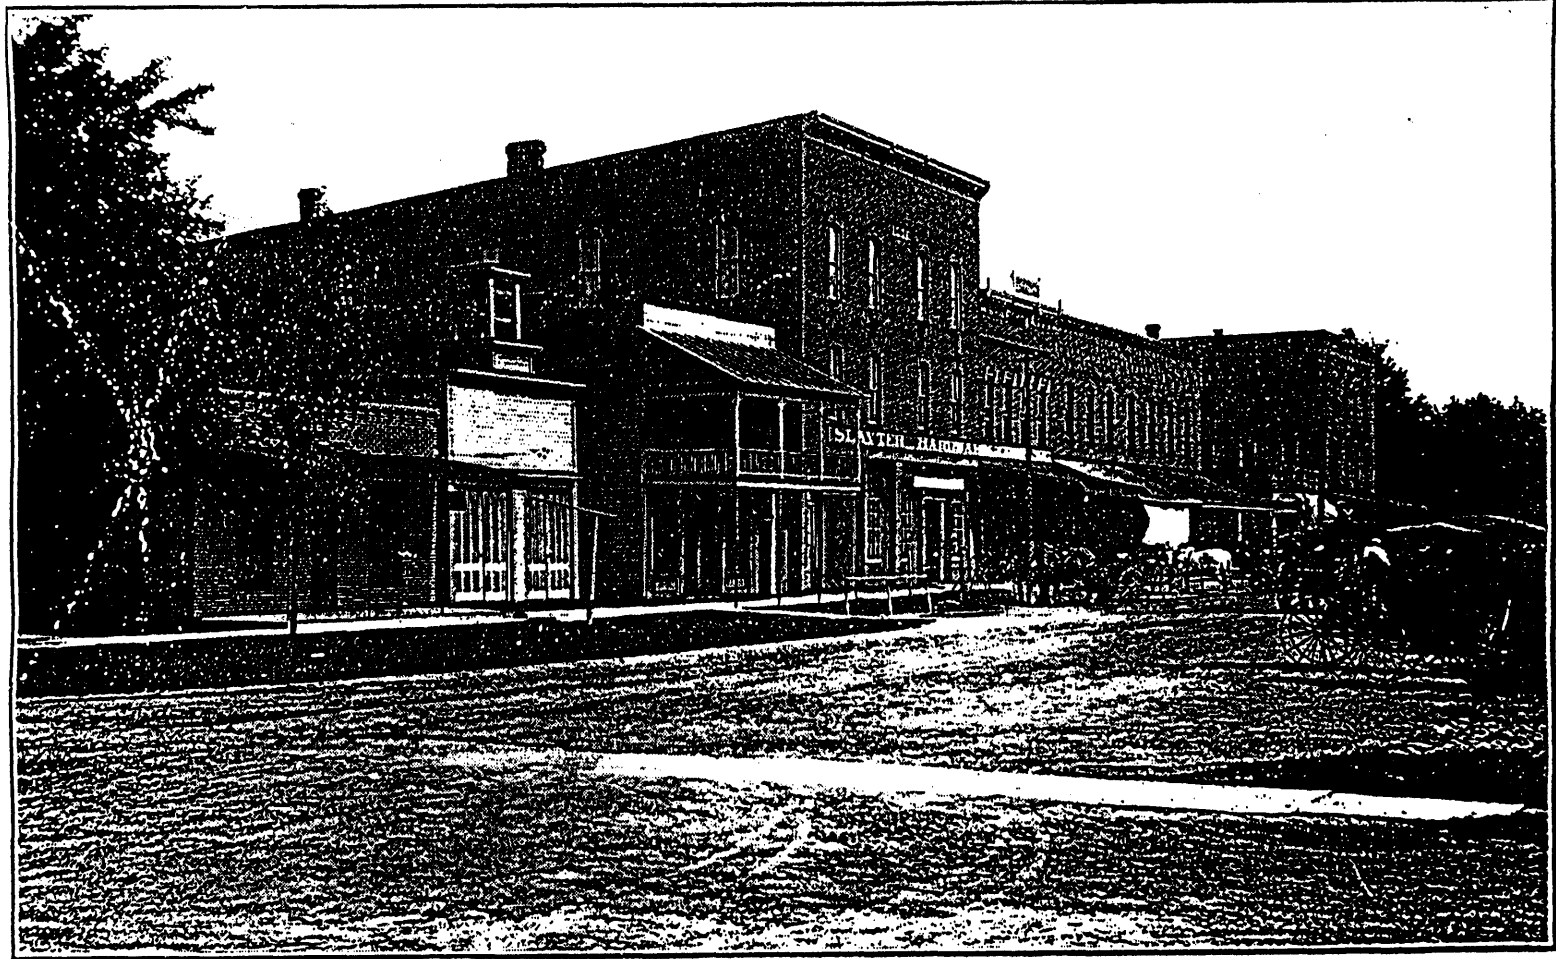
ARGOS DOWNTOWN HISTORIC DISTRICT  
Marshall County, IN  
East side, North Michigan St c. 1900

*Former Hardware  
Later became Masonic Hall*

*Main Street looking south, Argos, IN*

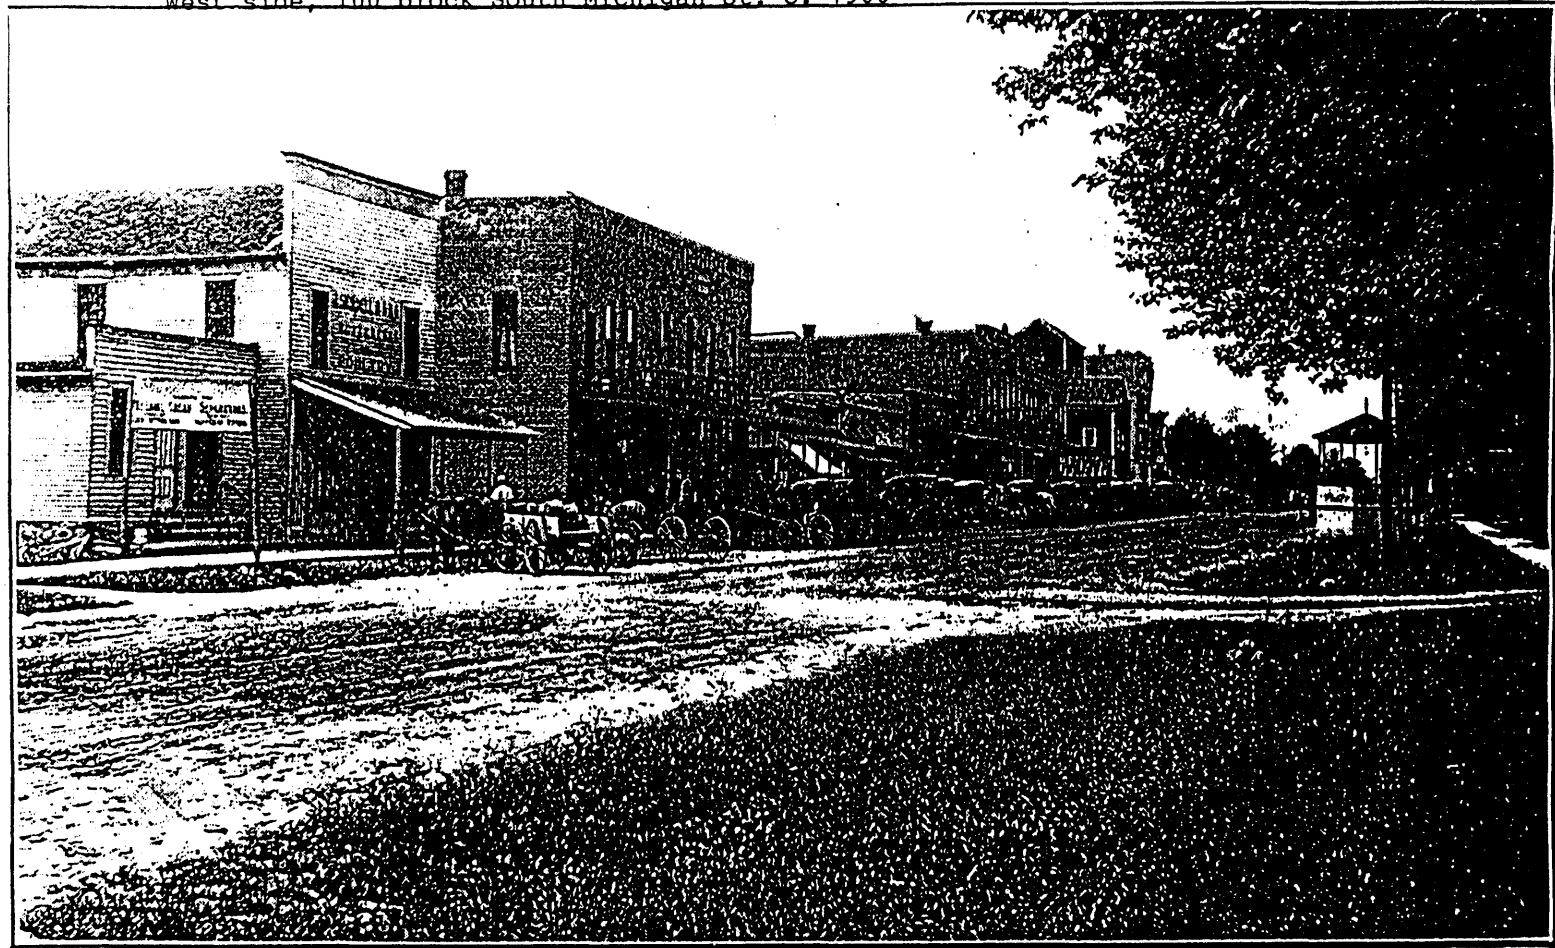
ARGOS DOWNTOWN HISTORIC DISTRICT  
Marshall County, IN  
West side, 100 block South Michigan St., c. 1900

MAIN STREET, LOOKING NORTH, ARGOS, IND. 1909

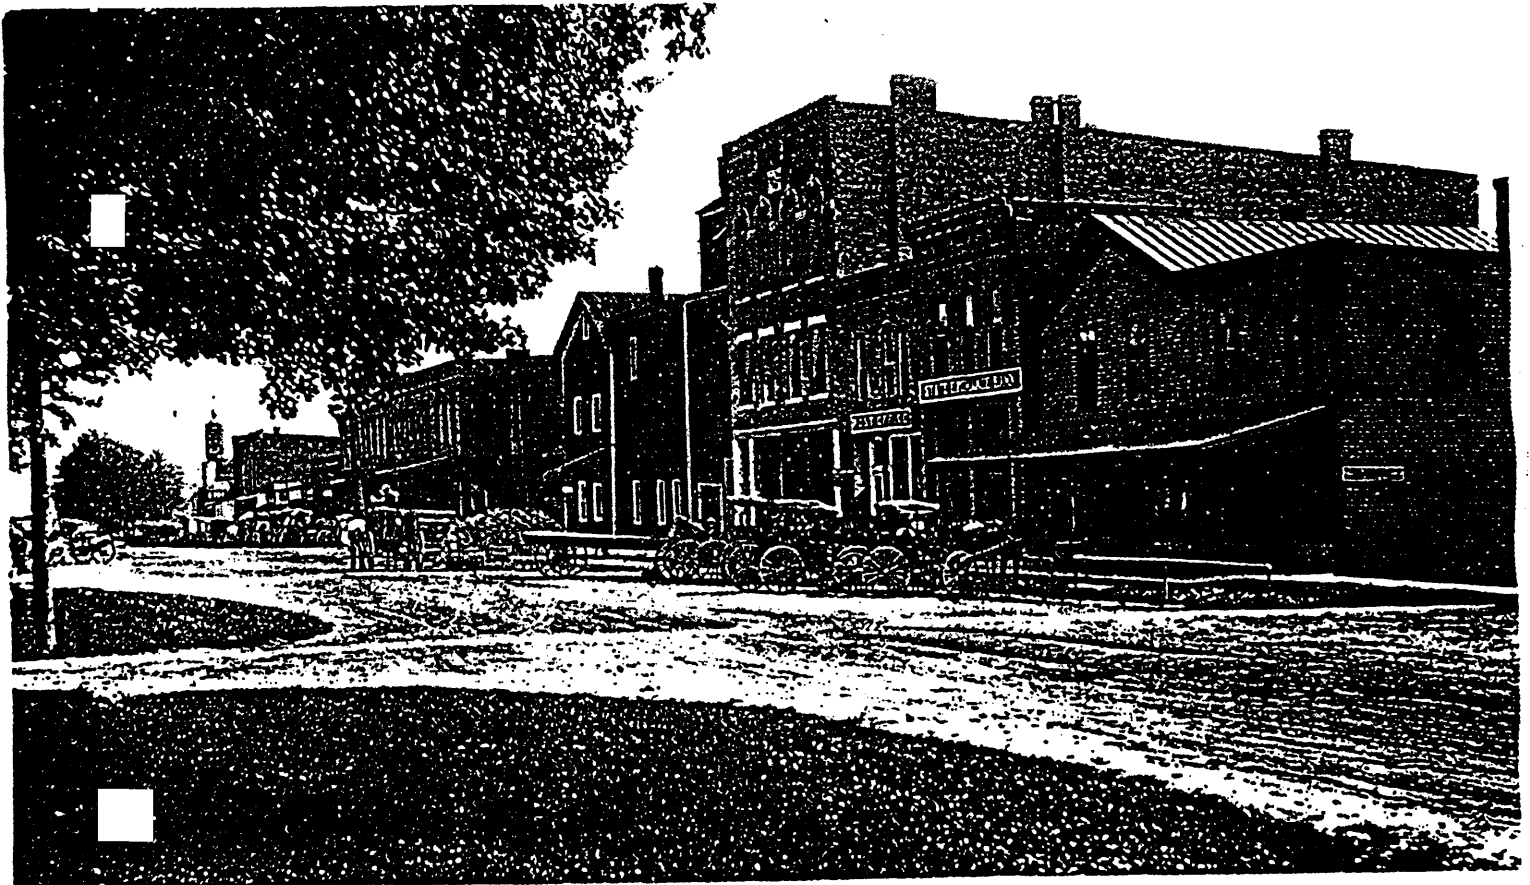
ARGOS DOWNTOWN Historic District  
Marshall County, IN  
West side, 100 block North Michigan St. 1908

West Side Michigan Street, Looking South, Argos, Ind.

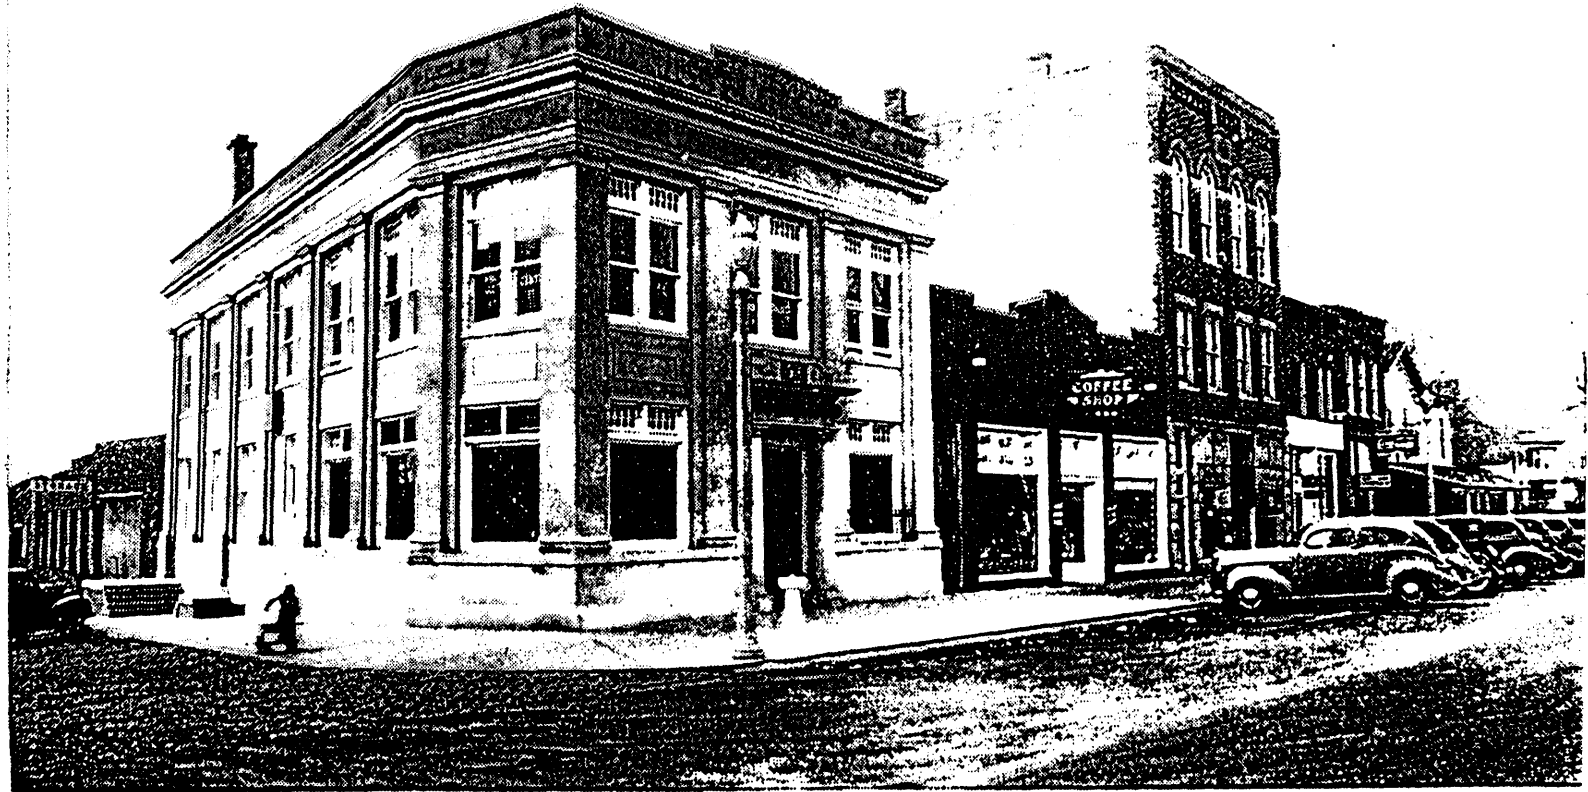
ARGOS DOWNTOWN HISTORIC DISTRICT  
Marshall County, IN  
West side, 100 block North Michigan St. c. 1920

STATE EXCHANGE BANK BLOCK, ARGOS, IND.
