First United Methodist Church of Salem
600 State Street
Salem, Marion County, Oregon

Series A #1 of 5

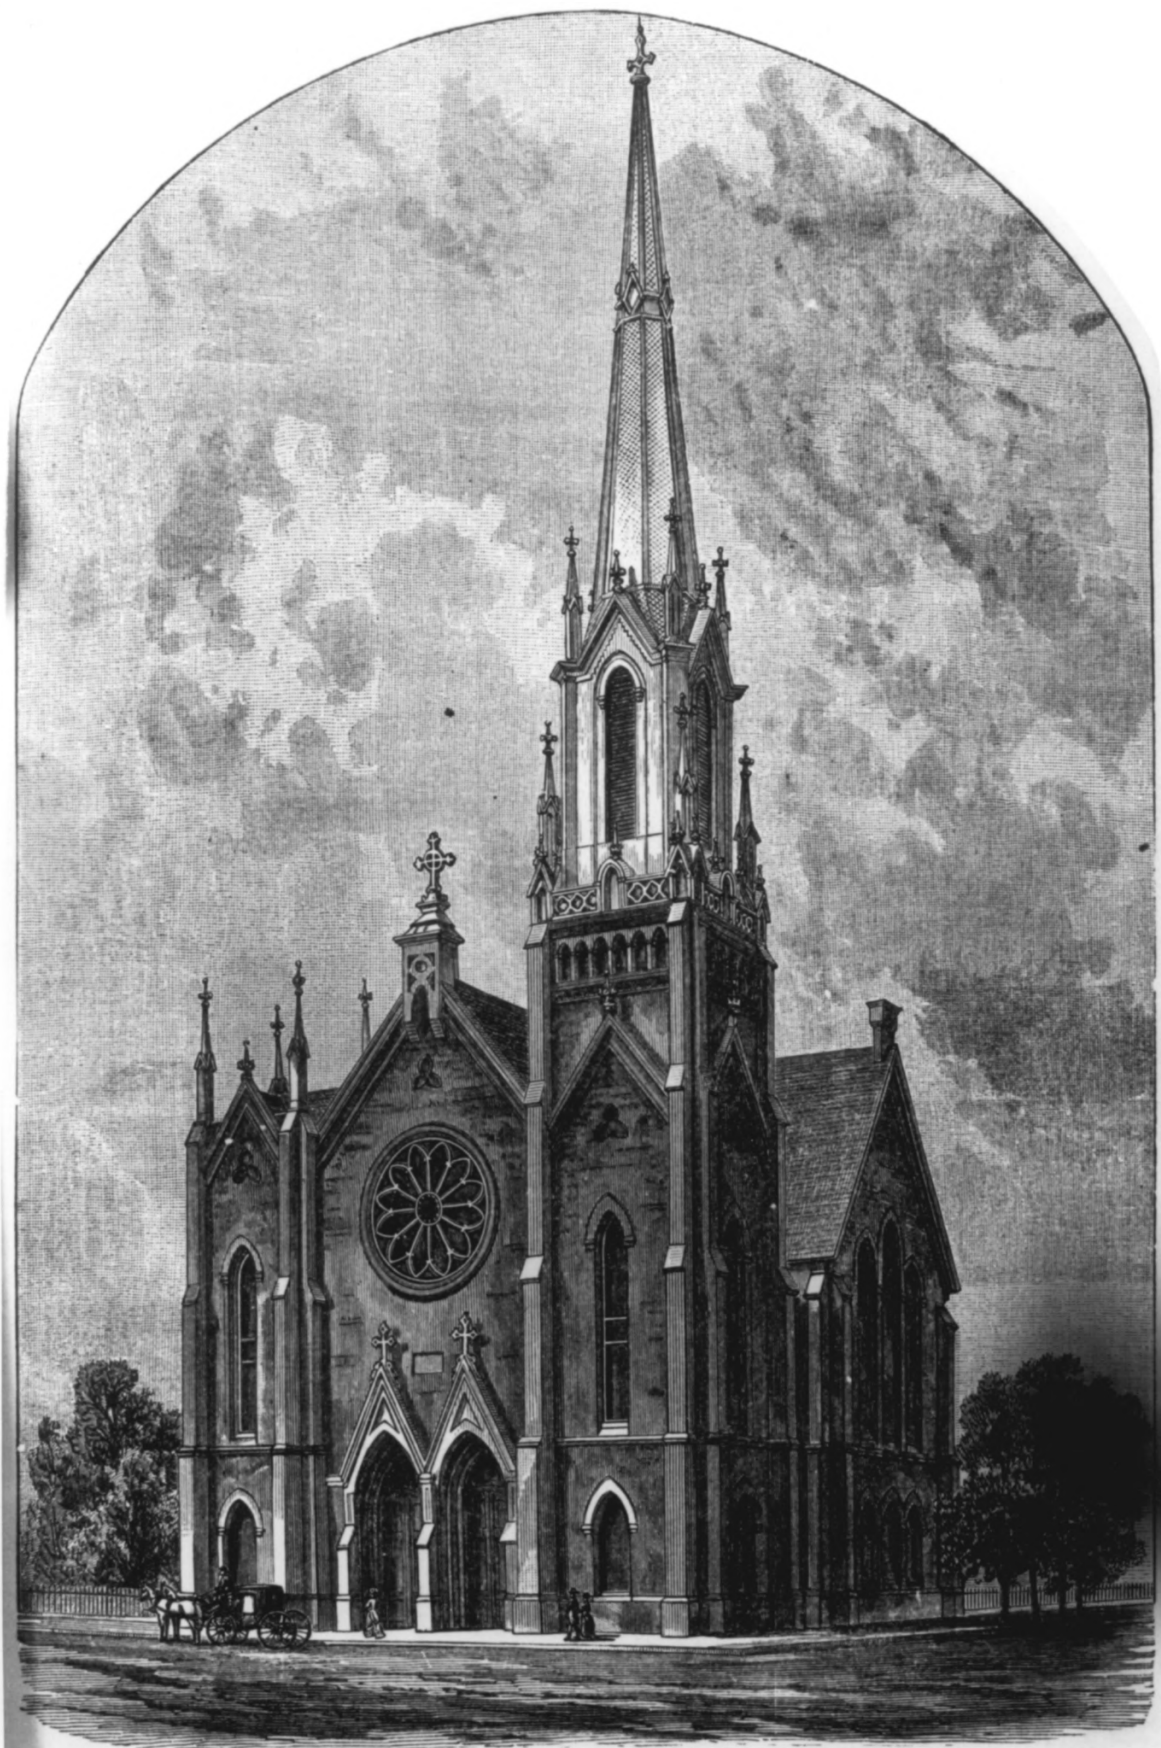
Engraved perspective view, north and west facades, c. 1878-1880?
The source of this engraving which documents the original
appearance of the church is unidentified.

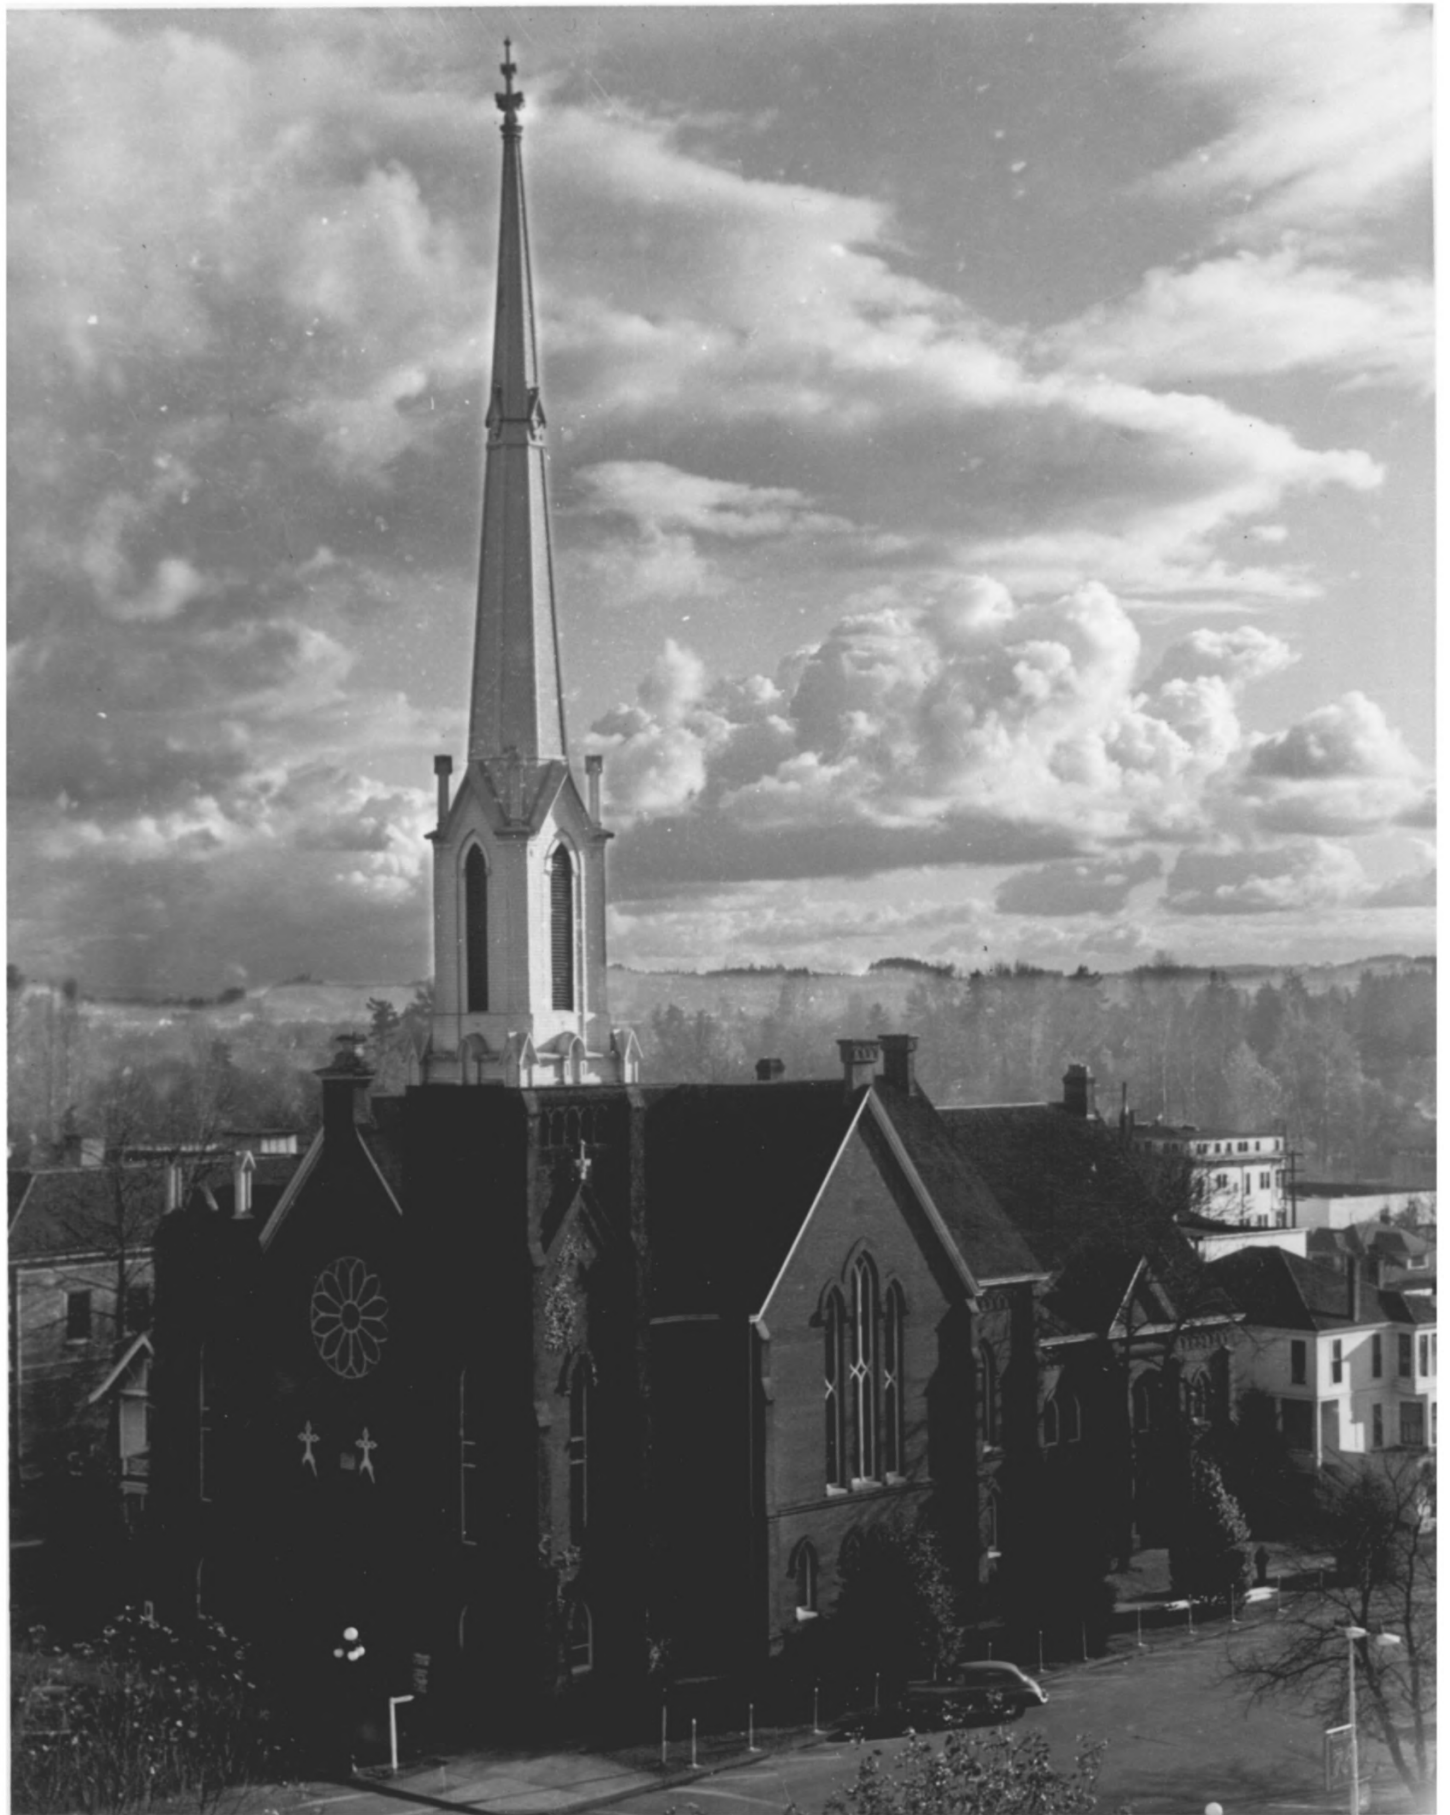
Series A #2 of 5

North and west elevations, C. 1948-1950, showing Sunday School Temple wing of 1935 on the south. On the east is the bungalow built as parsonage in 1911. This view shows attrition of pinnacles and cross finials which had occurred prior to the restoration of

1950-1954.

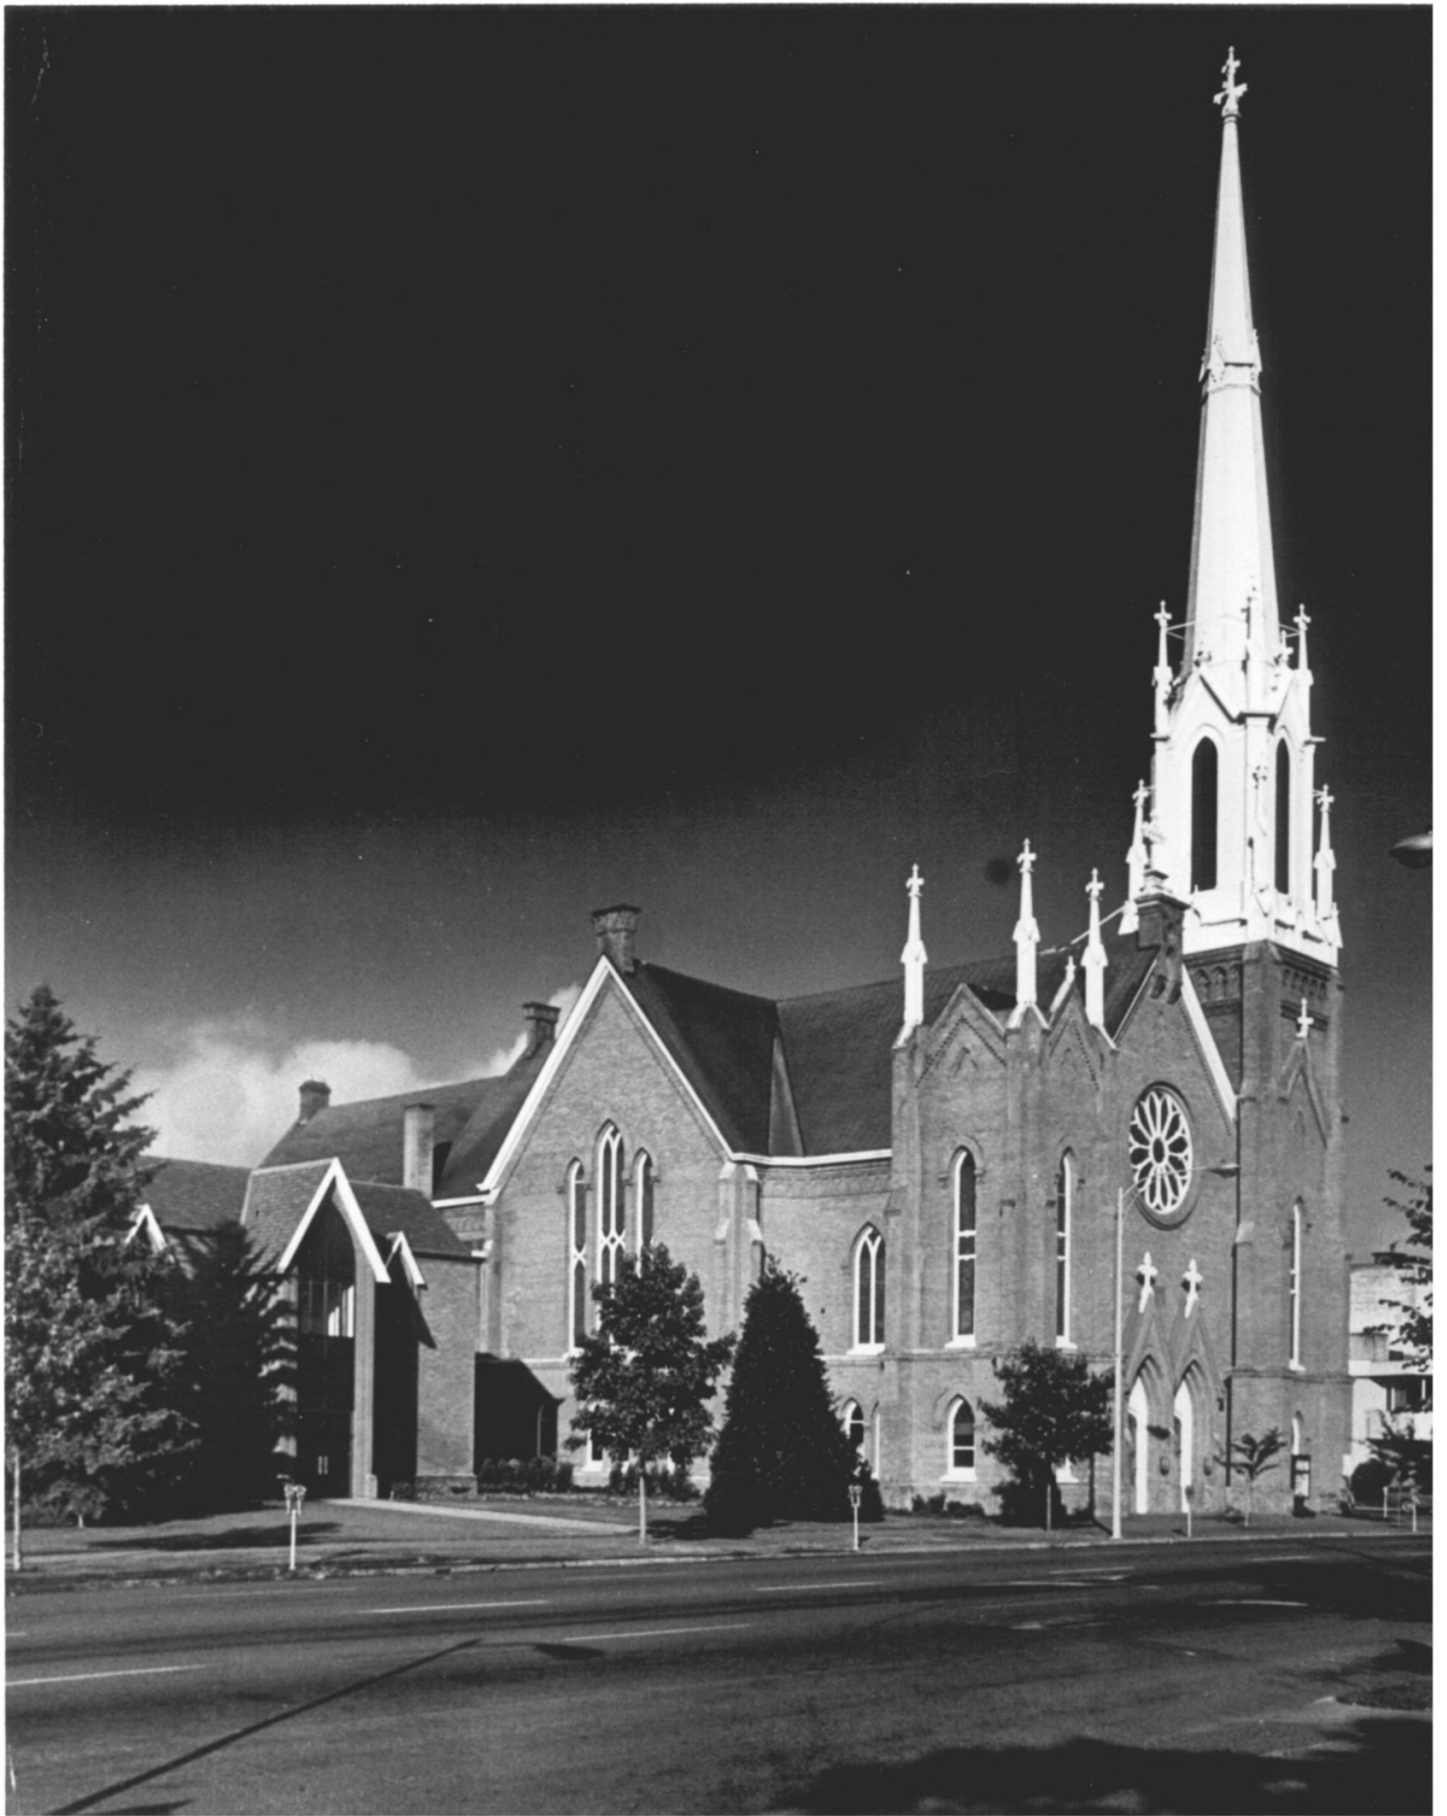
Series A #3 of 5

East and north elevations from State Street, c. 1980, showing
Education and Office addition of 1967, which replaced the
parsonage of 1911.

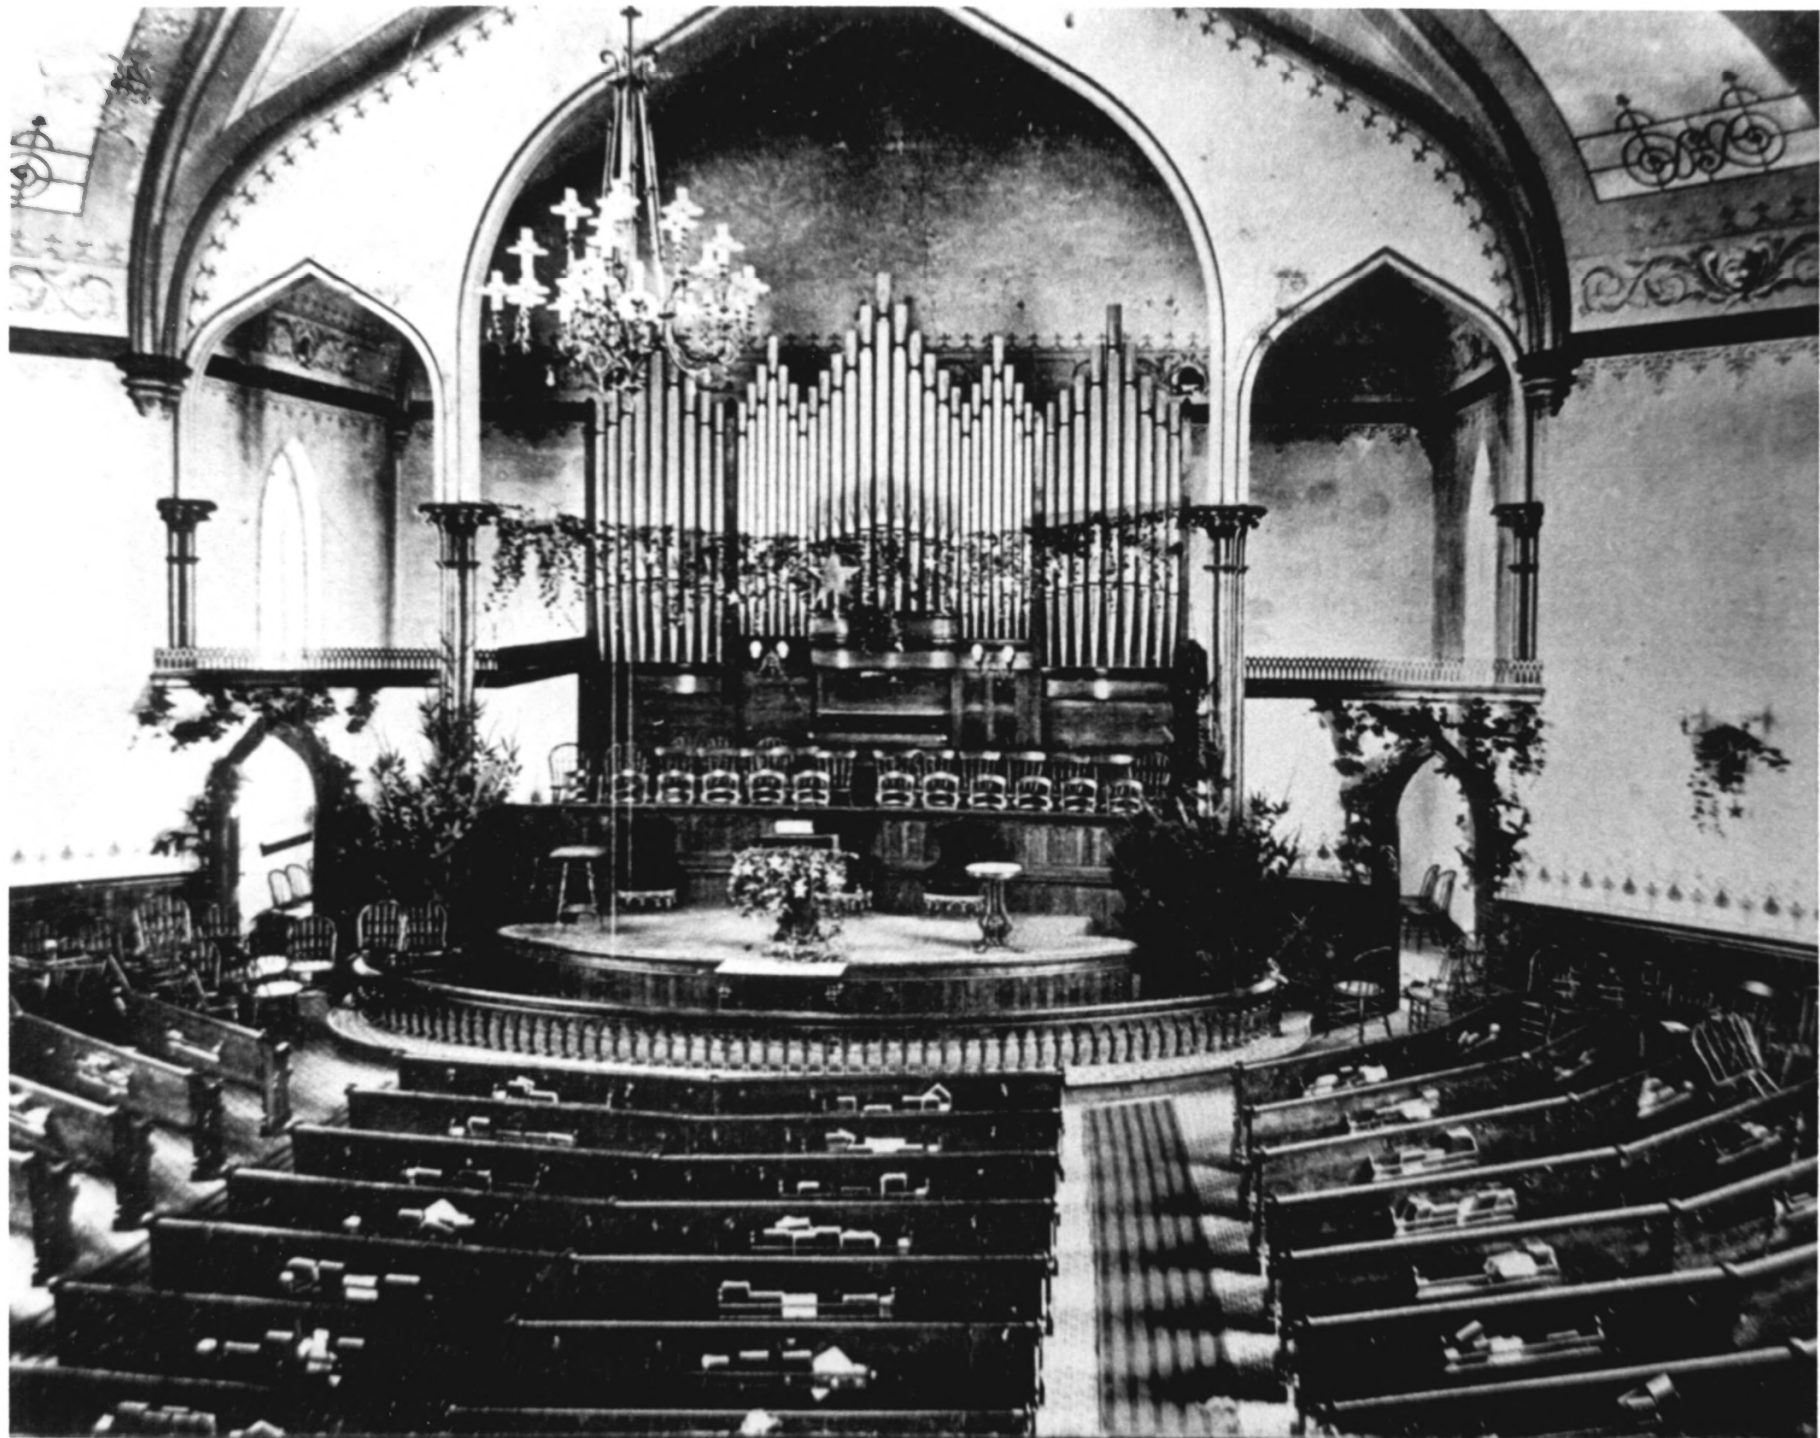
Series A #4 of 5

Interior view of auditorium, 1905, showing original configuration of chancel, including bowed pulpit platform and communion rail, and auditorium seating. Note stenciled decoration on walls and ceiling, 25-light gasolier, and the pipe organ. This pipe organ, installed in 1905, replaced the original pipe organ, thought to have been the first in a Methodist church anywhere in the state when the church was dedicated in 1878.

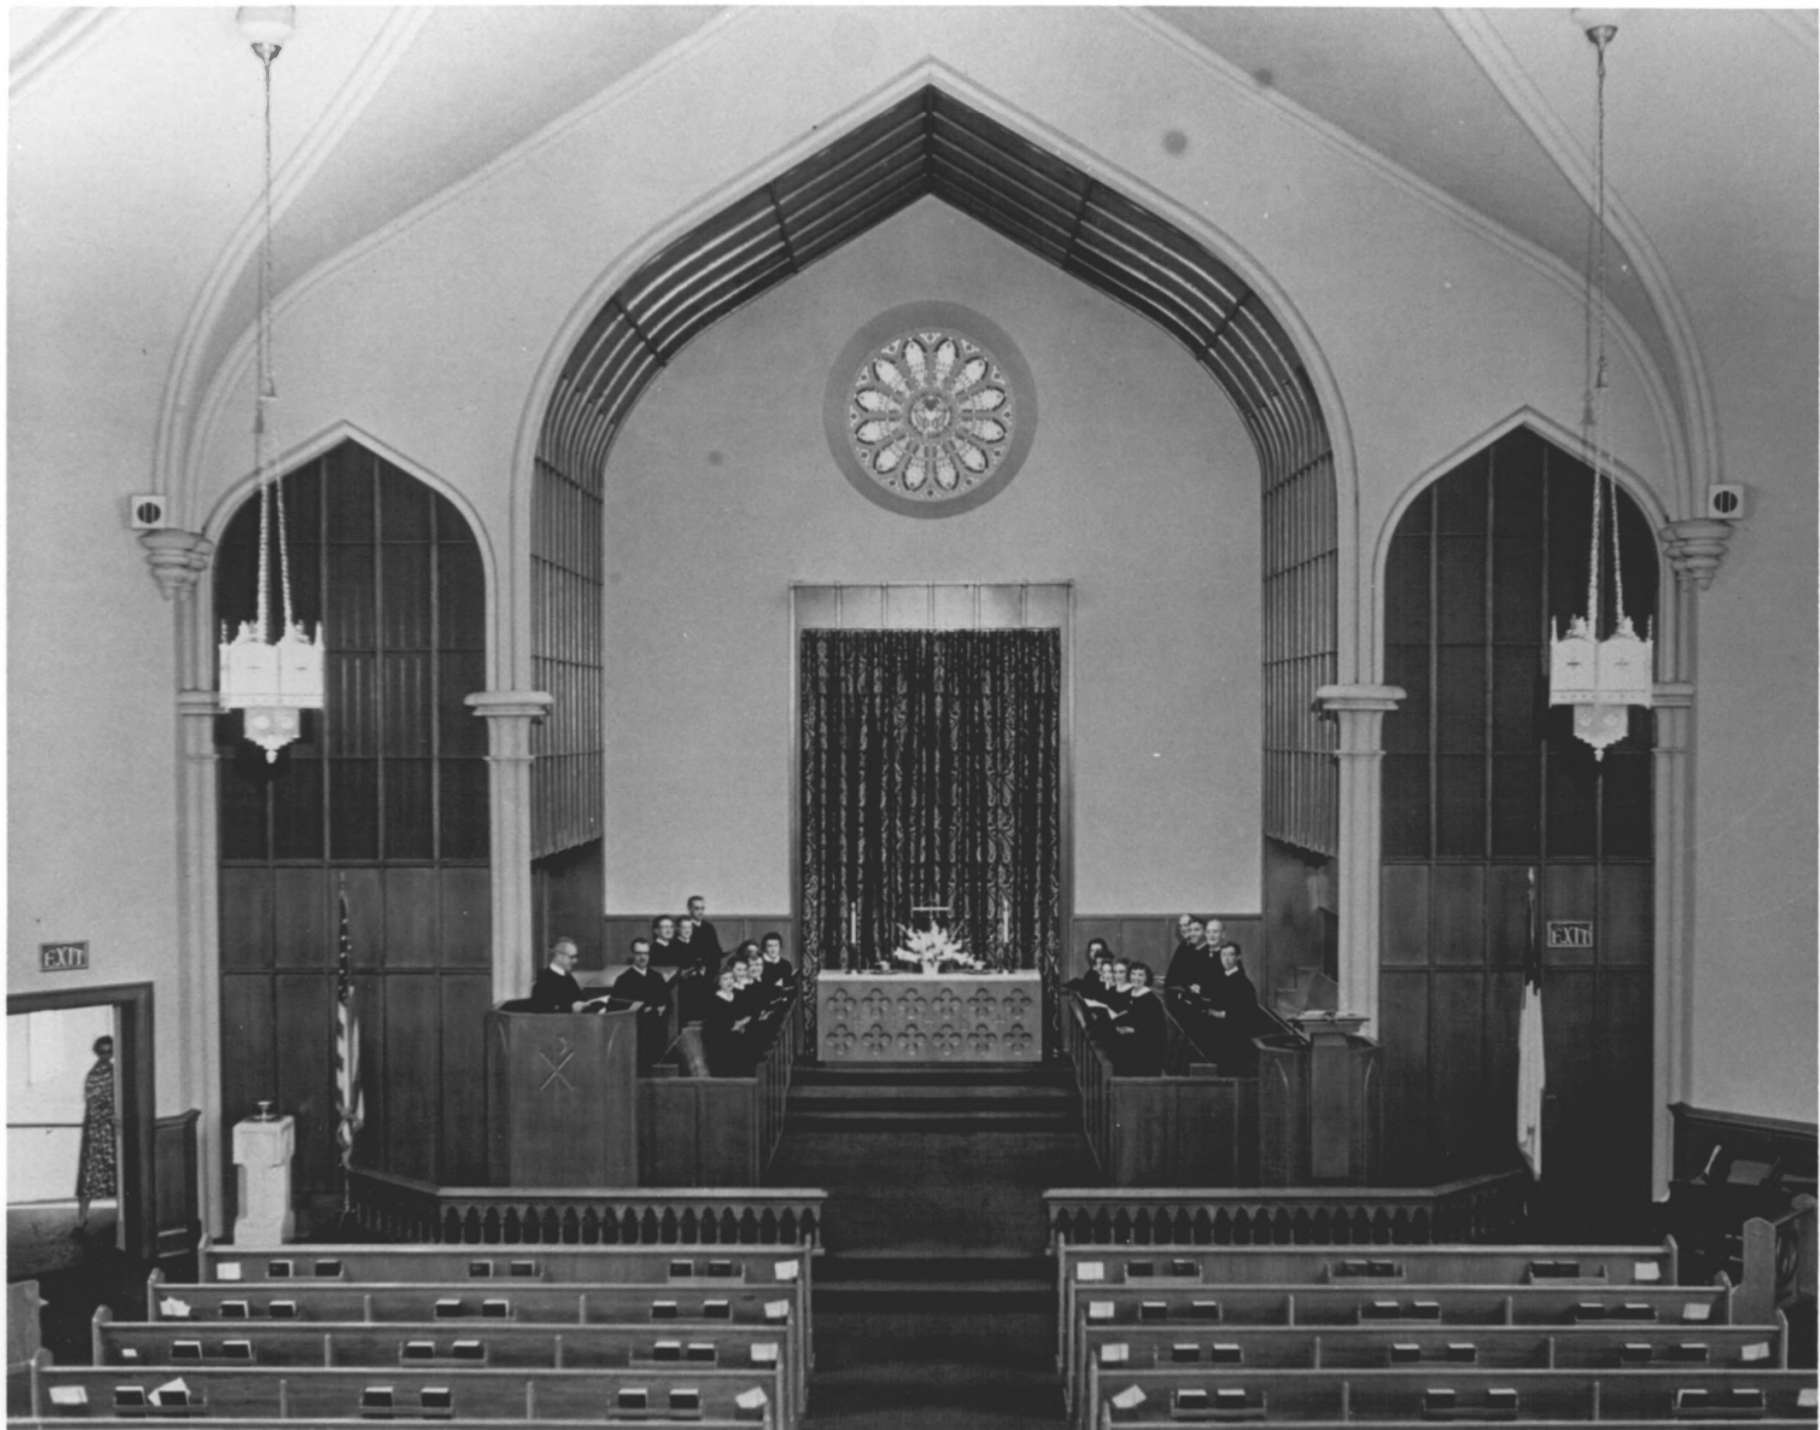
Series A #5 of 5

Interior view of auditorium following completion of remodeling of 1952. This shows present configuration of chancel with more liturgical arrangement, including altar and dossal, artificially-lighted rose window, choir stalls, pulpit and lectern.

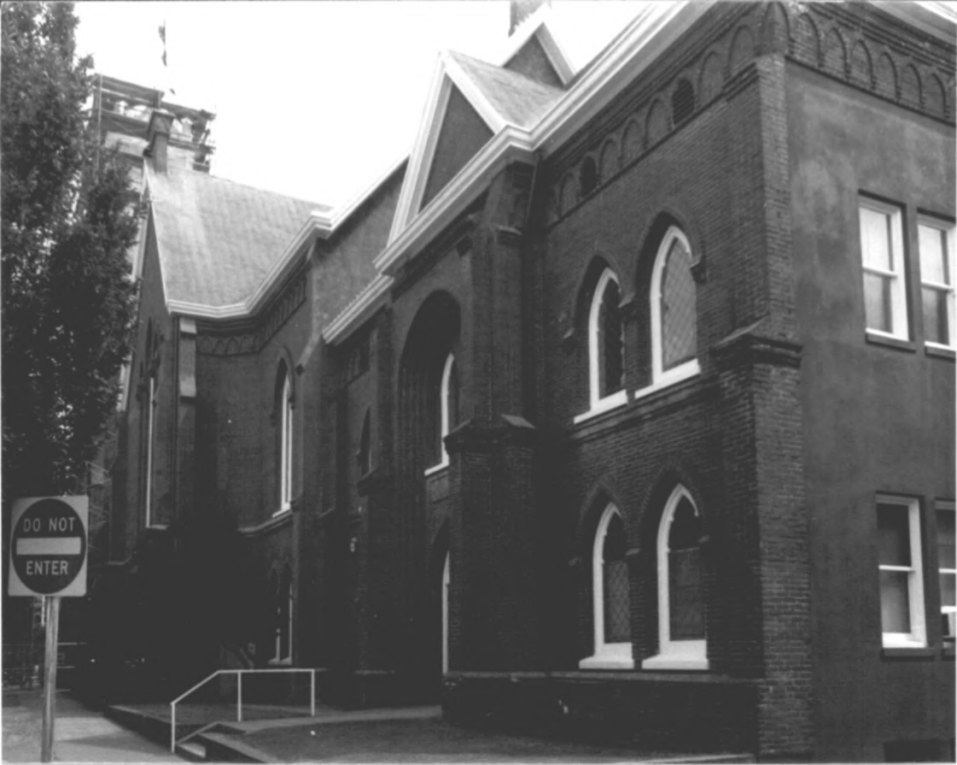
Series B #1 Of 16

West elevation from the south, showing
integration of 1935 Sunday School Temple
with original building. The former is

a wing at a right angle to the main axis
of the church.

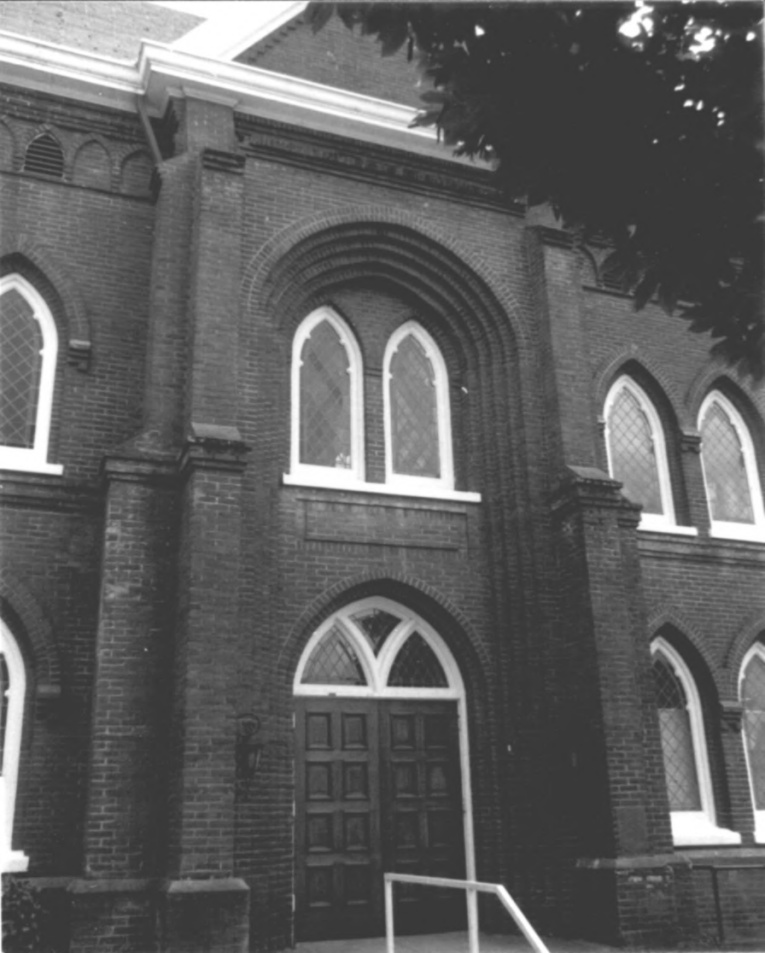
Series B #2 of 16
West elevation of Sunday School Temple
wing of 1935, showing entrance bay.

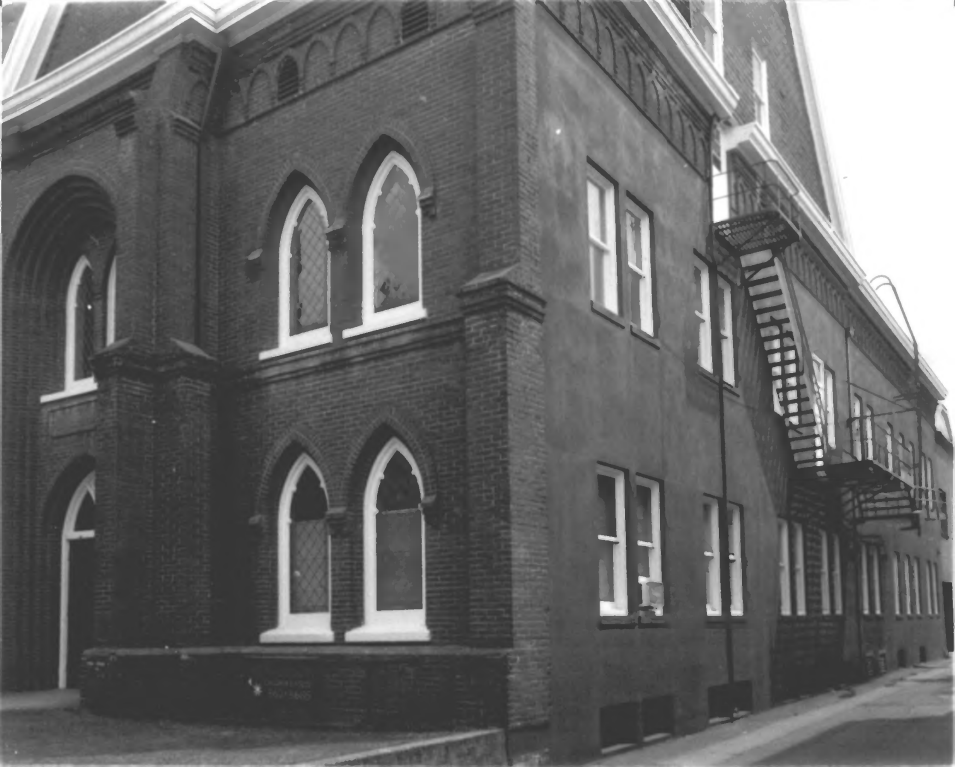
Series B #3 of 16
Sunday School Temple wing, west and south
(alley) elevations.

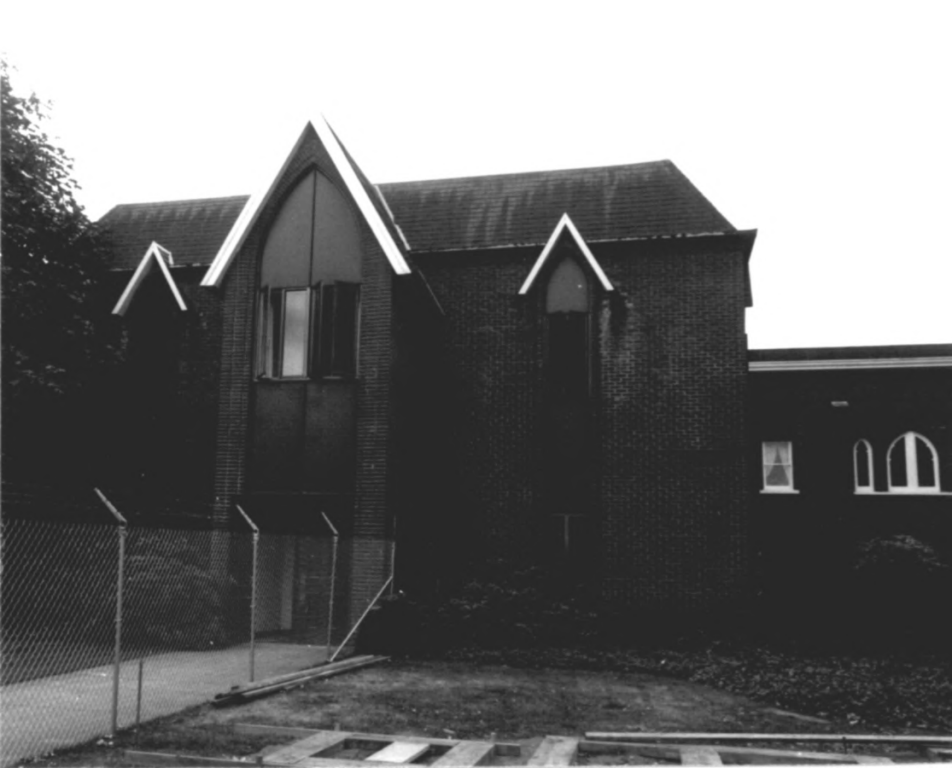
Series B #4 of 16
North elevation of Education and Office
Addition of 1967. Fence is temporary for
duration of steeple reconstruction

completed in 1982.

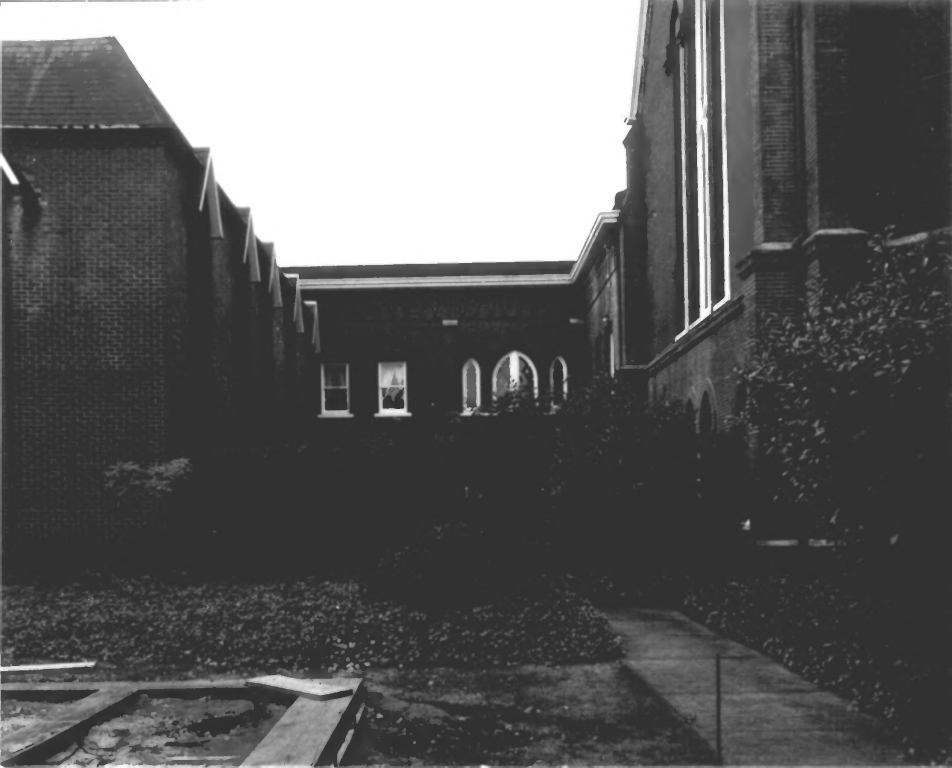
Series B #5 of 16

Looking south from State Street to
courtyard formed by church (right),
Sunday School Temple (center) and

Education and Office Addition (left).

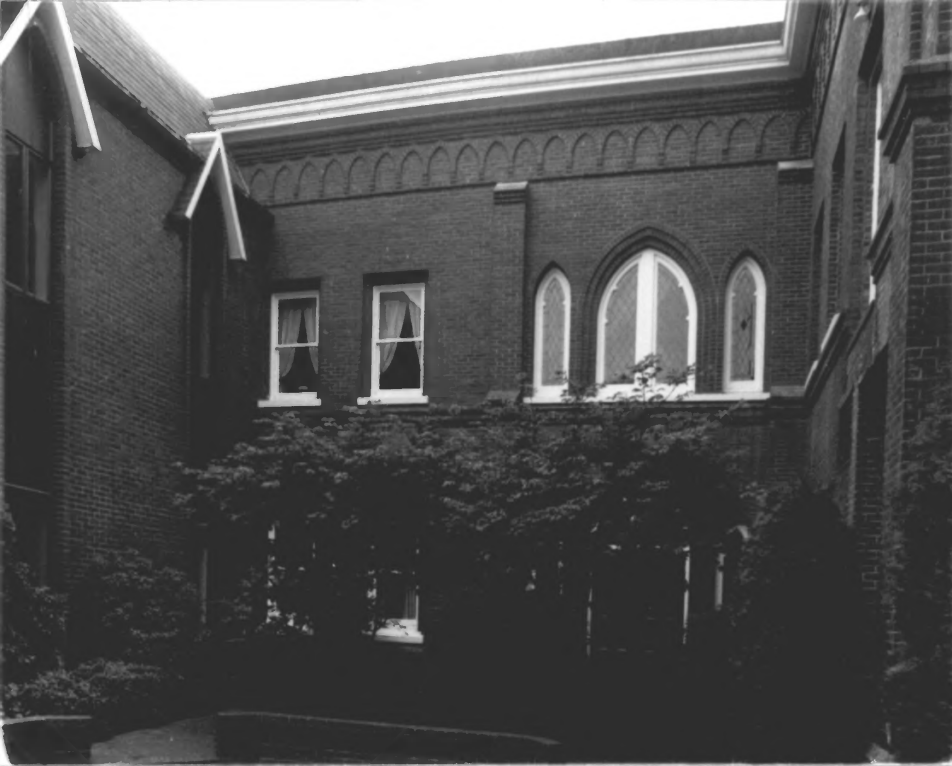
Series B #6 of 16
North wall of Sunday School Temple wing
of 1935 from courtyard.

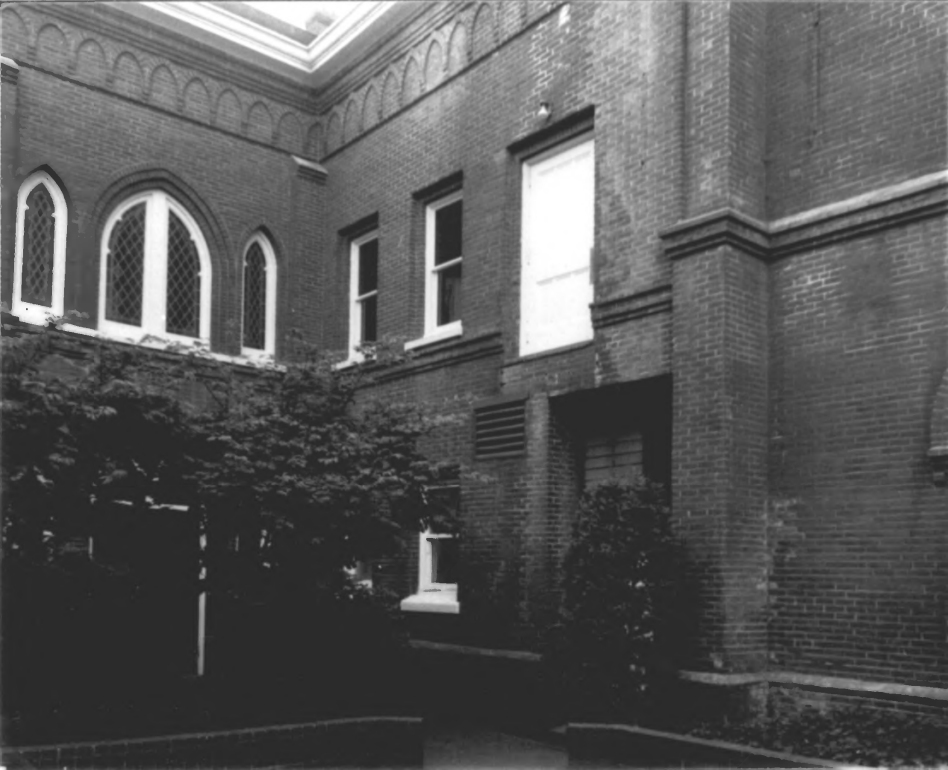
Series B #7 of 16
East elevation of original building
(right) and north elevation of Sunday
School Temple wing of 1935.

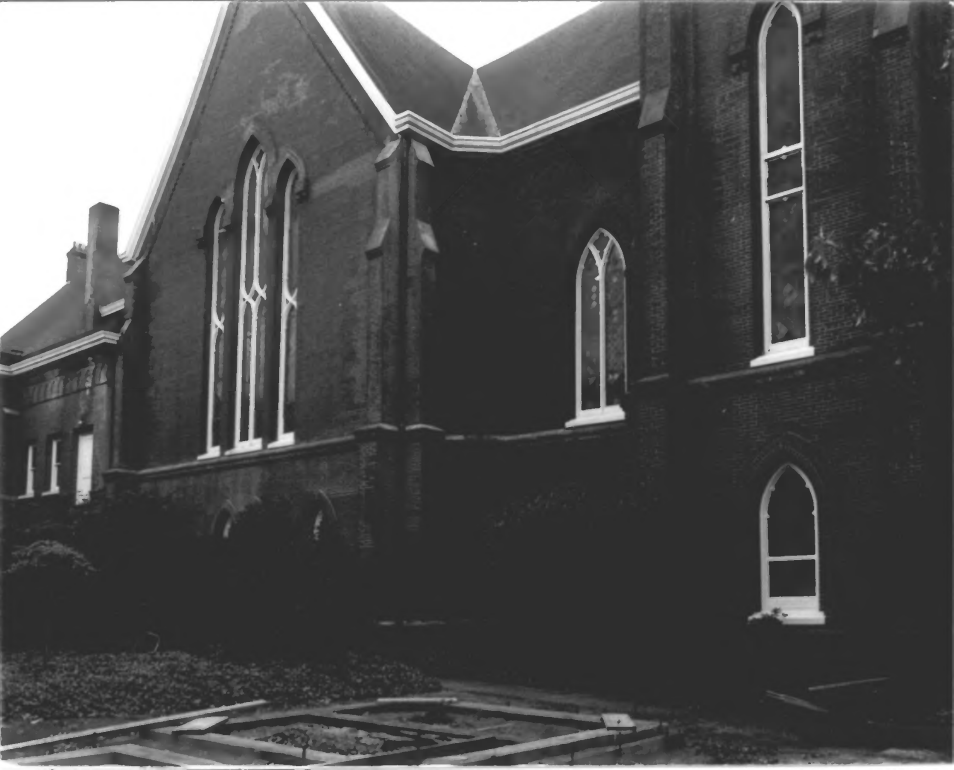
Series B #8 of 16
East Elevation of church showing
tripartite window arrangement lighting
auditorium.

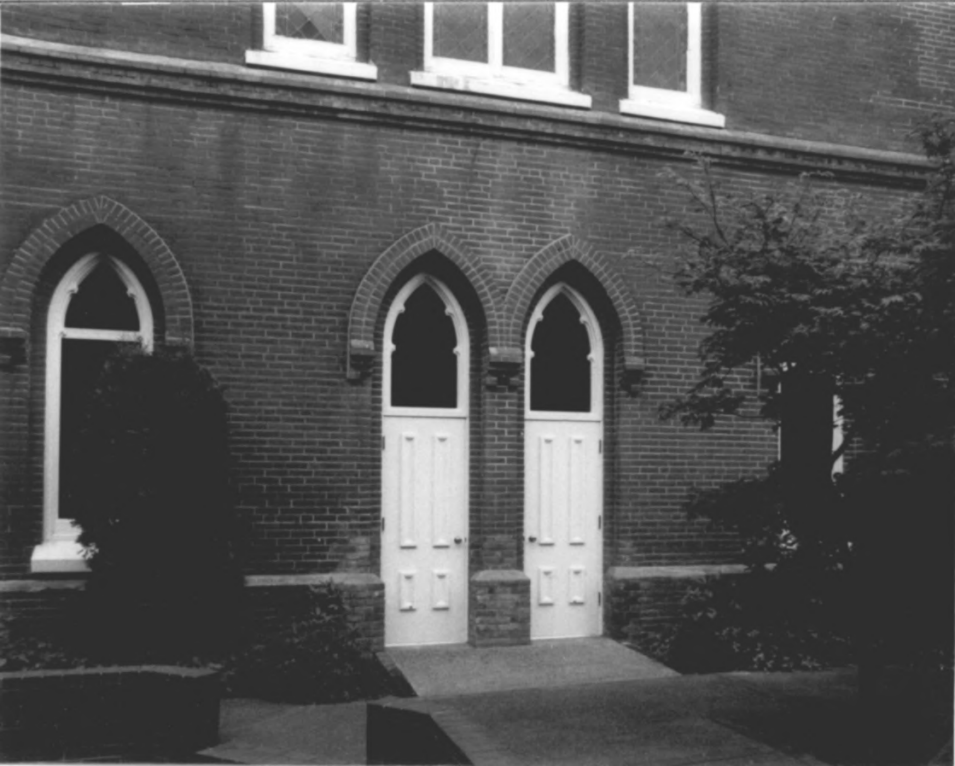
Series B #9 1f 16

East wall of church showing ground
story windows recently cut down to
grade level to provide access from

courtyard to ground story lecture hall.

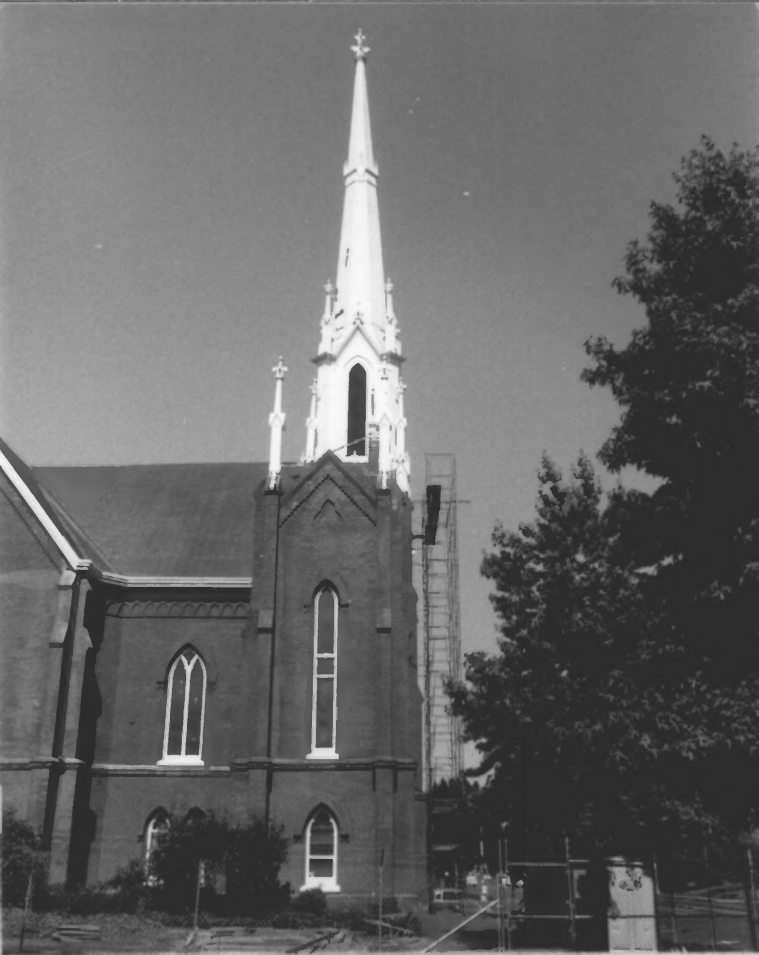
Series B #10 of 16
East elevation showing scaffolding
being erected prior to steeple recon-
struction of 1982.

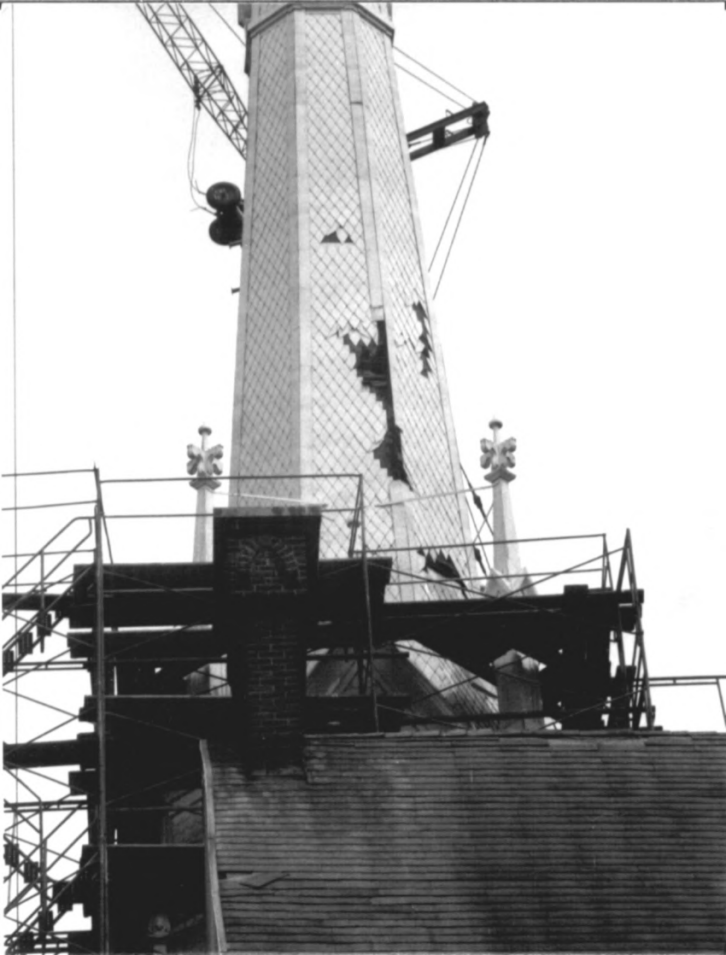
Series B #11 of 16
Looking north at steeple at
commencement of repairs.

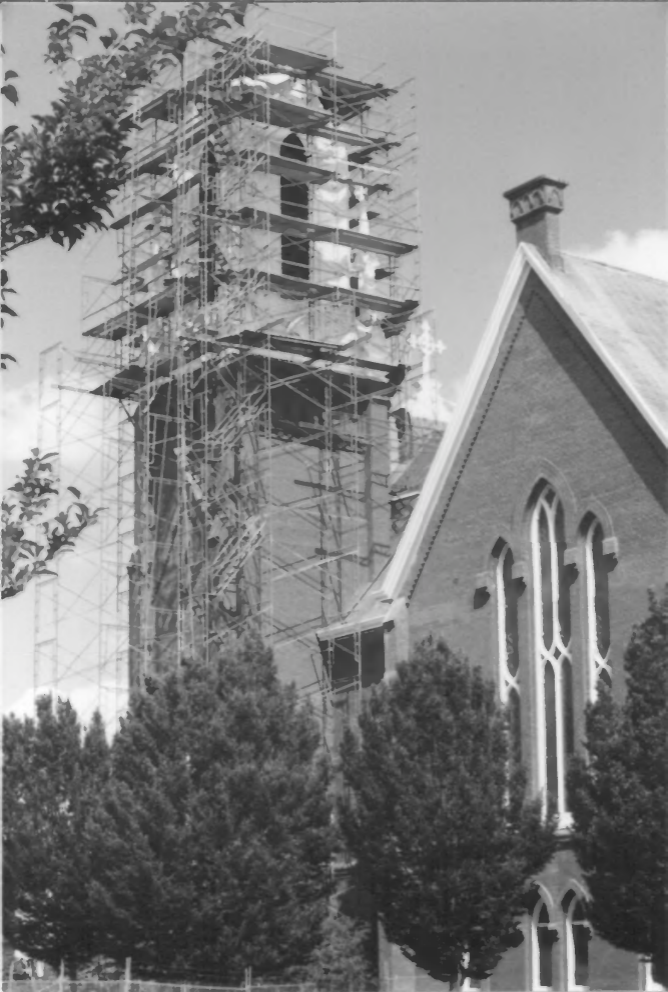
Series B #12 of 16
West elevation. Steeple dismantled
for repairs.

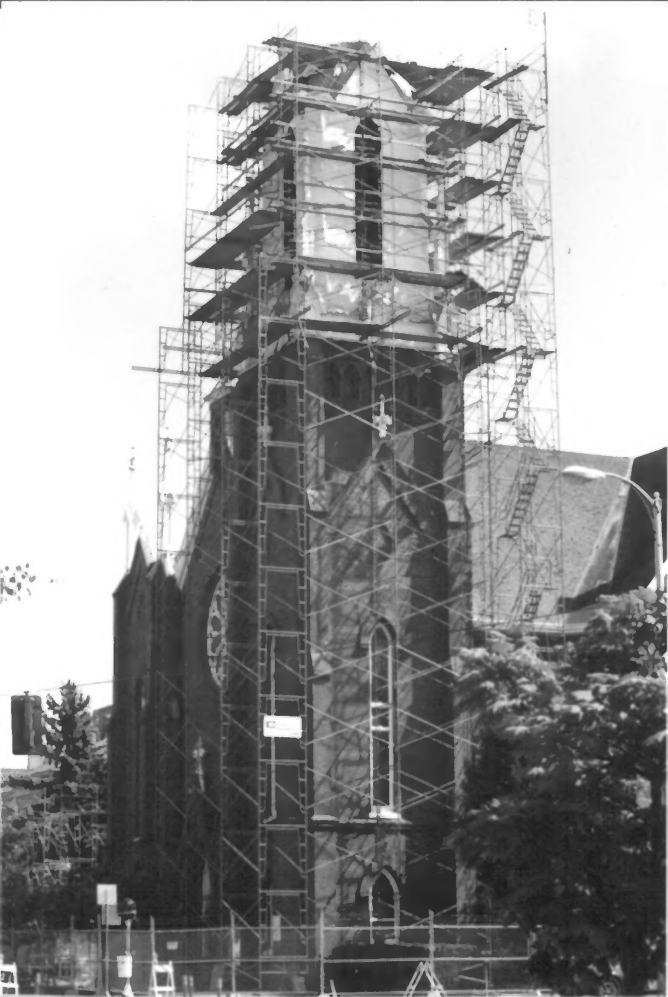
Series B #13 of 16
North and west elevations. Steeple
dismantled for repairs.

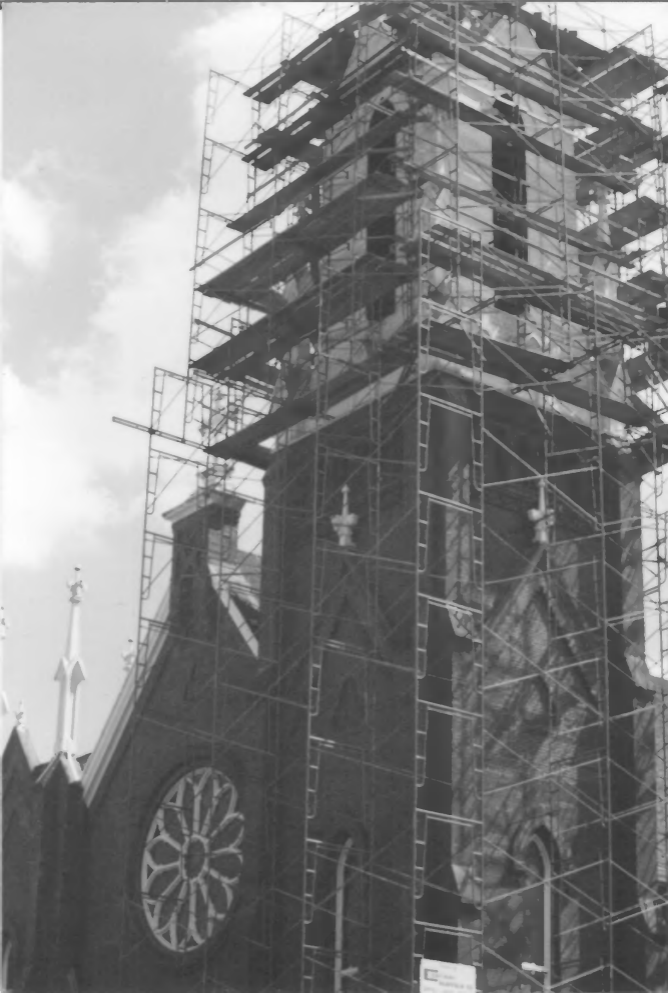
Series B #14 of 16
Detail of northwest stair tower and
scaffolding for belfry steeple repairs.
