First United Methodist Church of Salem
600 State Street
Salem, Marion County, Oregon

Series A #1 of 5

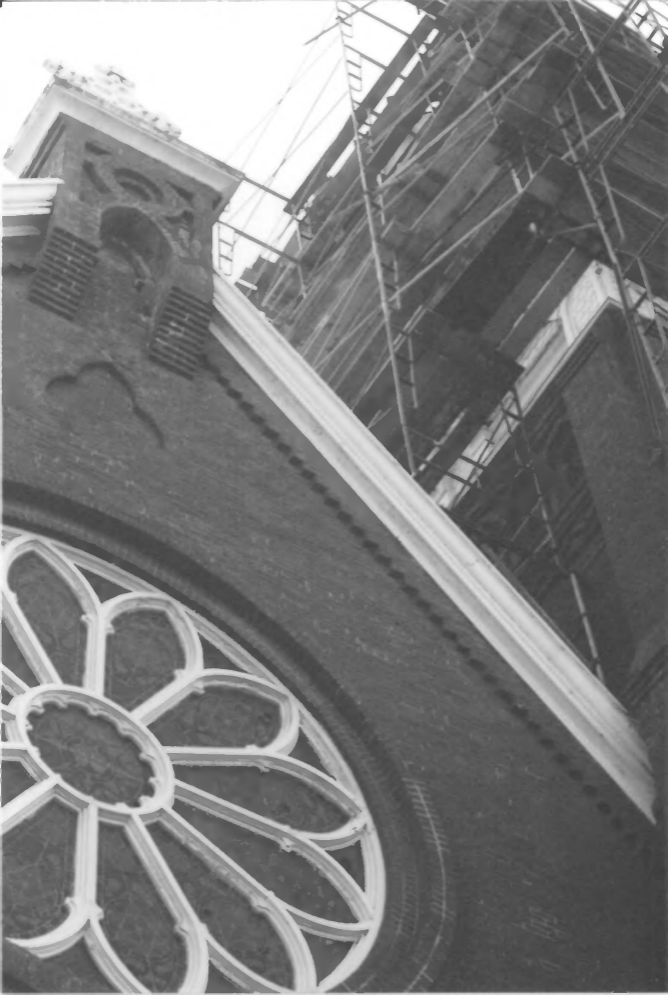
Series B #15 of 16
Detail fo wheel window and gable turret
and scaffolding for belfry steeple
repair.

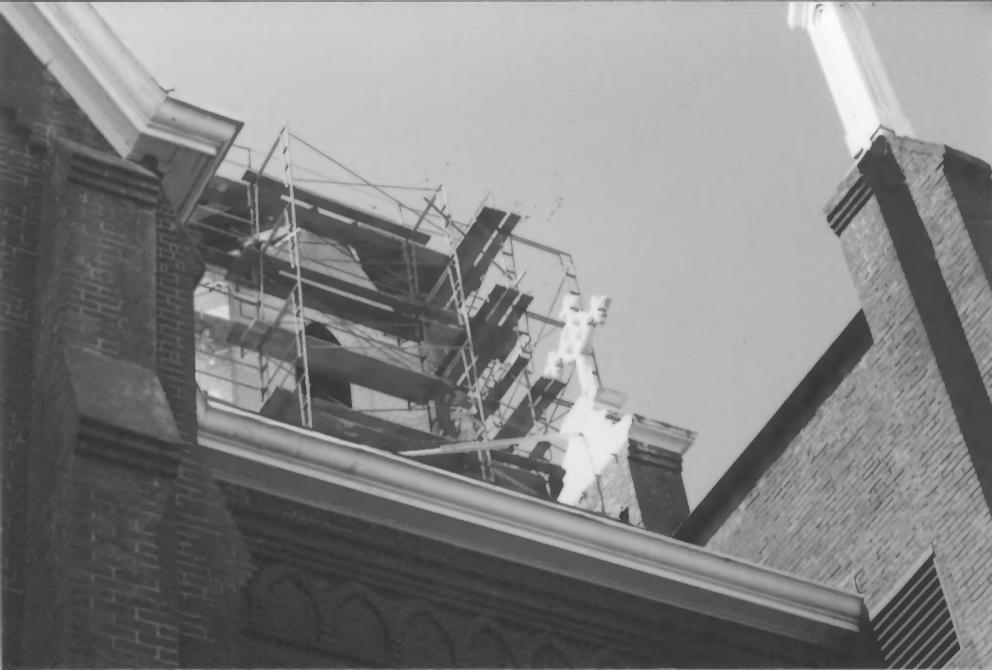
Series B #16 of 16
Detail of cross finial on gable turret.
Looking west and scaffolding for belfry
steeple repairs.
