National Register of Historic Places Registration Form

Historic name: Slusser-Ryan Farm
Other names/site number: Hickory Ridge Farm/DHR 060-0337
Name of related multiple property listing:
N/A
(Enter "N/A" if property is not part of a multiple property listing)

Street & number: 2028 Mt. Tabor Road
City or town: Blacksburg State: VA County: Montgomery
Not For Publication: N/A Vicinity: X

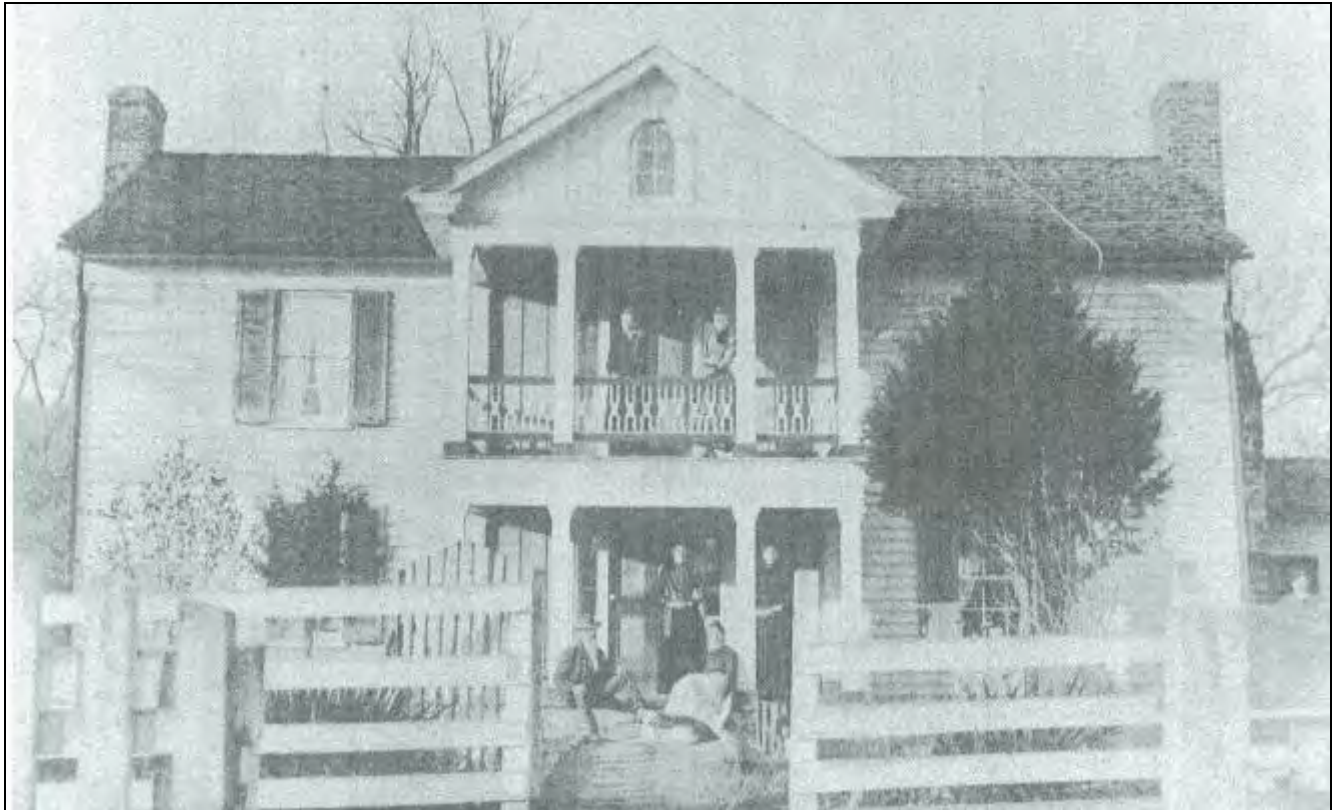
1. James P. Slusser House, ca. 1880. Source: Tom Slusser (Grandson of James P. Slusser) and Susan Bull Ryan, current property owner.

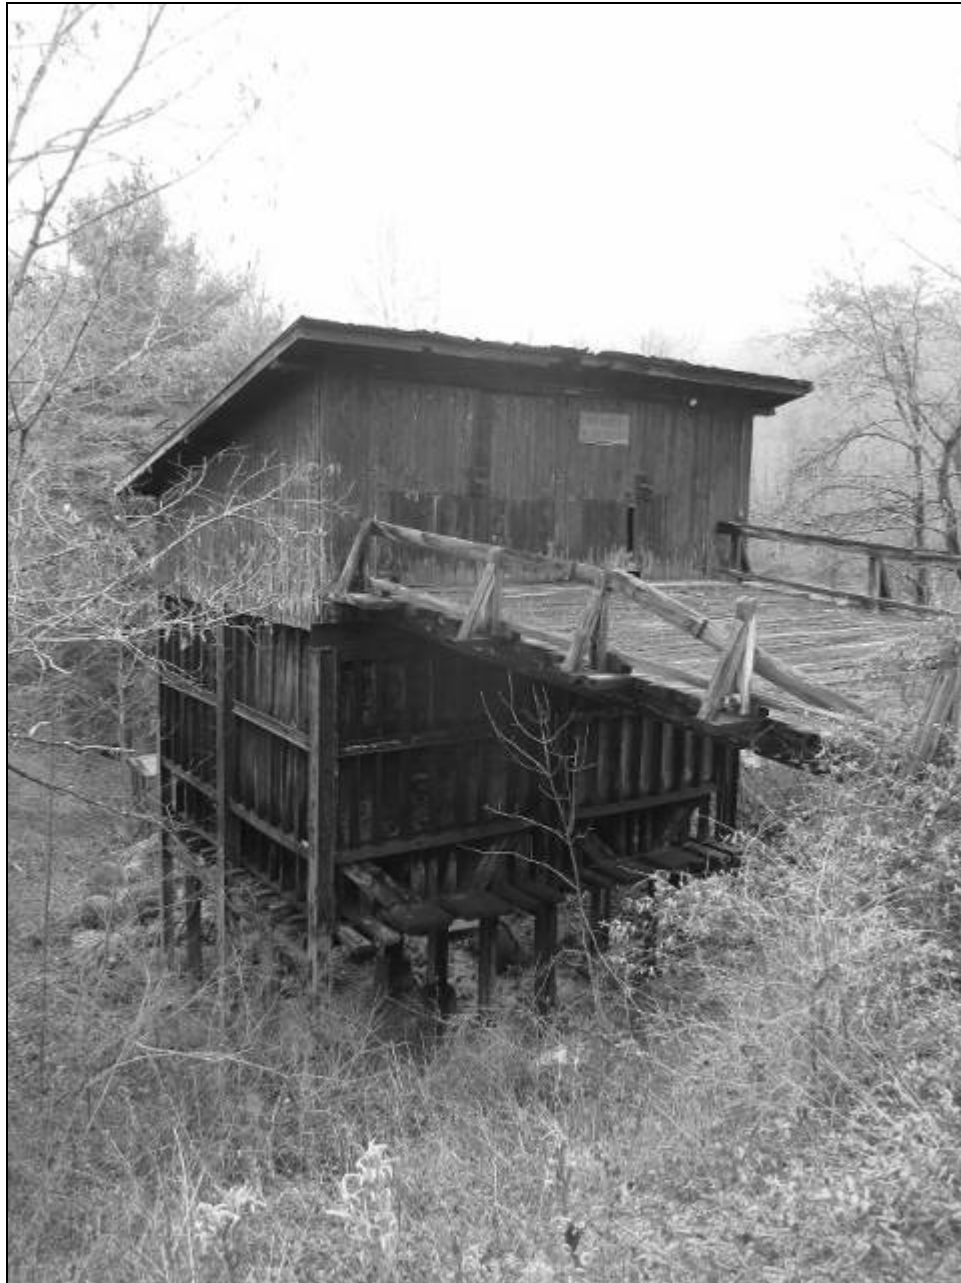
8. Slusser Coal Mine Tippie at intersection of Route 460 and Coal Bank Hollow Road.
Photo by Debra A. McClane, 2017.

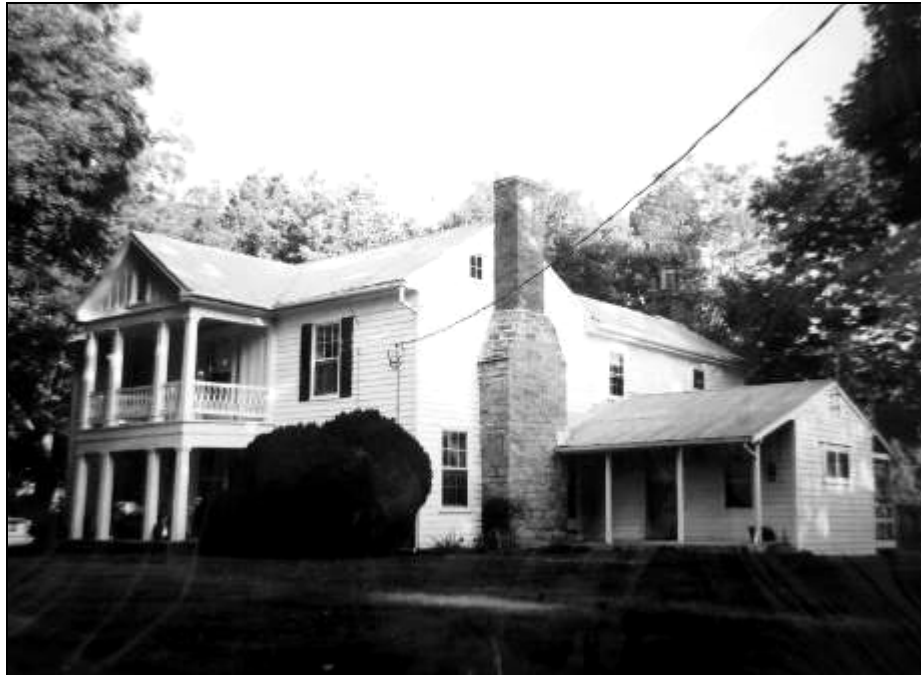
9. Slusser-Ryan House Showing Old Kitchen Wing, prior to 2011. Source: Susan Bull Ryan.

By the early twentieth century, a one-story, frame kitchen wing had been constructed on the east end of the house. This wing replaced an earlier detached kitchen on the property (location unknown). In the early twenty-first century, the wing was removed and replaced with a larger one-story wing that incorporates a great room and a basement level living space. Stones from the kitchen wing foundation were reused on interior mantels and decorative features.

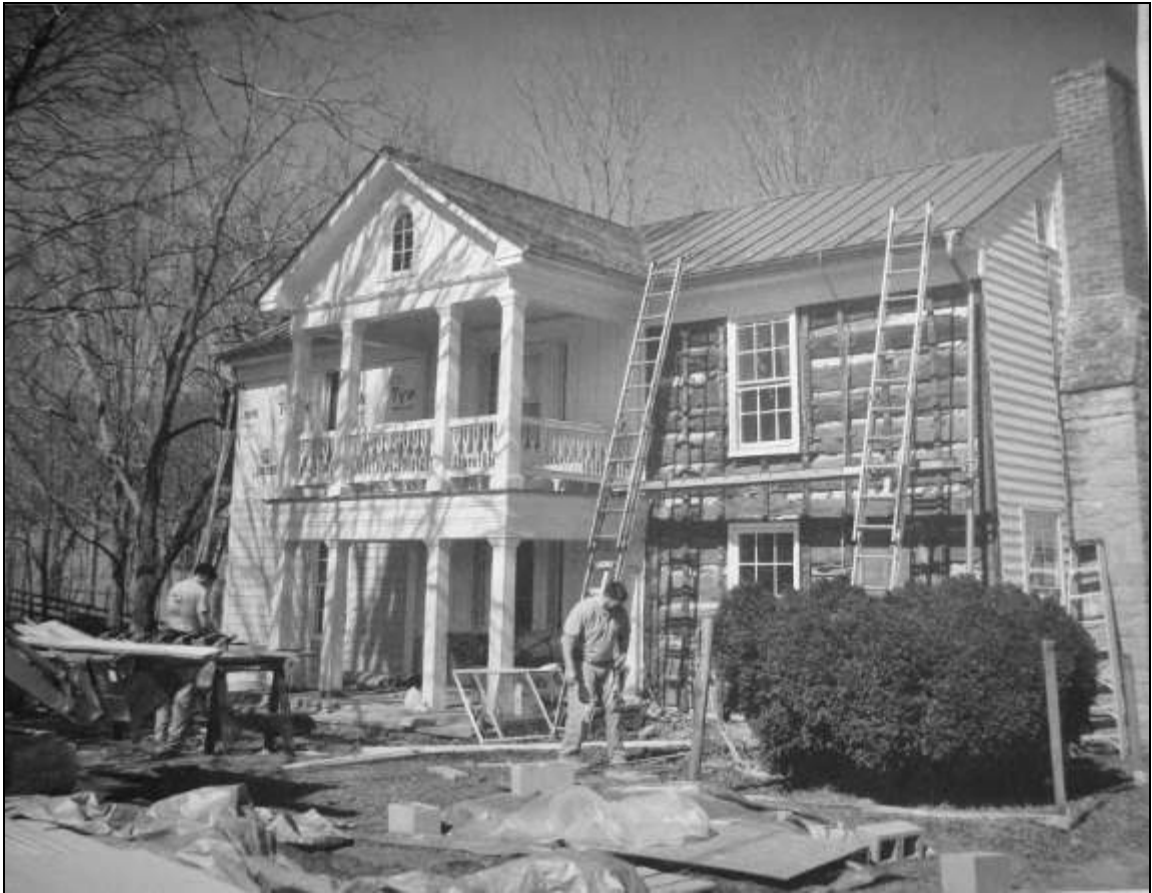
11. Slusser-Ryan House during Renovation Showing Log Construction of East Wing, Prior to 2011.
Source: Susan Bull Ryan.

In Montgomery County, log construction continued to be popular into the mid- and late-nineteenth century, due in part to the building traditions brought by the German immigrants who settled there.¹¹ The use of hewn logs secured with notched corners with the spaces between the logs filled with wood or stone chinking and daubed proved to be a more permanent . The Slusser house reflects a high level of workmanship in its log construction with its tight fitted notched corners and logs hewn both on the interior and exterior. Over the years, the daubing appears to have been replaced and resurfaced in areas, but the overall profile of the walls is intact. The Slusser house also reflects the historical practice of expanding the floor plan of the original house rather than replacing the original structure. Although log houses of the period were often one-and-a-half-story hall-parlor houses, the Slusser house appears to have been a two-story, single-pen house. The log construction is visible on the interior, but investigation of the exterior was limited to a single photograph taken during early twenty-first century renovations.
