KENTUCKY HISTORIC RESOURCES INVENTORY

Site No. 00 367

| 1. Historic Name(s) <u>Wm Crow house</u> | | 22. ADD/County <u>Bluegrass Boyle</u> | |

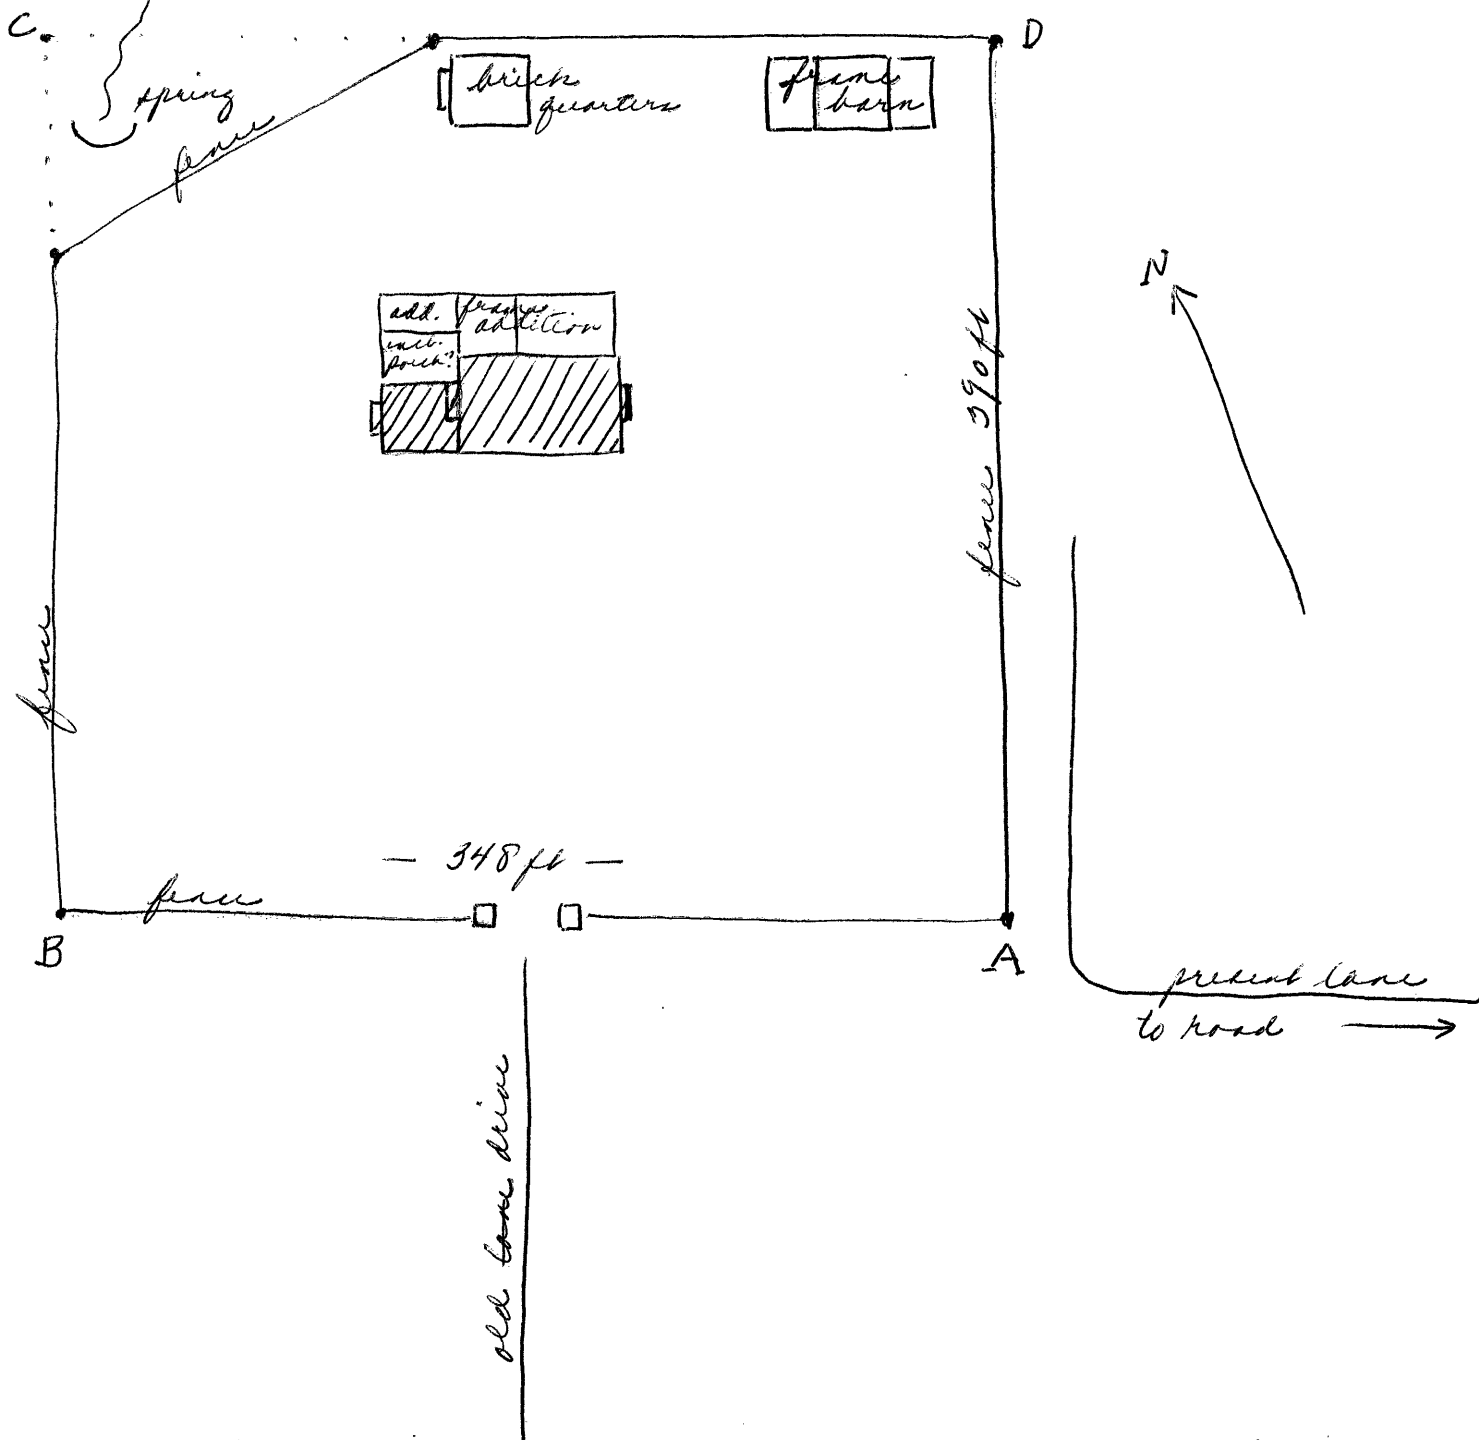
SKETCH MAP OF SITE SHOWING BOUNDARIES AND KEY BUILDINGS AND FEATURES WITH NORTH ARROW.

Beginning at A, at the SE corner of the yard, thence W fence, 348 ft W to B, 390 ft N to C, 348 ft E to D, and 390 ft S to the beginning, going outside the fence in the NW corner to include the spring. Boundary contains stone house, brick quarters, and later barn - about 3 acres.

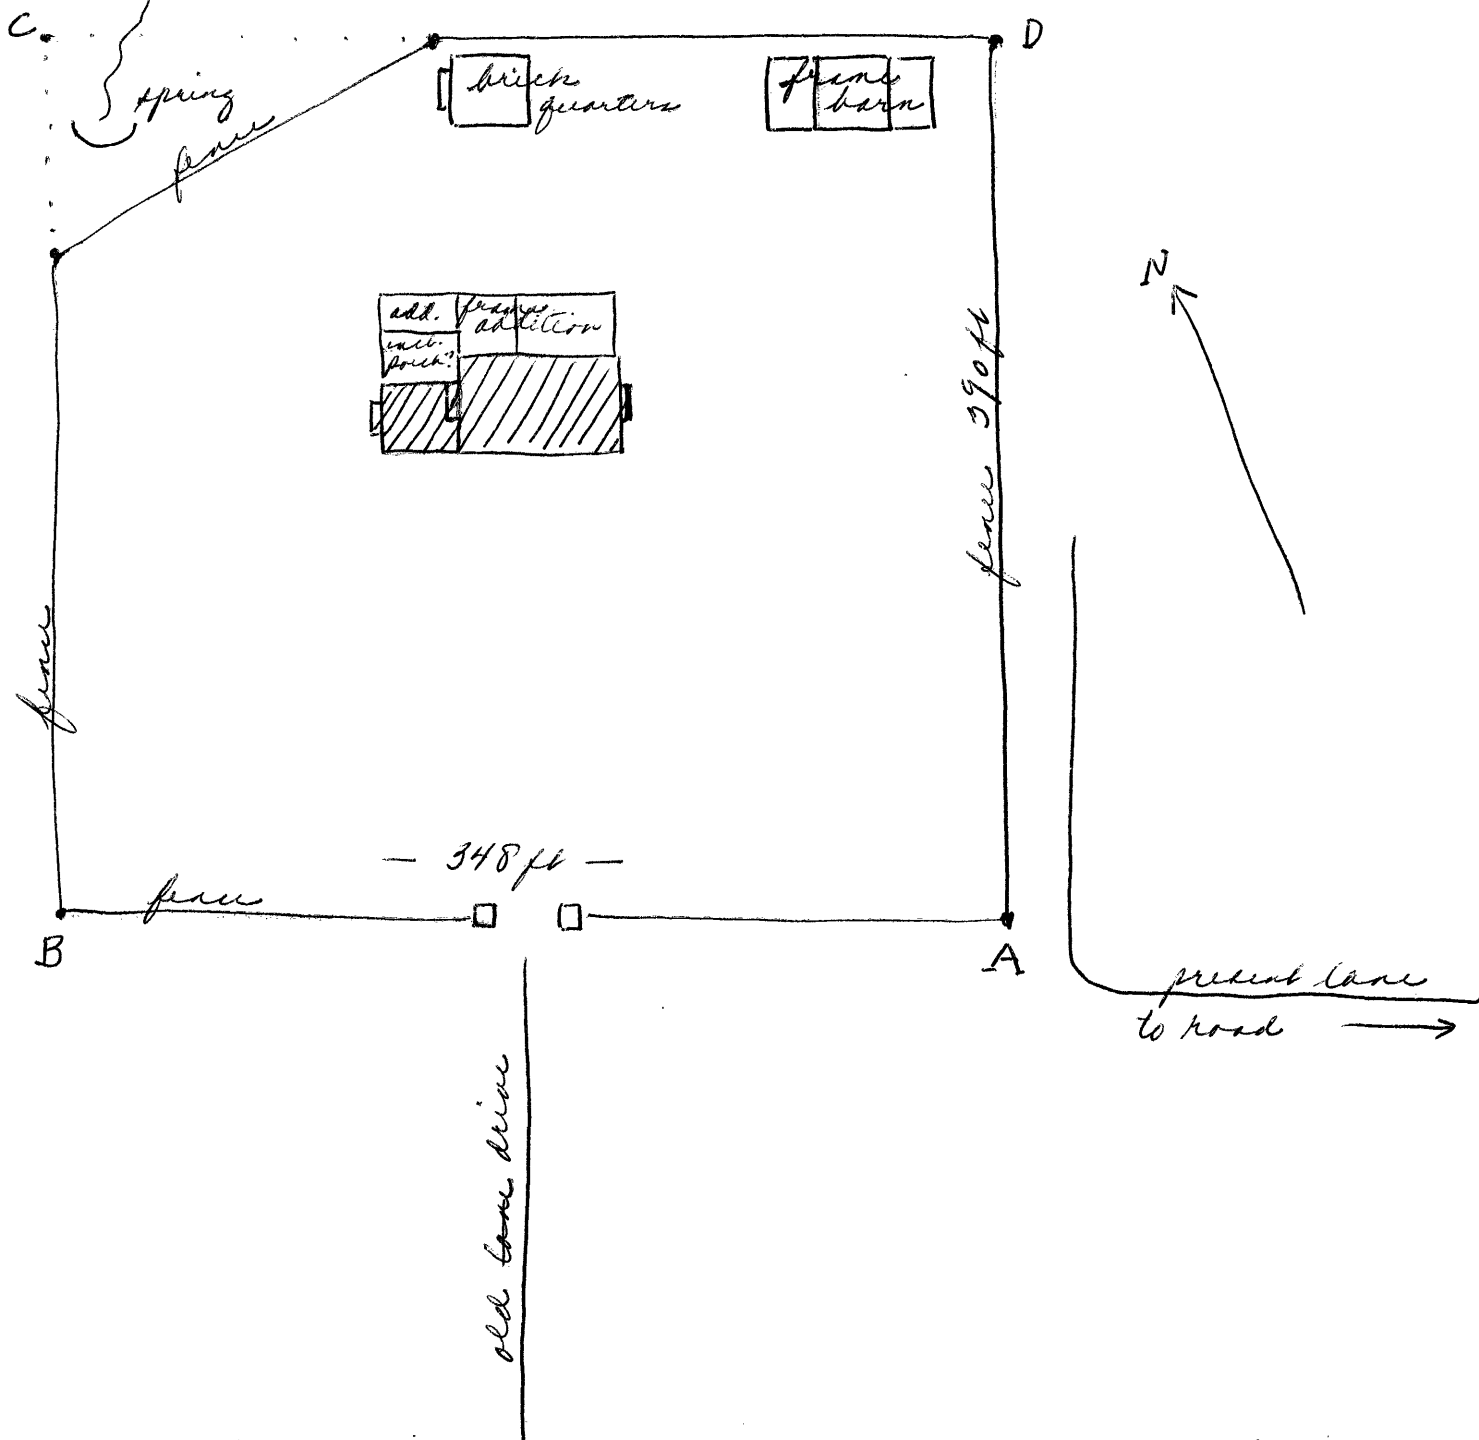
SKETCH MAP OF SITE SHOWING BOUNDARIES AND KEY BUILDINGS AND FEATURES WITH NORTH ARROW.

Beginning at A, at the SE corner of the yard, thence W fence, 348 ft W to B, 390 ft N to C, 348 ft E to D, and 390 ft S to the beginning, going outside the fence in the NW corner to include the spring. Boundary contains stone house, brick quarters, and later barn - about 3 acres.
