**National Register of Historic Places
Registration Form**

historic name Center Township Grade & High School
other names/site number Mays Elementary School 139-391-07024

street & number 929 East South Street N/A not for publication
city or town Mays N/A vicinity
state Indiana code IN county Rush code 139 zip code 46155

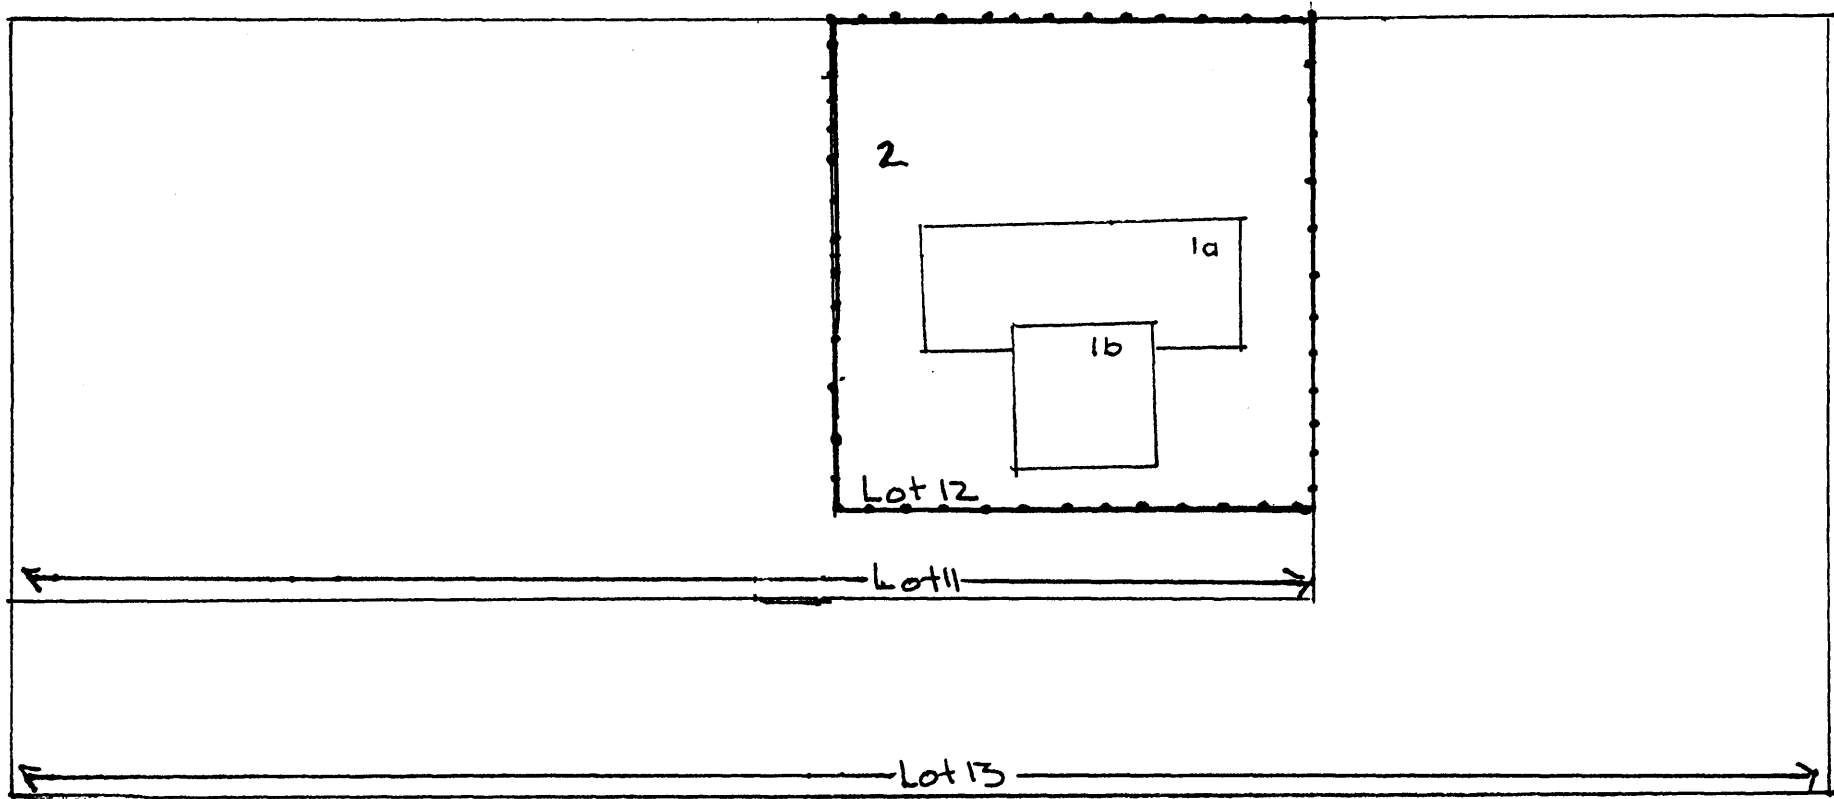
Center Township Grade & High School
 Site Map - Lot 12 Boundary
 30 June 2003

Key
 1a school (c)
 1b gymnasium (c)
 2 totem pole (NC)

Drawing not to scale
 Approximate boundary of
 Lots 12, 11, & 13

(c) = contributing
 (NC) = non-contributing

Site: The school sits on a large grassy lot with a gravel parking lot to the west (photo 2), concrete slabs directly in front of the building on the north elevation and in the southeast corner (between school building and gymnasium) and playground on the east (photo 3). Concrete walks lead from each entrance. A concrete sidewalk edges the building on the north and west elevations, and a long straight concrete walk runs from the center of the building to the road on the north side leads to the gravel passenger drop-off. A large grassy area is to the south (photo 4). Beyond the west gravel parking lot the school owns a ballpark. A contemporary timber edged, gravel and stepping-stone path leads to the flagpole and small flowerbed on the west side of the north elevation. The grade is slightly higher on the south lawn and slopes to the east. The setting for the school is decidedly rural. Bordering the north side of the school building is the residential and business community, farm fields are on east and south sides. Remnants of an old canning factory remain in the view shed to the west. Several large trees stand both north and south of the school, and several young trees have been planted.

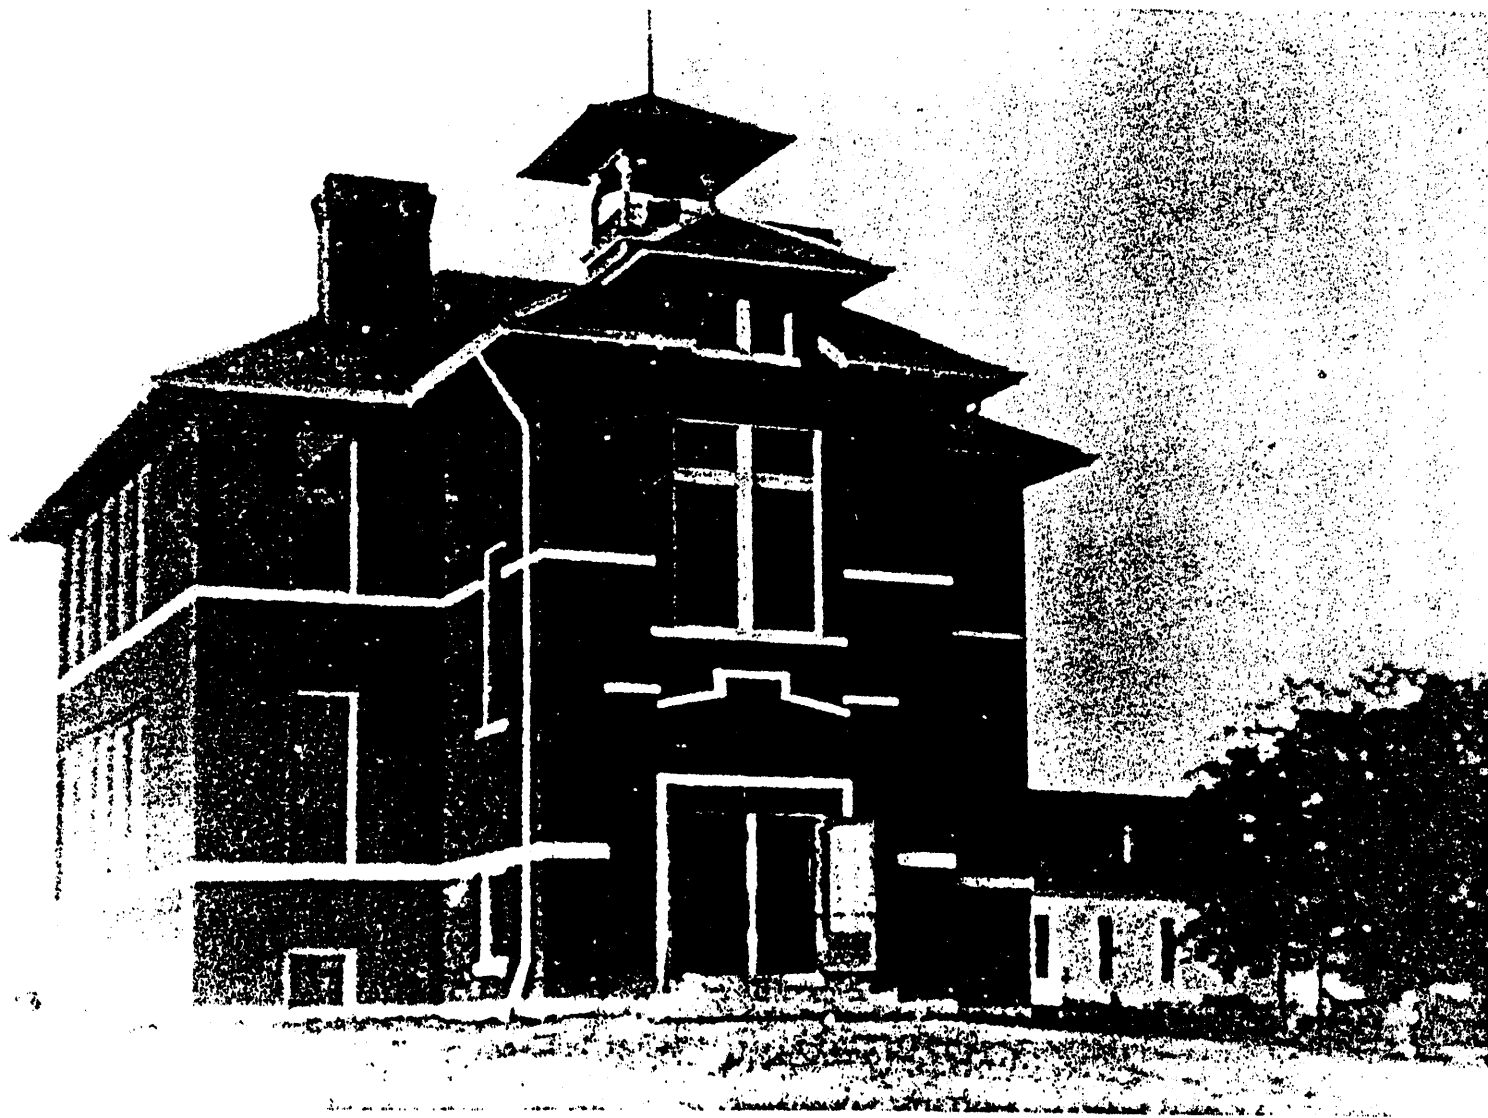
ILL. 2

Center High School 1909

Center Township High School was located west of State Road 3, about one mile west of Mays, Indiana, at the site of school number 5. The 1909 school was a massed brick building with a large projecting central entry and bell tower. (See illustration 2.) Stringcourse detail was present at the sill level of the first and second story windows. The school had two upper stories and a partially underground basement. The single-story frame schoolhouse is visible in the background of a 1909 photograph. Trustee Chester Rhodes directed the construction of the Center Township High School and the demolition of the old one teacher school. The first teacher/principal was Lot Hufferd. The four-year college preparatory course of study at Center High School included algebra, geometry, botany, physics, Latin (three years), English (four years), history and government (three years). Students had no choice of classes, and took four subjects a year. Initially, only grades one through eleven were offered. Students desiring grade twelve attended Spiceland Academy in Henry County or High School in Rushville. The high school was remodeled in 1917 with the installation of chemical toilets and a heating plant. Since the Civil War a territorial conflict raged among residents in Center Township; the conflict extended to the school system. Students in Mays, Indiana, approximately one mile west of Center High School, attended Raleigh High School in Washington Township six miles east of Mays. Raleigh was the result of consolidation of five one-teacher schoolhouses in 1877. County histories claim that Raleigh School was the first graded school in Indiana. (Gary and
