FORM B - BUILDING

Barnstable (Osterville-Main St.)

Original Name Osterville Baptist Church

Osterville Baptist Church OVA18

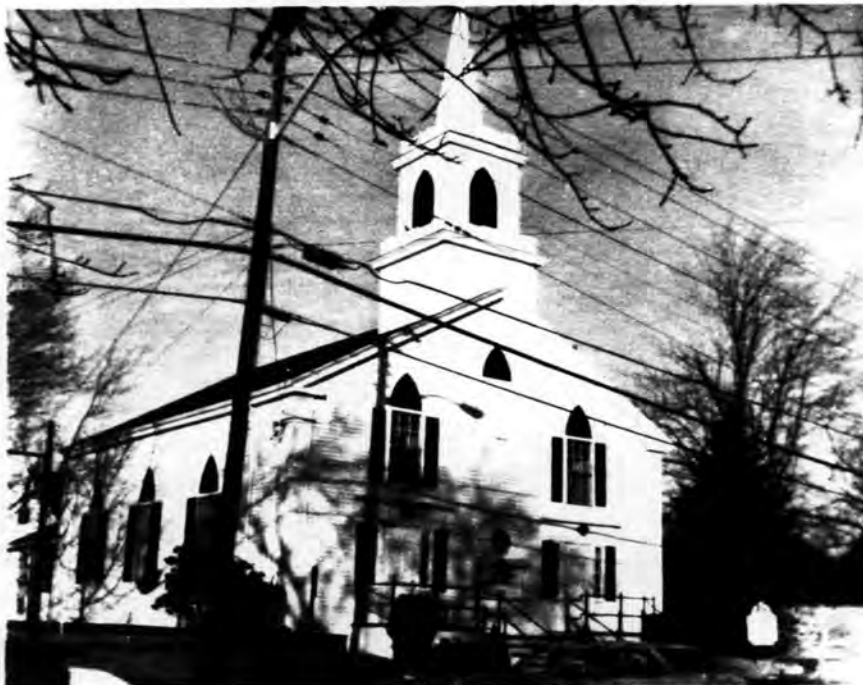
photo #99-28-A18

The Baptist Church is the most prominent remaining historic structure in the center of Osterville, an area which has been largely rebuilt in the second half of the 20th century. It retains the traditional rectangular meetinghouse form, and faces gable end to the street with a belfry and steeple rising above the facade. The facade contains two entries at the first story, two windows at the second and a small triangular window in the gable. The entries are enframed by sidelights and pilasters supporting entablatures. The windows, which contain 6/6 sash, are headed by pointed arches in the Gothic Revival style. The building is articulated by corner pilasters supporting an entablature. Windows on the three bay sides are similar to those of the facade.

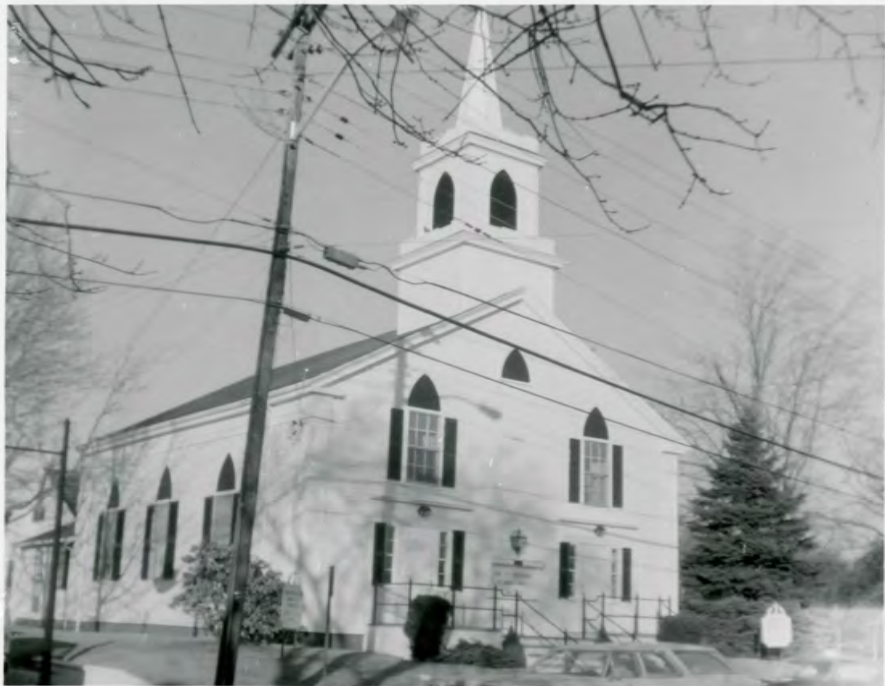
The Baptist Church is the most prominent remaining historic structure in the center of Osterville, an area which has been largely rebuilt in the second half of the 20th century. It retains the traditional rectangular meetinghouse form, and faces gable end to the street with a belfry and steeple rising above the facade. The facade contains two entries at the first story, two windows at the second and a small triangular window in the gable. The entries are enframed by sidelights and pilasters supporting entablatures. The windows, which contain 6/6 sash, are headed by pointed arches in the Gothic Revival style. The building is articulated by corner pilasters supporting an entablature. Windows on the three bay sides are similar to those of the facade.

Facing NE
