National Register of Historic Places Registration Form

Historic name: Bethlehem Baptist Church

City or town: Bethlehem State: NC County: Hertford 091

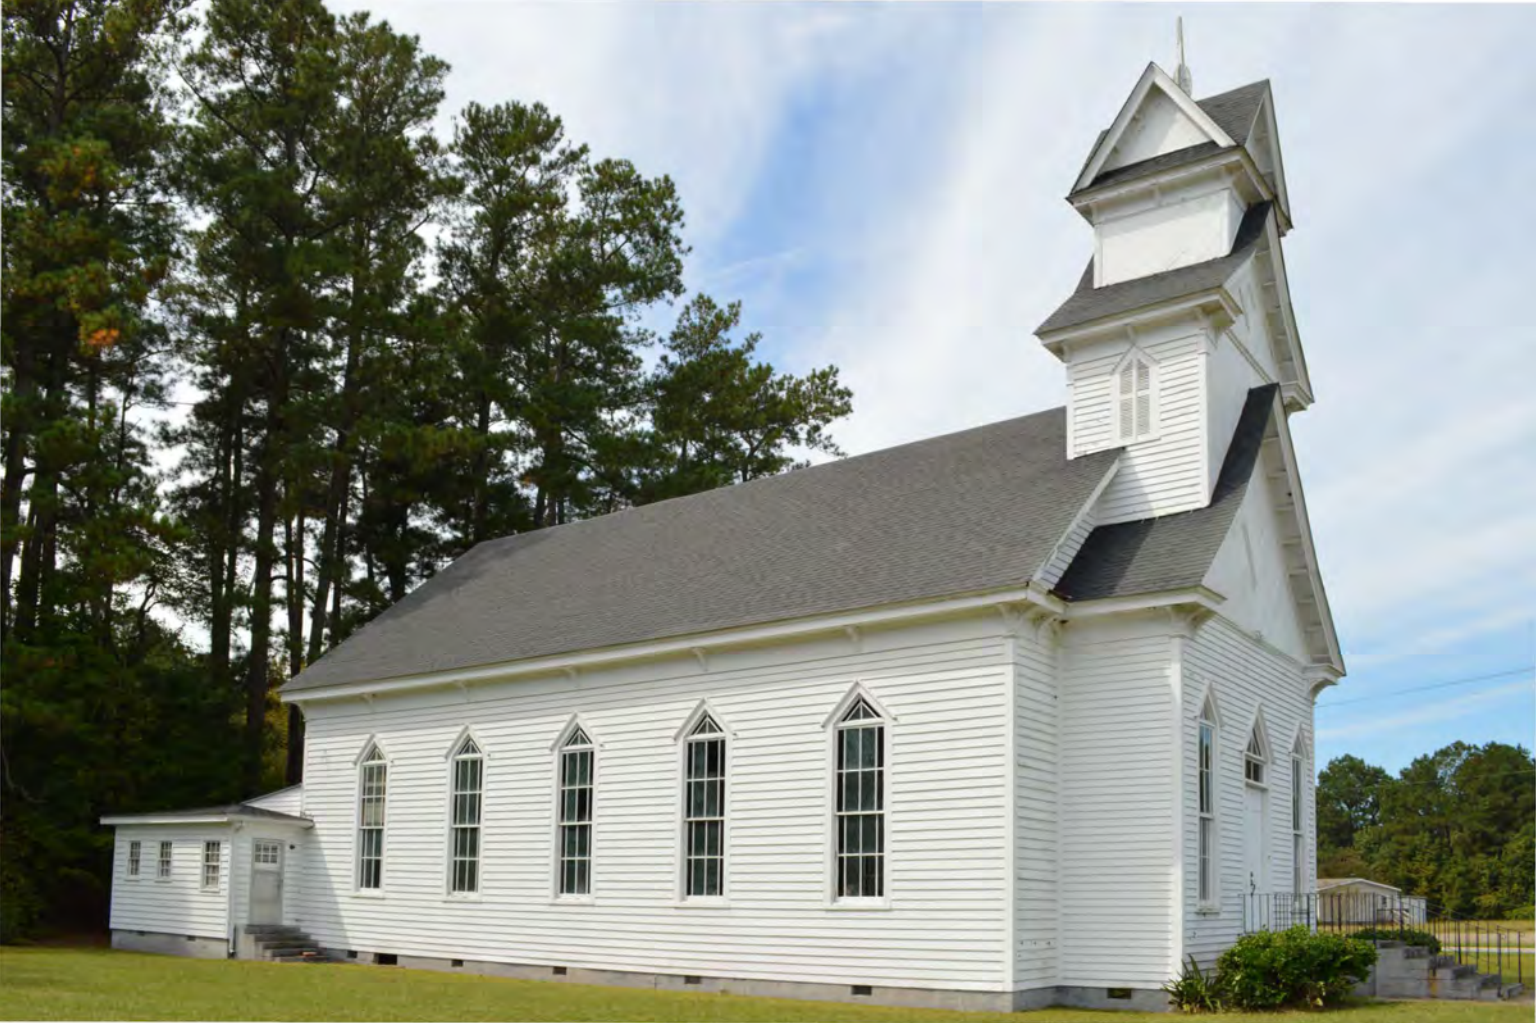
- 1) View of Bethlehem Baptist Church looking southwest.
- 2) View of the vestibule looking west.
- 3) Oblique view of Bethlehem Baptist Church, northeast corner.
- 4) Oblique view of Bethlehem Baptist Church, southeast corner.
- 5) View of west side elevation looking east.
- 6) Interior View of Alter and Sanctuary looking southwest.
- 7) Interior View of Sanctuary looking northeast.
- 8) Interior View of stairhall looking southwest.
- 9) Interior View of easternmost first floor classroom.
- 10) Interior view of hall in addition looking east.
- 11) Interior view of second floor stair looking east.
- 12) Interior view of easternmost second floor classroom.

Bethlehem Baptist Church is a gable-front, wood-frame church building that stands one-tall story capped by a two-tier steeple. The symmetrical gable-front façade has a central, projecting three-bay entrance vestibule composed of a central double-leaf door surmounted by two-light transom and triangular pointed-arch. The wooden entry doors each feature six panels: small at the top, large in the middle, and medium sized at the bottom. Tall and narrow windows, with similar triangle-arched windows with molded surrounds to match, flank the entrance. Each window is composed of two, four-light sashes of frosted glass surrounded by narrow strips of clear glass and capped by two triangular-shaped panes framed by strips of color glass. Plain weatherboard sheaths the first floor of the façade of the projecting portion. The gable is marked by corner posts and gable returns supported by a pair of decorative brackets on each side of the façade, marking a change in the façade sheathing from weatherboard to a v-shaped pattern of beadboard. An elongated diamond-shaped motif covers the original diamond-shaped window opening and is centered in the gable. This change was made at an unknown date. Gentle flares of the roof on the vestibule portion, add flourish to the architectural charm of the building. The main body of the church is sheathed with weatherboard and serves as the backdrop to the projecting entrance vestibule. The vestibule is blind on both side elevations. A concrete block foundation supports the church and an asphalt shingle roof protects it.
