KENTUCKY HISTORIC RESOURCES INVENTORY

Site No. Bb-187

1. Historic Name(s) <u>Sandusky house</u>		22. ADD/County <u>Bluegrass / Bourbon</u>	
Original Owner <u>Jacob or James Sandusky (or Sandoustky)</u>		23. U.S.G.S. Quadrant (15'/75') <u>Carlisle vic</u>

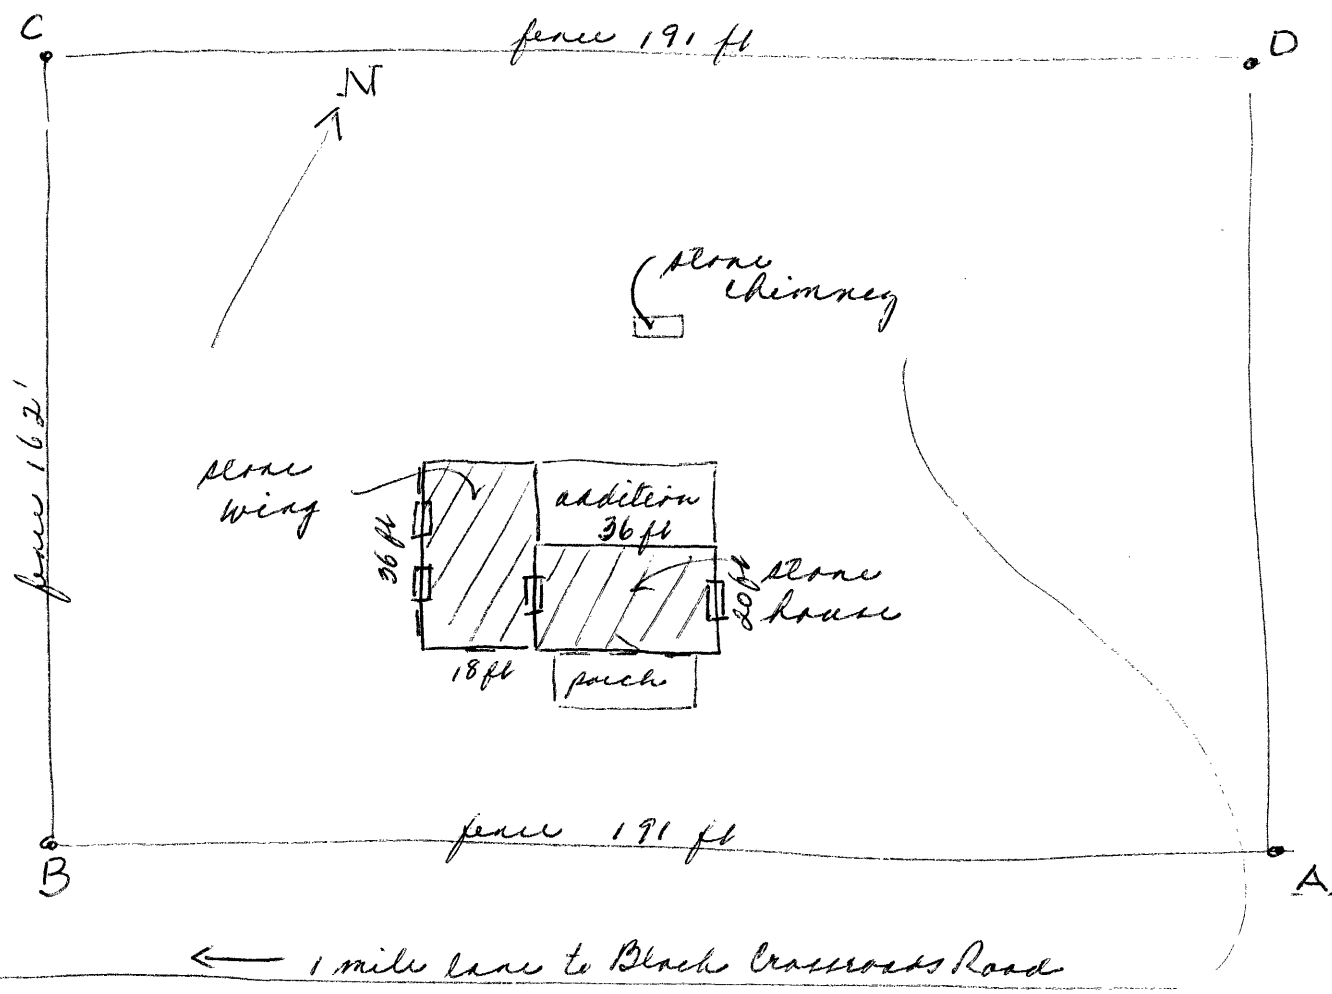
SKETCH MAP OF SITE SHOWING BOUNDARIES AND KEY BUILDINGS AND FEATURES WITH NORTH ARROW.

Beginning at A at the corner of the yard at the gate, there is
with fence around yard W 191 ft, N 162 ft, E 191 ft and
S 162 ft to the beginning containing the stone house and stone
chimney, about 2/3 acre. Outbuildings are recent.

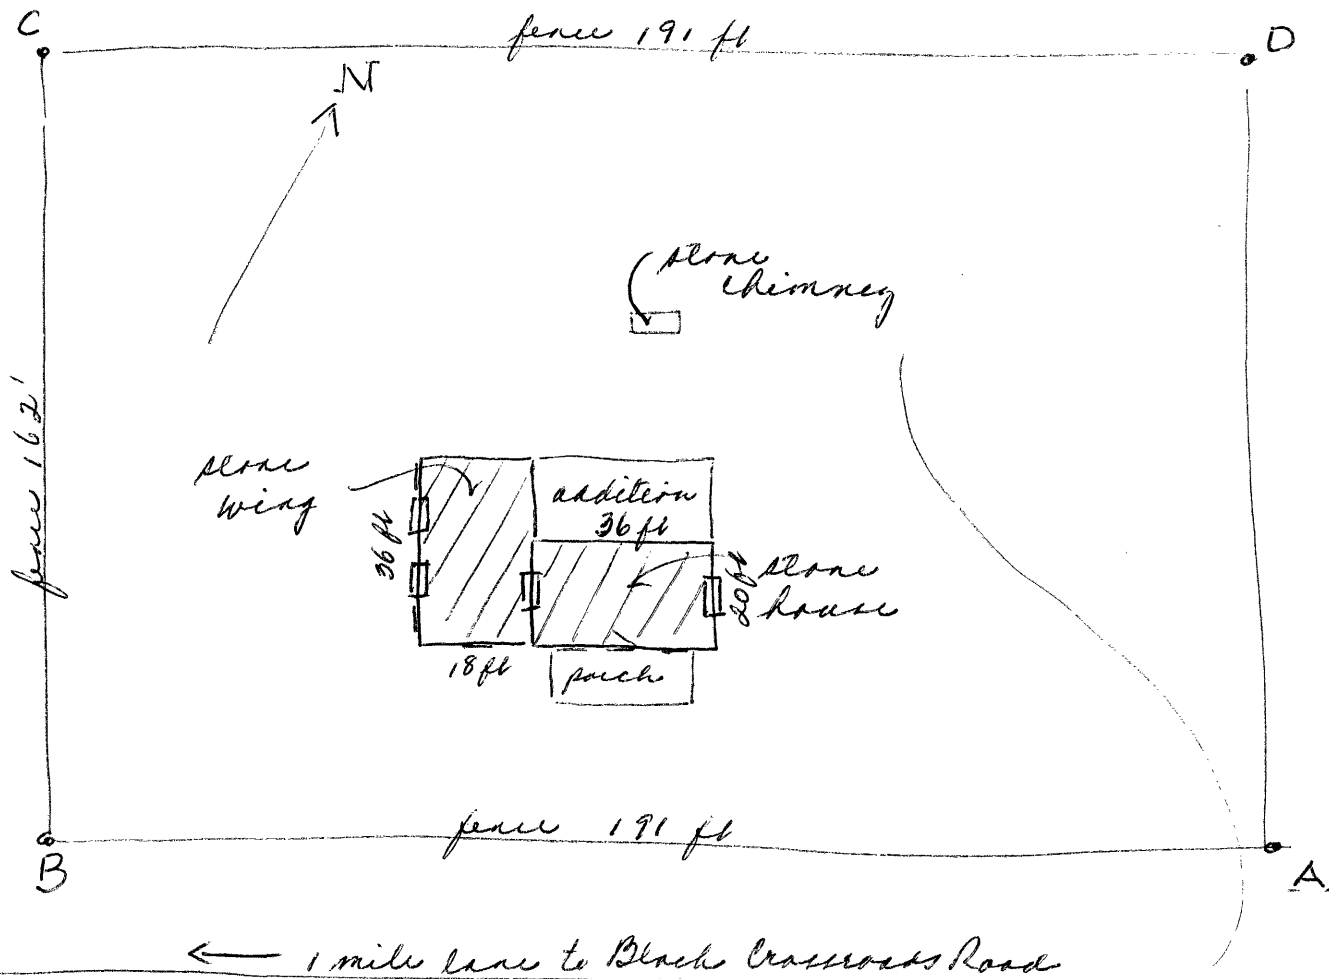
SKETCH MAP OF SITE SHOWING BOUNDARIES AND KEY BUILDINGS AND FEATURES WITH NORTH ARROW.

Beginning at A at the corner of the yard at the gate, there is
with fence around yard W 191 ft, N 162 ft, E 191 ft and
S 162 ft to the beginning containing the stone house and stone
chimney, about 2/3 acre. Outbuildings are recent.
