National Register of Historic Places Registration Form

Historic name Young, John Quincy Adams and Elizabeth, House

street & number 12050 NW Cornell Road

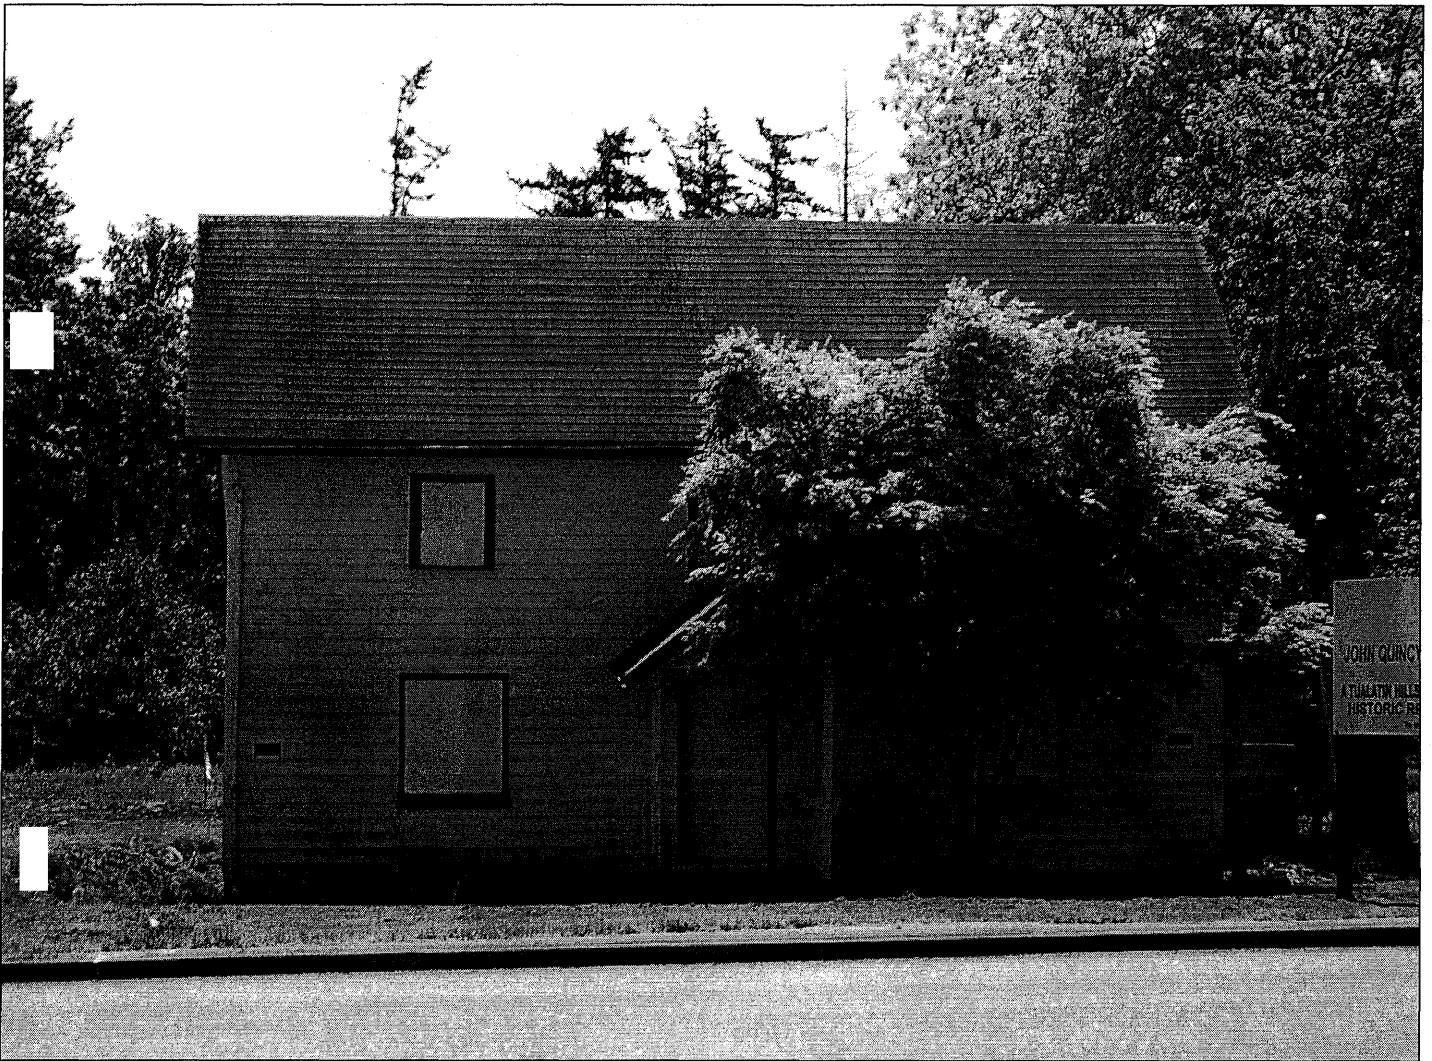
Photo 1 of 22. North (front) elevation from NW Cornell Road.

Fenestration on the front (north) elevation is symmetrical and consists of a centrally-placed front door (the original door is missing) flanked by a set of double-hung windows. (Photos 1 and 2) At the attic level of this elevation are three smaller four-pane wood sash windows – equally spaced and corresponding in placement to the lower level openings. The entrance is marked by a non-historic narrow gabled porch with 4' x 4' supports, a concrete slab floor and open side rails of modern lumber. The circa-1888 photograph shows a full-width, shed-roofed front porch supported by either narrow paired posts or sawn supports. (Figure 14) The only evidence of this porch that remains visible today is a notch in the remaining original northeast cornerboard at the height of the porch roof.

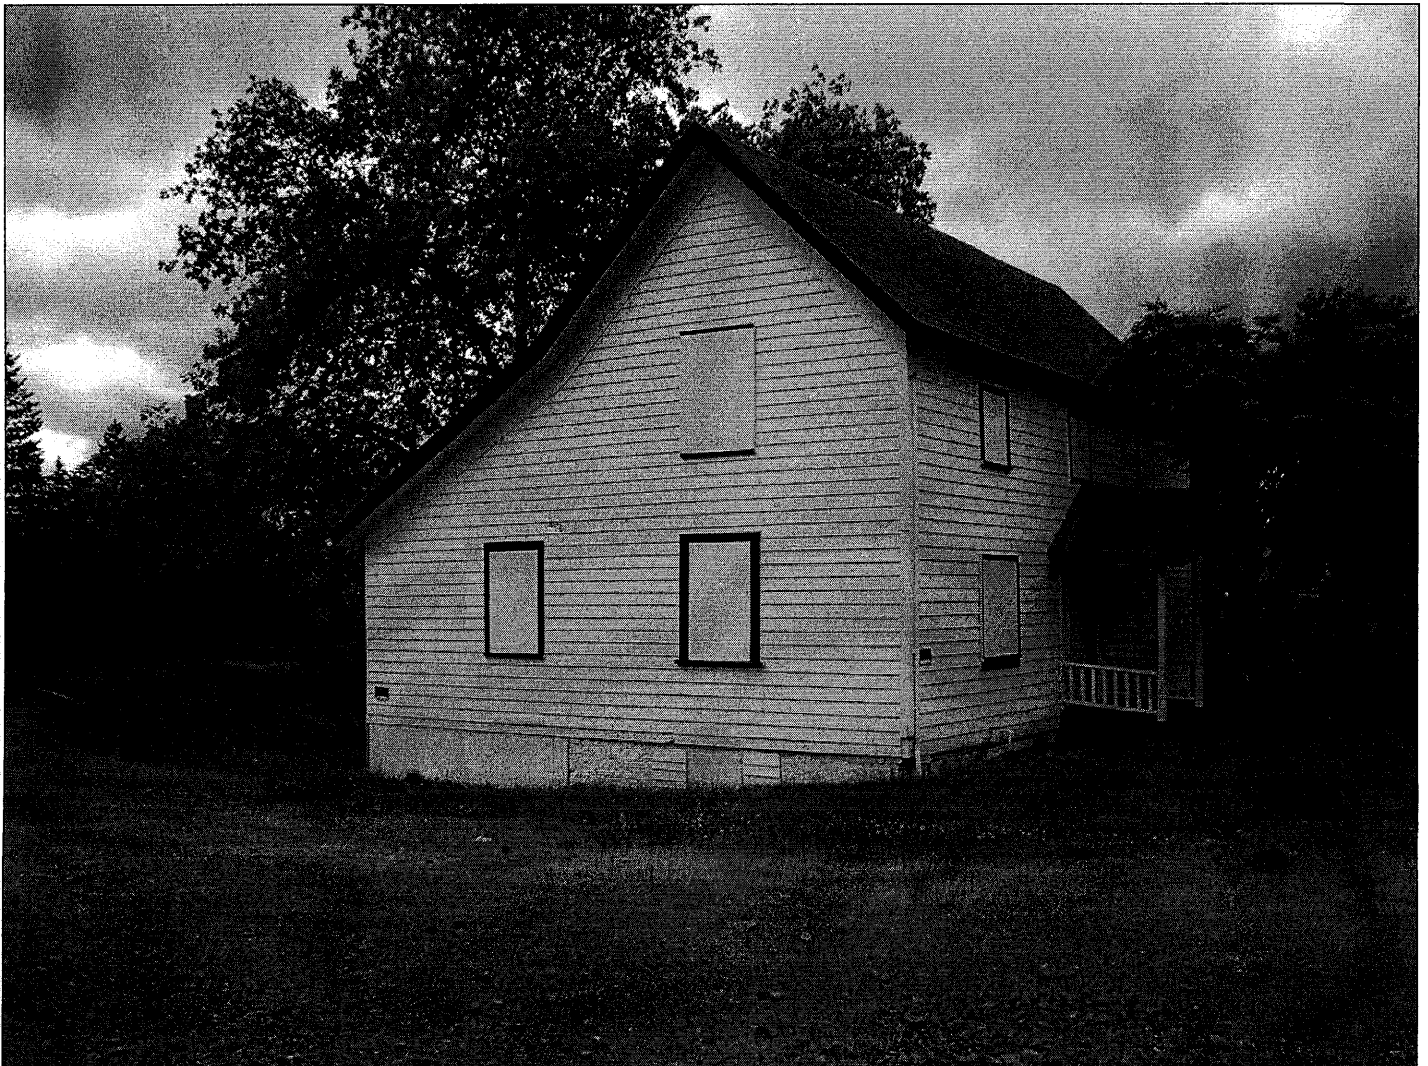
Photo 2 of 22. View of northeast corner, looking southwest.

The current land configuration is such that the front (north) elevation sits at grade, and the rear (south) elevation is approximately 4' above grade, exposing the foundation wall along the east and south. An early photograph of the house, dated circa 1888, shows the house situated on the west bank of a creekbed or slough, resulting in the partial exposure of the north (front) foundation wall, and full exposure on the east side.² This topographic feature has recently been partially obliterated by fill (in the area of the house) that buries north foundation wall, and encroaches significantly on the eastern side, though this eastern wall is still almost completely visible. (Photos 2-4)

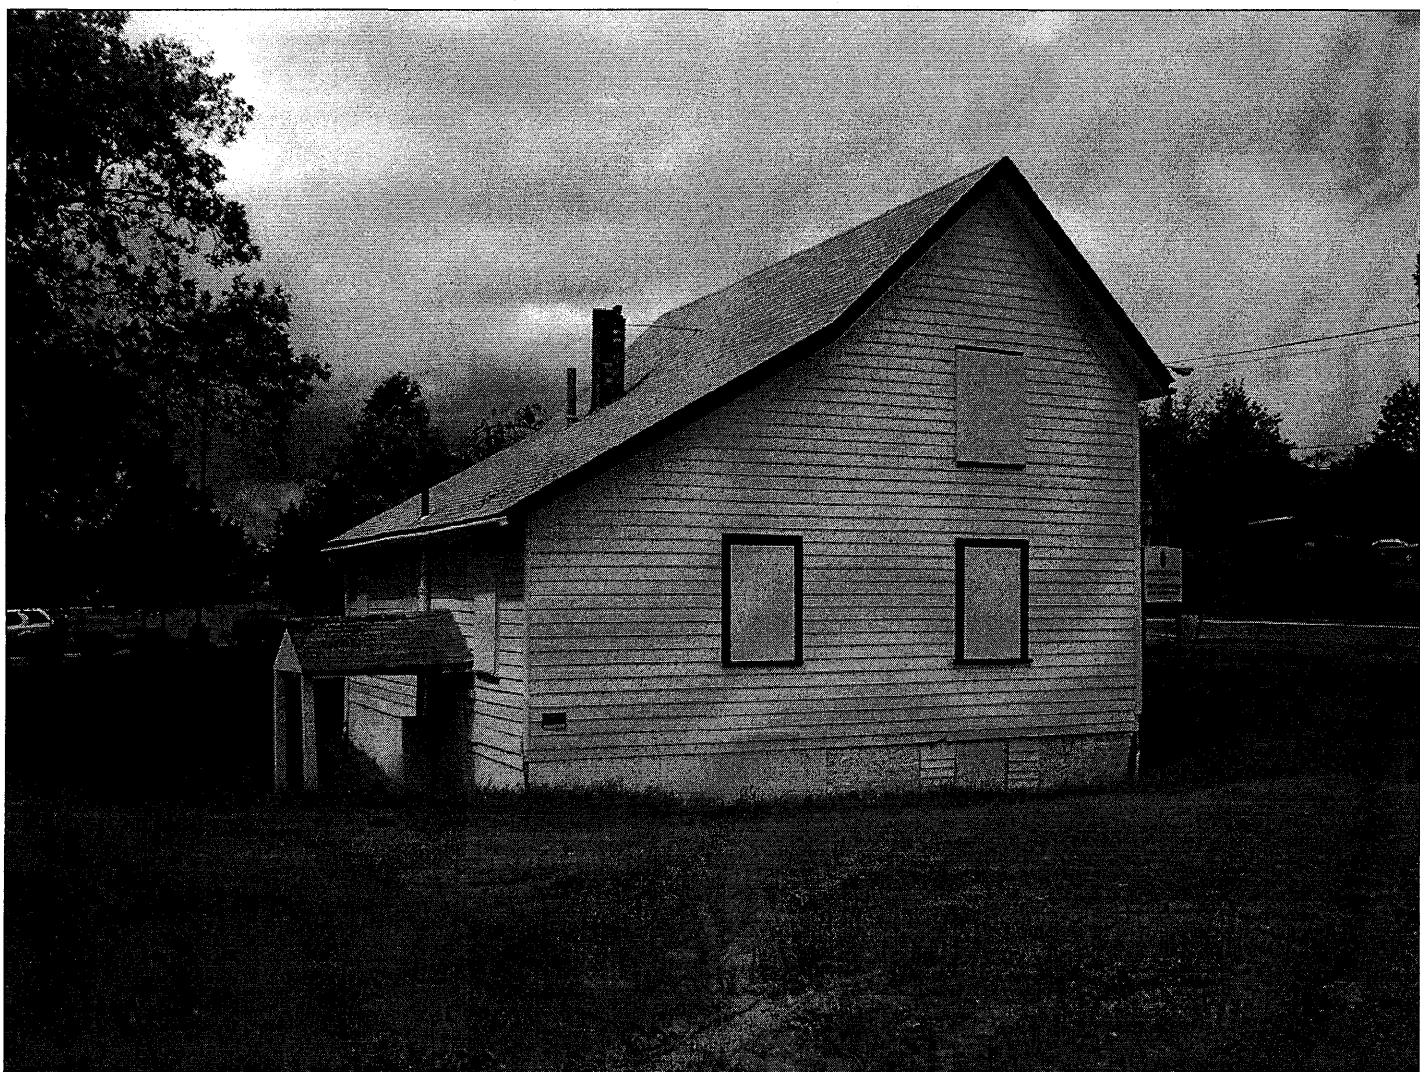
Photo 3 of 22. East elevation, looking west/northwest.

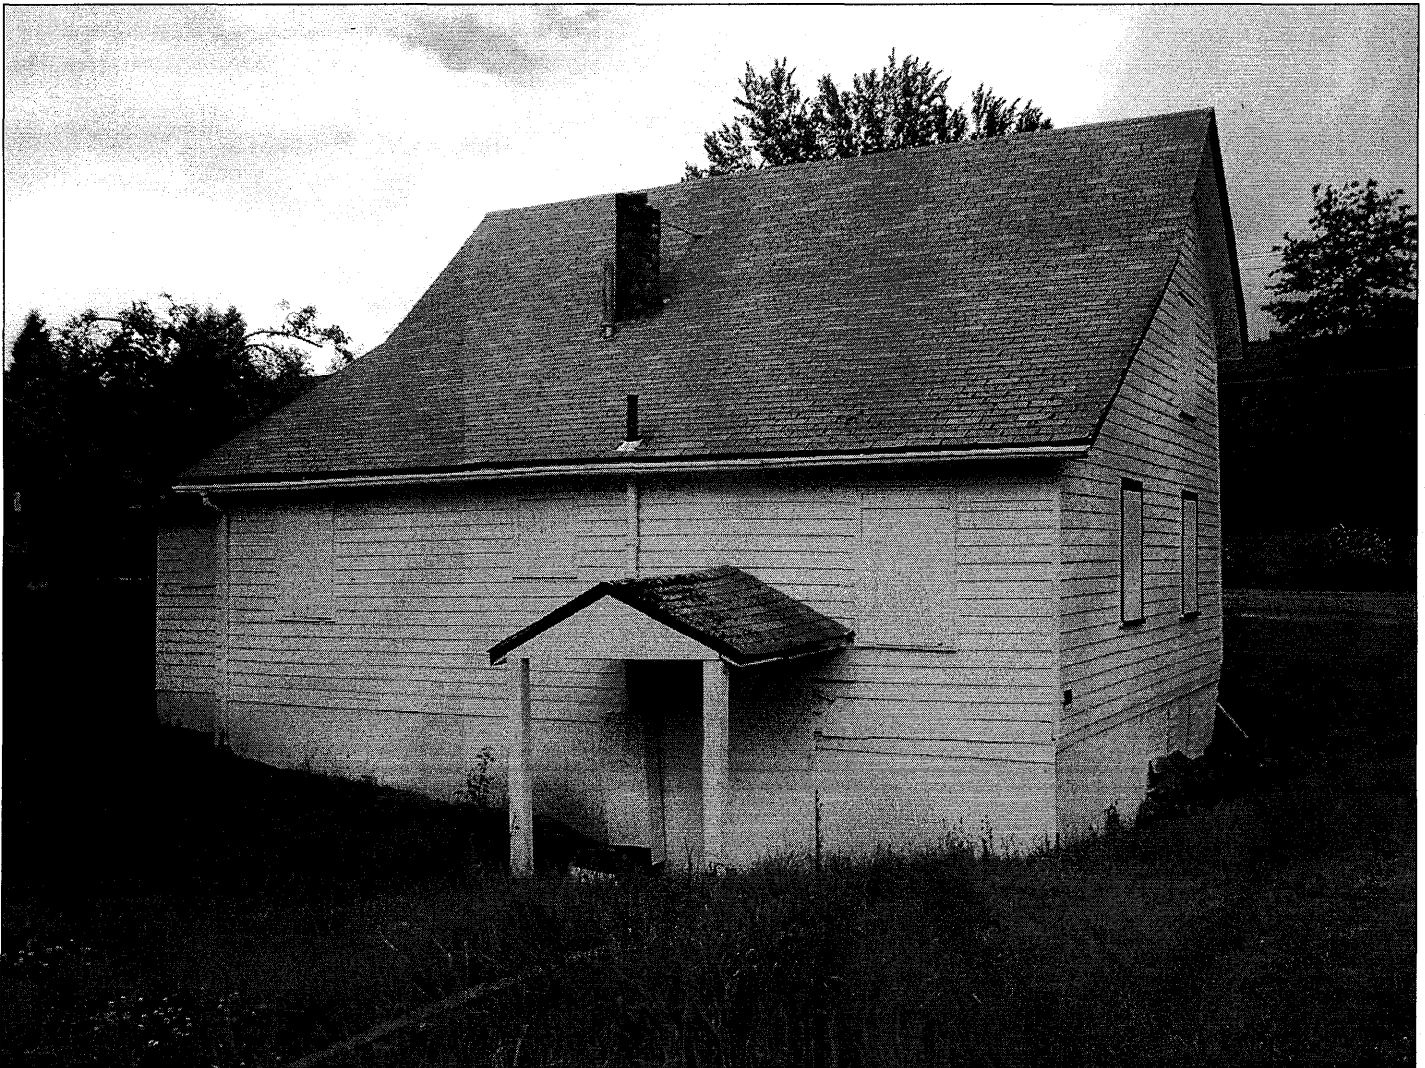
Photo 4 of 22. South (rear) elevation. Note dip in topography and recent fill at right of photograph.

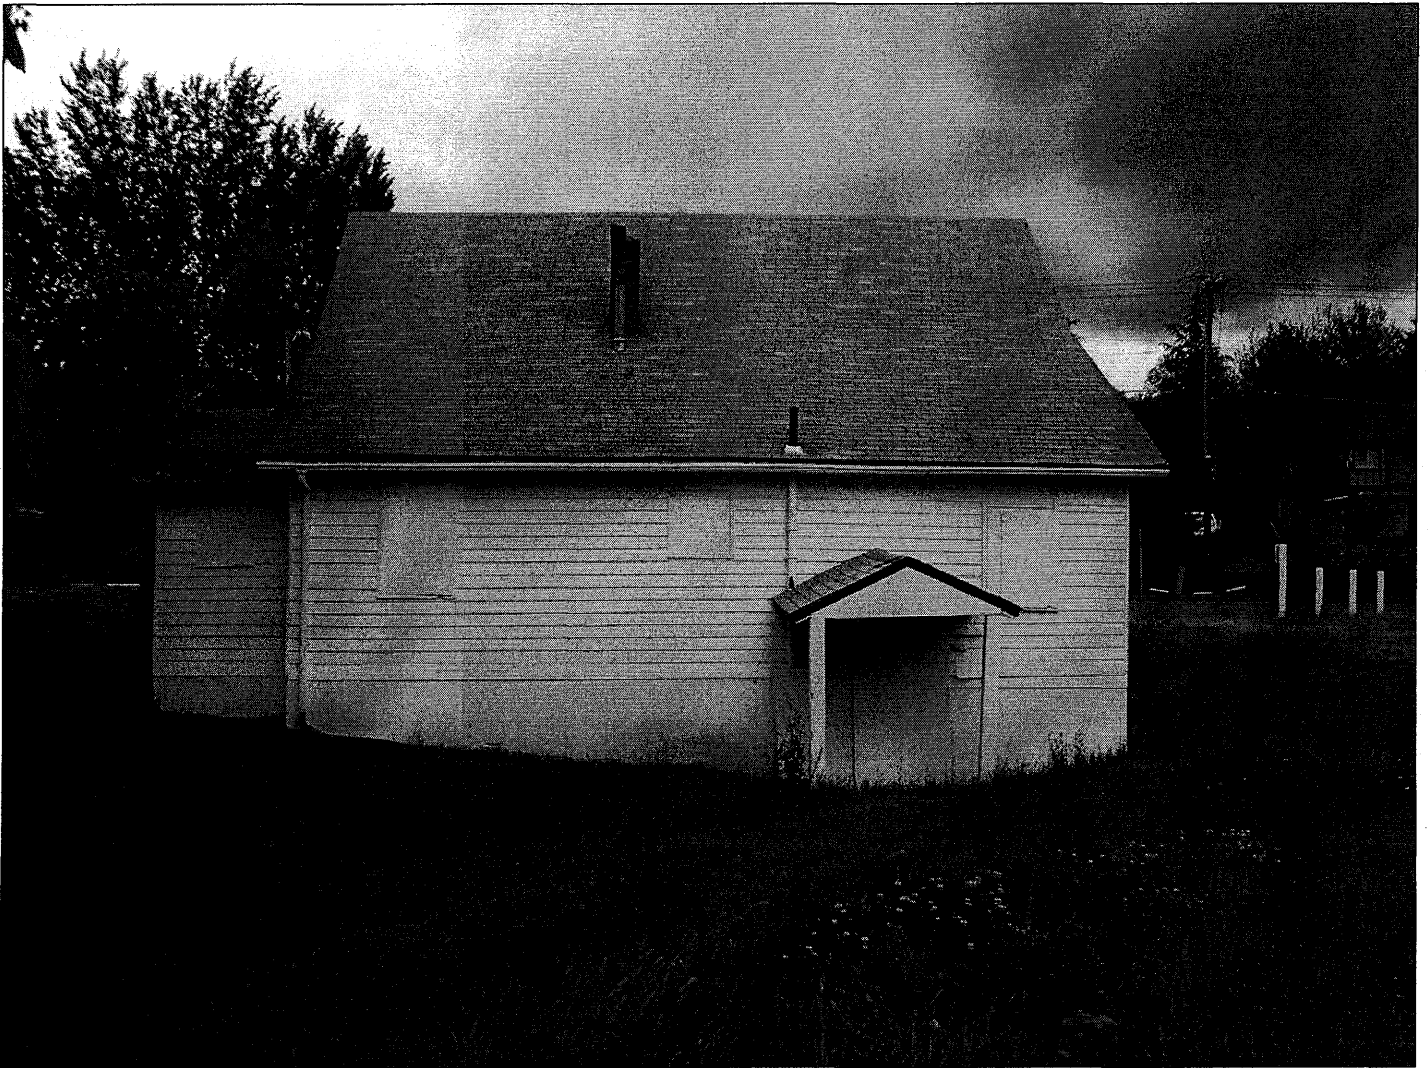
Photo 5 of 22. South (rear) elevation.

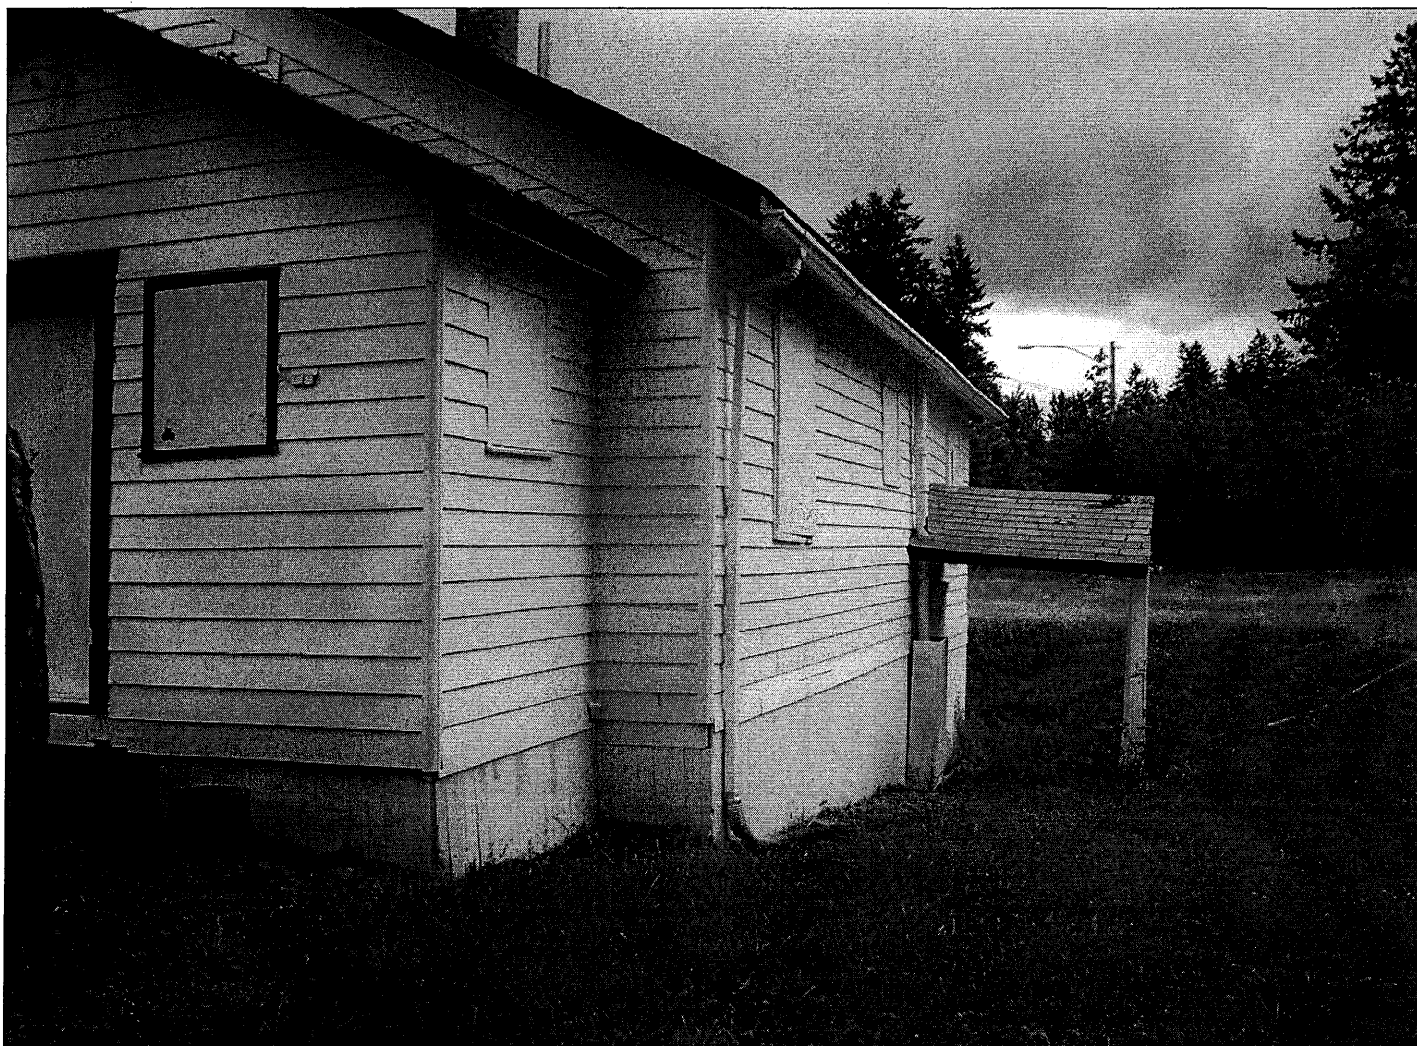
Photo 6 of 22. View of southwest corner. Kitchen porch/entrance addition to left.

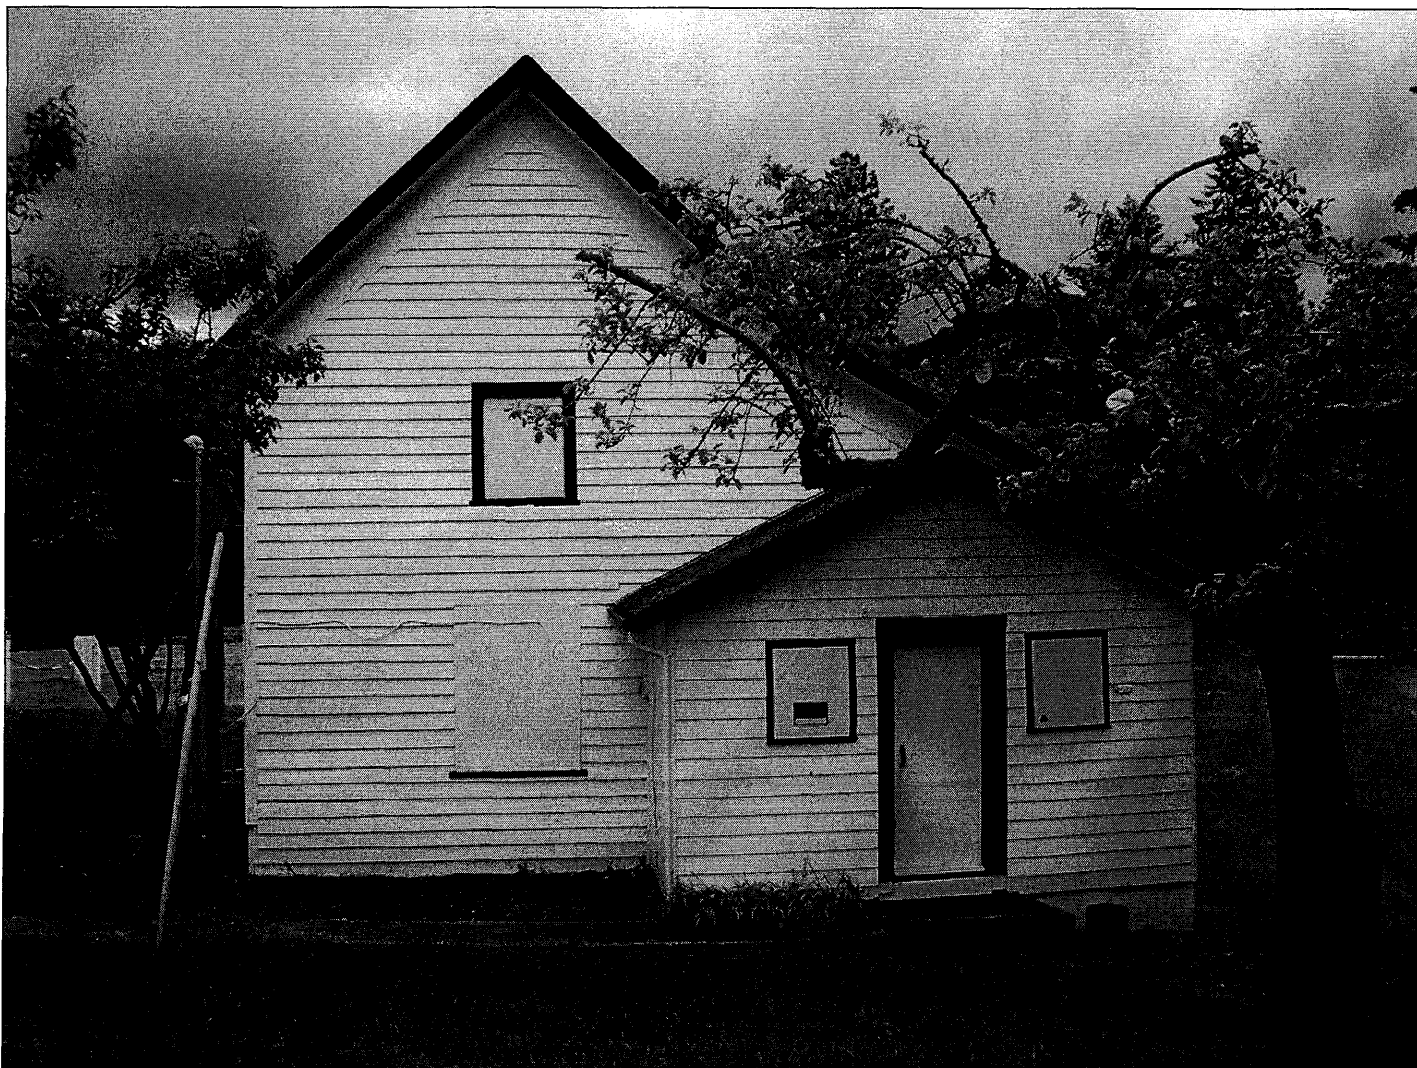
Photo 7 of 22. West side elevation with one of two early fruit trees at right.

The east and west gable-end elevations display two openings on the lower level, and one in the gable end. (Photos 3 and 7) All openings are double-hung sash configurations except the west elevation upper four-paned casement sash window, and the west elevation door into the kitchen. The west elevation has been altered by a small low-pitched gable addition – essentially an enclosed porch – that was added sometime after the application of the droplap siding.

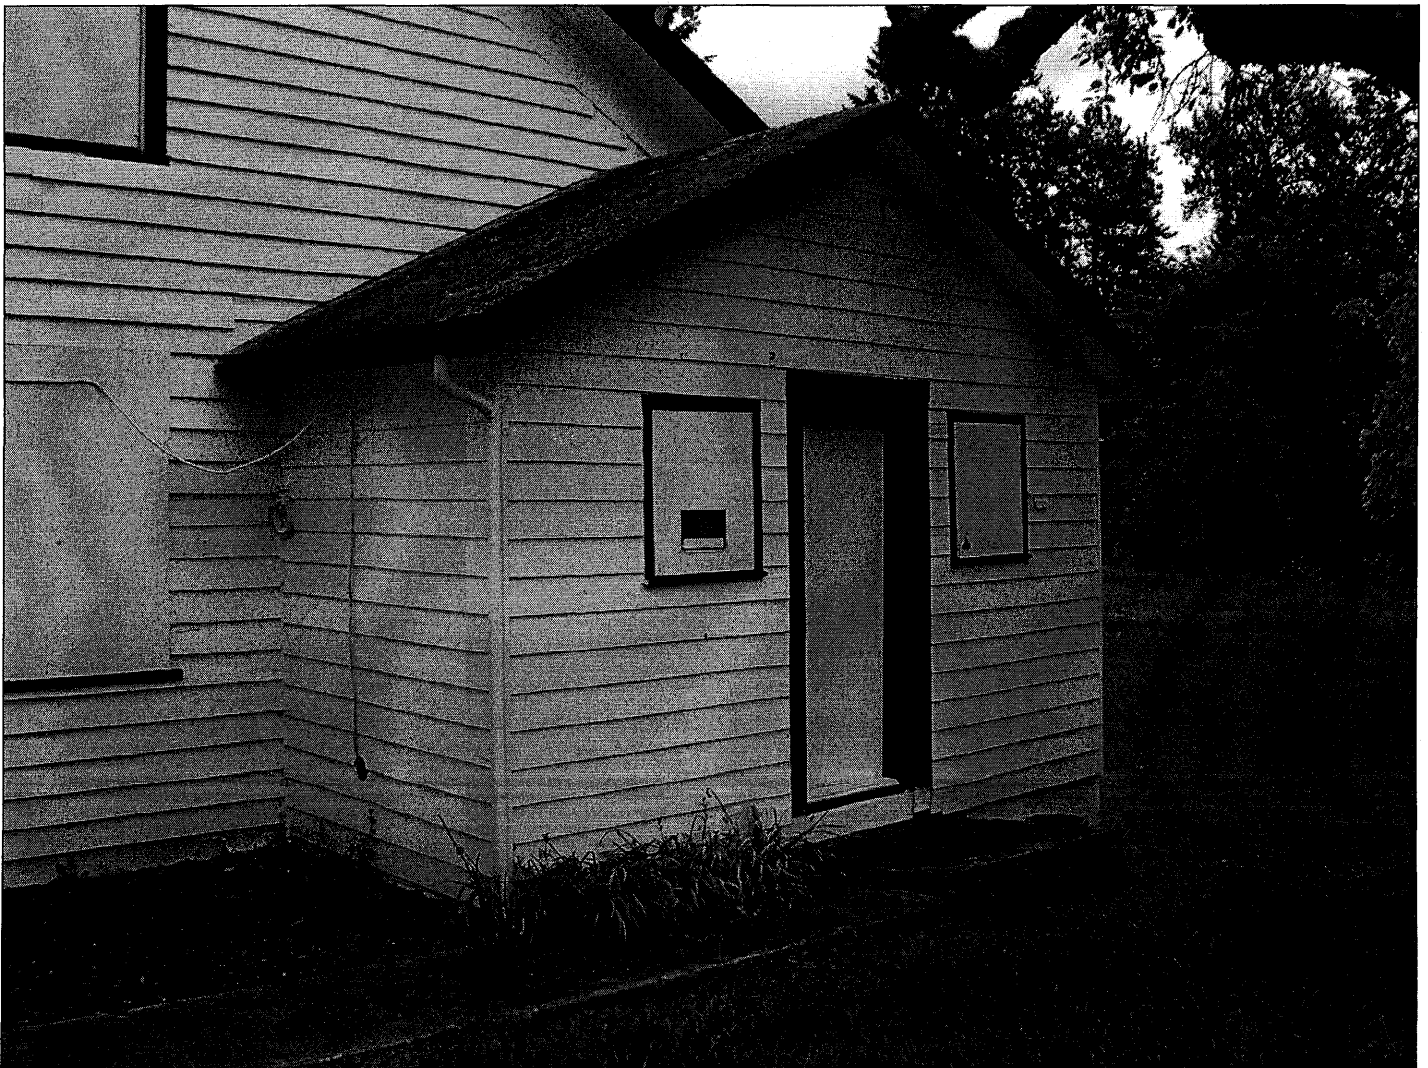
Photo 8 of 22. Kitchen porch/entrance addition.

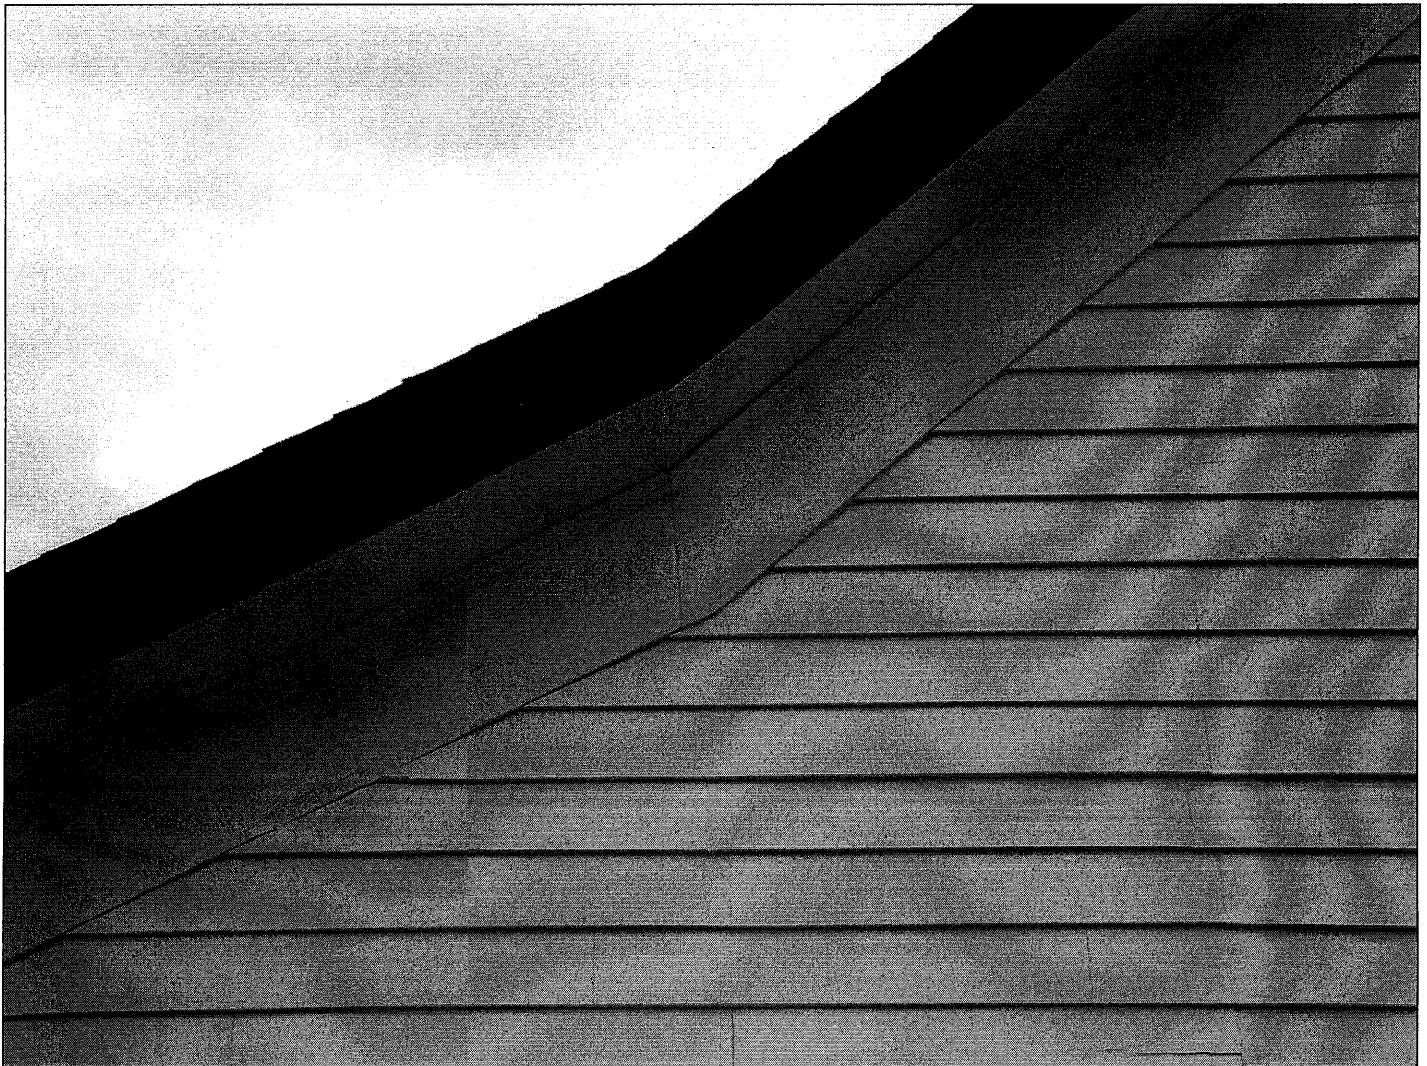
Photo 9 of 22. Eave, frieze and siding detail.

The moderate double-pitched side-gable roof is built with sawn 2"x4" rafters and a central ridge beam. The skip sheathing consists of waney-edged sawn boards, and the roof is clad in newer asphalt composition shingles. The red brick stove chimney rises from the southern roof slope. The exposed portion of the chimney is deteriorated, with the top several courses of brick and mortar missing. A wide frieze board wraps the east, north and west sides of the house, and the shallow eaves are boxed with a modest curved bed molding. The frieze on the south (rear) elevation has been removed.

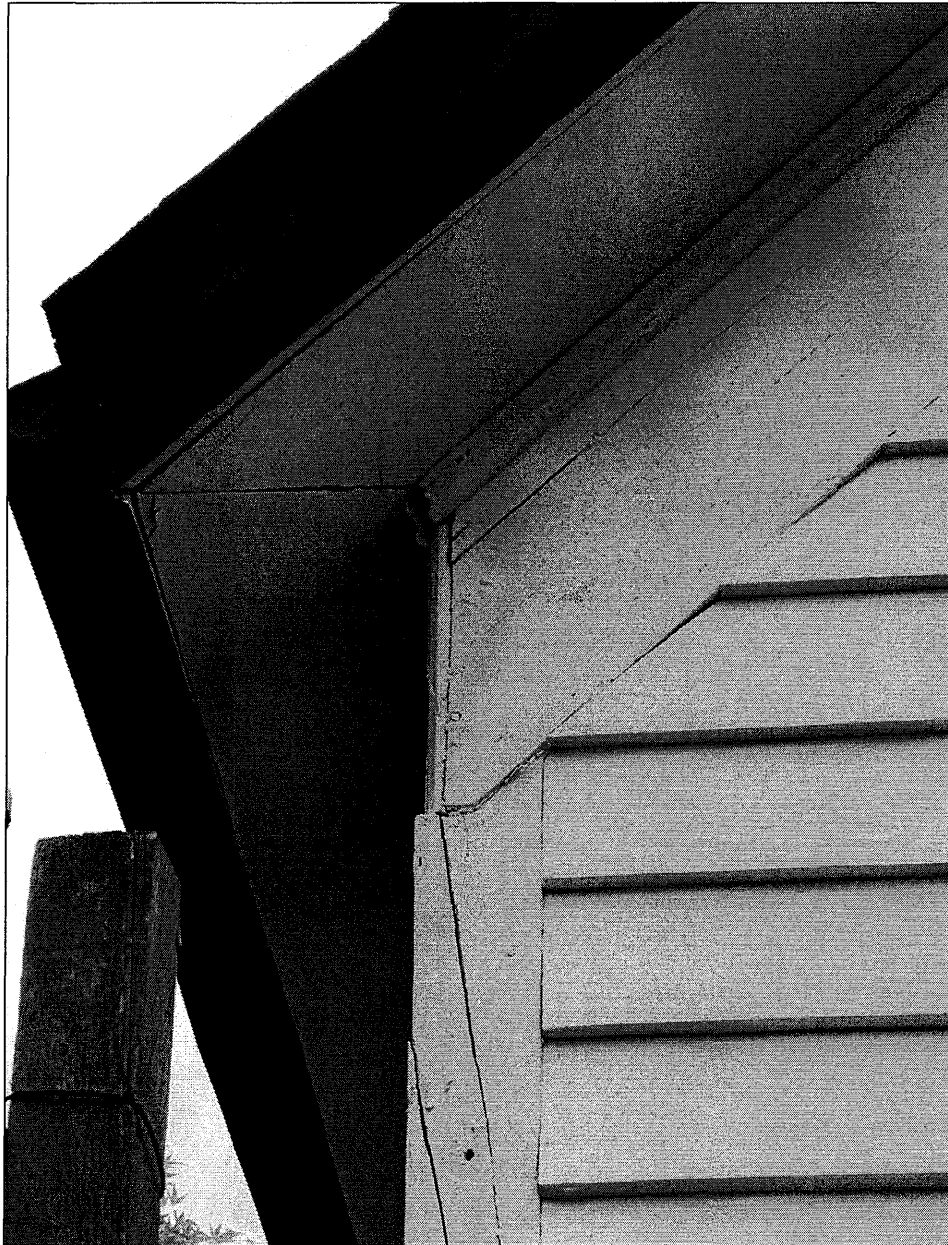
Photo 10 of 22. Eave and cornerboard detail.

that appear to be original. (Photo 10) Cornerboards at the southeast and southwest corners have been replaced with curved corner boards that physically wrap the corners, and appear to be of circa 1940s vintage.

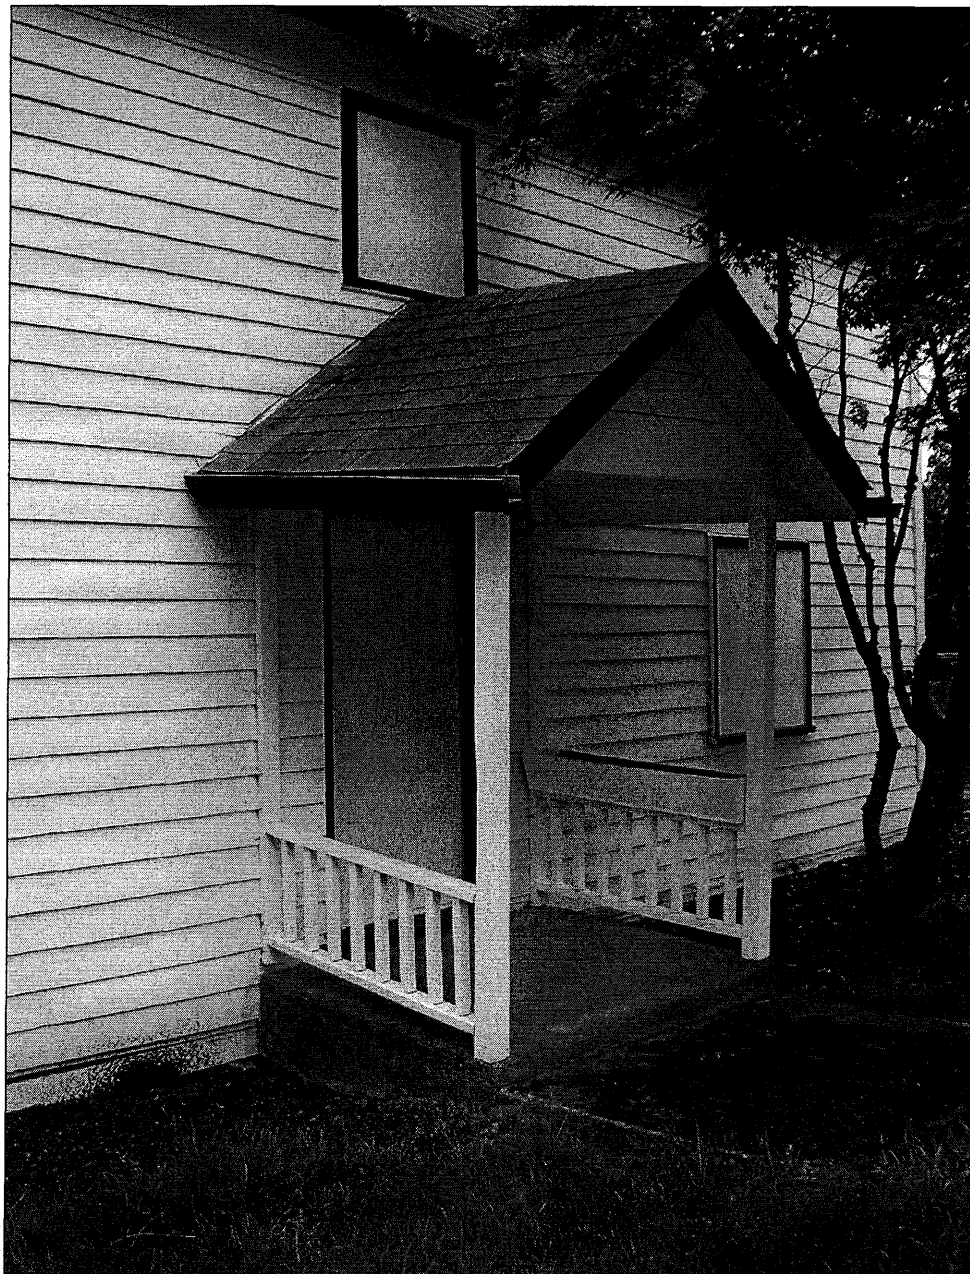
Photo 11 of 22. Front porch detail.

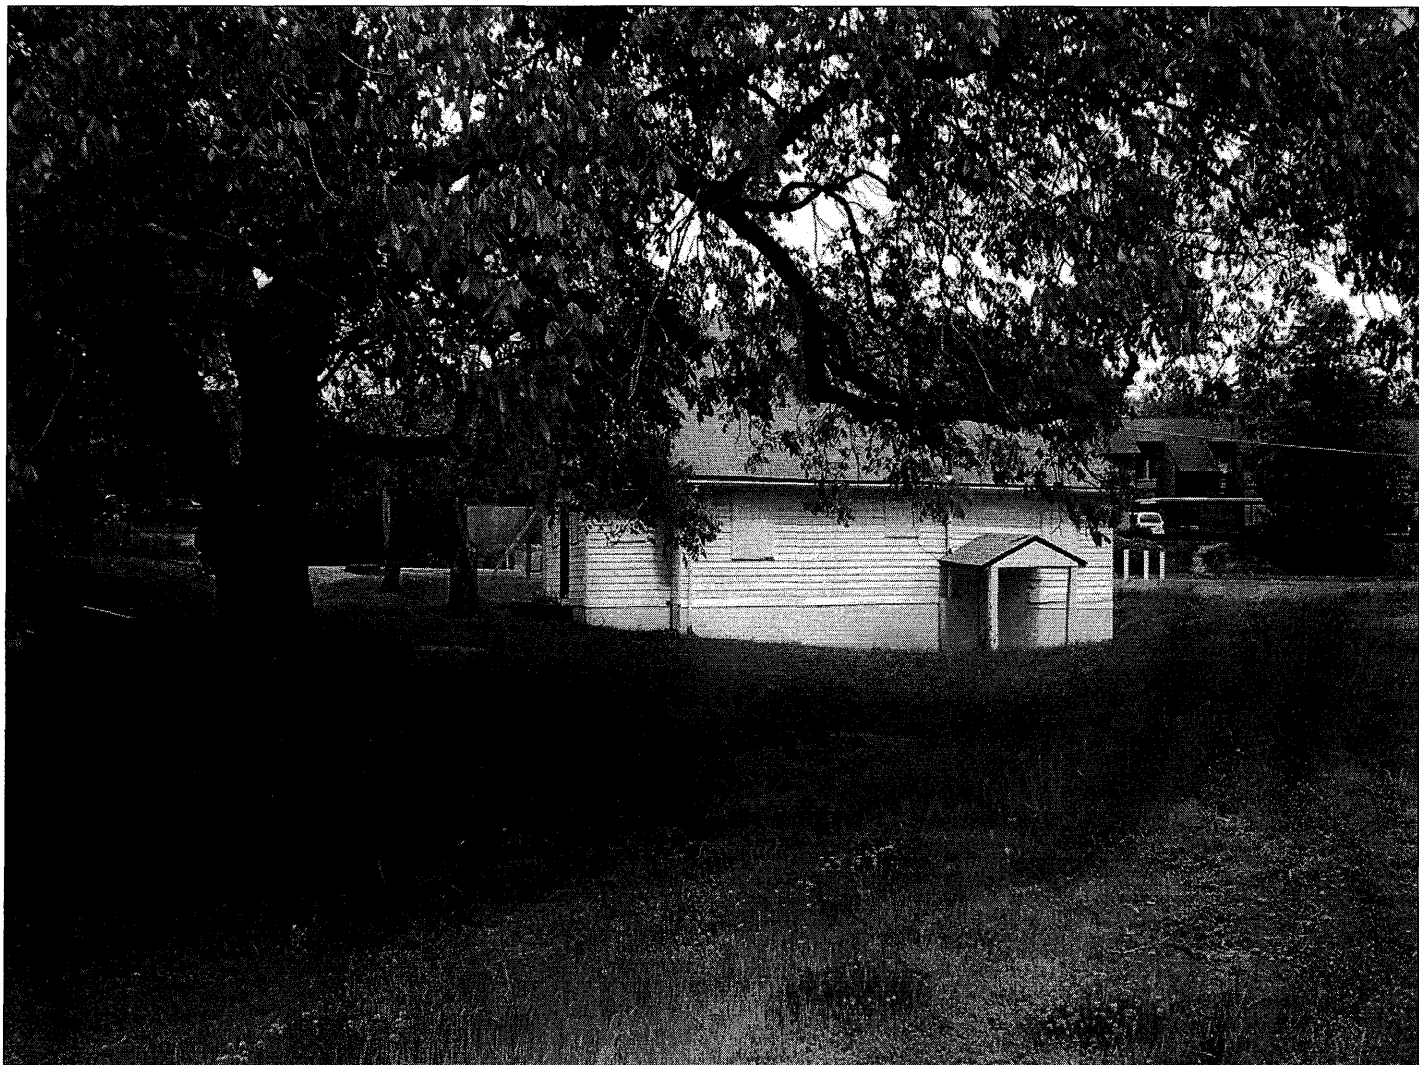
Photo 12 of 22. South (rear) of house looking north toward NW Cornell Road.
Hickory tree and two fruit trees to left of house.

It may be supposed that this house was once set in a quasi-industrial landscape given the close proximity to the sawmill; the historic photograph from the 1880s suggests little, if any, decorative plantings around the house. (Figure 14) After the turn of the century it appears the landscape changed to one more agrarian in nature, with foundation plantings and orchard trees. (Figure 5) By the mid-20th century the yard appears to have been nicely landscaped with a fenced front yard with a paved sidewalk and water pump, foundation plantings, flowering trees and shrubs and a small orchard to the west, landscaping the yard and surrounds today is minimal. (Figure 17) One non-historic ornamental tree of unknown type is growing near the foundation in the front yard. Two old pear and apple trees to the west, and a large hickory tree at the rear are all that remain of the historic plantings. (Photo 12)

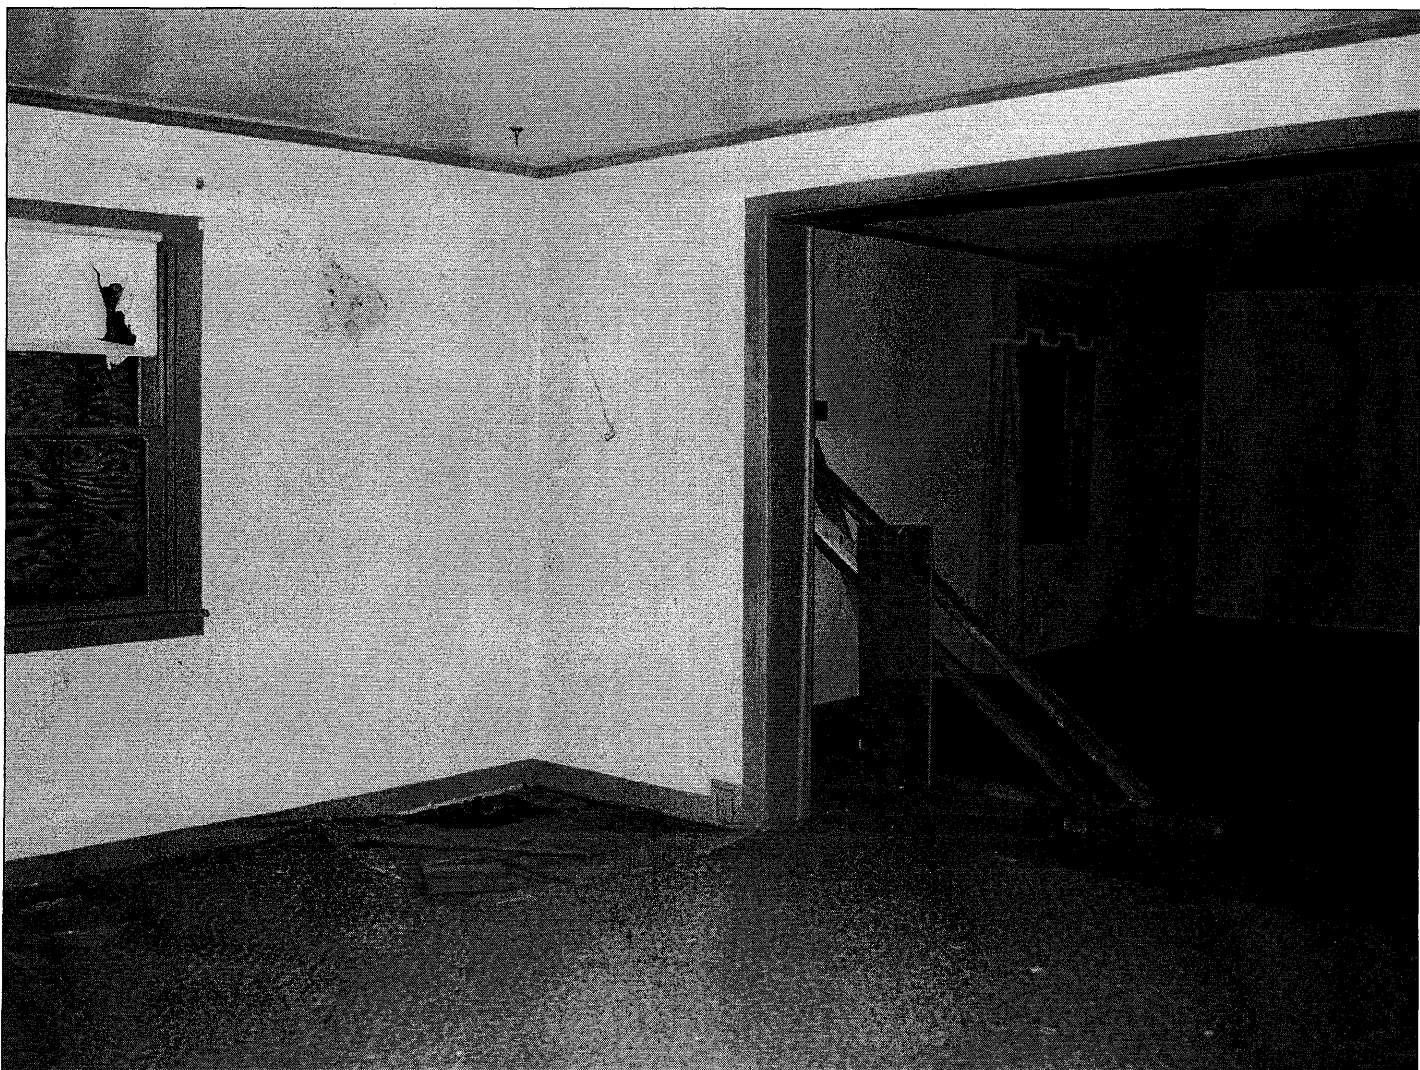
Photo 13 of 22. View of dining room looking into living room. Bracing marks location of front door.

On the interior, the opening of the wall between the current living room and dining room has been enlarged. A bathroom was added at an unknown date. The existing stair to the attic is a later addition (no date). The original stair is no longer extant. Original flooring on the main level has been replaced or covered with 3" tongue-and-groove wood flooring, which has in turn been covered with either carpet and/or floor tiles. Many of the original wall surfaces have been covered with wallboard, and baseboards, door trim and doors appear to have been replaced on the main floor.

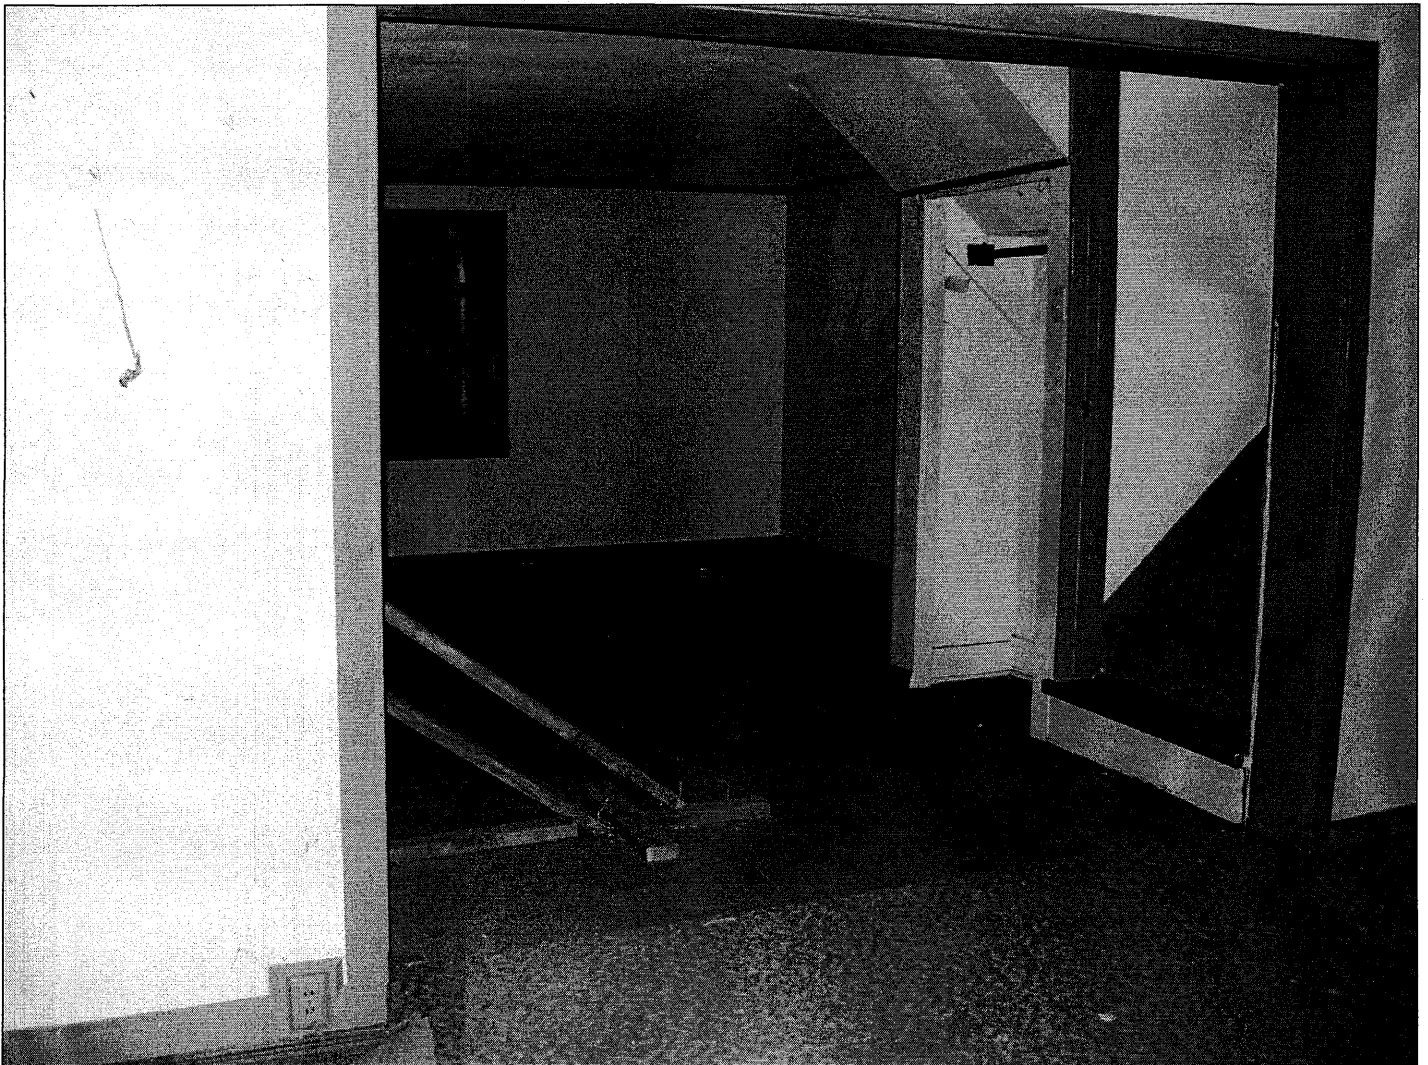
Photo 14 of 22. View from dining room into living room with stairs to attic at right.
