National Register of Historic Places Registration Form

Historic name Young, John Quincy Adams and Elizabeth, House

street & number 12050 NW Cornell Road

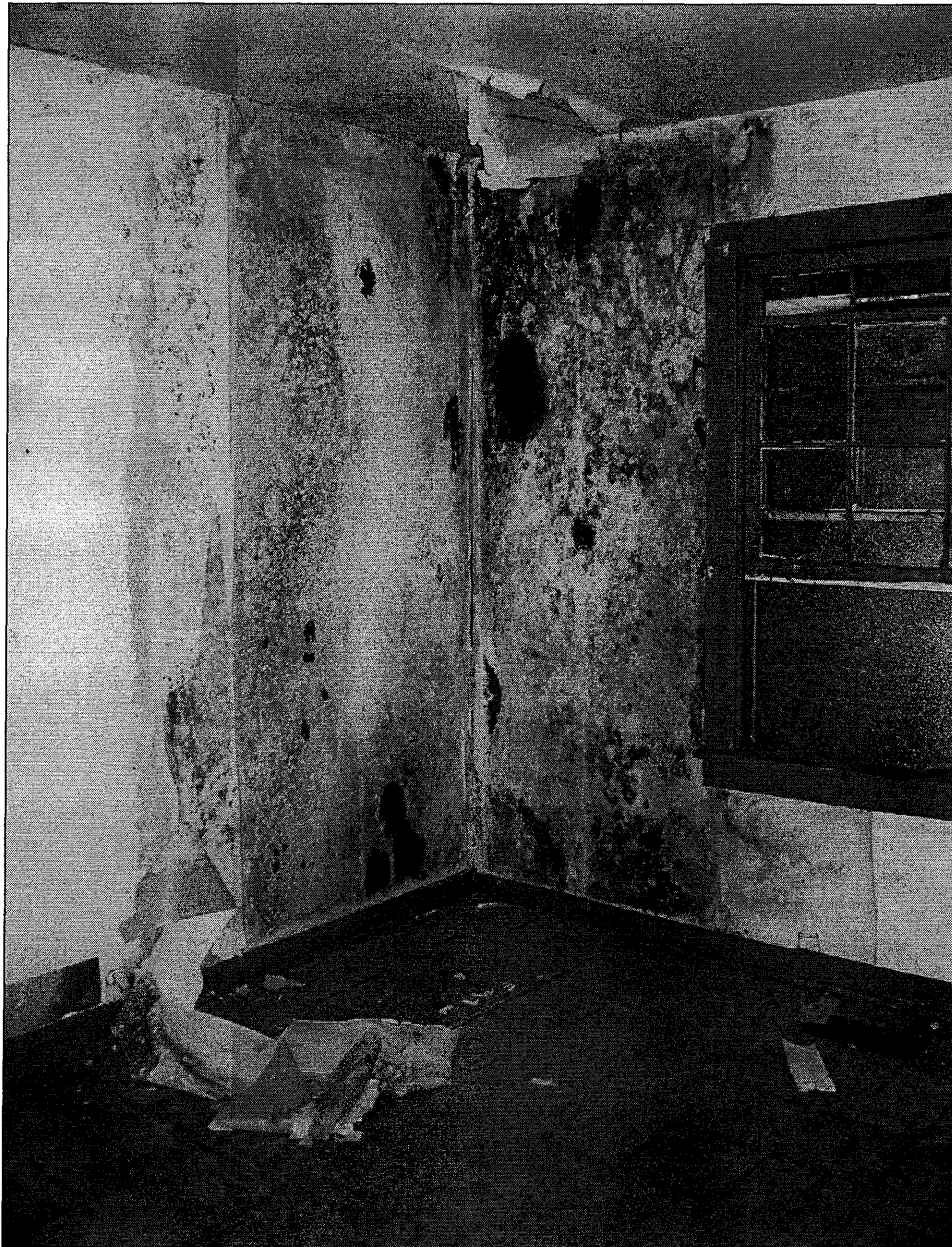
Photo 15 of 22. Main floor bedroom; note original six-over-six window sash. View looking southeast.

The fenestration pattern is regular and appears to be unaltered. Original windows would have included a number of wood six-over-six (6:6) double-hung sash, and four-pane casement sash. Several of the original 6:6 windows have been replaced with one-over-one double-hung sash of the same dimensions; at least seven of the six-pane sash that were removed are being stored in the house. These appear to be in generally good condition and retain many of their original (or historic) glass panes. Window surrounds are simple flat sawn boards with no molding.

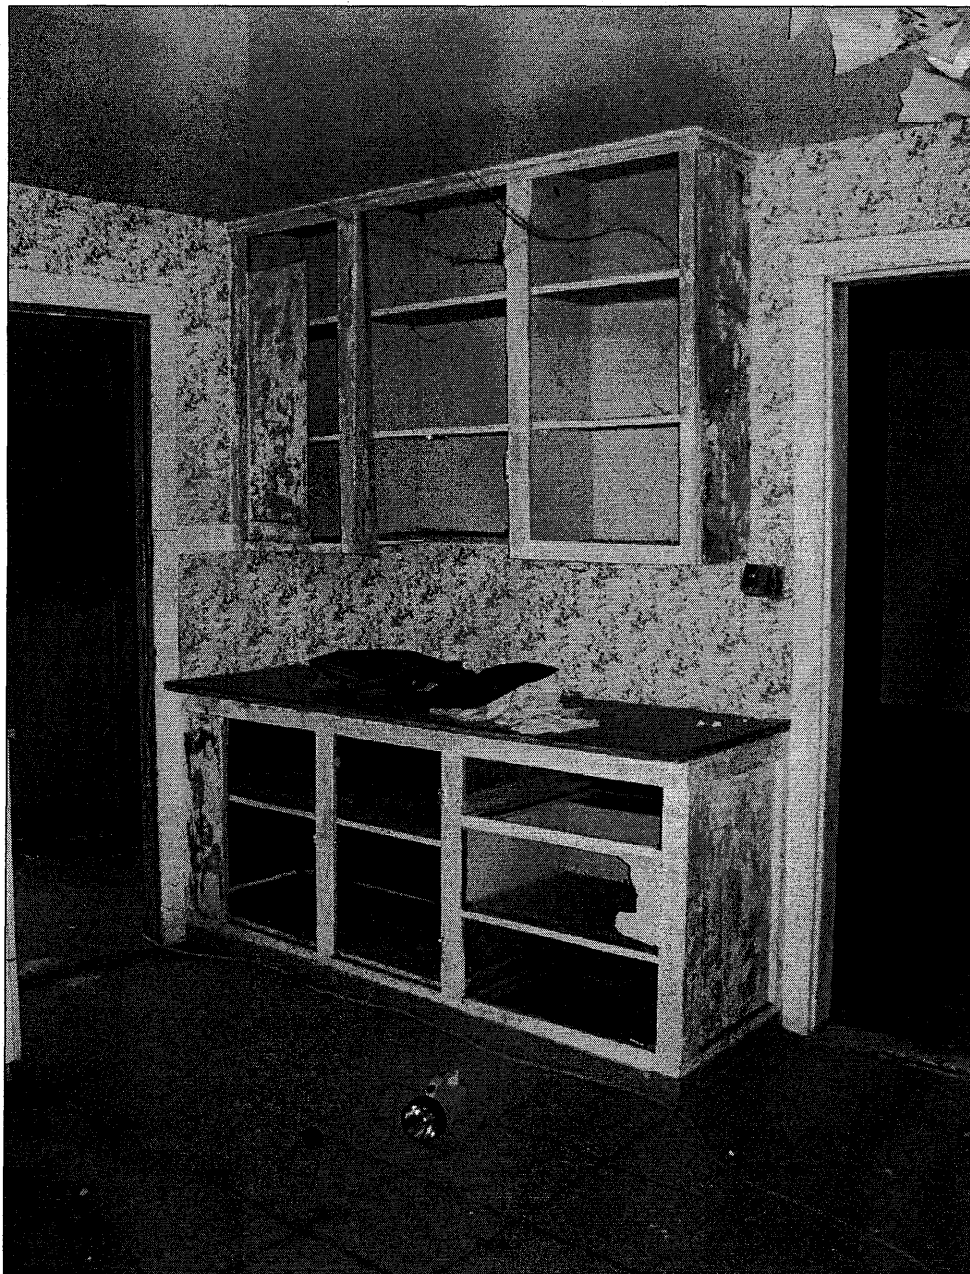
Photo 16 of 22. Kitchen. Left door leads to porch, right doorway to dining room. View looking northwest.

The existing kitchen cabinetry appears to date to the mid-20th century, and while the flue remains in place the kitchen stove has been removed. (Photo 16) The 'kitchen porch' projecting from the west facade of the house appears to be a post-World War II addition that remains largely intact. (Photo 8) A historic ¾-light door with recessed panels below and four panes above is being stored on the porch. No specific date has been determined for the addition of the bathroom, but the existing fixtures appear to also date to the mid-20th century.

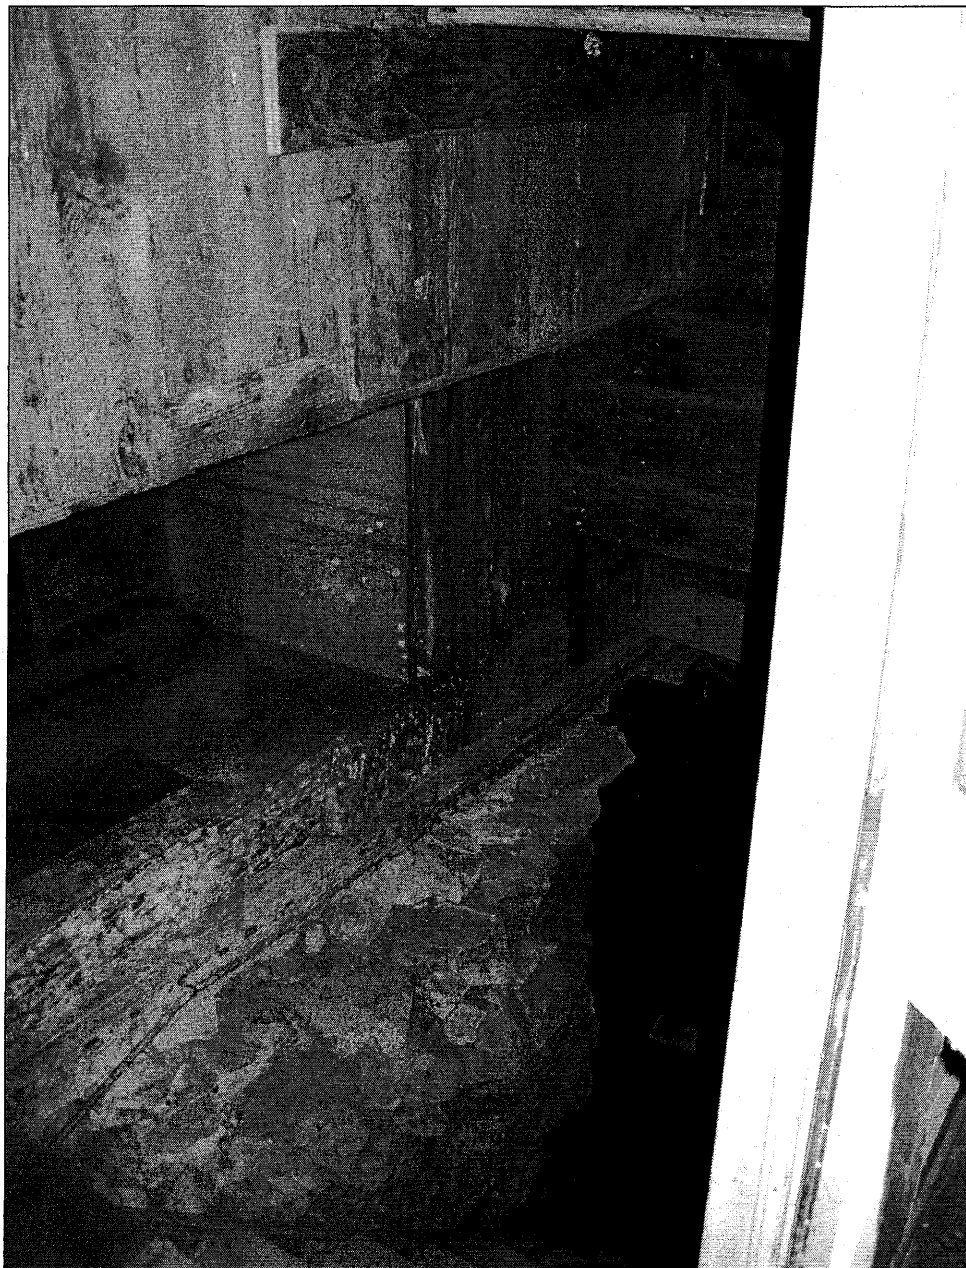
Photo 17 of 22. Stairs leading to cellar.

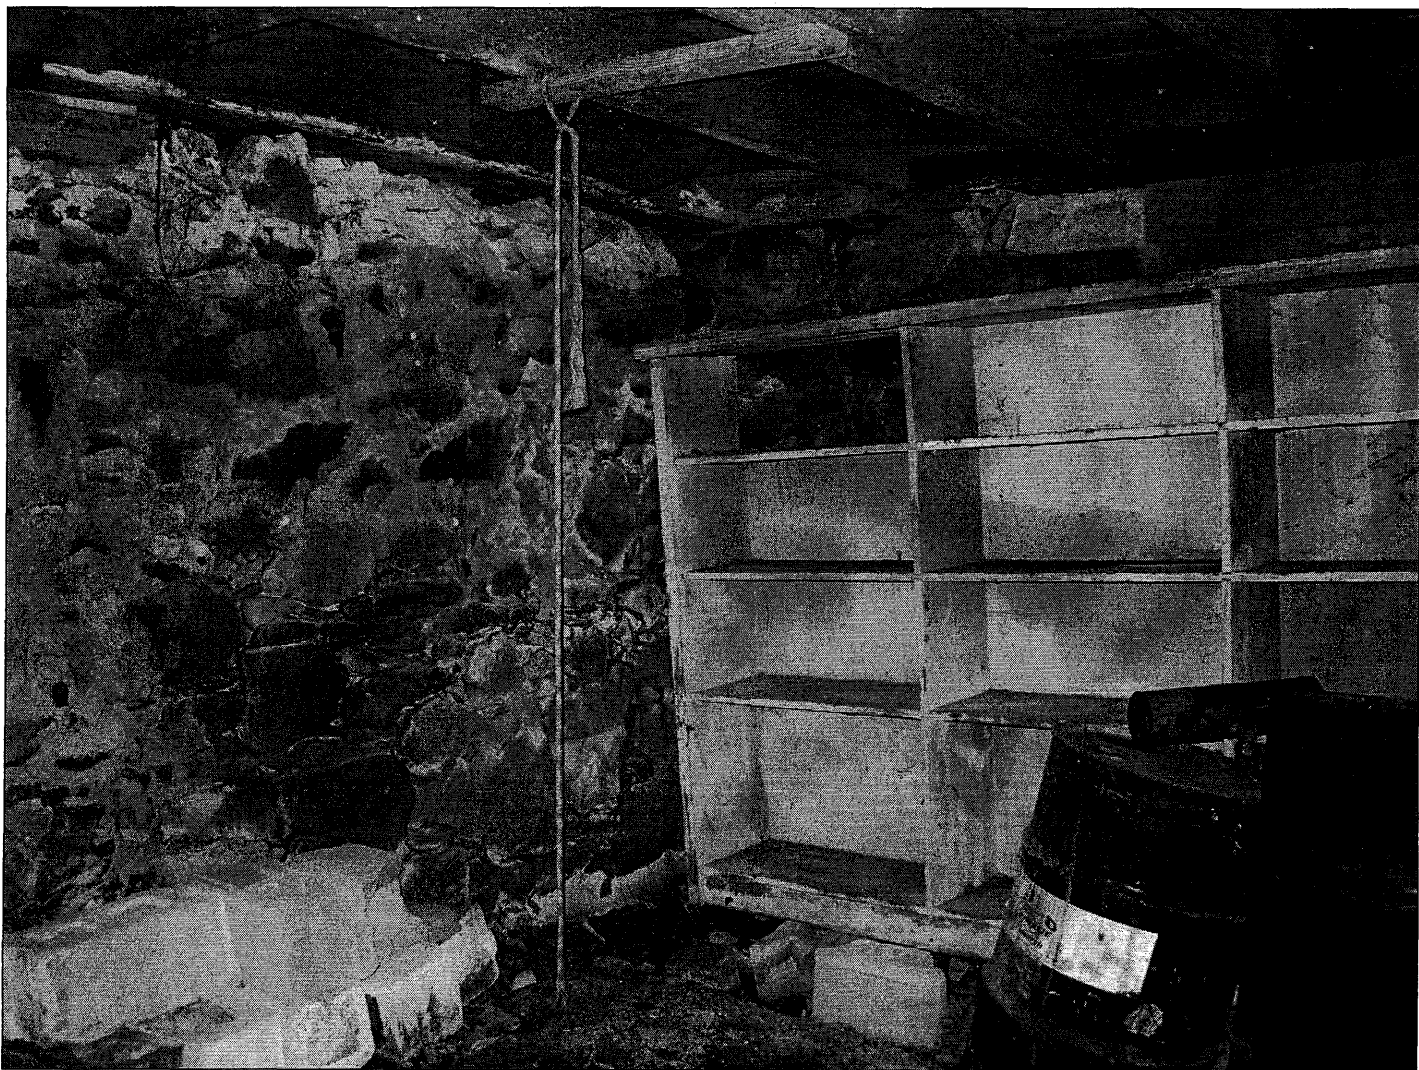
Photo 18 of 22. View of west and north (obscured by cabinet) wall of cellar, looking northwest.

The foundation consists of a combination of stone, brick, concrete, and post-and-pier, with wood post and modern concrete pier supports. A stone, concrete block and brick-walled cellar with an earthen floor encompasses slightly more than one-quarter of the total basement area at the northeast corner. (Figure 7) The east wall is brick, and part of the north wall is concrete block, giving the impression that the area was open at one time, and later walls were infilled. (Photos 3 and 4) Once enclosed, access to the cellar was provided via a doorway in the east brick wall that has since been filled in; a later access door to the basement is located on the south wall. The southeast corner of the basement is excavated but unfinished, and the western portion is unexcavated. The substructure of the building is comprised of a combination of hand-hewn and sawn beams measuring approximately 10" x 7" at the perimeter, and 4" x 6" on the interior, joined with lap joints. Corner and interior support posts are similar in size, and have been placed on modern concrete footings. A majority of the sub-structural elements along the southern (rear) portion of the building are sawn, suggesting either a slightly later construction date or perhaps early repairs.

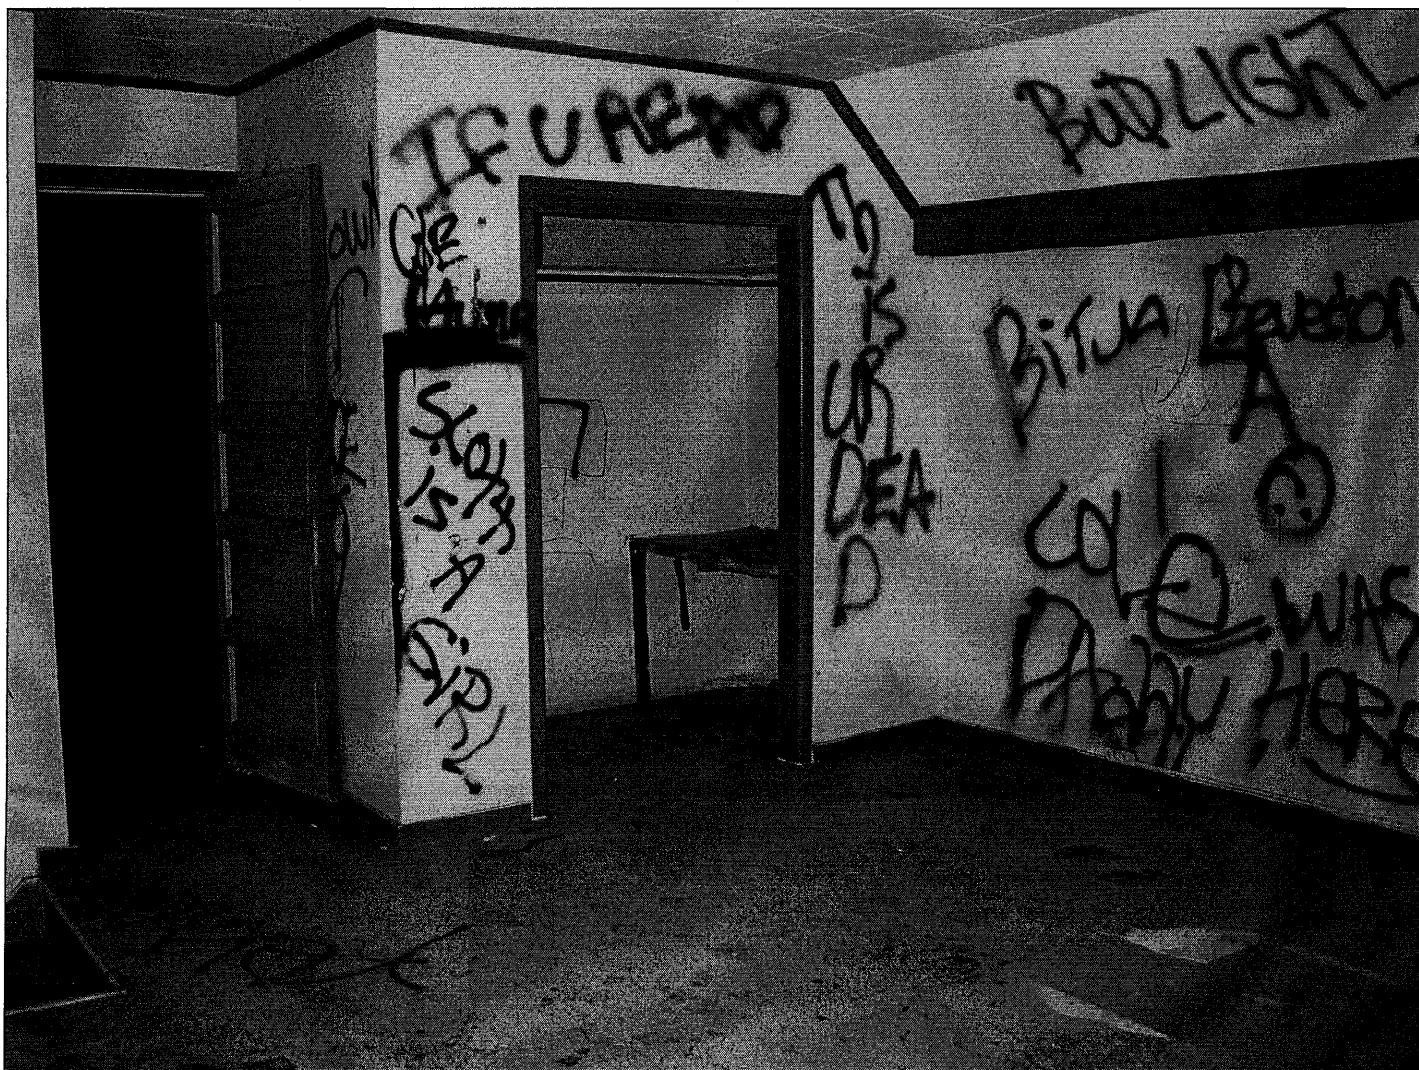
Photo 19 of 22. Attic, east bedroom with stairs at left of picture, view looking northwest.

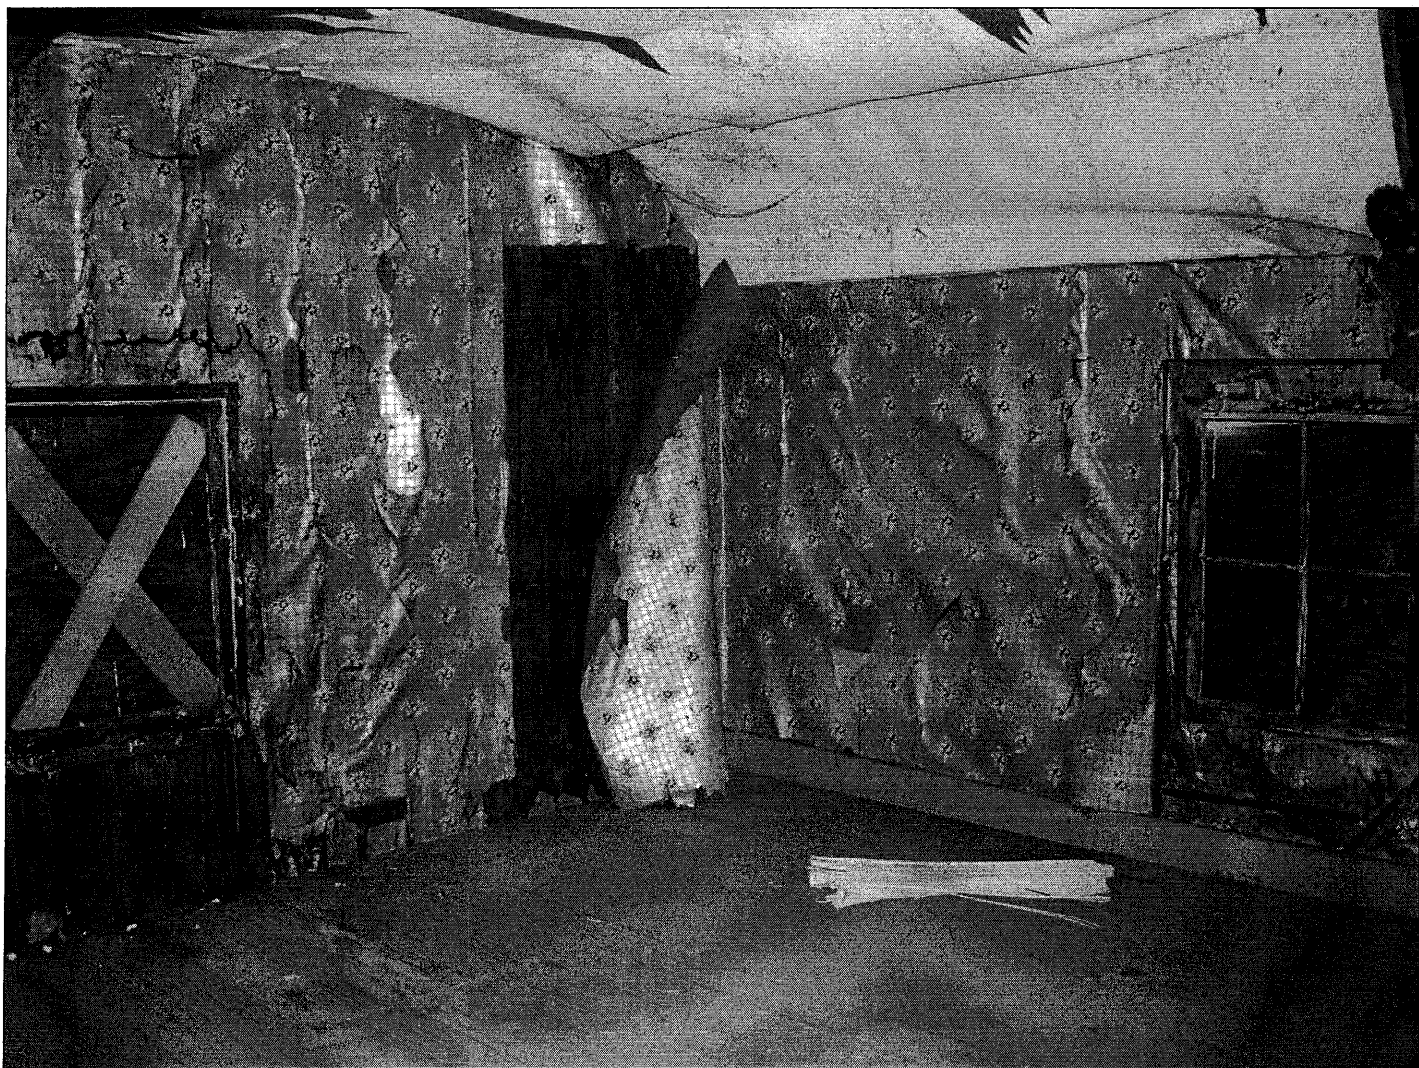
Photo 20 of 22. Attic, west bedroom. Barely visible in left lower portion of photo is patch in flooring marking possible location of original stair. View looking northwest.

On the interior, the opening of the wall between the current living room and dining room has been enlarged. A bathroom was added at an unknown date. The existing stair to the attic is a later addition (no date). The original stair is no longer extant. Original flooring on the main level has been replaced or covered with 3" tongue-and-groove wood flooring, which has in turn been covered with either carpet and/or floor tiles. Many of the original wall surfaces have been covered with wallboard, and baseboards, door trim and doors appear to have been replaced on the main floor.

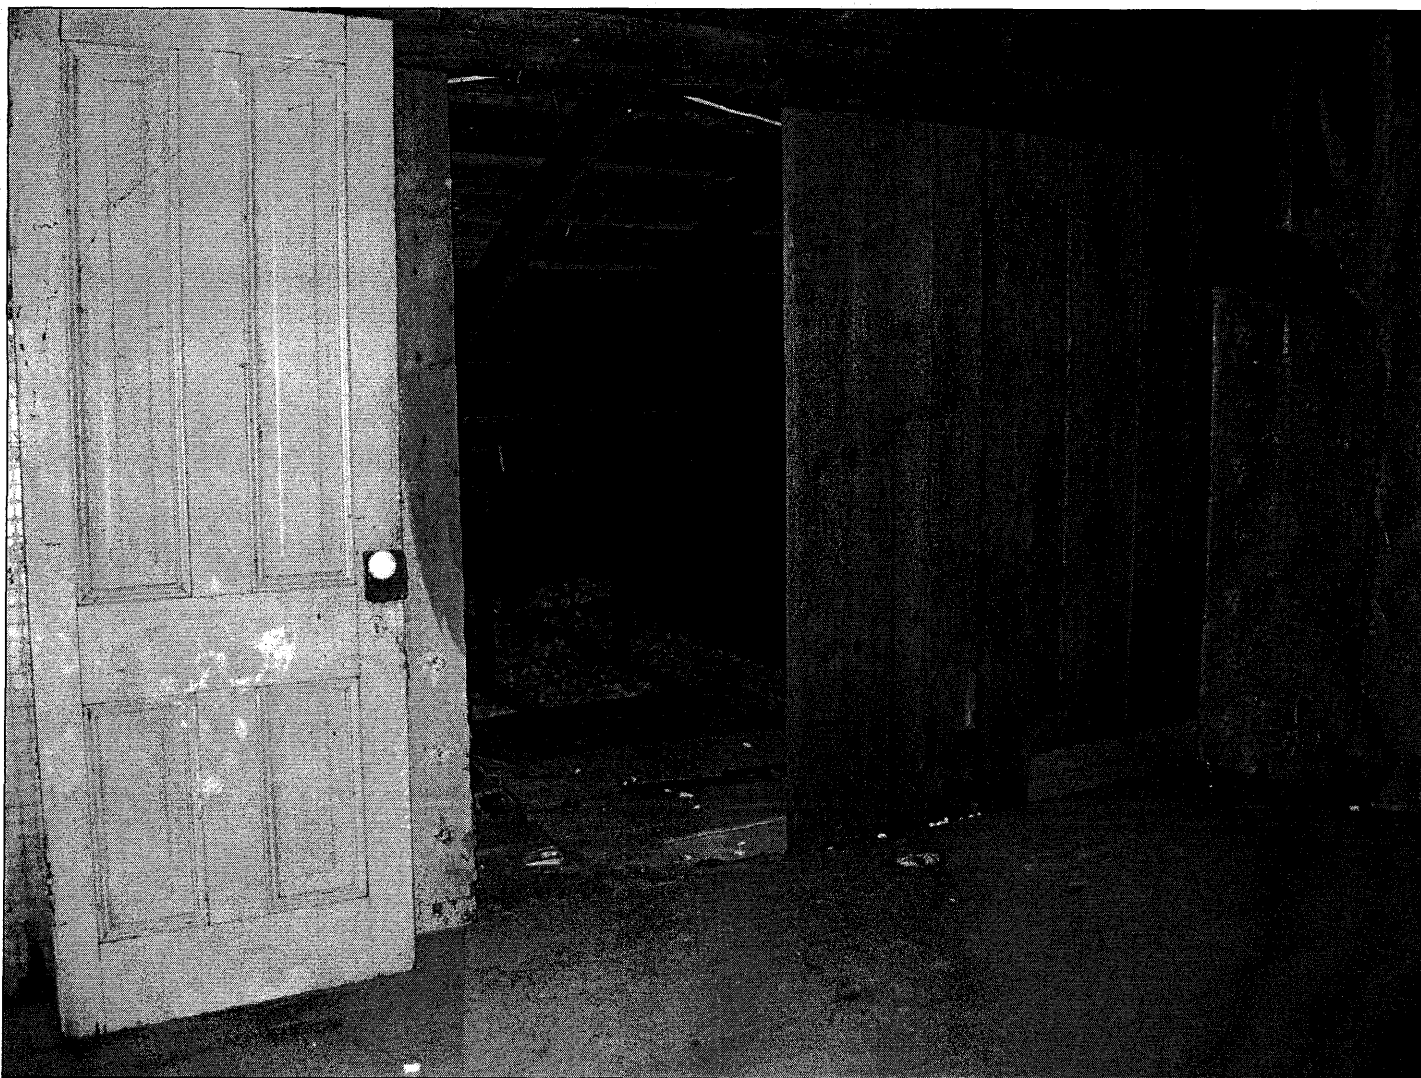
Photo 21 of 22. Attic, west bedroom, south wall, looking south/southwest. Door appears to be only remaining original or early door in the house. Planks form structural wall extending from sill to top plat (visible along top of photo). Sloping roof beyond plank wall encompasses "saltbox" section along south elevation that includes kitchen, bathroom and bedroom on first floor.

Utilizing the plank wall construction (more specifically plank-on-frame) commonly employed in the 1840s-1860s in Oregon, the walls are built of 2"-thick planks set vertically to form a solid wall; they are resting on a ledger at the sill and are nailed to the sill and to the hand-hewn top plate.³ These planks in conjunction with the hewn members form the support system for the building. The house is clad in wood clapboard siding in short lengths of contemporary material and size with 7" exposure, with a later application of narrow vertical boards at the foundation level. Beneath this siding, the west elevation retains older 6½"-exposure droplap siding that appears to be historic but is likely not original. Portions of this older siding are visible in and around the kitchen porch addition, with the majority of it obscured by the later clapboard. Original siding would have likely been wood weatherboard. On the northeast and northwest corners the siding terminates at 4½ - 5" cornerboards

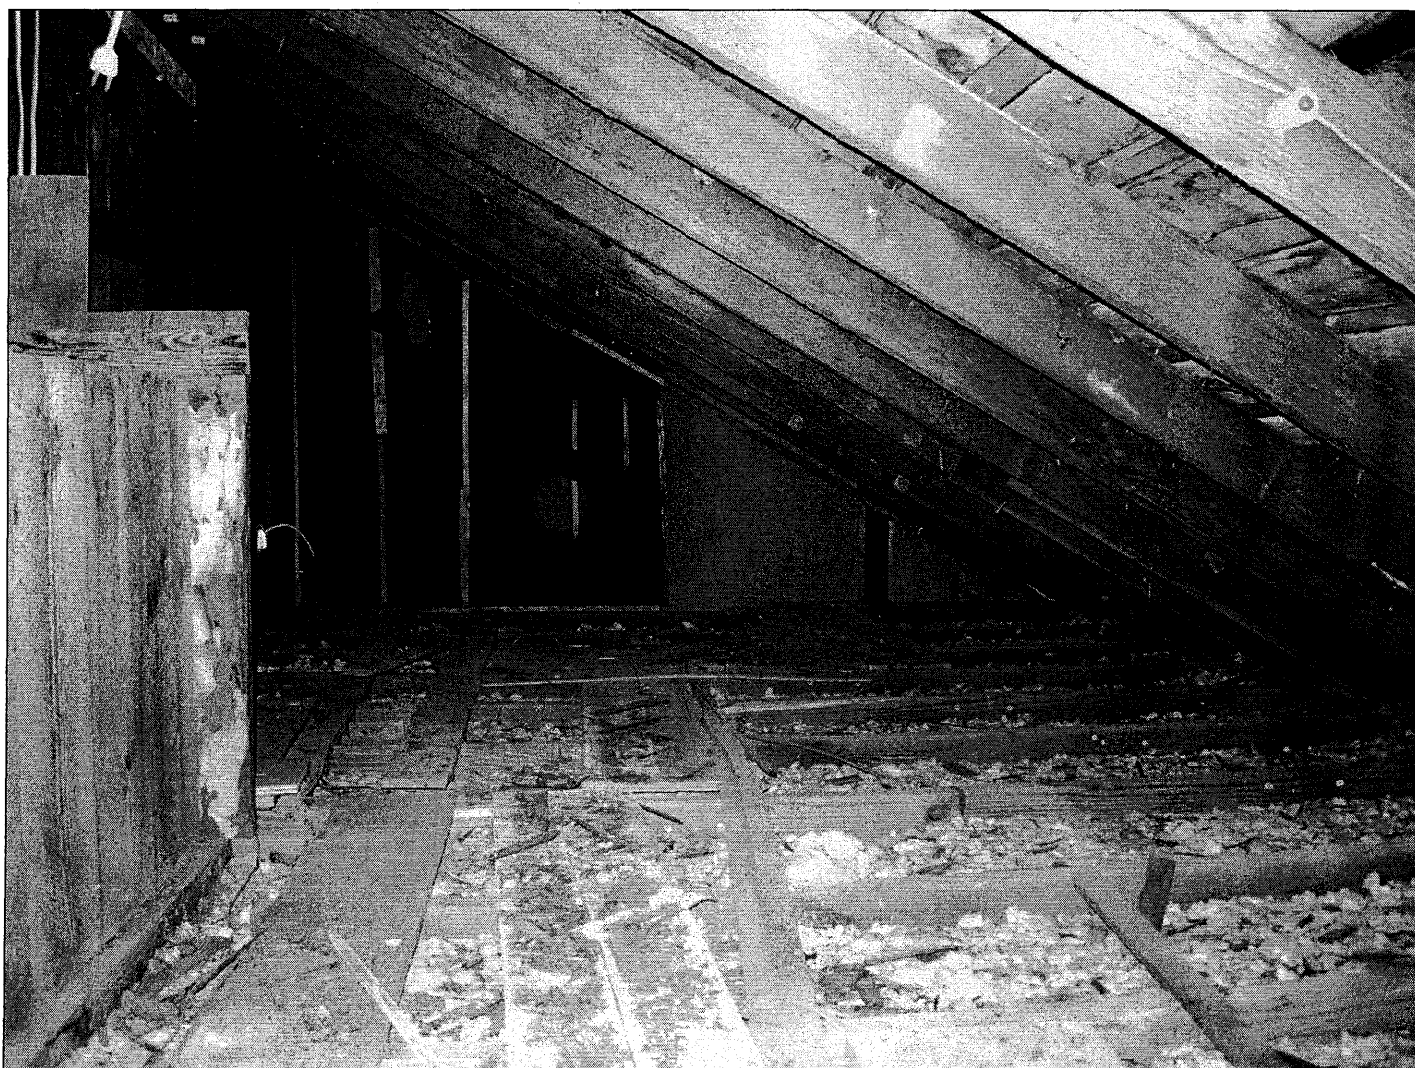
Photo 22 of 22. View of framing inside south wing roof portion of house, looking east. This section is attached to southern plank wall (at left), and consists of stud wall construction with horizontal board sheathing.

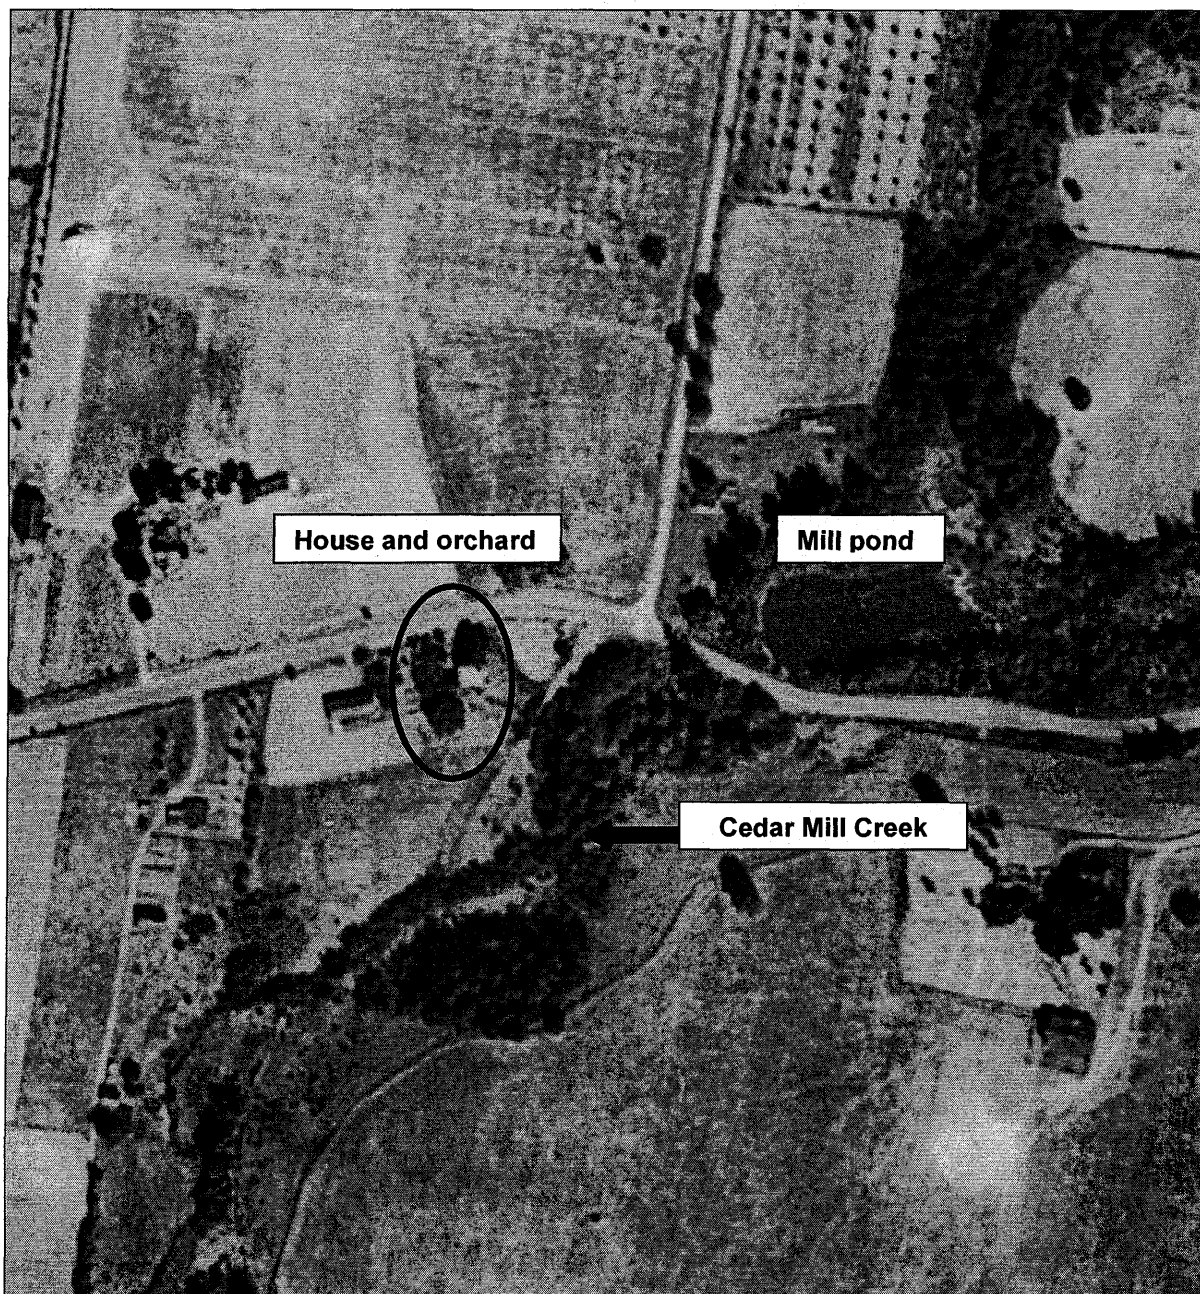
Figure 5. 1936 aerial photograph detail showing house, small orchard to west, Cedar Mill Creek and remnant of mill pond.

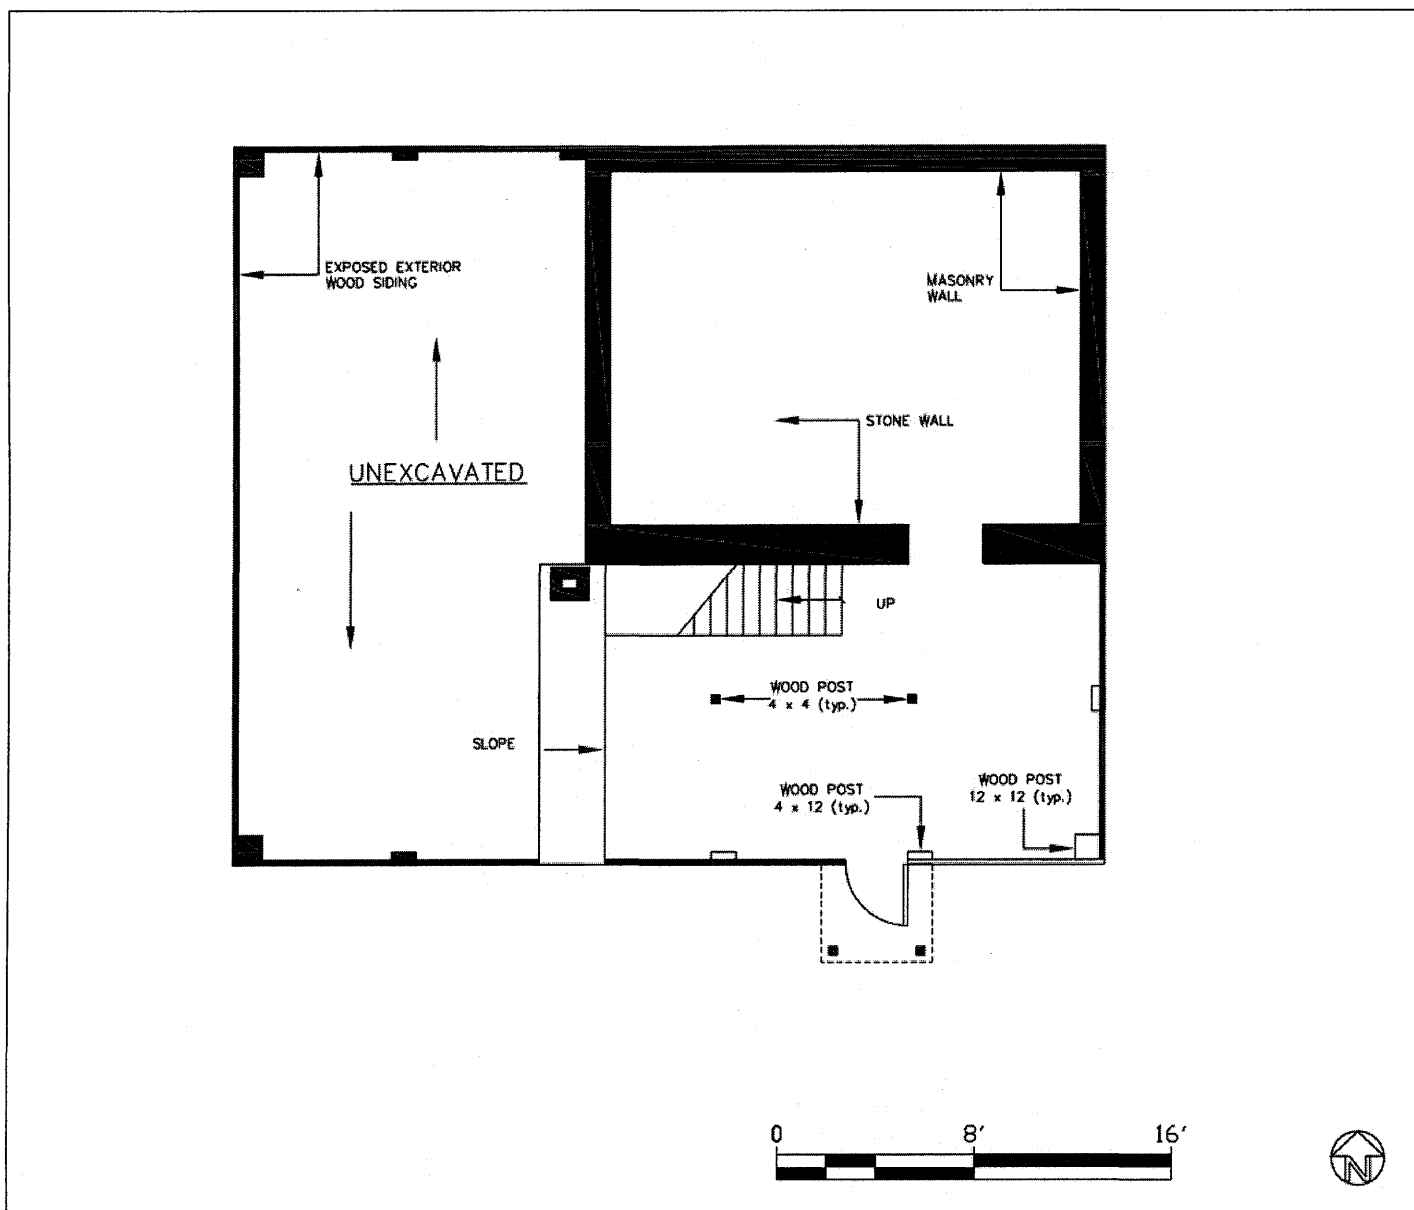
Figure 7. Young House basement plan.
Drawing by Peter Meijer, Architect

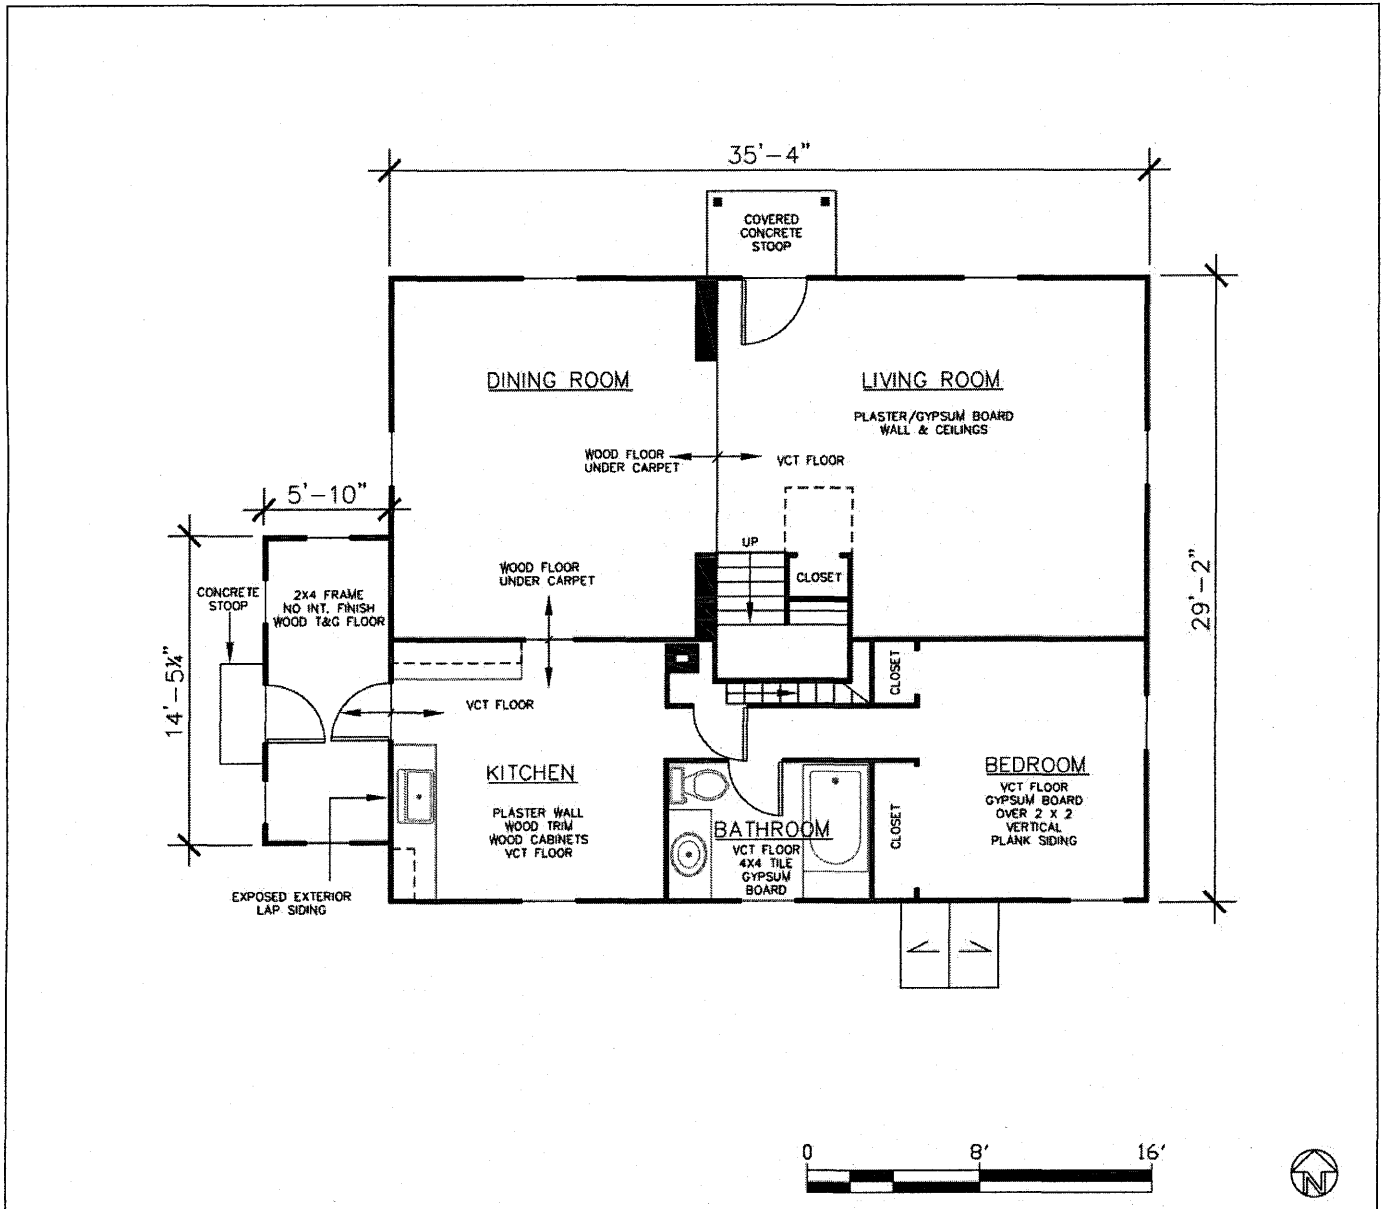
Figure 8. Young House first floor plan.
Drawing by Peter Meijer, Architect

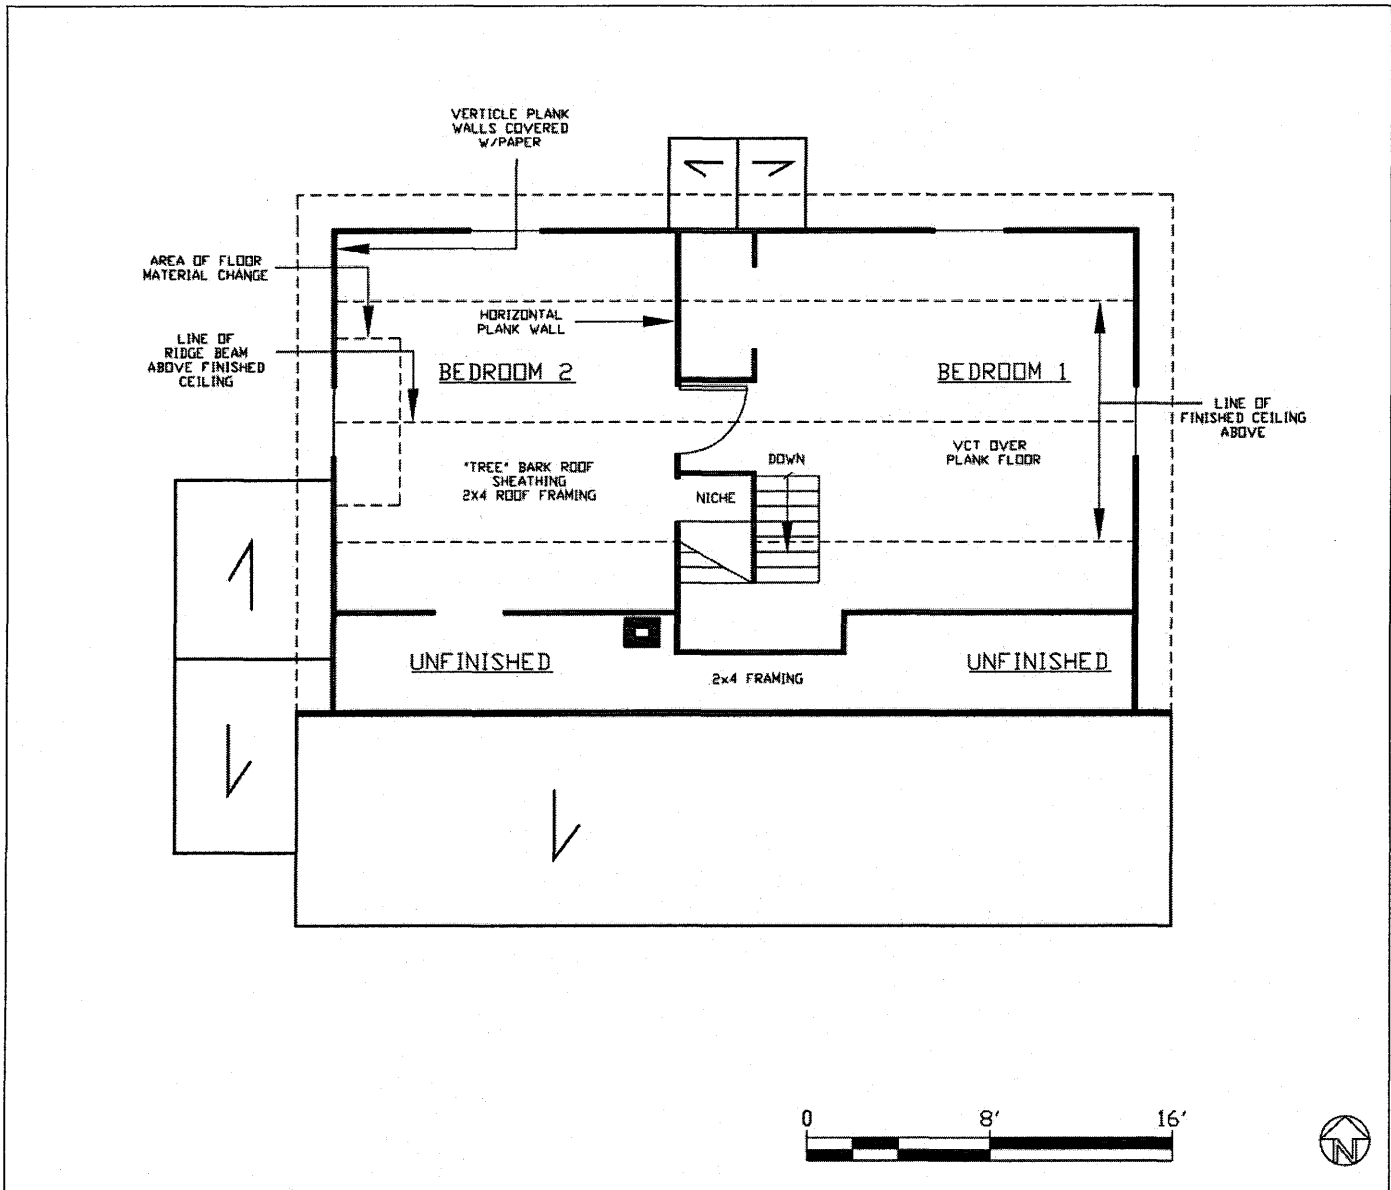
Figure 9. Young House attic plan.
Drawing by Peter Meijer, Architect

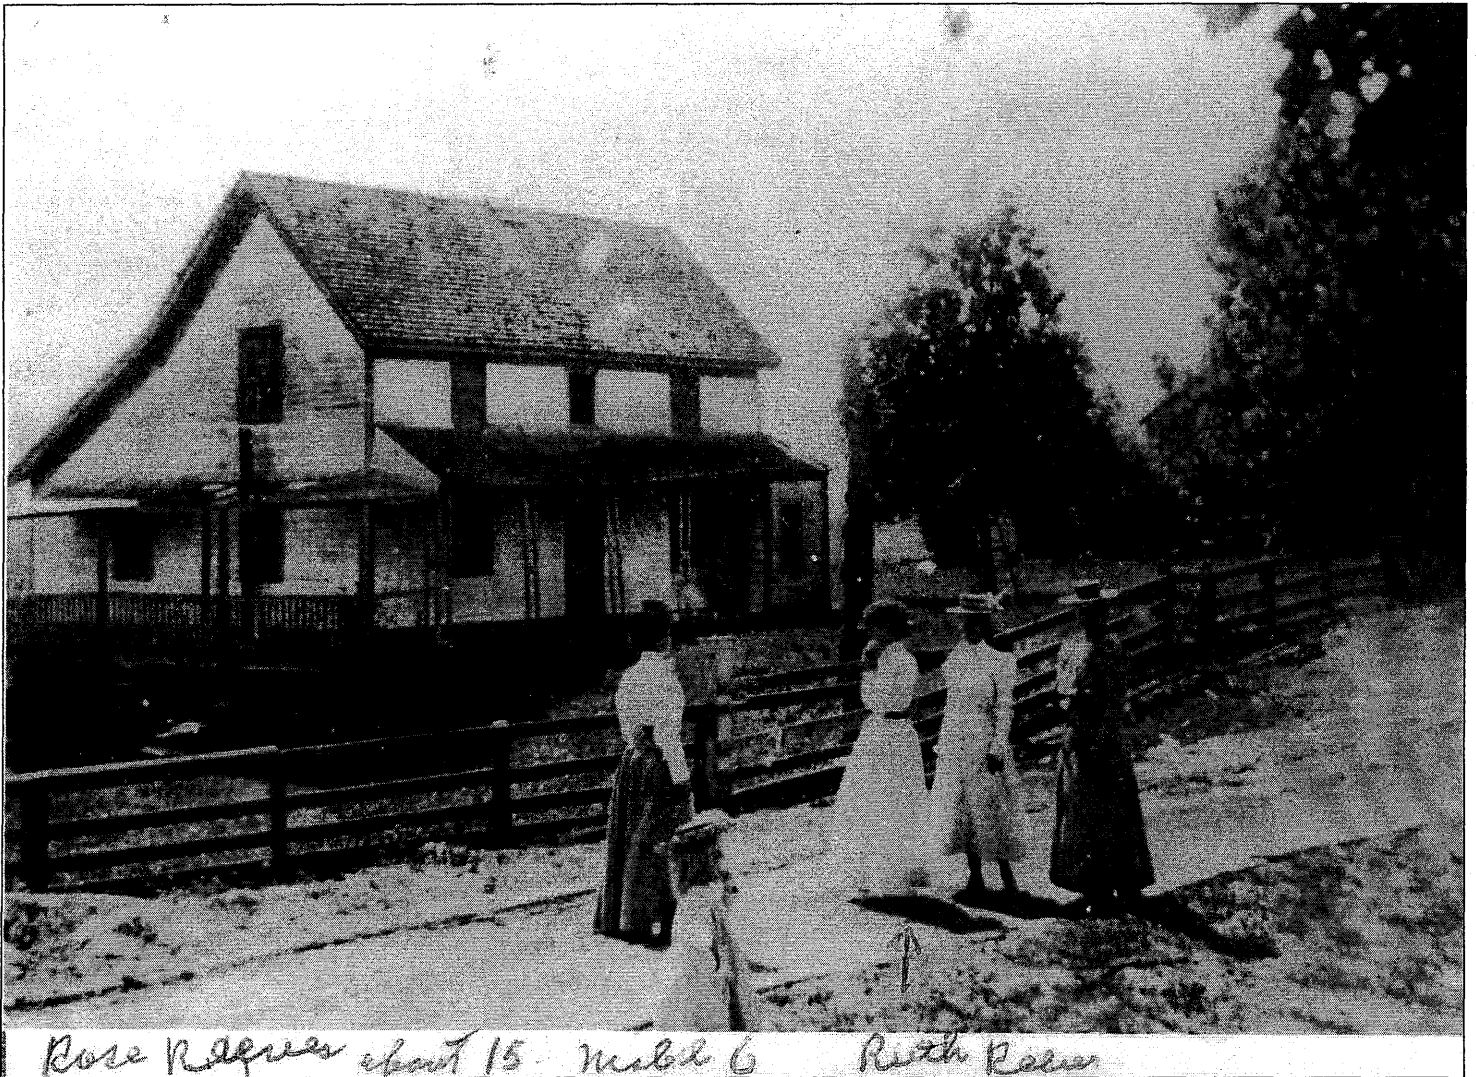
Figure 14a. Young House, circa 1888.
Image courtesy of Bernie and Mary Young.

² See Figure 14. The date of this photograph is based on family notes on the photo indicating age of the child Mable, aged 6 at the time of the photograph. Mable was born in 1882, hence the date of the photograph would be 1888.

It may be supposed that this house was once set in a quasi-industrial landscape given the close proximity to the sawmill; the historic photograph from the 1880s suggests little, if any, decorative plantings around the house. (Figure 14) After the turn of the century it appears the landscape changed to one more agrarian in nature, with foundation plantings and orchard trees. (Figure 5) By the mid-20th century the yard appears to have been nicely landscaped with a fenced front yard with a paved sidewalk and water pump, foundation plantings, flowering trees and shrubs and a small orchard to the west, landscaping the yard and surrounds today is minimal. (Figure 17) One non-historic ornamental tree of unknown type is growing near the foundation in the front yard. Two old pear and apple trees to the west, and a large hickory tree at the rear are all that remain of the historic plantings. (Photo 12)

The family moved to a larger new house he had constructed across Cornell Road and converted part of the first floor of the older house into the post-office and the first general store in the Cedar Mill community.³³ (Figures 14 and 15) Notes on the circa 1888 historic photograph of the house indicate that the post office was located in an enclosed portion of the west end of the front porch. (Figure 14) Prior to the establishment of the Cedar Mill post office, area residents received mail at the Oceola post office (located about a mile south of Cedar Mill on Walker Road) beginning in 1854. The Oceola office closed in 1863, leaving Portland and Hillsboro the two closest post offices to the Cedar Mill community.³⁴ The establishment of the Cedar Mill post office in the Young house perpetuated its position – along with the mill – as the economic center of the agrarian and lumber-based community, providing both a business and social gathering point for the surrounding residents. In mid- to late-19th century rural Oregon communities, mail was often delivered on a weekly basis rather than every day, making the post office a social gathering place where local news was exchanged.
