National Register of Historic Places Registration Form

historic name Clark, R. C., House

street & number 215 North Church Street

city or town Tupelo

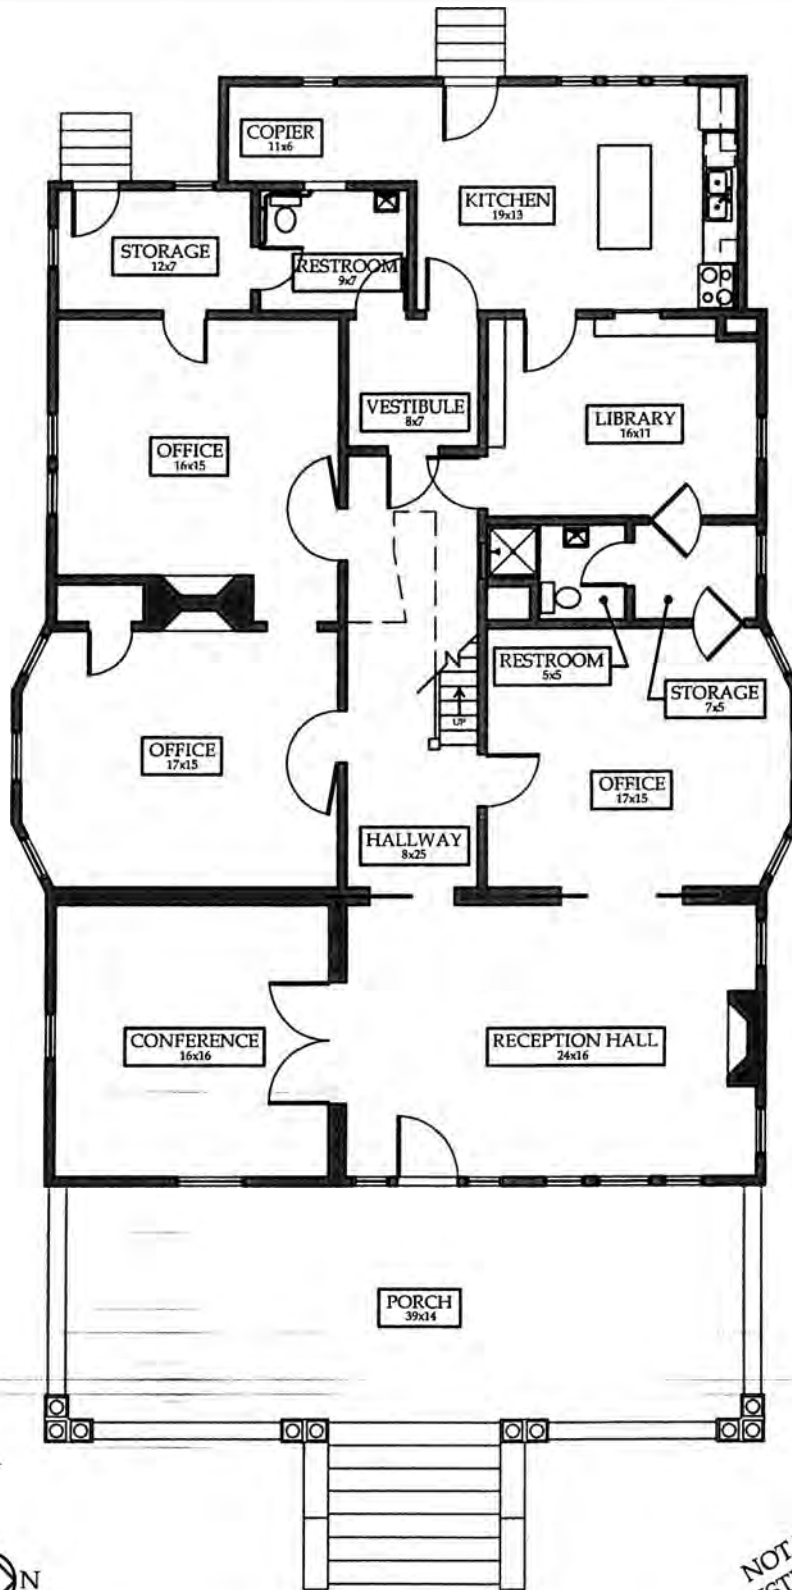
1 FIRST FLOOR PLAN
SCALE: 3/32"=1'-0"

The interior first floor plan of the house is a combination of a traditional center hall format and a format by which rooms are placed directly on the front of a house in the absence of a central hall. The ceilings on the first floor (except the back porch addition) are twelve feet tall. The walls and ceilings are the original plaster, but in a few rooms, the plaster ceilings were too water damaged and insecure to retain and have been replaced with sheetrock. The floors on the first floor of the main house are heart pine with the exception of the back porch addition, the bay window bedroom, and the library, where the floor had been damaged and had to be replaced with oak. Virtually all of the original doors remain, with the original elliptical door knobs.

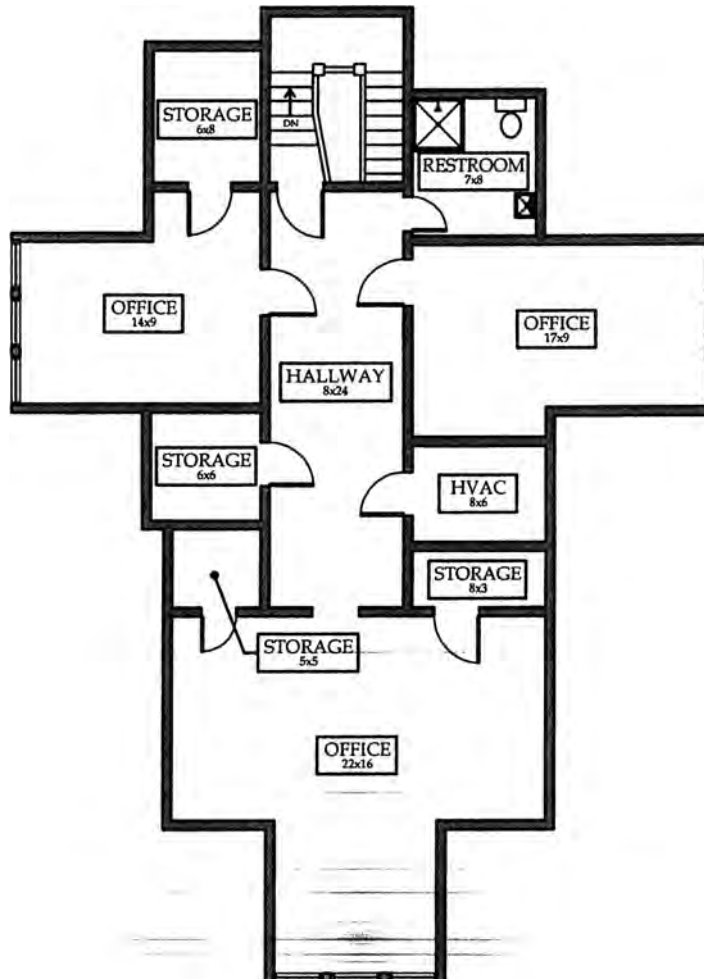
1 SECOND FLOOR PLAN

Once you land on the second floor from the only staircase in the house, you find yourself in a hall which opens up into basically three main spaces, all created by the hipped roof dormers of the house. This living space was most likely created in the post-tornado period of Tupelo – circa 1940s – when residential space was needed for rent and when the city started expanded greatly. The third owner of the home ran a boarding house there. The previously open, non-residential attic was walled up and had ceilings installed all out of tongue and groove pine lumber. The ceilings lie under the house joists, making the room height just over 7 feet in the largest front room and under seven feet in the other two dormer rooms. The most substantial is the room with the largest dormer facing the street. This room has two walk-in closets. The south dormer has a large walk-in closet. The north dormer does not have any closet. There are three other spaces off the central hall besides the three dormer rooms. One is the former attic fan area, which was reprogrammed for the heat pump and duct work. A second space is a large walk in closet. Finally, a door just off the landing of the stairway leads to a small bathroom for the second floor. A new oak floor was installed to overcome the various inconsistencies of the crude upstairs floor. Central heat and air was installed here as well.
