National Register of Historic Places Registration Form

Historic Name: Heights Theater Other name/site number: NA

Architectural Classification: MODERN MOVEMENT: Art Moderne

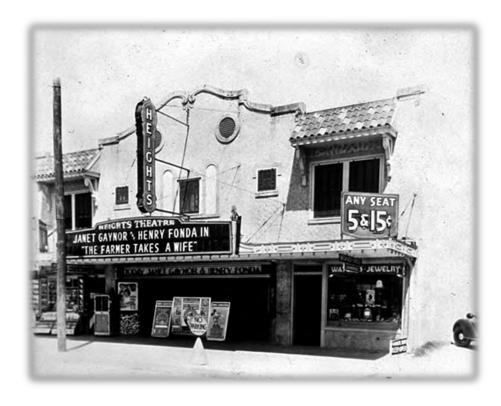
Figure 1: Heights Theater, 1935. This photo shows the theater's original Mission-style facade before it was modified to its present Moderne-style later in 1935. *Courtesy of the Houston Metropolitan Research Center, Houston Public Library*.

The 2-story building was Mission Revival style with a stucco facade, ornate, curved 'mission' style parapet, marquee canopy suspended from the building facade, with vertical canopy sign, a large projecting HEIGHTS sign, and a pent roof that extended over a pair of windows at each side bay; these pent roofs were multi-colored roofing tiles. The center bay had five fenestrations-a window opening with fixed wood shutters in the center of the bay, flanked on each side by a tall arched opening that was filled, two smaller, rectangular openings at the side of the center bay, with fixed wood shutters and two large circular vents (with trim surround) near the roofline.

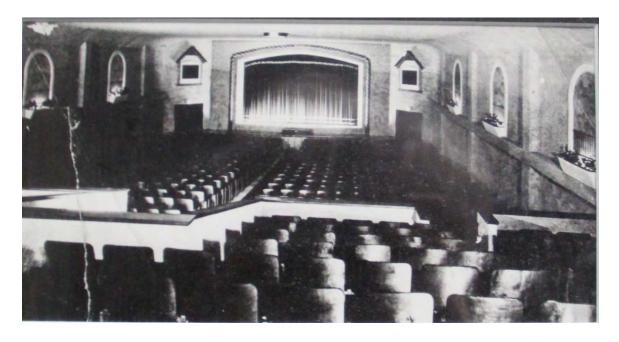
Figure 2: Heights Theater, interior c. 1929-1935. This photo shows the theater's interior prior to its modification in 1935, and is only photograph of theater interior located. *Courtesy of Edwin Cabaniss*.

The auditorium was located at the rear (north end) of the building with a balcony that was approximately one-third the size of the auditorium below, located at the front (south end). This recessed entry sloped up from the sidewalk to the slightly raised elevation at the theater lobby; this sloped entry flooring was 'broken' red ceramic tile flooring. The theater's seating capacity was 750, including the first fifteen to eighteen rows of wooden seats that were designed specifically for children. The interior has been described as having red curtains at the stage and wood seats with green and ruby leather'. Only one interior photograph remains from this period and shows a proscenium at the front with curtains, exposed structural columns and horizontal concrete perimeter beams at the exterior walls and wood chairs (Refer to Figure 6). The auditorium sloped down to the stage, and had a wide center aisle. The interior wall finishes appear to be stucco with faux windows inset into the upper portion of the walls. The ceiling appears to have been flat with rounded (or angled) stucco cove at the wall to ceiling transition. Although the theater was designed primarily for movies, it also had a small stage that was one bay deep; a proscenium with curtains was provided (see Figure 6). This allowed staff or guests to speak or introduce movies, and accommodate performances by local organizations or the occasional traveling performances. This reflected the last era of live performances at local theaters; by 1935 neighborhood theaters would be designed only for film and without stages for live performances.

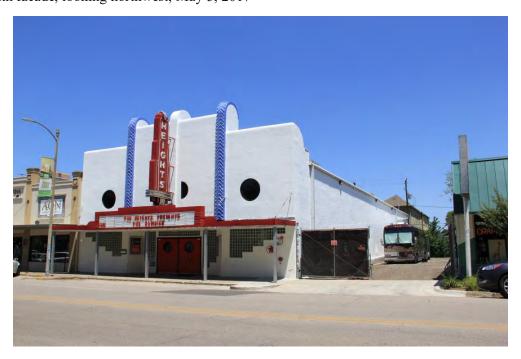
Photo 2: South facade, looking northwest, May 5, 2017

The building's primary, two-story high south facade faces West 19th Street and is clad in stucco, painted white. This Moderne Style facade includes typical features of this style, including rounded wall and parapet forms, smooth stucco wall surfaces, round windows, and limited ornamentation. The theater is composed of two distinct massing components-the first is the 2-story front portion of the building that extends from the south (front) facade approximately 10' into the remainder of the building and second is the rectangular building mass that comprises the remainder of the building to the rear. This rear building mass extends from the back of the first massing component to the north (rear) facade. The floor plan is rectangular with the west facade adjoining an adjacent one-story building. The rear facade adjoins and faces the alley at the back of the lot and the east facade adjacent to a vacant lot. Apart from a 4' setback at the front facade, the theater occupies the entirety of its urban lot.

A horizontal marquee canopy extends across the front facade at the second-floor level and provides protection for pedestrians on the sidewalk and theater entry. This marquee canopy divides this front facade into two zones-the first floor with its flat stucco wall, entry doors and glass block windows, and the upper zone with its flat stucco wall that is divided by vertical signs and pilasters, and has a stepped parapet with rounded forms. Below the marquee canopy, the walls at the two side bays align with the plane of the upper facade.

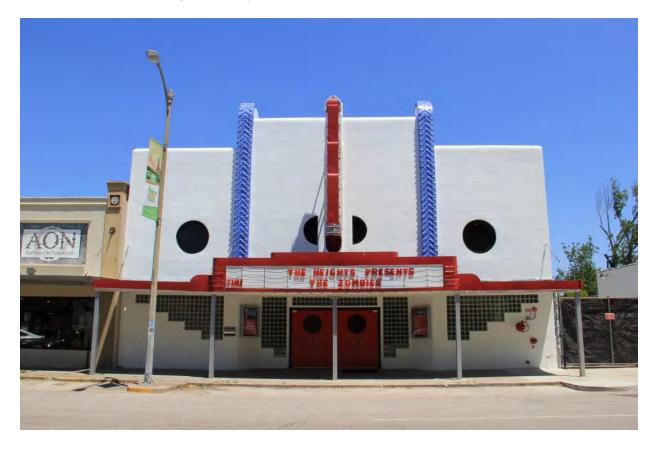
Photo 3: South Facade, looking north, May 5, 2017

Above the marquee canopy, two vertical metal signs with neon lighting (in chevron patterns) separate the side bays from the wide center bay; these signs extend above the parapet and return to the roof several feet in a semi-round form, forming a stucco 'side' to the lower side bays. A third vertical element, clad in stucco, has the same form as the vertical metal signs and extends above the parapet. These vertical signs separate this facade plane into three bays, with the outside bays lower than the center bay, giving the facade a 'stepped' appearance. The marquee canopy is suspended from the building facade by five metal tie rod assemblies that are anchored into the front facade, and by five small (4" square) metal columns at the outside edge of the canopy. The marquee canopy is metal, with a simple, approx. 8" high, fascia on three sides. The marquee canopy dates from 1929 but was modified in 1935. The tie rods date from 1929, while the columns are thought to date from 1989 as they are not shown in Robert Morris' 1984 drawings that were used for the 1989 renovation; these columns are painted gray.

The rectangular marquee canopy vertical sign includes two rows for information to announce the current show or activity at the theater, and is framed by a perimeter metal band that steps up near the center of the marquee. Like the marquee canopy, this appears to date from 1929, and was modified in 1935 to its current appearance. The canopy fascia and surround around the marquee are currently orange in color. The vertical, large projecting sign is metal, painted maroon with neon lighting in the 'HEIGHTS' letters and sign surround. This sign has a Deco appearance and dates from 1935. The three horizontal metal supports are not as long as those shown in the c.1935 (pre-renovation) historic photograph but are in the same location as that projecting sign and are thought to date from 1929, although modified in length.

Other elements at this facade include four windows at the second floor: one round (porthole) window at each of the side bays, and two semi-circular windows on each side of the center stucco pilaster; these windows date from the 1989 renovation.

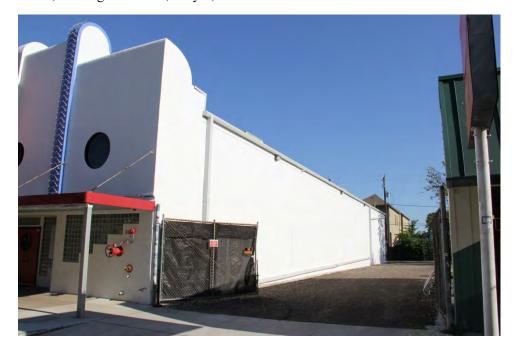
Photo 4: East Facade, looking northwest, May 5, 2017

This facade is open to a vacant lot, and the building's original (1929) structural concrete frame with clay tile infill remains intact. This exterior wall has been stuccoed and remains largely intact and painted white. The metal fascia, gutters and downspouts at the roofline are visible, and are also painted white.

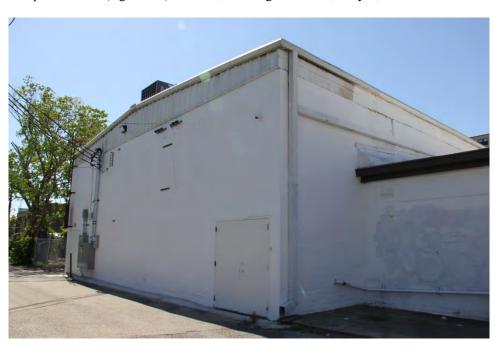
Photo 5: North and partial west (right side) Facades, looking southeast, May 5, 2017

The building's structural concrete frame with clay tile infill remains intact at this facade; these materials remain unpainted and reflect their original gray color. The white end gable (metal panels) and gutters of the 1989 metal roof structure remain intact. There are two pairs of exterior doors at this facade, located near each end of the facade. These openings are original (c. 1929) and still serve as exits from the theater. The flush metal doors date from 1989 and are painted. There are a few areas of this facade with graffiti that has been over painted with white paint. The building's electrical service enters the building below the roofline, and electrical conduit leads to the large electrical panel in the center of this facade.

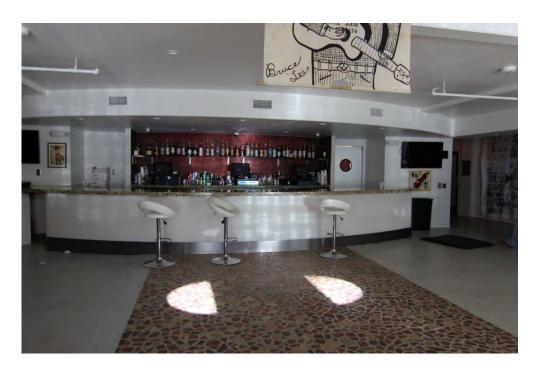
Photo 7: First floor lobby and bar; bar front at center and 'broken' ceramic tile re-laid in new concrete floor, looking north. January 30, 2017

This center bay of the Lobby was originally an outdoor, sloped entry to the 1929 theater's recessed entrance and was enclosed in 1935, leaving the floor sloping up immediately in front of the entry doors. The flooring in this exterior entry area was 'broken' red and brown ceramic tile flooring. While this ceramic tile flooring is unique and its preservation was desired in the recent rehabilitation project, this sloping floor at the front entry doors did not allow an accessible entry into the building from West 19th Street. The Owner and Architect worked with Texas Historical Commission and the National Park Service to explore alternatives to this issue, resulting in the historic ceramic tile flooring being removed (in pieces) and re-laid in a new, level concrete slab that was at the same elevation as the public sidewalk. This original ceramic tile now extends from the entry doors to the rounded bar, in its original, although lower, floor location. The adjacent floor areas of the lobby are sealed concrete. The north wall of the bar contains an inset space for shelves and a countertop. The curved bar top is supported by curved sheetrock walls, and a dropped sheetrock ceiling extends throughout the bar space, following the curve of the bar top. The bar, the kitchen and adjacent restrooms create demising spaces between the 'listening room' (auditorium). The men's and women's restrooms are located to each side of the kitchen and accessed from the vestibules that leads to the listening room. These two side vestibules flanking the bar and restrooms lead to the listening room; these spaces provide acoustic separation between the lobby and the listening room.

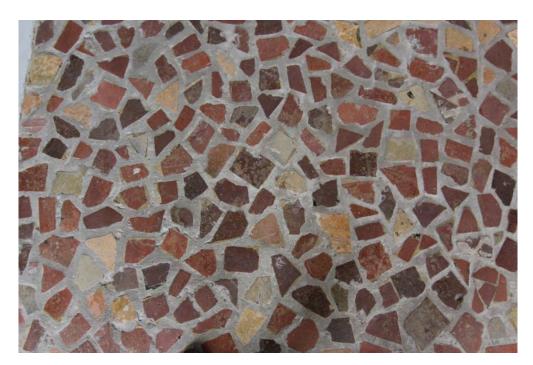
Photo 9: Detail of broken tile re-laid at First Floor Lobby, January 30, 2017

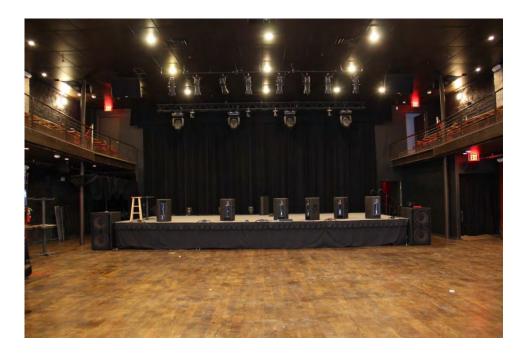
Photo 10: First floor Listening Room, looking to stage with Mezzanine balconies at both sides, looking north. January 30, 2017

The listening room is a large, two-story space; the floor is level with simulated wood flooring material over the concrete floor. The south wall of the listening room is the rear wall of the kitchen, and is painted drywall. Two private seating areas and an open control booth are located next to the south wall. The interior east and west walls are painted, with areas of clay tile block construction visible beneath. These upper portions of these walls at the balcony are unpainted exposed clay tile block within the concrete frame. The north wall of the listening room dates from the original 1929 construction and is the only original interior wall to remain after the 1969 fire. The wall is

painted clay tile block, and extends to the underside of the roof. A movable low stage and stage curtain have been installed adjacent to this wall. Door openings in this wall (at both sides of the stage) provide access to the 'back of the house' spaces. The ceiling of the listening room consists of 2x4 lay-in ceiling tiles in a metal grid, painted black. Stage lights, sound equipment, and projection equipment are suspended from metal frames supported by the roof structure.

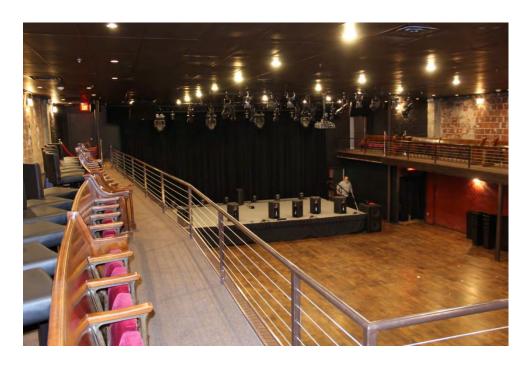
Photo 11: Mezzanine Balcony, overlooking Listening Room and stage, with Mezzanine balconies at both sides, looking northeast. January 30, 2017

Within the listening room, the U-shaped steel balcony structure is supported by round steel columns, creating seating areas at the sides and rear that overlook the listening room. A metal railing with horizontal cables extends the entire perimeter of the balcony. The east and west sides of the balcony accommodate 2 rows of seating, with repurposed wood and metal bench-style theater seating, and new high-backed chars. The sides of the balcony angle slightly inward toward the stage at the north. The south side of the balcony is two aisles deep and contains the same seating. The floor of the balcony is covered with carpet.

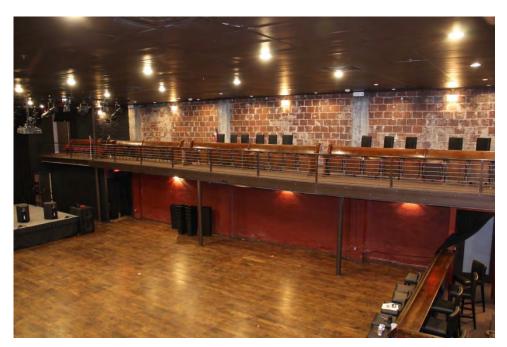
Photo 12: Mezzanine Balcony, overlooking Listening Room with east Mezzanine balcony across the room, looking northeast. January 30, 2017
