National Register of Historic Places  
Continuation Sheet

SUPPLEMENTARY LISTING RECORD

Property Name: US Naval Station Tutuila Historic District AD

historic name U.S. Naval Station Tutuila Historic District  
other names/site number Fagatogo and Utulei villages; Pago Pago

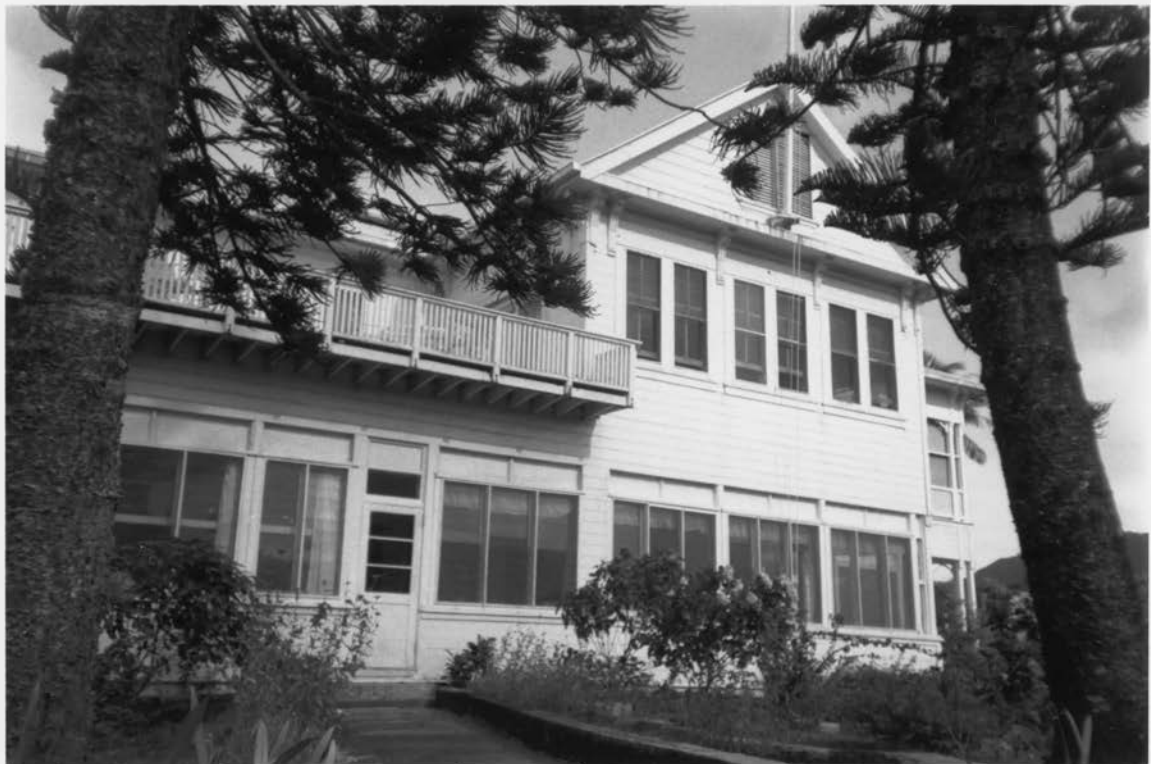
#5.

~~THE~~ FRONT OF GOVERNMENT HOUSE, NAVY NO. 1, 1988  
U.S. NAVAL STATION TUTUILA, AMERICAN SAMOA

Government House, Navy No. 1. The commandant wrote in 1902 that if he were to be appointed governor of American Samoa, he should be given the proper establishment, with servants, etc., that usually went with such a position. The Navy approved plans for an elaborate (for that place and time) residence. Work began on government house, or the commandant's residence, that fall. The next spring two skilled carpenters arrived from the United States, and with the help of Samoan workers, completed the house in July 1903. While all other buildings stood on low-lying ground near water level, this large, airy house stood high above the rest on Observatory Point which had been graded from eighty-five feet to sixty feet in elevation. It is a two-story, frame structure with an attic having two dormers. It stands on concrete piers and is cruciform in shape.

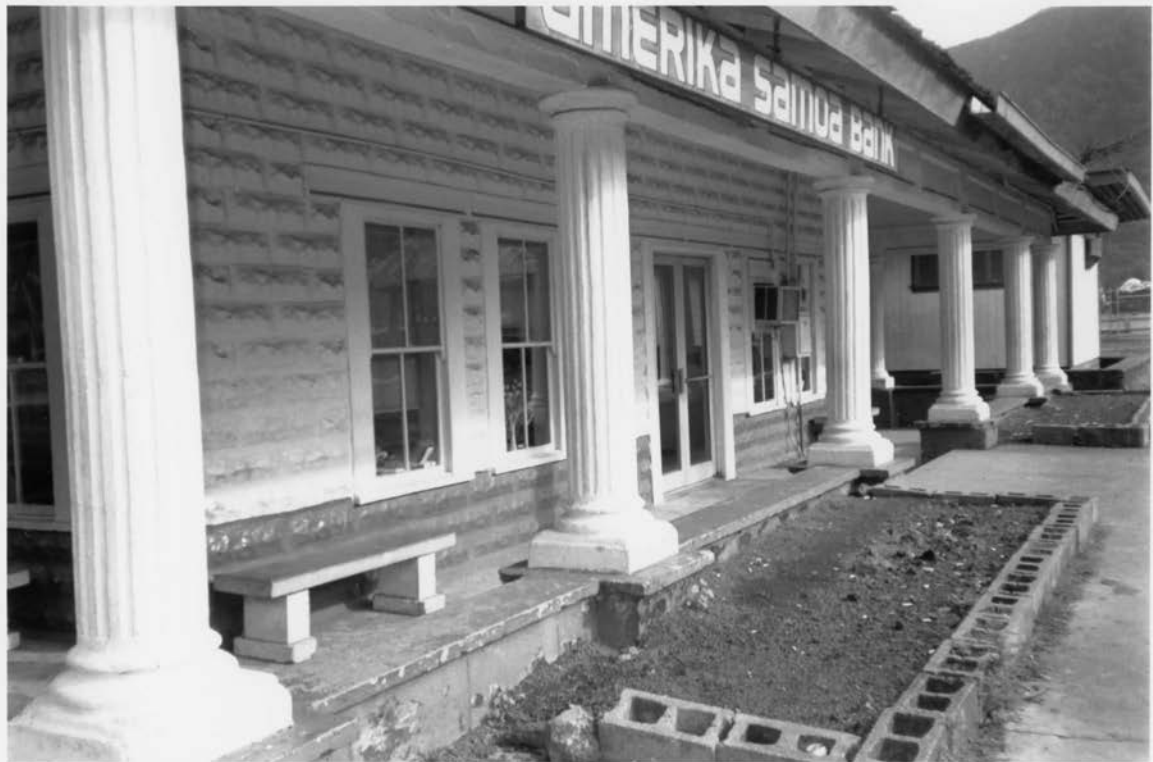
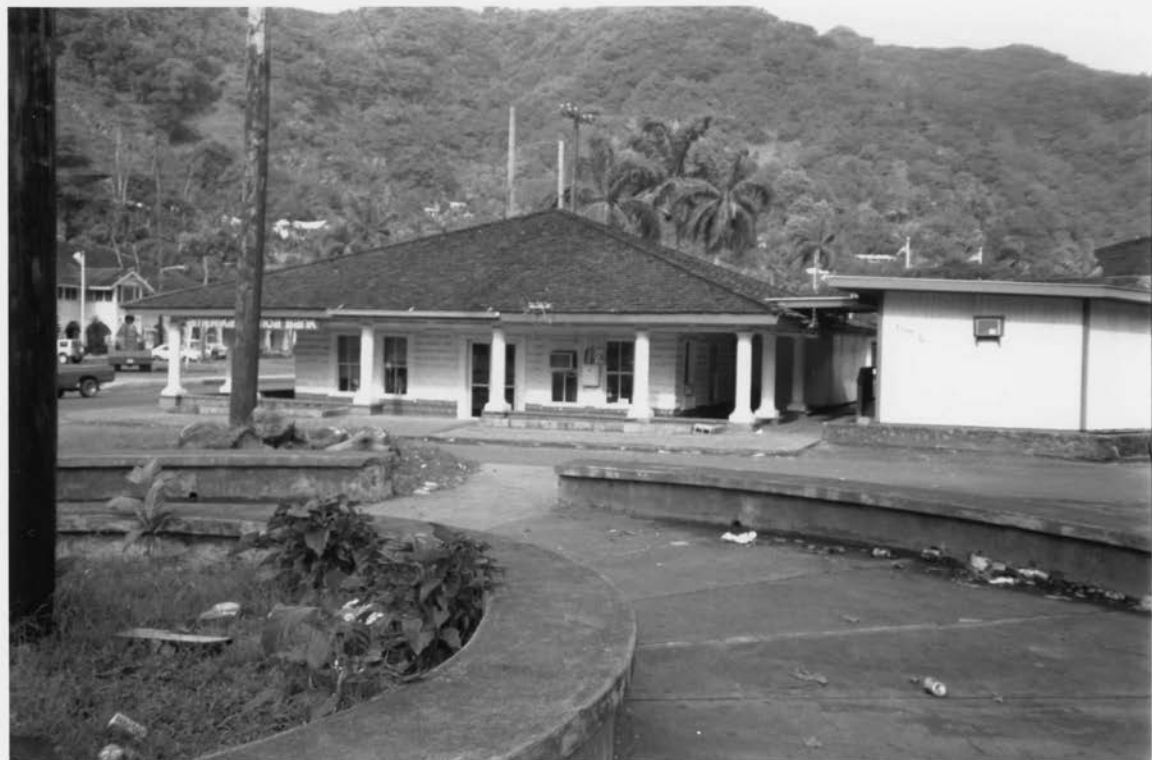
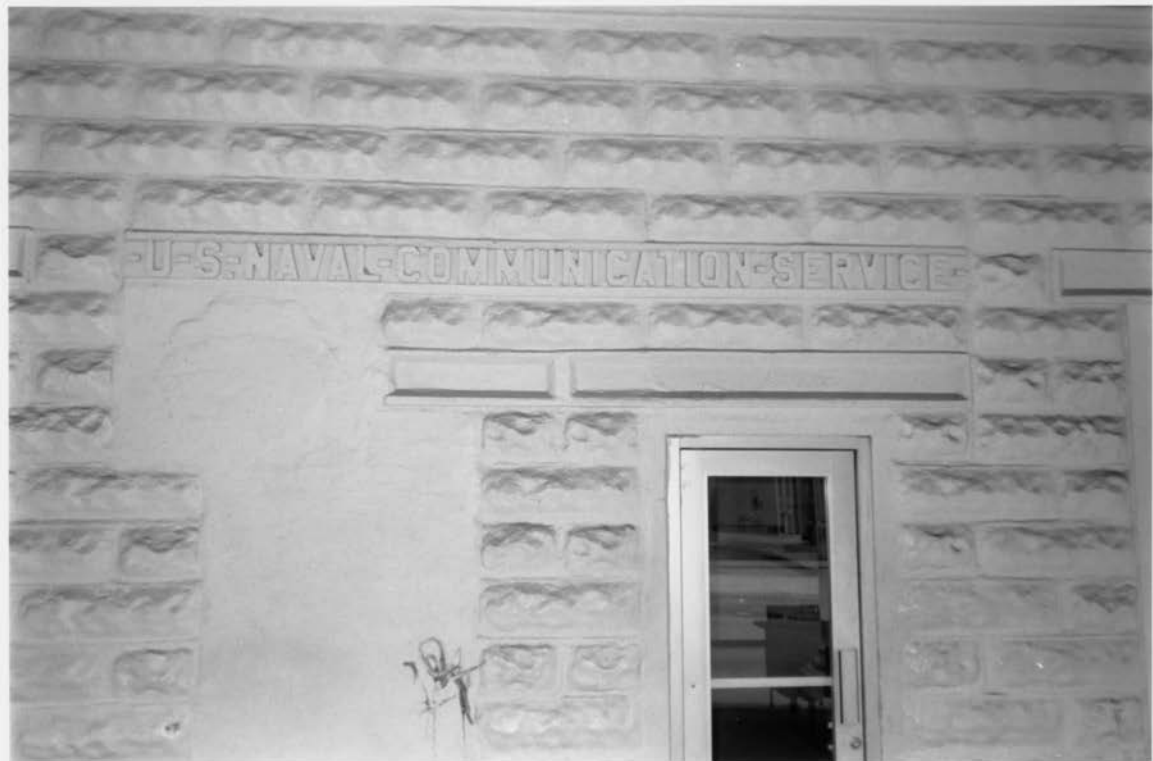
#11. RADIO STATION, NAVY NO. 38, 1988  
U.S. NAVAL STATION TUTUILA, AMERICAN SAMOA

#12. RADIO STATION, NAVY NO. 38, 1988,  
U.S. NAVAL STATION TUTUILA, AMERICAN SAMOA

#13. RADIO STATION, NAVY NO. 38, 1988,  
U.S. NAVAL STATION TUTUILA, AMERICAN SAMOA

Radio Station, Navy No. 38. The naval station's first radio set-up operated from a hill outside the naval station. In 1917, with World War I raging, the Navy Department directed the dismantling of this station and the installation of the apparatus in a new building on the naval station, building 38. The walls of this single story structure marked a new element in Tutuila's architecture. To overcome termites and hurricanes, they were constructed of locally manufactured concrete blocks moulded to imitate rough-cut stone, with concrete lintels and sills. The building measured sixty feet square. Originally a covered veranda extended along all four sides of the building. Today the veranda along the west side and half of the north (rear) side has been boarded in (vertical boarding). The veranda's roof, an extension of the main roof, is supported by large concrete columns, also locally manufactured, six to a side and mounted on a low concrete wall.

The original front of the building faced south looking on to the station's main road. Here the Navy emplaced a concrete low relief lintel reading "U.S. NAVAL COMMUNICATION SERVICE." The wall below this inscription has been modified and a modern steel and glass door installed to provide security. The east side of the building is now the main entrance. The four window openings

on this side appear to be original, while a set of double, steel and glass doors has been installed at the center. The roof today is cedar shake shingle. The floor is a reinforced concrete slab.

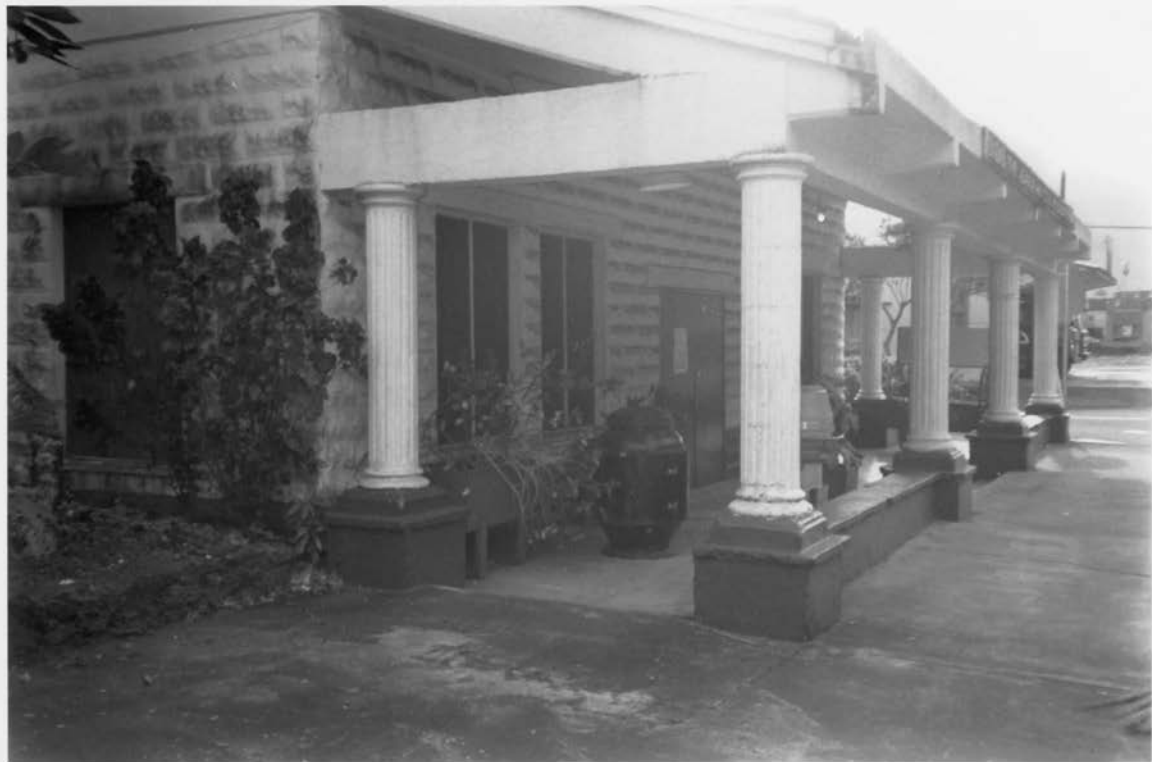
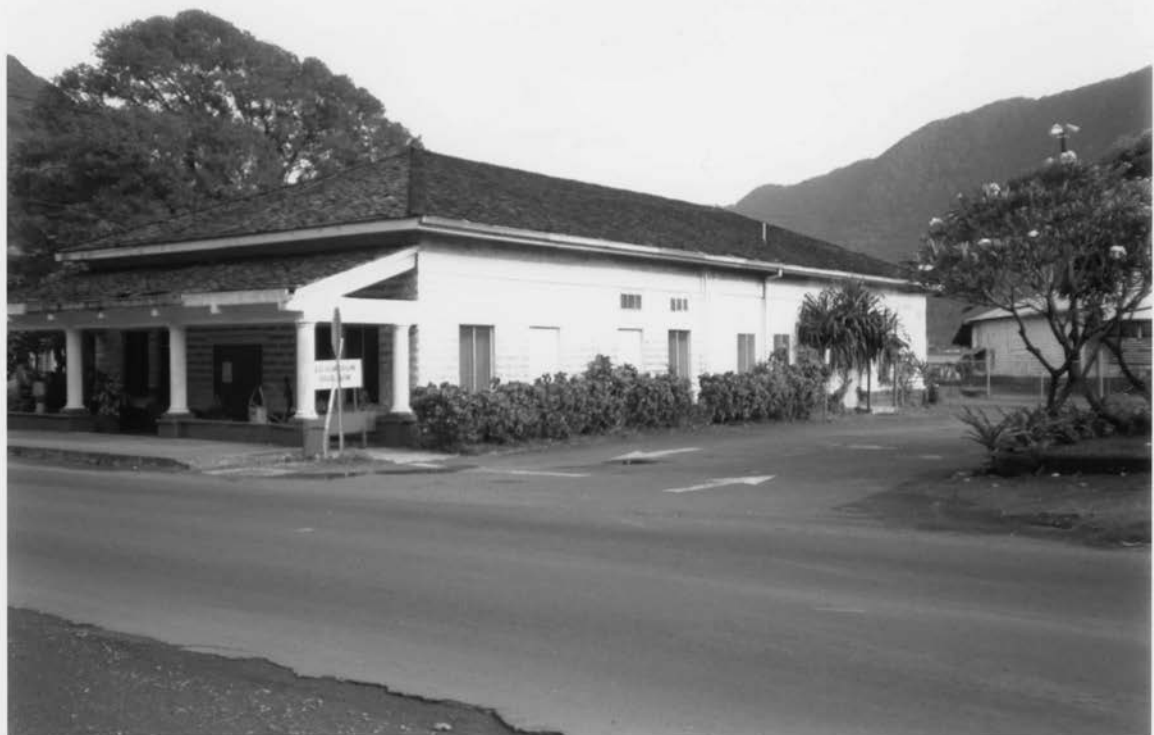
#14. COMMISSARY, NAVY NO. 43, 1988,  
U.S. NAVAL STATION TUTUILA, AMERICAN SAMOA

#15. COMMISSARY, NAVY NO. 43, IN FRONT; GARAGE, NAVY NO. 24, IN REAR, 1988  
U.S. NAVAL STATION TUTUILA, AMERICAN SAMOA

Commissary Store, Navy No. 43, and Garage, Navy No. 24. The Navy Department authorized construction of a new one-story commissary store in 1919. Separated from the radio station by one of the radio towers, it too stood on the north side of the main road. Workmen constructed its walls with the same locally-manufactured concrete blocks moulded to imitate rough-cut stone. In contrast to the radio station, it had a covered veranda only on the front. This roof was supported by four concrete columns on the outside and one at either end on the inside. It was constructed separately from the main roof. The columns stood on low concrete walls and piers. On either side of the double front door are two large window openings. Four more windows are on either side of the building. All these openings are now boarded up. All lintels and sills are reinforced concrete. The building was about forty feet wide and sixty feet long. By 1949 the Navy had converted this building into the Treasurer's Office.

The construction date of the one-story garage behind the commissary store remains unknown. built with the same locally-manufactured concrete block, it may have been constructed about the same time as 38 and 43. Only the east and north walls of the structure may be seen from the outside. The north wall has no openings. The east wall possesses a double door with a simple wooden portico. The garage measured about thirty feet by fifty feet.

After the Interior Department took over the former naval station in 1951, it converted the commissary store into the Pago Pago post office. Then, in 1971, a new post office was constructed. At the same time, the government decided to move the Jean P. Haydon Museum out of its room in Government House and convert both the commissary and the garage into a single structure to house an enlarged museum facility. The east wall added between the commissary and the garage was poured, reinforced concrete. The plans added a reinforced concrete ell to the west side of the garage making the whole structure L-shaped. Cedar shake shingles cover the roof. From the street, the front of the former commissary maintains its integrity and helps preserve the historic scene of this area.

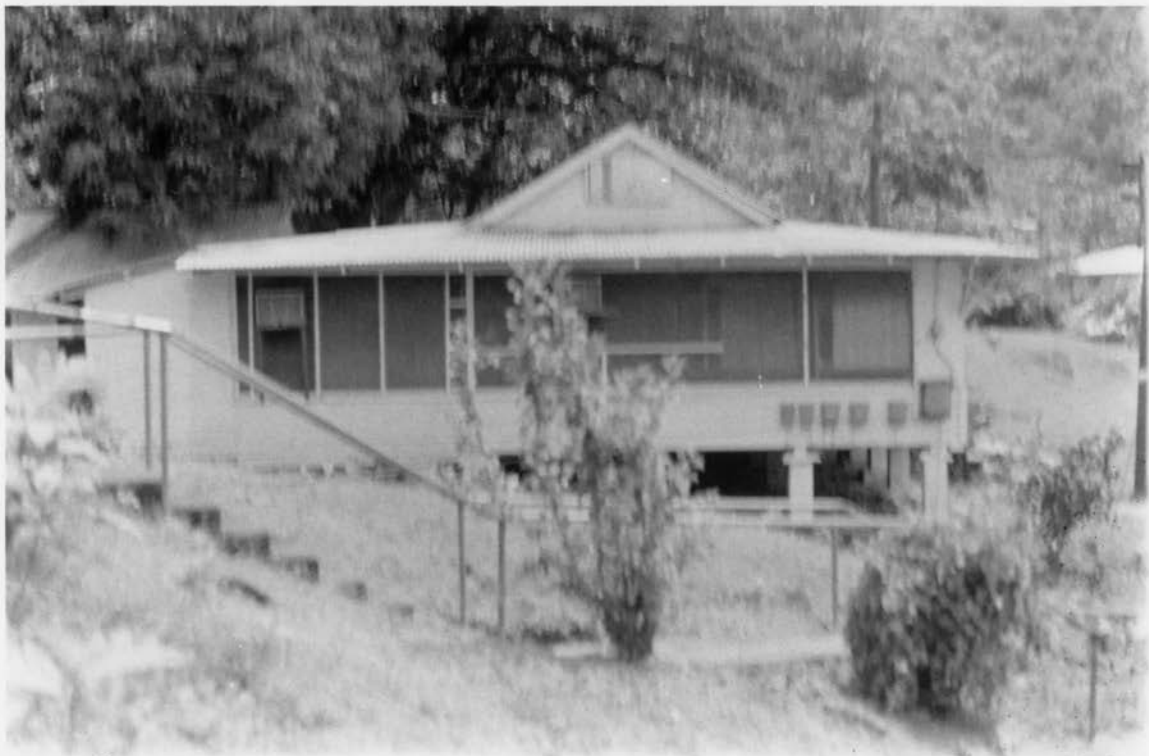
26. MARINE SERGBANT'S QUARTERS , NAVY NO. 30  
U.S. NAVAL STATION TUTUILA, AMERICAN SAMOA

26. Marine sergeant's quarters. Today, the office of the motor carrier safety officer. Navy no. 30. Photo by Stan Sorensen, American Samoa.

Marine Sergeant's Quarters, Navy No. 30. Located on high ground behind the Fita Fita barracks, this small, modest structure housed the Marine sergeant and his family assigned to the naval station to train the Fita Fita Native Guard. The date of construction of this one-story frame building is unknown. The commandant requested that a Marine sergeant be sent to Tutuila in 1903. The Navy Department approved the request and presumably quarters were erected soon thereafter.

This structure, covered with a corrugated iron roof, measures approximately forty-five by twenty-five feet. As originally constructed it had a covered veranda across the front and part of one side. The veranda on the front has been removed and that on the side has been enclosed and added to the interior. Today the building serves as the office of the motor carrier safety officer.

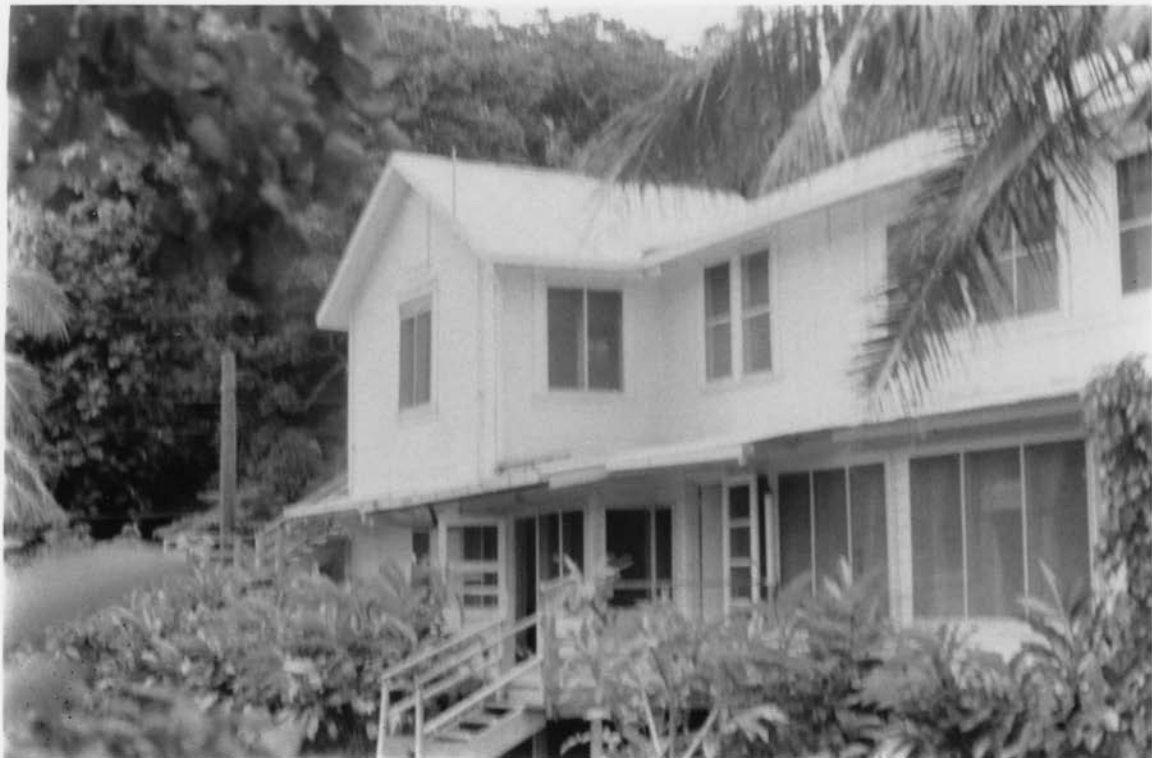
27. DUPLEX OFFICERS' QUARTERS , NAVY NO. 26  
U.S. NAVAL STATION TUTUILA, AMERICAN SAMOA

27. Duplex officers' quarters. Navy no. 26. Today, the residence of the lieutenant governor. Photo by Stan Sorensen.

Duplex Officers' Quarters, Navy No. 26. The construction date of this two-story, frame, duplex officers' quarters is unknown. Its low number suggests it was built in the first decade of the twentieth century. Standing on concrete piles, it is located east of and below Government House. A 1934 map shows that verandas extended across the front and part way back on the sides. Two ells had been built on the rear of the building. Corrugated iron covers the roof. In 1934 the station supply officer and the medical officer and their families occupied the quarters. That same year the maintenance records noted repairs to the roof and the exterior being painted. Today the lieutenant governor of American Samoa occupies the residence.
