KENTUCKY HISTORIC RESOURCES
Individual Inventory Form

Resource # 28
Shelby County

1. Name of Resource:
McMicken House

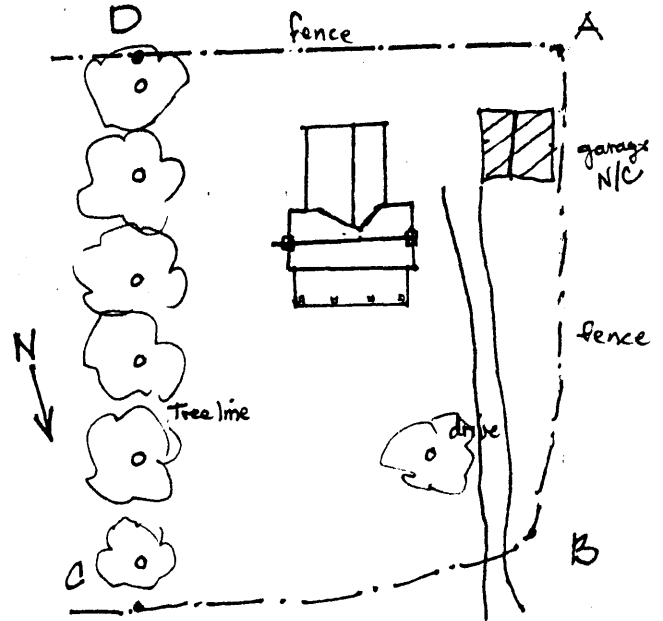
44. Site Plan (and boundary description and justification for N.R. sites):

Beginning at A where the fences intersect, N 150' along a fence to B, E 90' along a fence line and crossing the drive to C, S 150' along a treeline to D, W 90' along a fence line to the point of origin. The nominated acreage includes the house and a modern, non-contributing frame garage and separates the domestic space from the modern dairy farm complex.

Point A is at the intersection of the fences defining the southern and eastern edges of the yard and is 20 feet south of the southwestern corner of the garage.

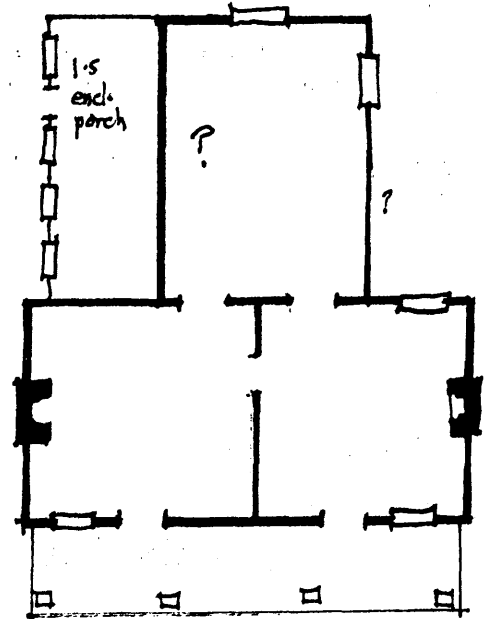
45. Description and House Plan:

1-story, 4-bay, 5-course common bond brick hall-parlor (two-room) plan with a later 19th c. rear ell with enclosed side porch (now covered with vinyl siding), ashlar stone foundation, partially exterior end chimneys, original box cornice and tapered rake boards, front doors replaced, windows altered to 2/2 (6/9 sash remains in rear wall and in east end wall), 20th century porch added.

Enclosed corner stair in southwest corner of east room, square corner blocks at interior doors and windows and at cupboards flanking fireplaces in both rooms, mantels similar in both rooms; molded architrave with shelf on tapering octagonal columns, low beaded baseboard in east room, high molded baseboard in west room, frame ell on concrete block foundation with enclosed porch on east side.
