KENTUCKY HISTORIC RESOURCES
Individual Inventory Form

Resource # Me-58
Mercer County

1. Name of Resource:
Williams House

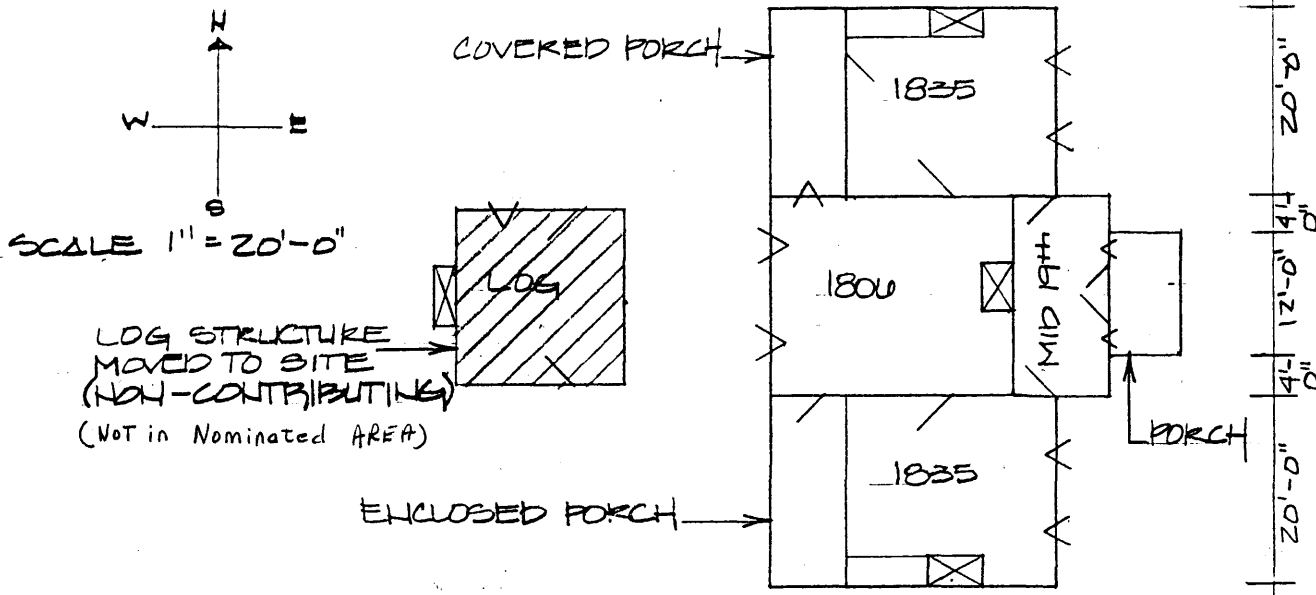
44. Site Plan (and boundary description and justification for N.R. sites):

The house, originally built for Polly Williams Foster, exhibits detailing from three periods of construction. The original hall-parlor portion of the house is upright timbers infilled with mud. Built in 1806, the original entrance faced south toward the Warwick Road which also ran past Williams Station east of the house. In 1835, two one-room wings were added on the north and south sides of the house and the entrance moved to the east side of the house. The added rooms were made of upright timbers with wood lath infill. The new entrance was recessed with side doors leading into each of the north and south rooms. In the mid-nineteenth century, a porch was added and a double-leaf door with sidelights and a transom moved up flush to the east exterior plane of the house. The present east, or front, side presents a five-bay facade clad in frame weatherboarding. The roofline varies in height because the rooms on the north and south sides are one story each and the center section is one-and-one-half stories. To the rear, or west, of the house a log cabin which was in danger of being destroyed on its original site has been reconstructed. It is a square hewn log pen with V-notching at the corners. It has an entrance and a single window on the north facade.

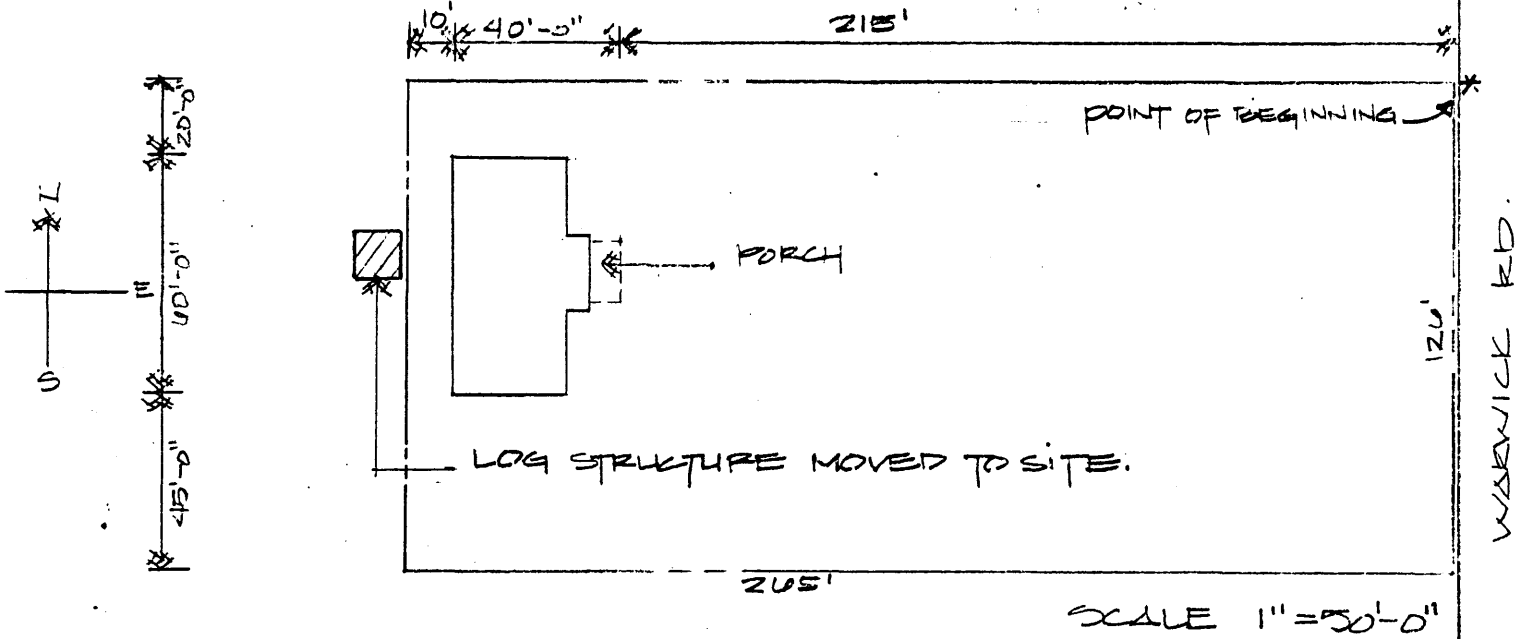
Sketch of Site Plan (Showing outbuildings, structures, landscape features and the site boundary as described above.)

From a point in the west side of Warwick Road 20 feet north and 230 feet east of the northeast corner of the Williams House, then 126 feet south along the west side of Warwick Road to a point; then 265 feet west to a point; then 126 feet north to a point; then 265 feet east to the point of beginning.

The boundary was chosen to preserve the setback of the house from Warwick Road, to include all of the contributing elements, and to provide minimal setting for the house. It excludes the log outbuilding because it was recently moved and reassembled on the site.
