National Register of Historic Places  
Registration Form

historic name Dallas Mill Village Historic District  
other names/site number N/A

street & number Dickson St. NE to Russell St. NE, Rison Ave. NE to Pratt Ave. NE  not for publication  
(see p. 3)  
city or town Huntsville  vicinity  
state Alabama code AL county Madison code 089 zip code 35801

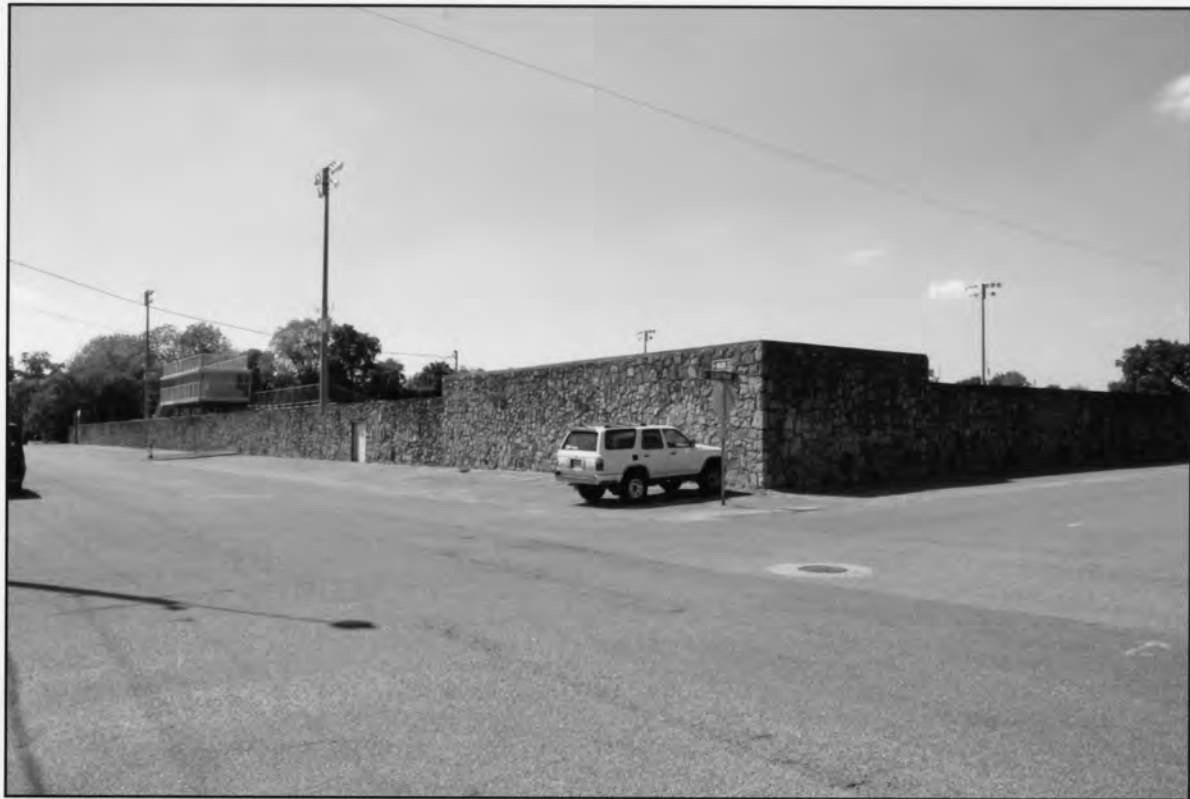
Photo #6  
Ward Avenue NE, Goldsmith-Schiffman Athletic  
Field (Inv. #6), camera facing northwest  
Image: AL\_MadisonCo\_DallasMillHD\_0006.tif  
*Epson Ultrachrome Ink on Premium Glossy Photo Paper*

**Community Planning and Development:** The Dallas Mill Village Historic District is significant for its documentation of a planned Southern textile mill village from 1891 to circa 1949. Begun in 1891, the company initially built its mill and then constructed the residential village between the 1890s and 1949. The industrial portion of the village was laid out adjacent to the Norfolk and Suffolk Railroad. The residential village (originally known as Lawrence Village) was developed on land adjacent to the mill by company investor Oscar Goldsmith. Under Goldsmith's planning and implementation, the company initially built houses adjacent to the mill in the 1890s (Inv. # 48, Photo #29, and Inv. # 148, Photo #2). Following that, between circa 1910 and circa 1949, the company planned and built additional houses which remain extant from each decade, a manager's house (Inv. # 44, Photo #26), and various amenities including an athletic stadium and athletic field (Inv. # 6 and 7, Photos

#6-7), a church (Inv. # 58, Photo #31), a commissary (Inv. # 106) and a drainage system (Inv. # 25, Photo #44) and water system (Inv. #s 26 and 27, Photo #43).

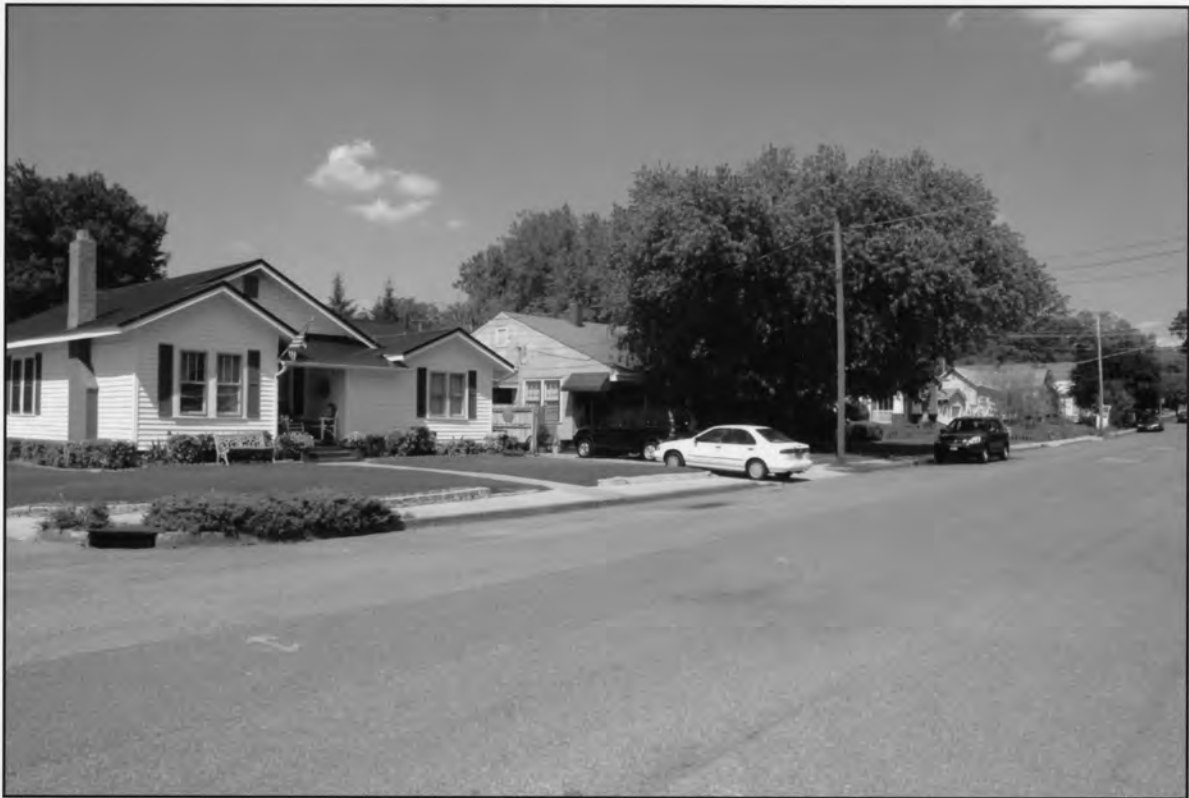
Photo #8  
Ward Avenue NE, streetscape, camera facing  
northeast  
Image: AL\_MadisonCo\_DallasMilHD\_0008.tif  
*Epson Ultrachrome Ink on Premium Glossy Photo Paper*

233	Ward Ave. NE, 500	House, Not Named	ca. 1930	Contributing	Type 6 house with a full facade gable porch with wood posts, wood 3/1 double hung sash windows, and replacement vinyl siding (ca. 1985). (Photo #9)
234	Ward Ave. NE, 501	House, Not Named	ca. 1925	Contributing	Type 5 house with an exterior end brick chimney replacement vinyl siding (ca. 1985), 3/1 windows and a modern cross gable addition to the east (ca. 1985). (Photo #8)
235	Ward Ave. NE, 502	House, Not Named	ca. 1925	Contributing	Type 6 house with replacement vinyl siding (ca. 1985), full facade gable porch with metal supports, 3/1 double hung wood windows, and a continuous brick foundation. (Photo #9)
236	Ward Ave. NE, 503	House, Not Named	ca. 1945	Contributing	One story side gable house with an interior brick chimney, less than full facade recessed porch with metal supports, replacement composite shingle siding, and 6/6 windows. (Photo #8)

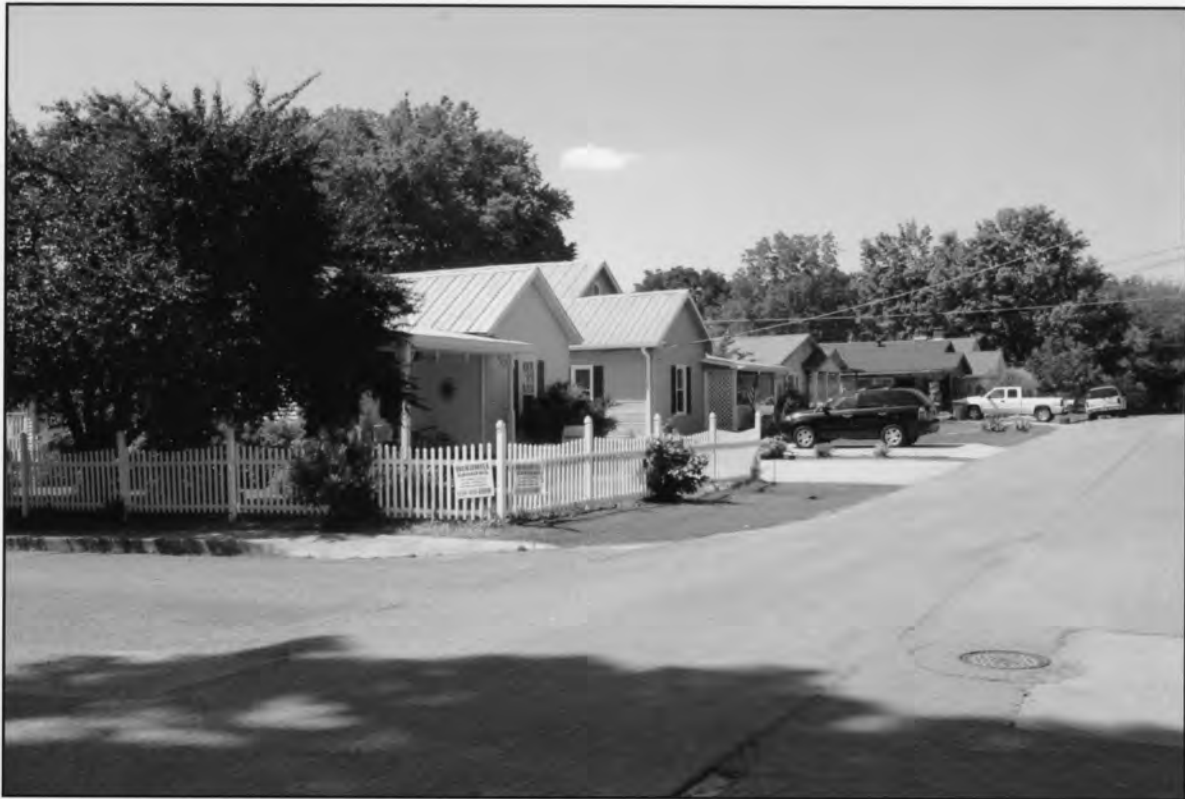
Photo #10  
Dement Street NE, streetscape, camera facing  
northwest  
Image: AL\_MadisonCo\_DallasMillHD\_0010.tif  
*Epson Ultrachrome Ink on Premium Glossy Photo Paper*

- 031 Dement St. NE, 401 House, Not Named ca. 1915 Contributing  
Type 8 house with a cross gable V-crimped metal roof, replacement vinyl siding (ca. 1985), 9/9 double hung wood windows (ca. 1985), and replacement turned porch posts. (Photo #10)

- 035 Dement St. NE, 409 House, Not Named ca. 1925 Contributing  
Type 5 house with replacement vinyl siding (ca. 1985) and the vinyl-clad porch supports on brick pedestals. (Photo #10)

Type 8: One story gable front and wing form house or duplex with a cross gable roof, central brick chimney, less than full façade shed porch with wood posts, central entrance with transom flanked by 4/4 double hung sash windows, duplex variants have second entrance at side elevation within porch, wood novelty siding, brick foundation. Variations and typical alterations: single family and duplex variants, front wing at right or left, later examples have single and double 3/1 double hung sash windows. 15 examples, inventory #s: 14, 31, 75, 85, 86, 90, 92, 93, 128, 146, 222, 223, 226, 242, and 246. (Photos #1, 10, 11, 14, and 18)

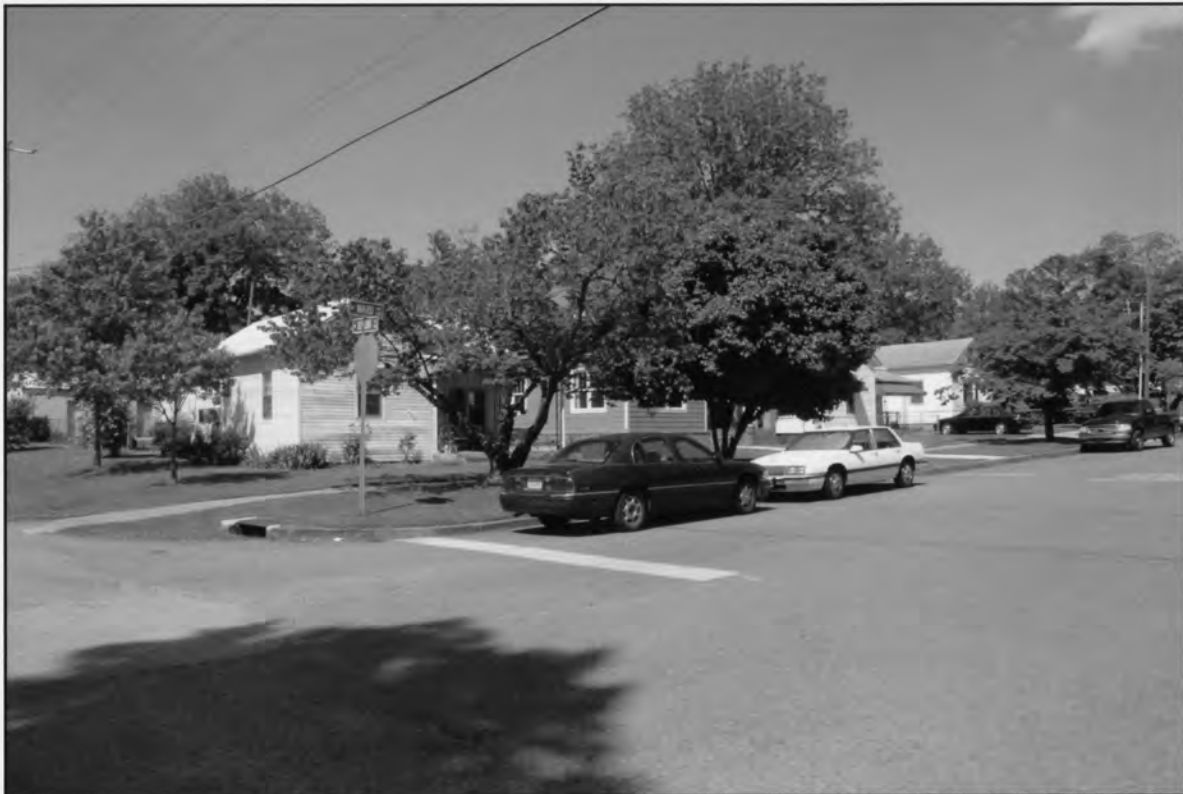
Photo #11  
Ward Avenue NE, streetscape, camera facing  
northeast

- 242 Ward Ave. NE, 601 House, Not Named ca. 1925 Contributing  
Type 8 house with a cross metal porch supports, replacement vinyl siding (ca. 1985), and 3/1 and horizontal 2/2 (ca. 1955) double hung wood windows. (Photo #11)

- 244 Ward Ave. NE, 603 House, Not Named ca. 2010 Noncontributing  
Modern two story frame house with a front gable roof. (Photo #11)
- 245 Ward Ave. NE, 604 House, Not Named ca. 1925 Contributing  
One story gable front form brick veneer house with wood shingles and bracketed eaves at its gable end, interior brick chimney, wood 6/6 double hung sash windows, wood porch supports on low brick pedestals and apron wall, and a brick foundation. (Photo #12)

- 246 Ward Ave. NE, 605 House, Not Named ca. 1925 Contributing  
Type 8 house with replacement vinyl siding (ca. 1985), 4/4 double hung wood windows, aluminum porch and window awnings, and metal porch supports. (Photo #11)

- 247 Ward Ave. NE, 607 House, Not Named ca. 1955 Contributing  
One story gable front and wing form house with a cross gable asphalt shingle roof, less than full façade shed porch with metal supports, replacement aluminum siding (ca. 1975), and replacement 1/1 windows (ca. 1975). (Photo #11)

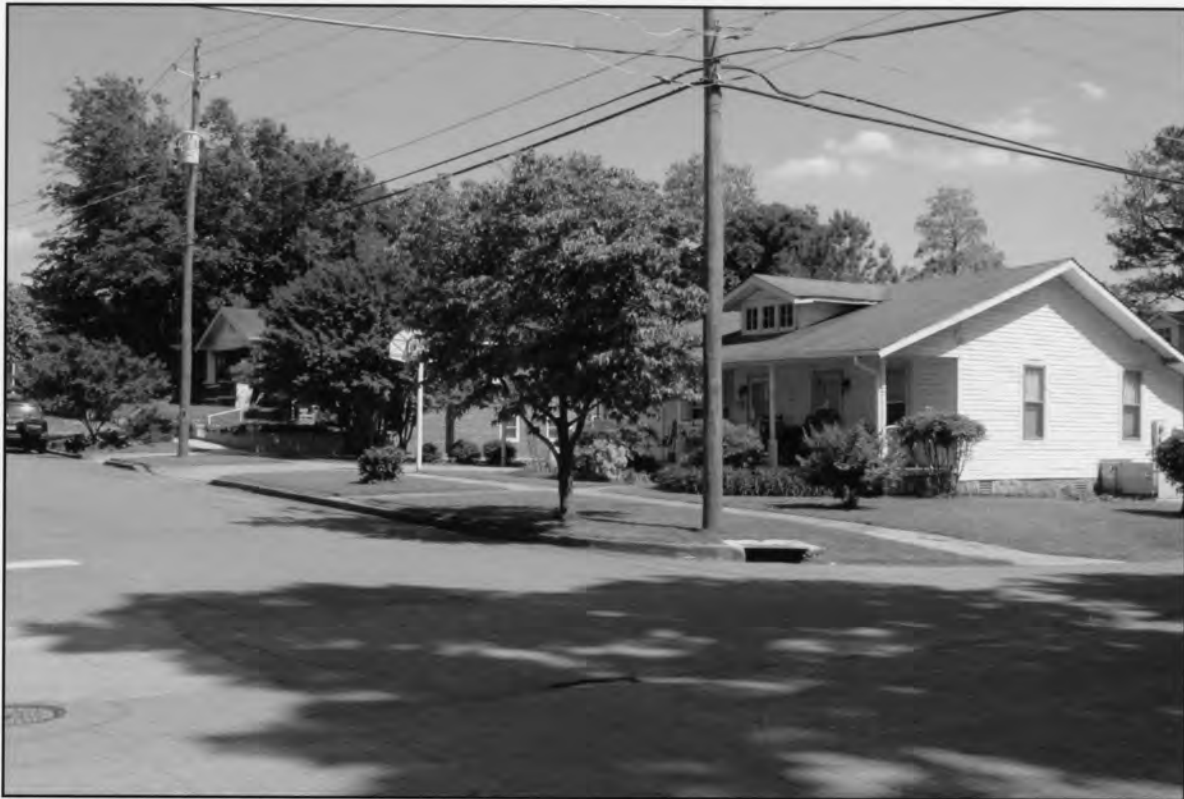
Photo #12  
Ward Avenue NE, streetscape, camera facing  
southeast  
Image: AL\_MadisonCo\_DallasMilHD\_0012.tif  
*Epson Ultrachrome Ink on Premium Glossy Photo Paper*

- 241 Ward Ave. NE, 600 Duplex, Not Named ca. 1930 Contributing  
One store frame side gable duplex with a central gable dormer, replacement vinyl siding (ca. 1980), 3/1 vertical double hung wood windows, and a full facade gable porch with replacement turned wood posts. (Photo #12)

- 243 Ward Ave. NE, 602 House, Not Named ca. 1925 Contributing  
Type 5 brick veneer house with wood novelty siding at its gables, an interior brick chimney and a partial end brick chimney, 3/1 vertical double hung wood windows, and a brick foundation. (Photo #12)

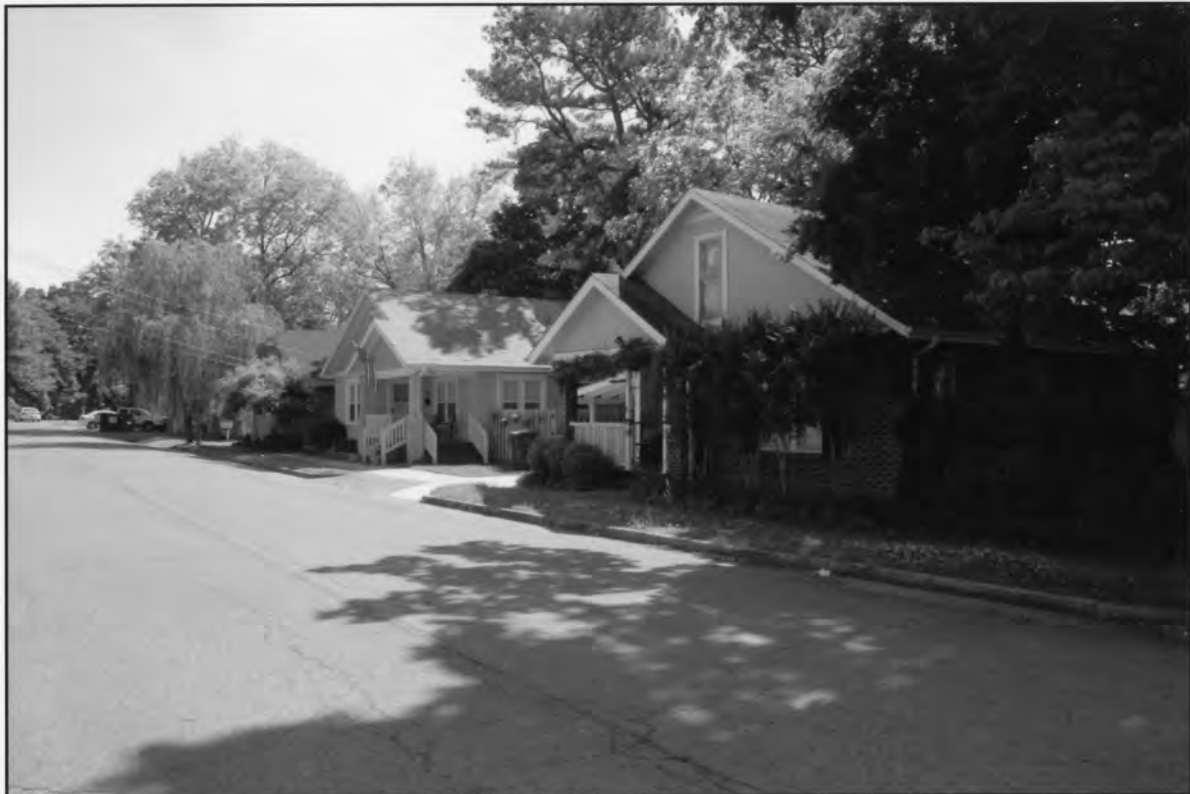
- 029 Dement St. NE, 307 Duplex, Not Named ca. 1945 Contributing  
Type 5 duplex with ca. replacement synthetic stucco and weatherboard siding (ca. 1985), tall brick chimney, 3/1 double hung wood windows, and the front porch has brick pillars on pedestals. (Photo #13)

- 030 Dement St. NE, 309 House, Not Named ca. 1925 Contributing  
Type 5 house with applied brick veneer (ca. 1960), end brick chimney, 3/1 double hung wood windows, brick foundation, and the porch has brick pillars on pedestals. (Photo #13)

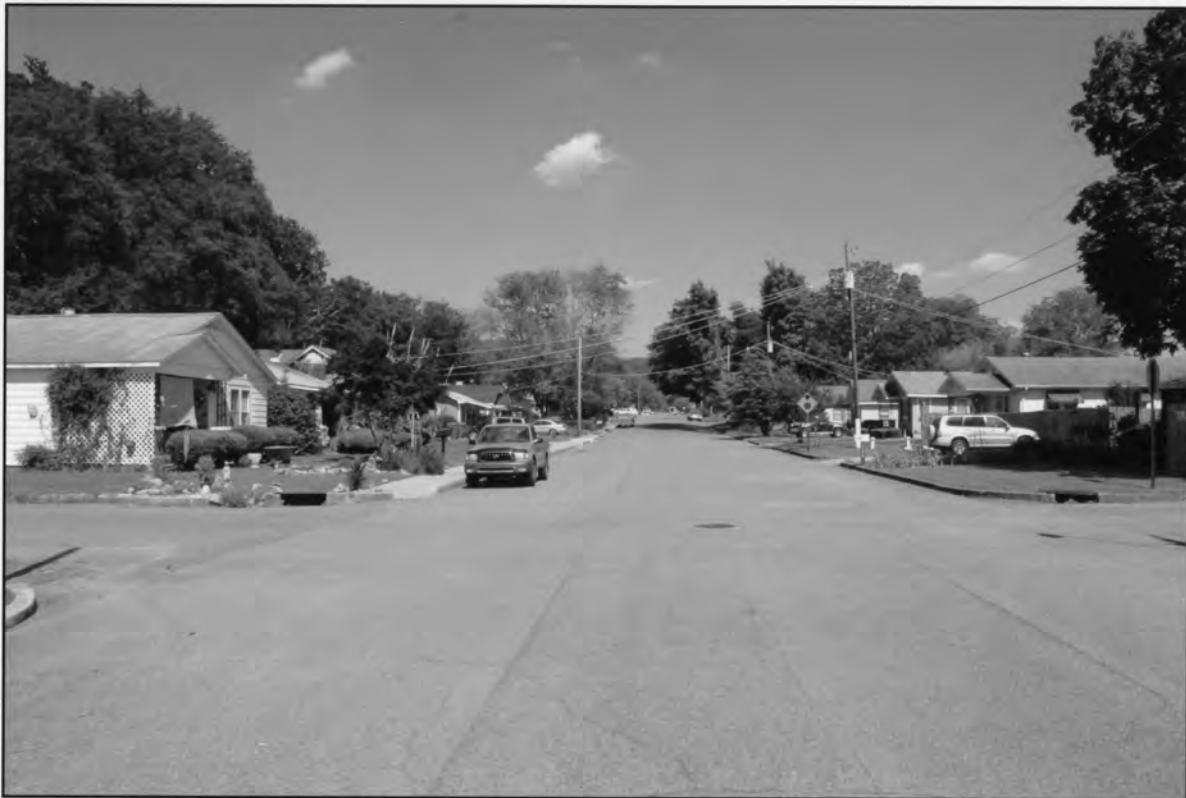
Photo #14  
Bierne Avenue NE, streetscape, camera facing  
east  
Image: AL\_MadisonCo\_DallasMilHD\_0014.tif  
*Epson Ultrachrome Ink on Premium Glossy Photo Paper*

| | Type 6 house with replacement composite shingle siding (ca. 1960). (Photo #14) | | | |

- 009 Beirne Ave. NE, 501 House, Not Named ca. 1925 Contributing  
Type 5 house with replacement weatherboard siding (ca. 1985), simulated stone foundation, 3/1 and 9/9 double hung wood windows, and a less than full facade partially recessed gable porch with metal supports on brick pedestals. (Photo #14)

- 010 Beirne Ave. NE, 502 House, Not Named ca. 1925 Contributing  
Type 5 house with ca. replacement vinyl siding (ca. 1980), 3/1 double hung wood windows, a continuous concrete block foundation and a less than full facade gable porch with metal supports on brick pedestals. (Photo #14)

- 011 Beirne Ave. NE, 503 Duplex, Not Named ca. 1925 Contributing  
Type 1 duplex faced with replacement composite shingle siding (ca. 1965), 1/1 double hung wood windows, a continuous concrete block foundation, and a full facade shed porch with wood supports on brick pedestals. (Photo #14)

- 012 Beirne Ave. NE, 504 House, Not Named ca. 1925 Contributing  
Type 5 house with ca. replacement vinyl siding with brick veneer within porch (ca. 1985), 3/1 double hung wood windows, and a less than full facade partially recessed gable porch with metal supports on brick pedestals. (Photo #14)

- 013 Beirne Ave. NE, 505 Duplex, Not Named ca. 1925 Contributing  
Type 1 duplex with replacement aluminum siding (ca. 1975), 3/1 double hung wood windows, a continuous brick foundation, and a less than full facade shed porch with wood posts. (Photo #14)

- 014 Beirne Ave. NE, 506 House, Not Named ca. 1925 Contributing  
Type 8 house with replacement vinyl siding (ca. 1985), no chimney, 3/1 windows, and metal porch supports. (Photo #14)

- 015 Beirne Ave. NE, 508 House, Not Named ca. 1925 Contributing  
One story gable front form house with replacement vinyl siding (ca. 1985), front gable asphalt roof with an interior brick chimney, 6/1 double hung wood windows, a continuous brick foundation, and an attached entrance bay gable porch with wood posts. (Photo #14)

- 016 Beirne Ave. NE, 509 House, Not Named ca. 1925 Contributing  
One story side gable house with a side gable roof with a central brick chimney, replacement weatherboard siding (ca. 1985), less than full facade shed porch, 3/1 double hung wood windows, and a continuous poured concrete foundation. (Photo #14)

Type 1: One story side gable frame duplex with a rear shed extension, two interior brick chimneys, less than full façade shed porch with wood posts, 4-bay façade with paired central entrances with transoms flanked at the outer bays by 4/4 wood double hung sash windows, continuous brick foundation. Variations and typical alterations: full façade porch, hipped porch. 26 examples, inventory #s: 11, 13, 19, 20, 40, 43, 57, 60, 84, 94, 125, 130, 131, 135, 162, 169, 183, 184, 195, 197-200, 202, 203, and 221. (Photos #14, 16, 32, 34, and 37)

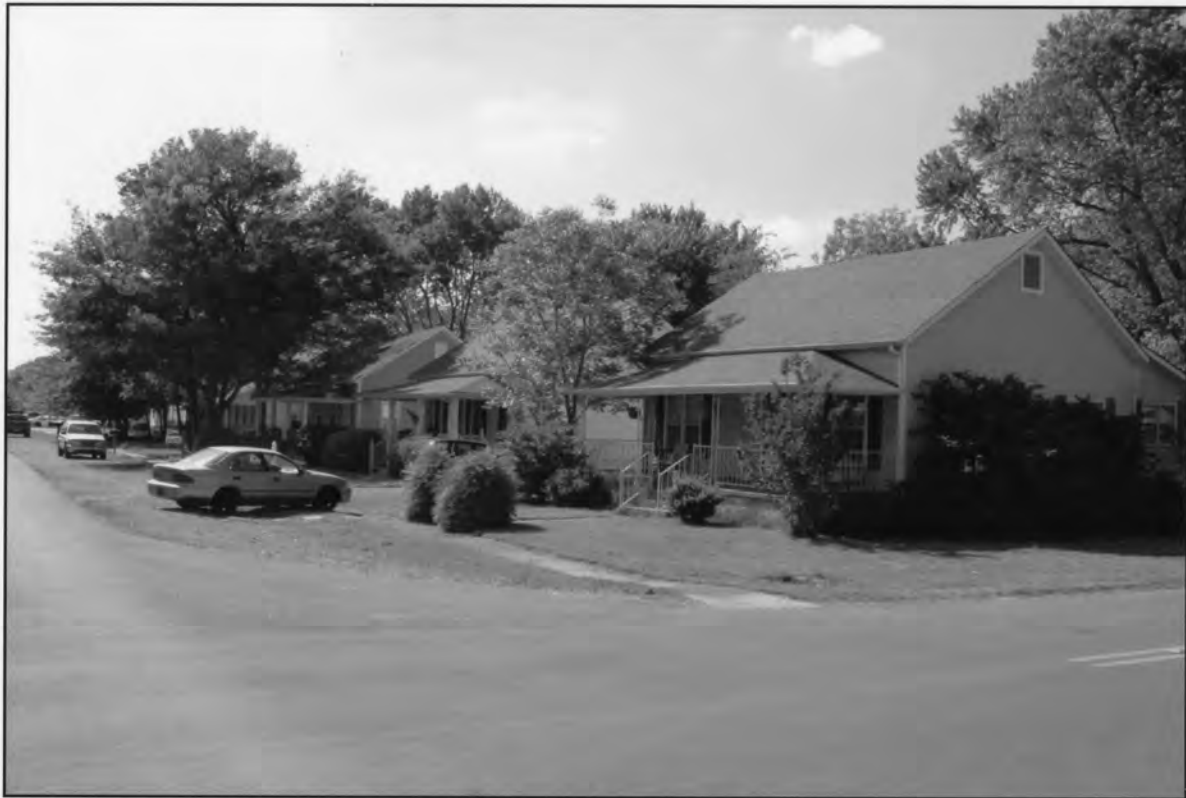
Photo #39  
Stevens Avenue NE, streetscape, camera facing  
southeast  
Image: AL\_MadisonCo\_DallasMilHD\_0039.tif  
Print: Epson Ultrachrome Ink on Premium Glossy Photo Paper

- 215 Stevens Ave. NE, 800 Duplex, Not Named ca. 1925 Contributing  
Type 2 duplex with replacement aluminum siding (ca. 1985), no chimney, and west bay of porch enclosed (ca. 1975). (Photo #39)

- 217 Stevens Ave. NE, 802 Duplex, Not Named ca. 1925 Contributing  
Type 7 duplex with replacement aluminum siding (ca. 1975) and one entrance. (Photo #39)

- 219 Stevens Ave. NE, 805 Duplex, Not Named ca. 1925 Contributing  
Type 2 duplex no chimney, replacement aluminum siding (ca. 1975), replacement 1/1 windows (ca. 1975), and metal porch supports. (Photo #39)

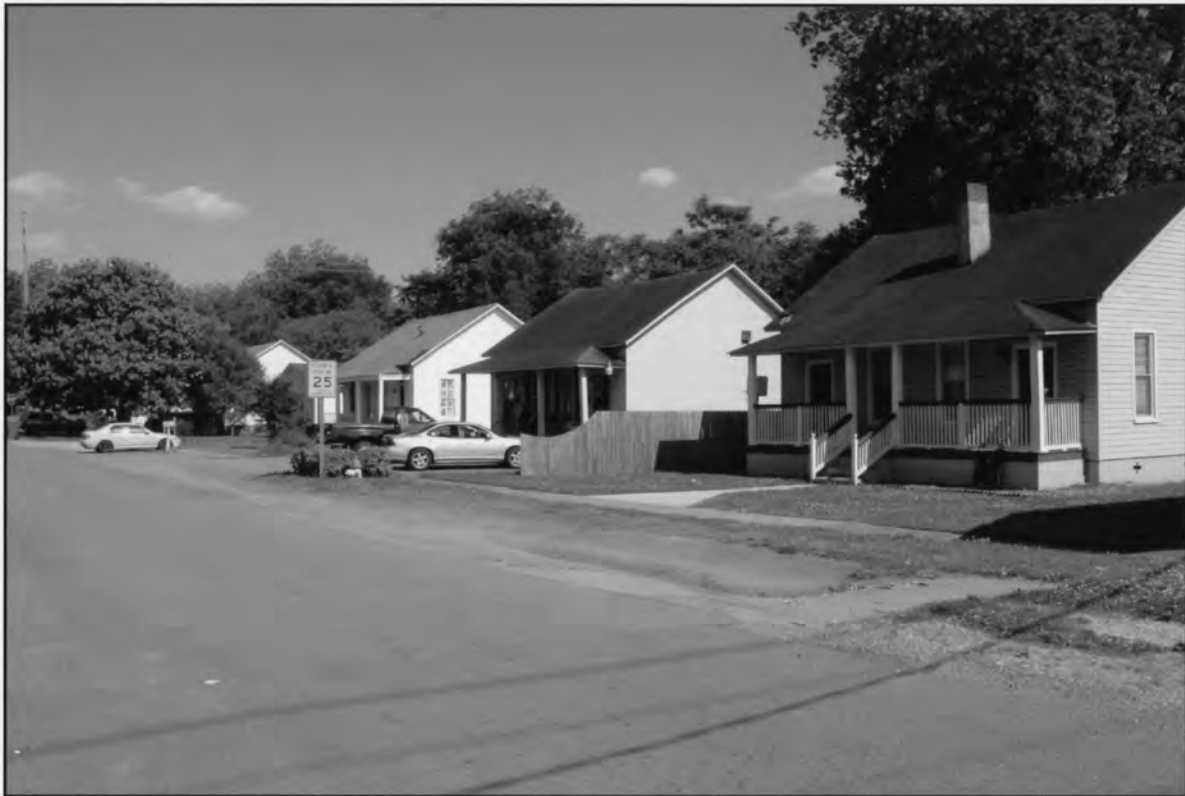
Photo #40  
Stevens Avenue NE, streetscape, camera facing  
northwest  
Image: AL\_MadisonCo\_DallasMilHD\_0040.tif  
*Epson Ultrachrome Ink on Premium Glossy Photo Paper*

- 209 Stevens Ave. NE, 712-714 Duplex, Not Named ca. 1925 Contributing  
Type 2 duplex with replacement vinyl siding (ca. 1985). (Photo #41)
- 210 Stevens Ave. NE, 713-715 Duplex, Not Named ca. 1925 Contributing  
Type 2 duplex with wood supports on brick pedestals, replacement vinyl siding (ca. 1985), west entrance replaced by window, and replacement 6/6 windows (ca. 1985). (Photo #40)

- 212 Stevens Ave. NE, 719 Duplex, Not Named ca. 1925 Contributing  
Type 2 duplex with replacement aluminum siding (ca. 1975), west entrance replaced by window, and replacement 6/6 windows (ca. 1985). (Photo #40)

- 214 Stevens Ave. NE, 721 Duplex, Not Named ca. 1925 Contributing  
Type 2 duplex with replacement vinyl siding (ca. 1985), no chimney, 3/1 windows, and metal porch supports. (Photo #40)
