National Register of Historic Places Registration Form

historic name Lafayette Heights Historic District

city or town Mobile vicinity

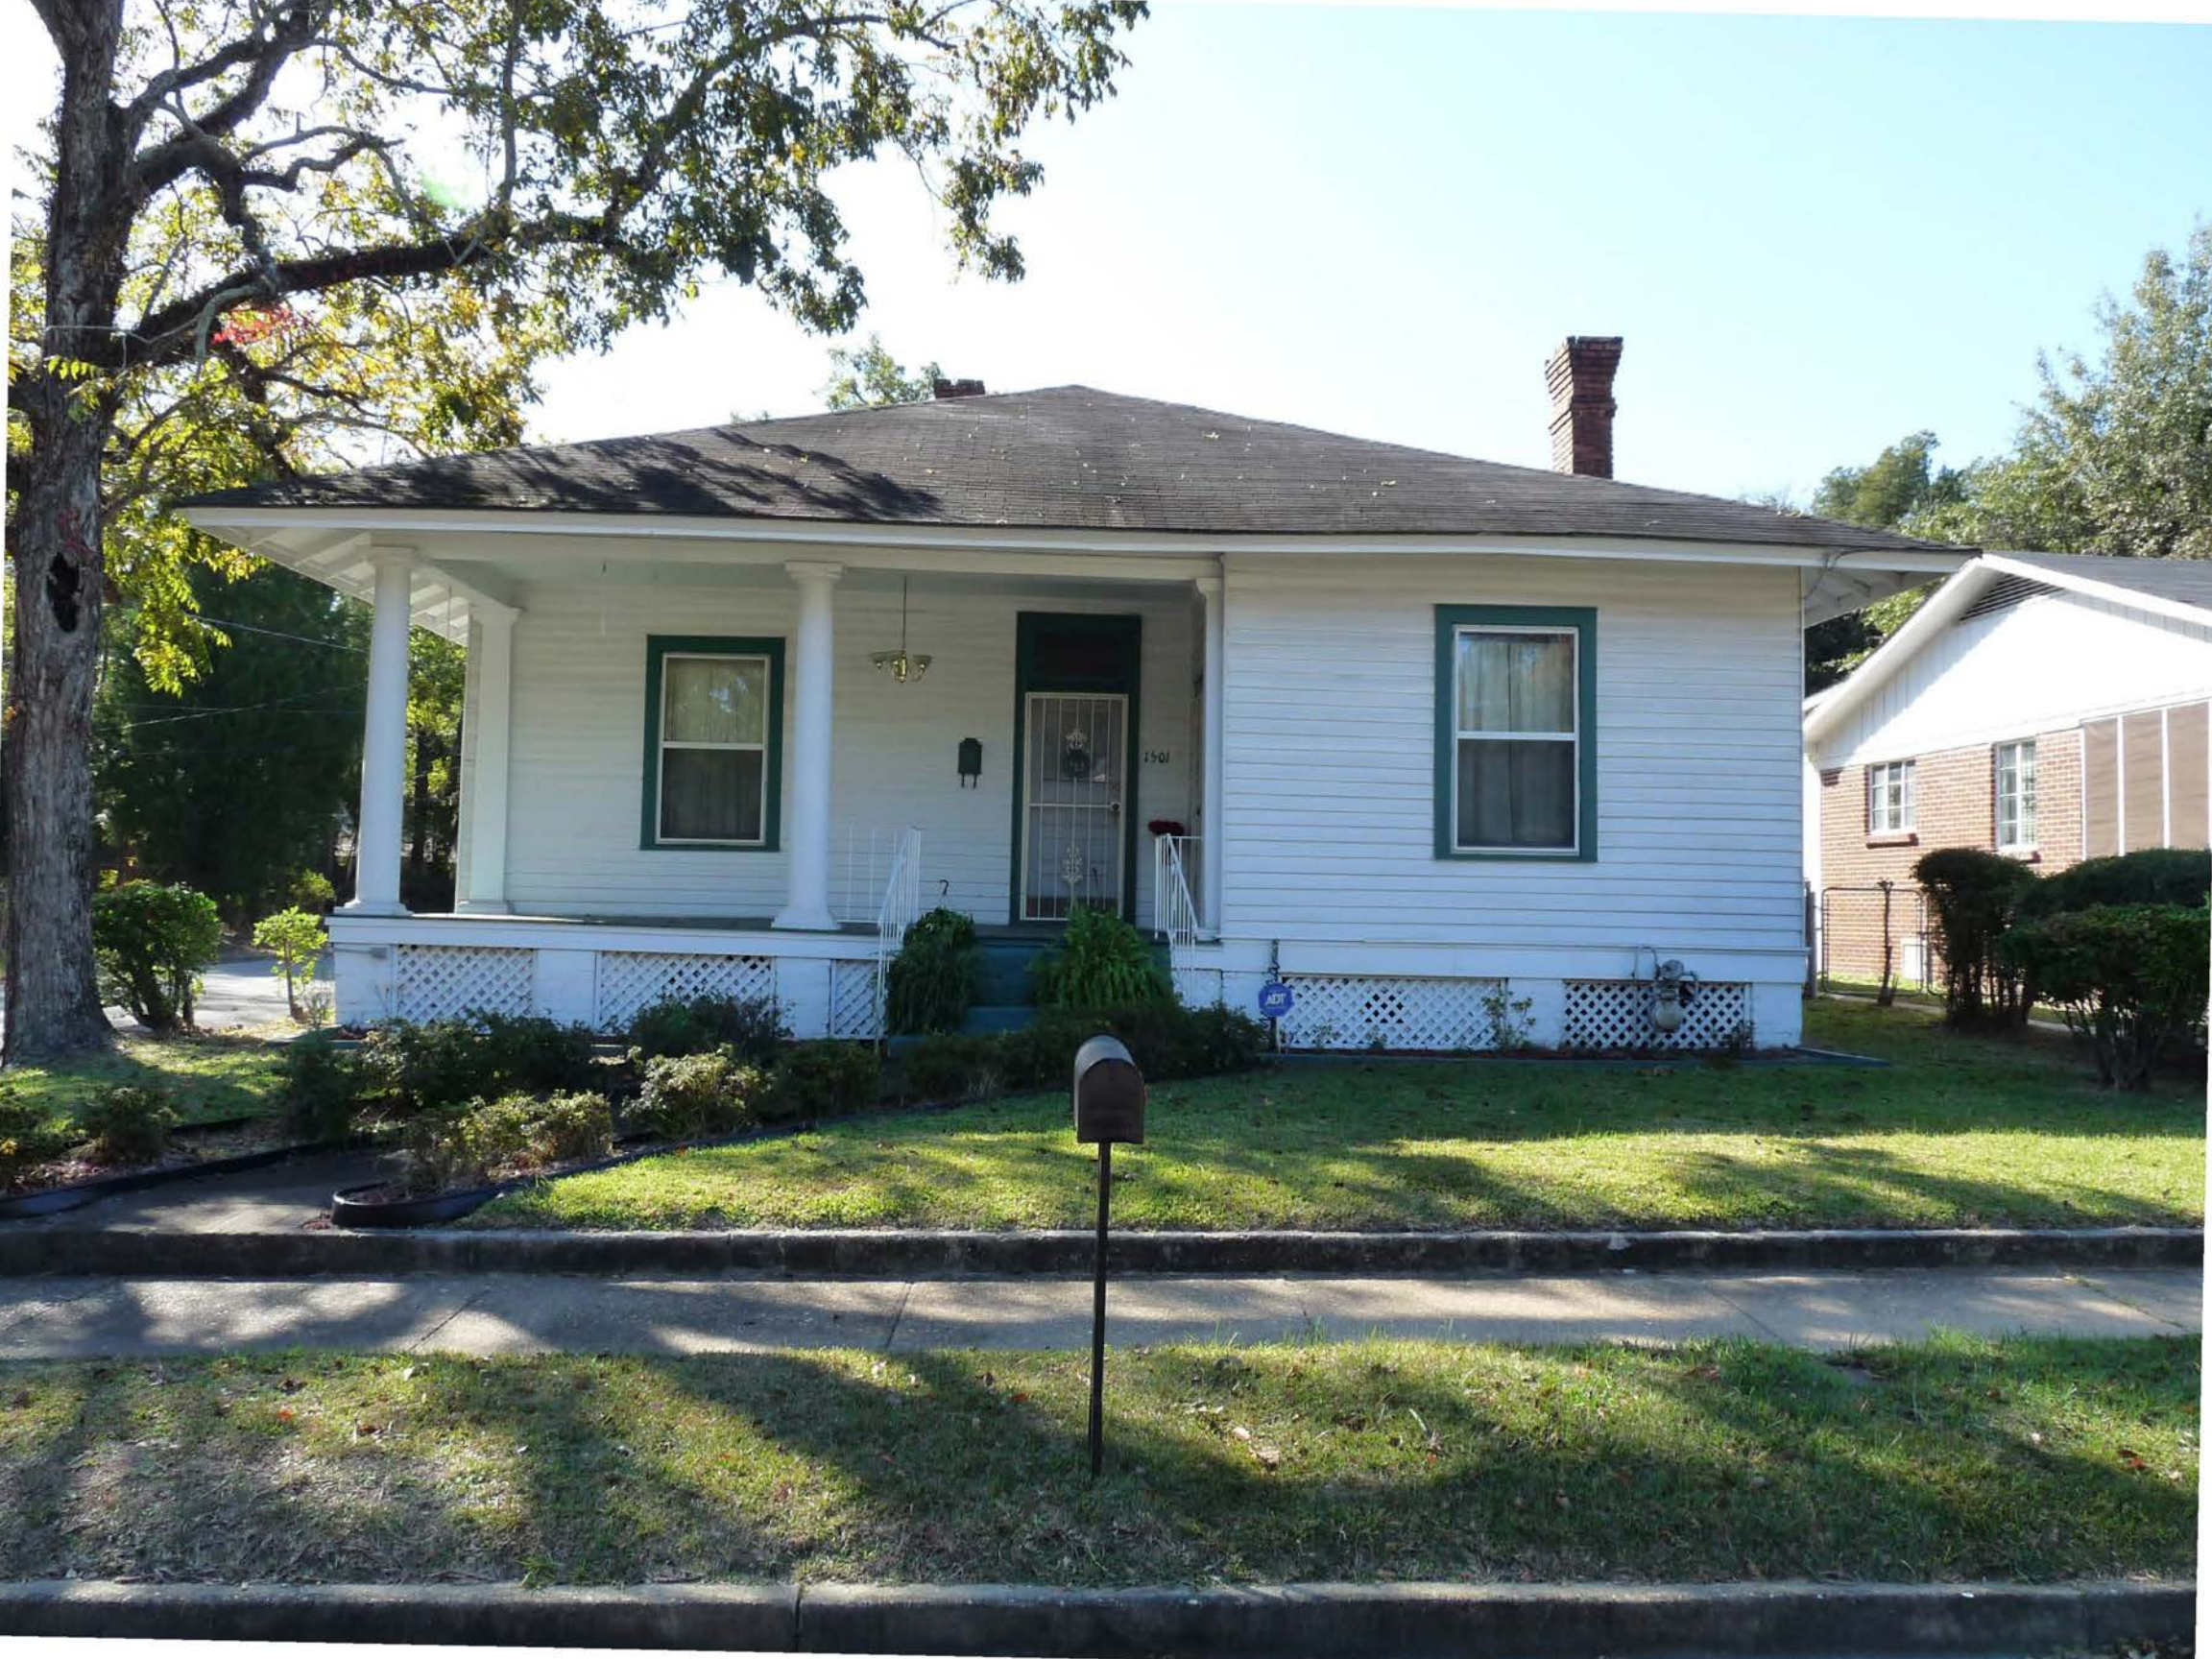
10. 1501 Adams Street. Circa 1900. 1 story wood frame Neo-classical cottage with hip roof, raised brick pier foundation, three bay façade, entrance under recessed porch supported by classical columns, one bay of porch infilled, metal frame 1/1 windows, side chimney, exposed rafters. Photo# 00004. C

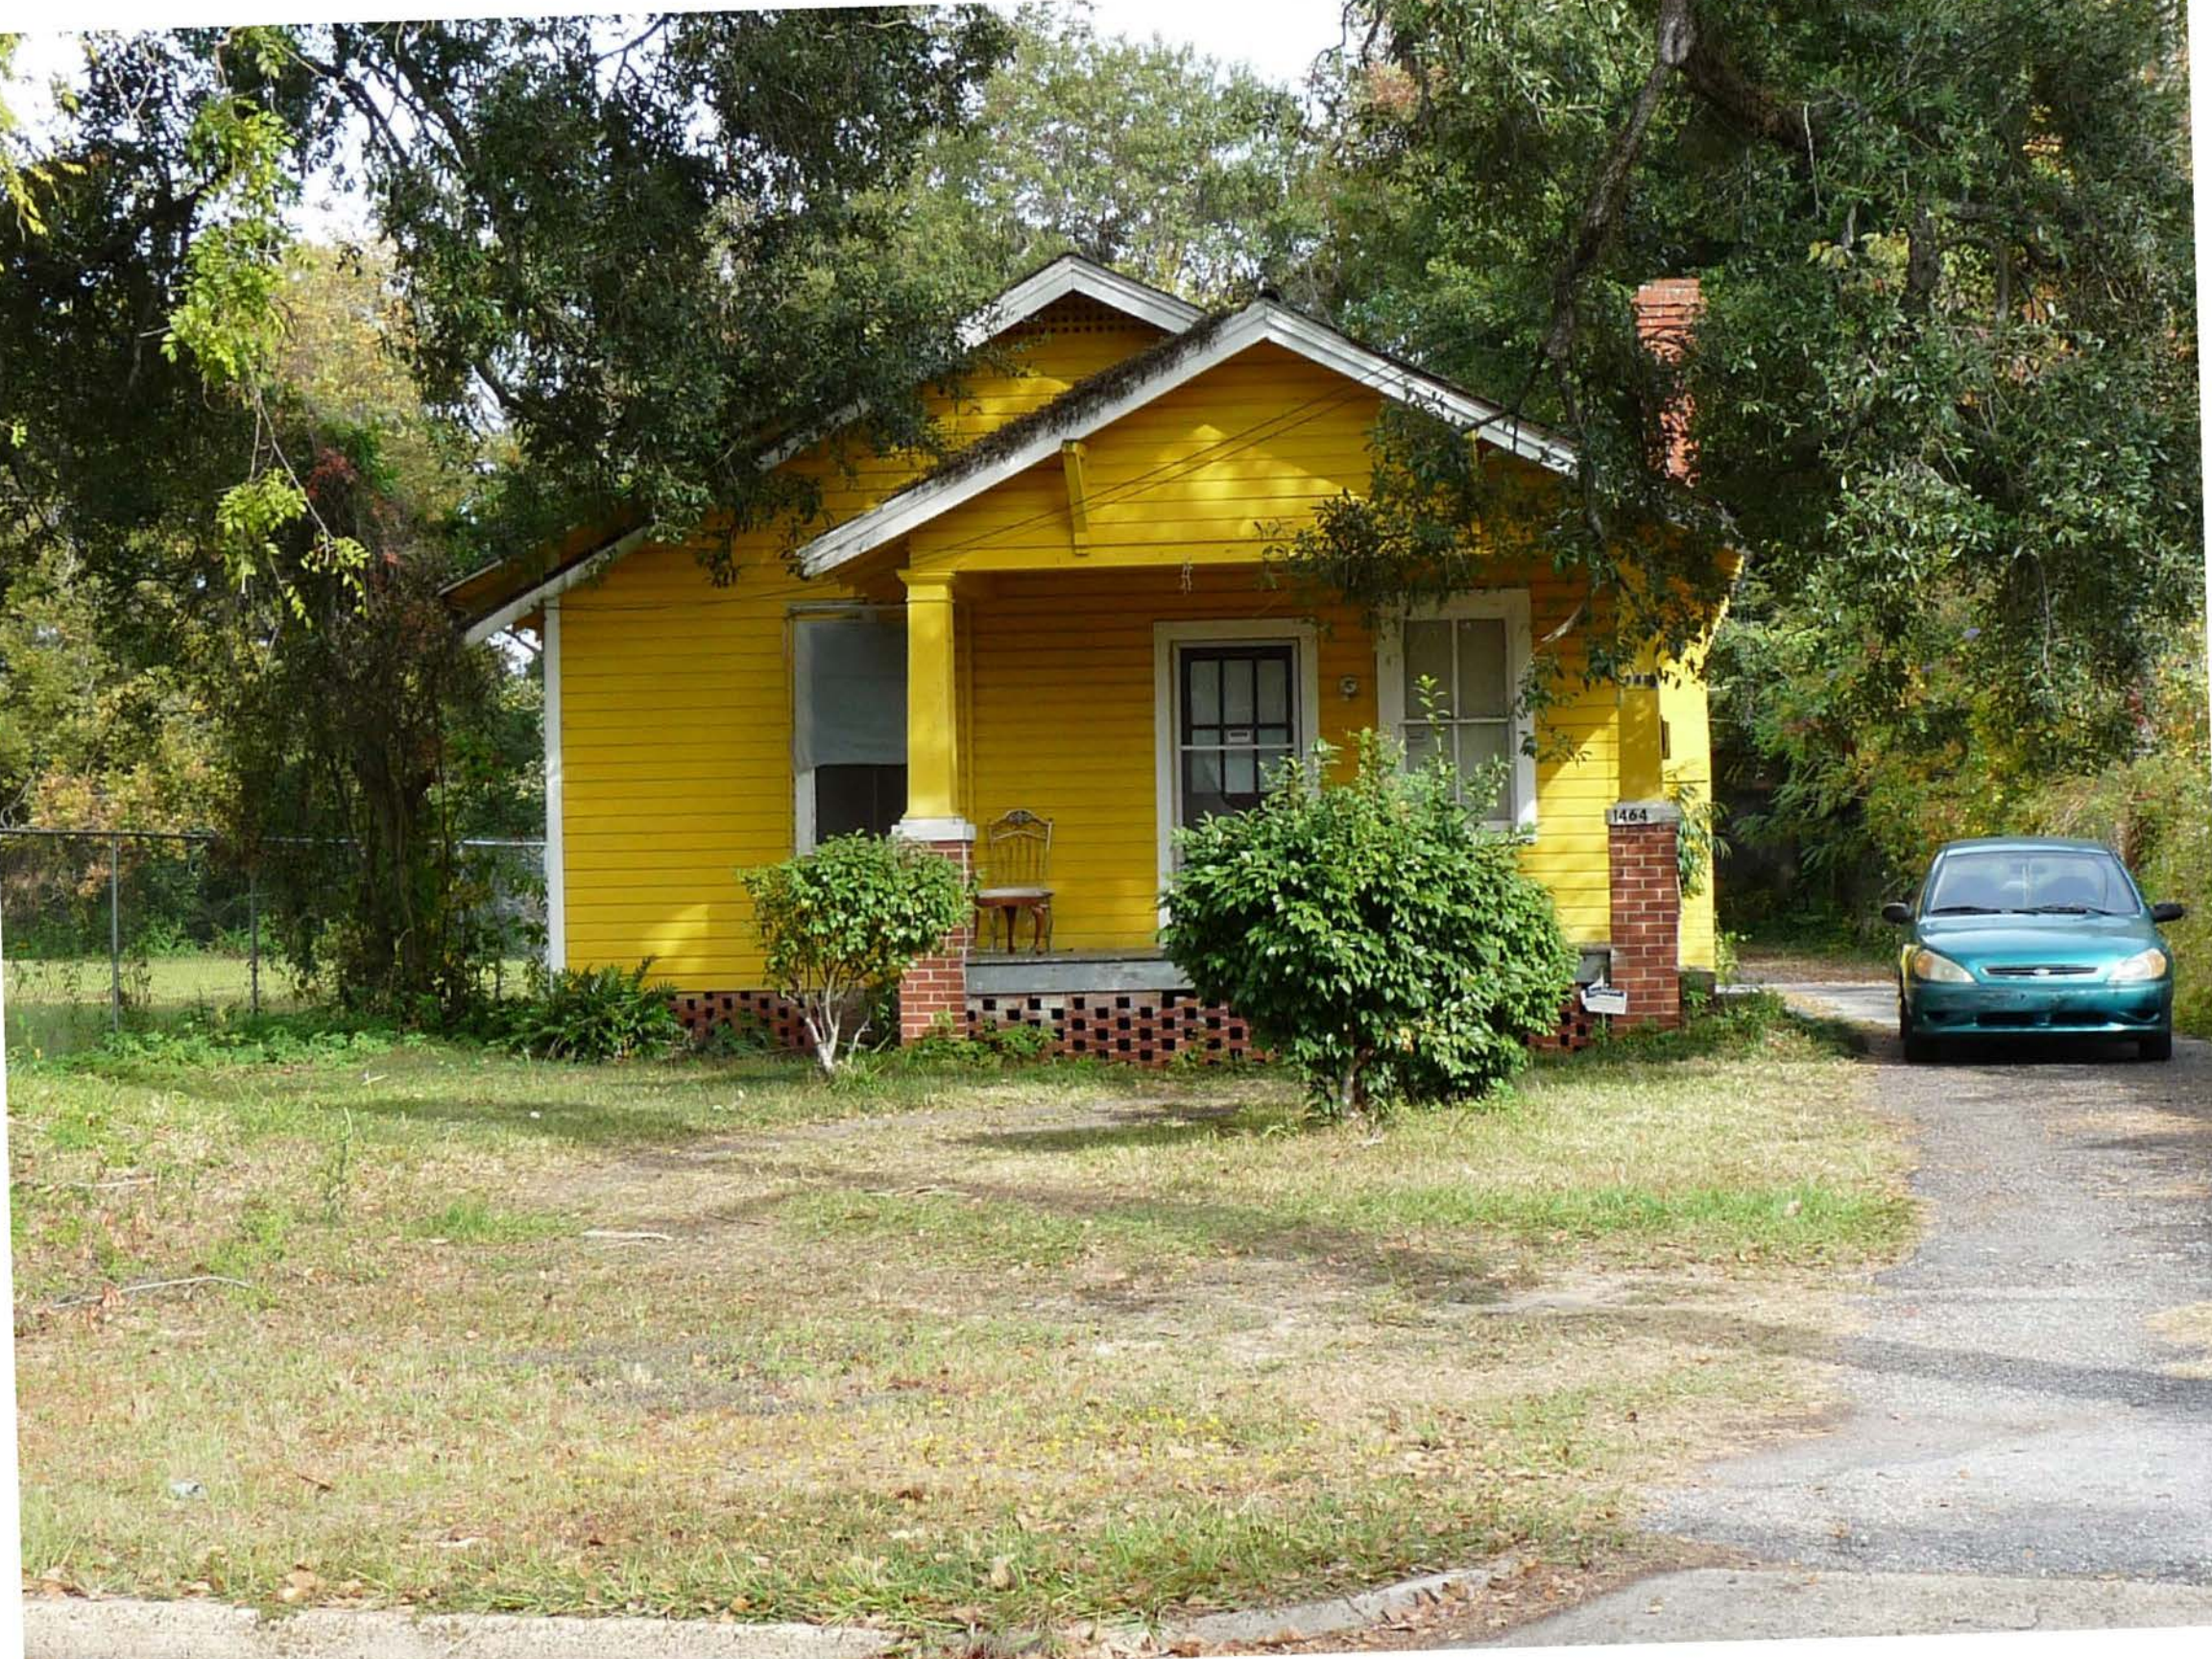
65. 1464 Center Street. Circa 1930. 1 story wood frame bungalow with front gable roof, raised brick pier foundation, three bay façade, entrance under projecting gabled porch supported by columns on brick piers, wood frame 2/2 windows, side chimney, knee braces. Photo# 00008. C

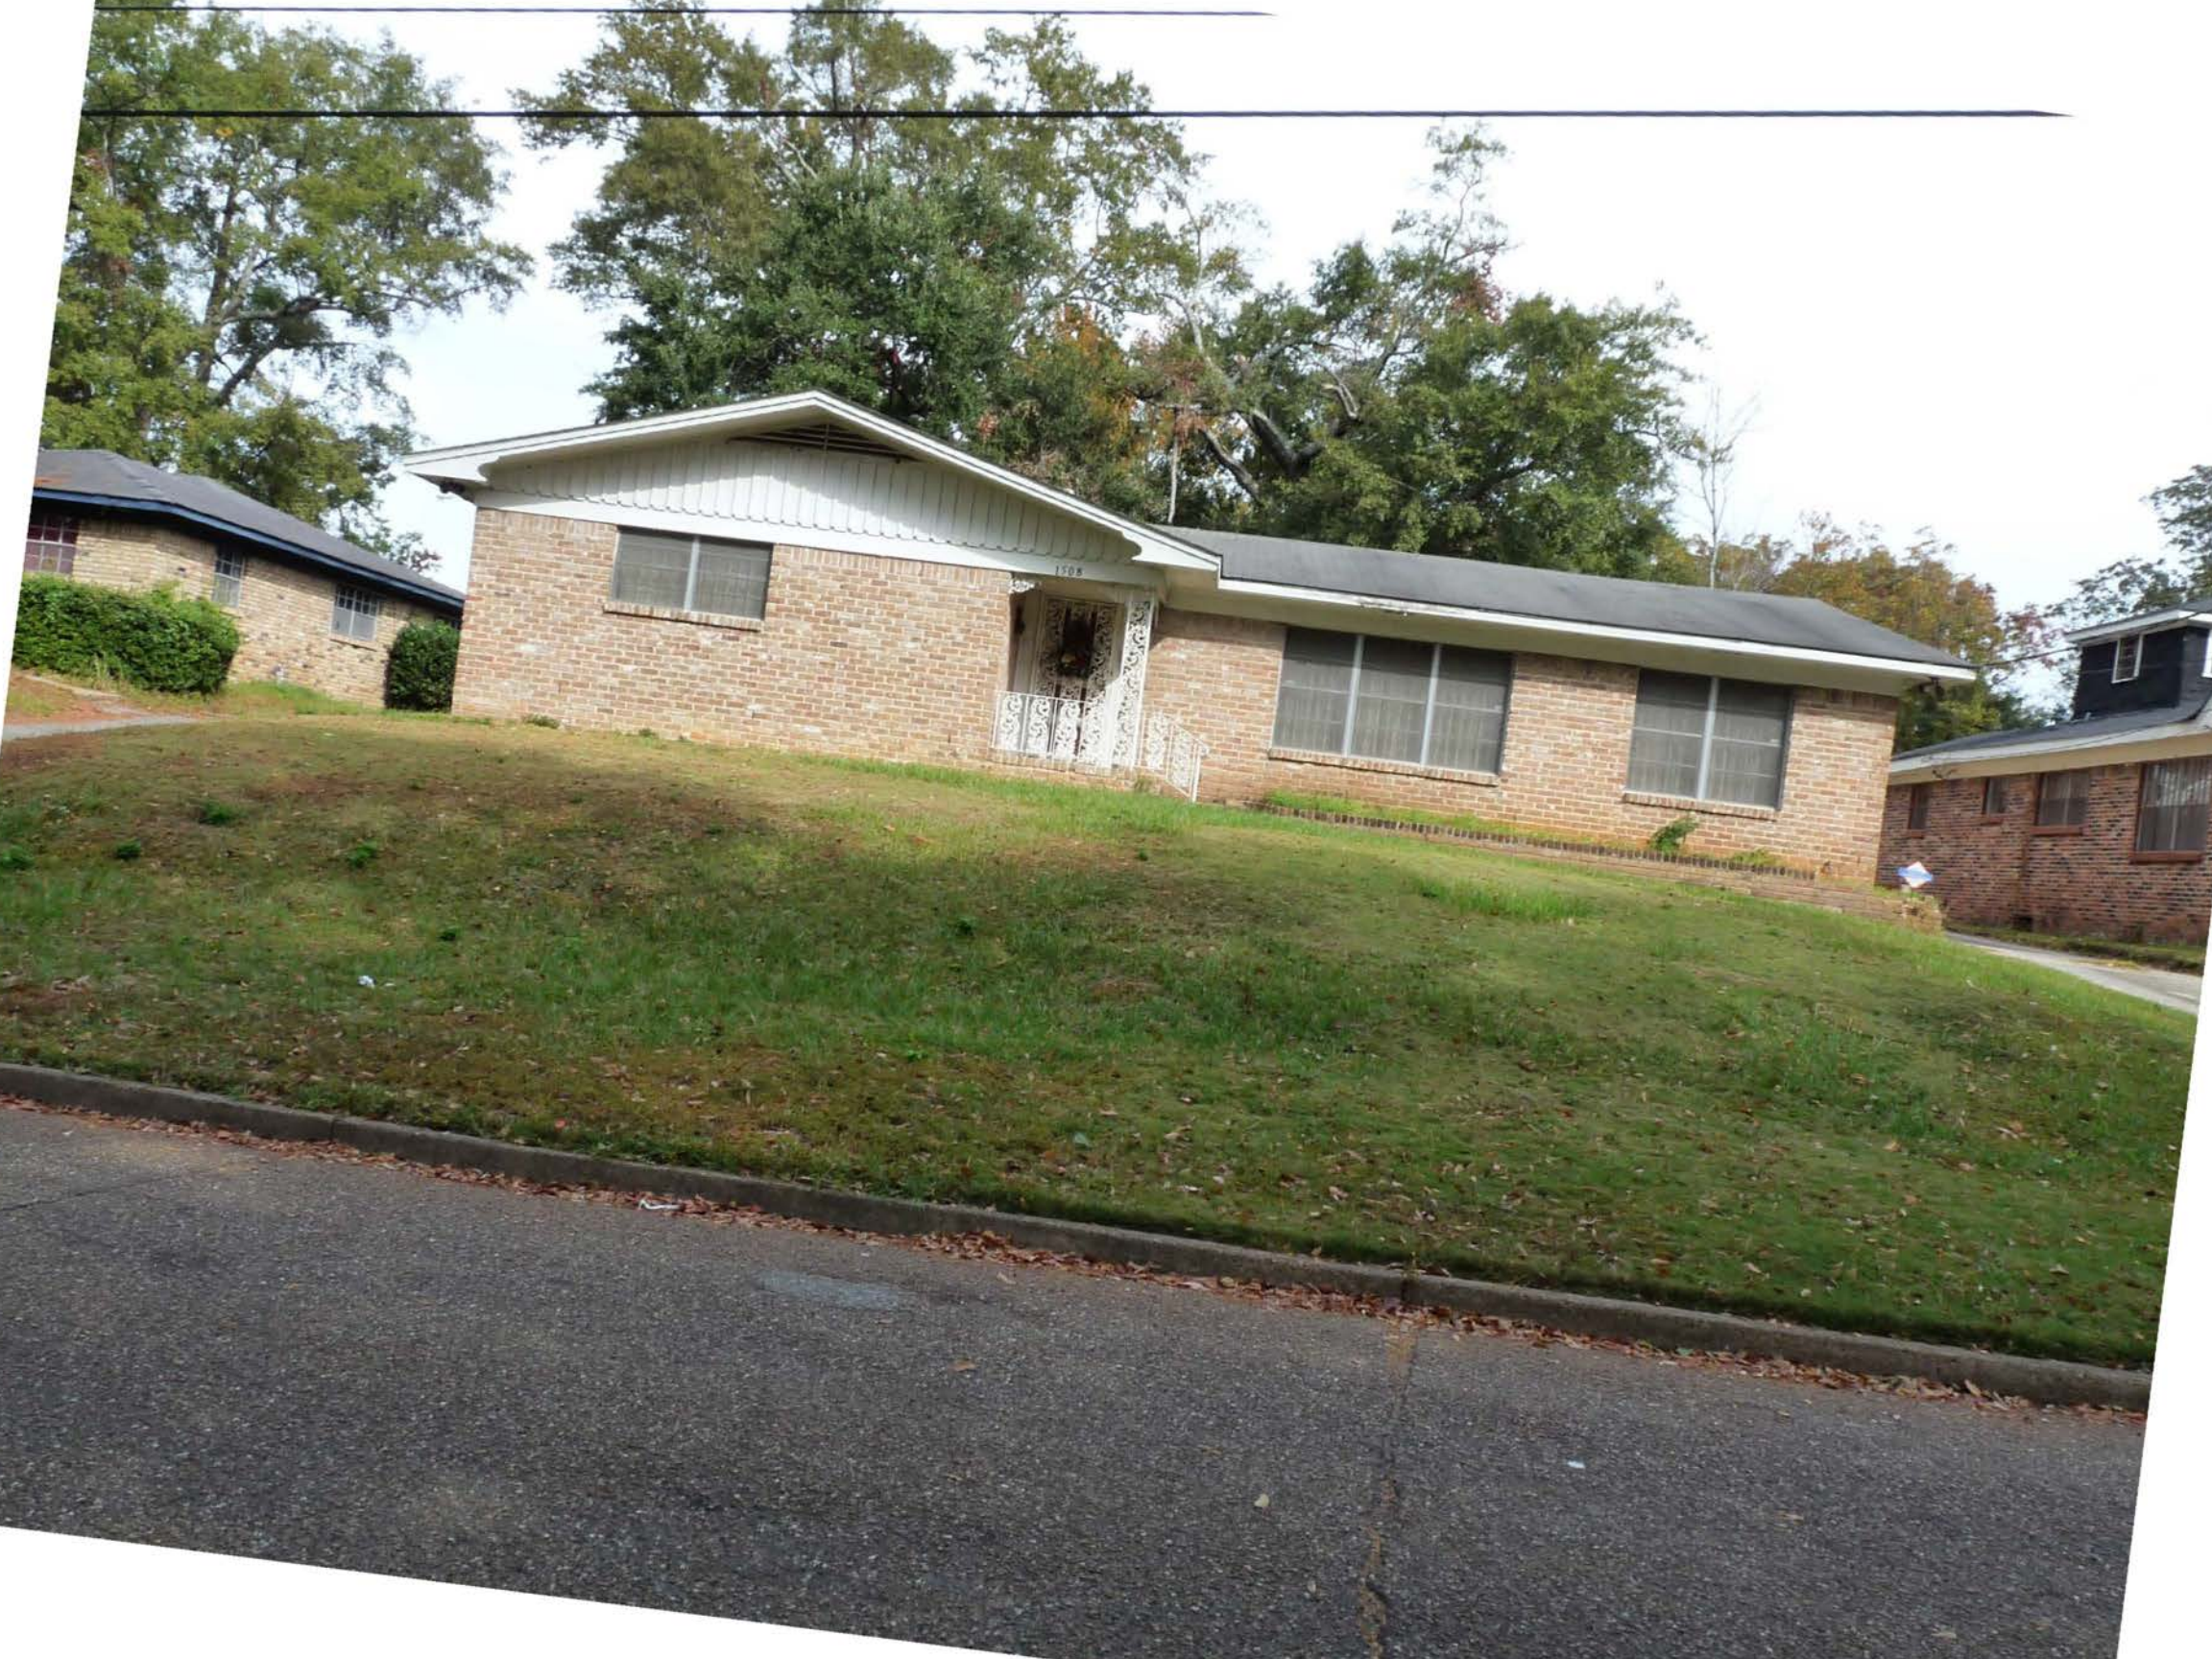
67. 1508 Center Street. Circa 1960. 1 story brick veneer L-shaped Ranch style house with side gable roof, raised concrete foundation, four bay façade, a projecting, gabled section set perpendicular to the main roof ridge on the left end of the façade contains the entrance in a recessed porch with decorative iron support and railing; paired and tripled metal frame 2/2 windows. Photo# 00018. C

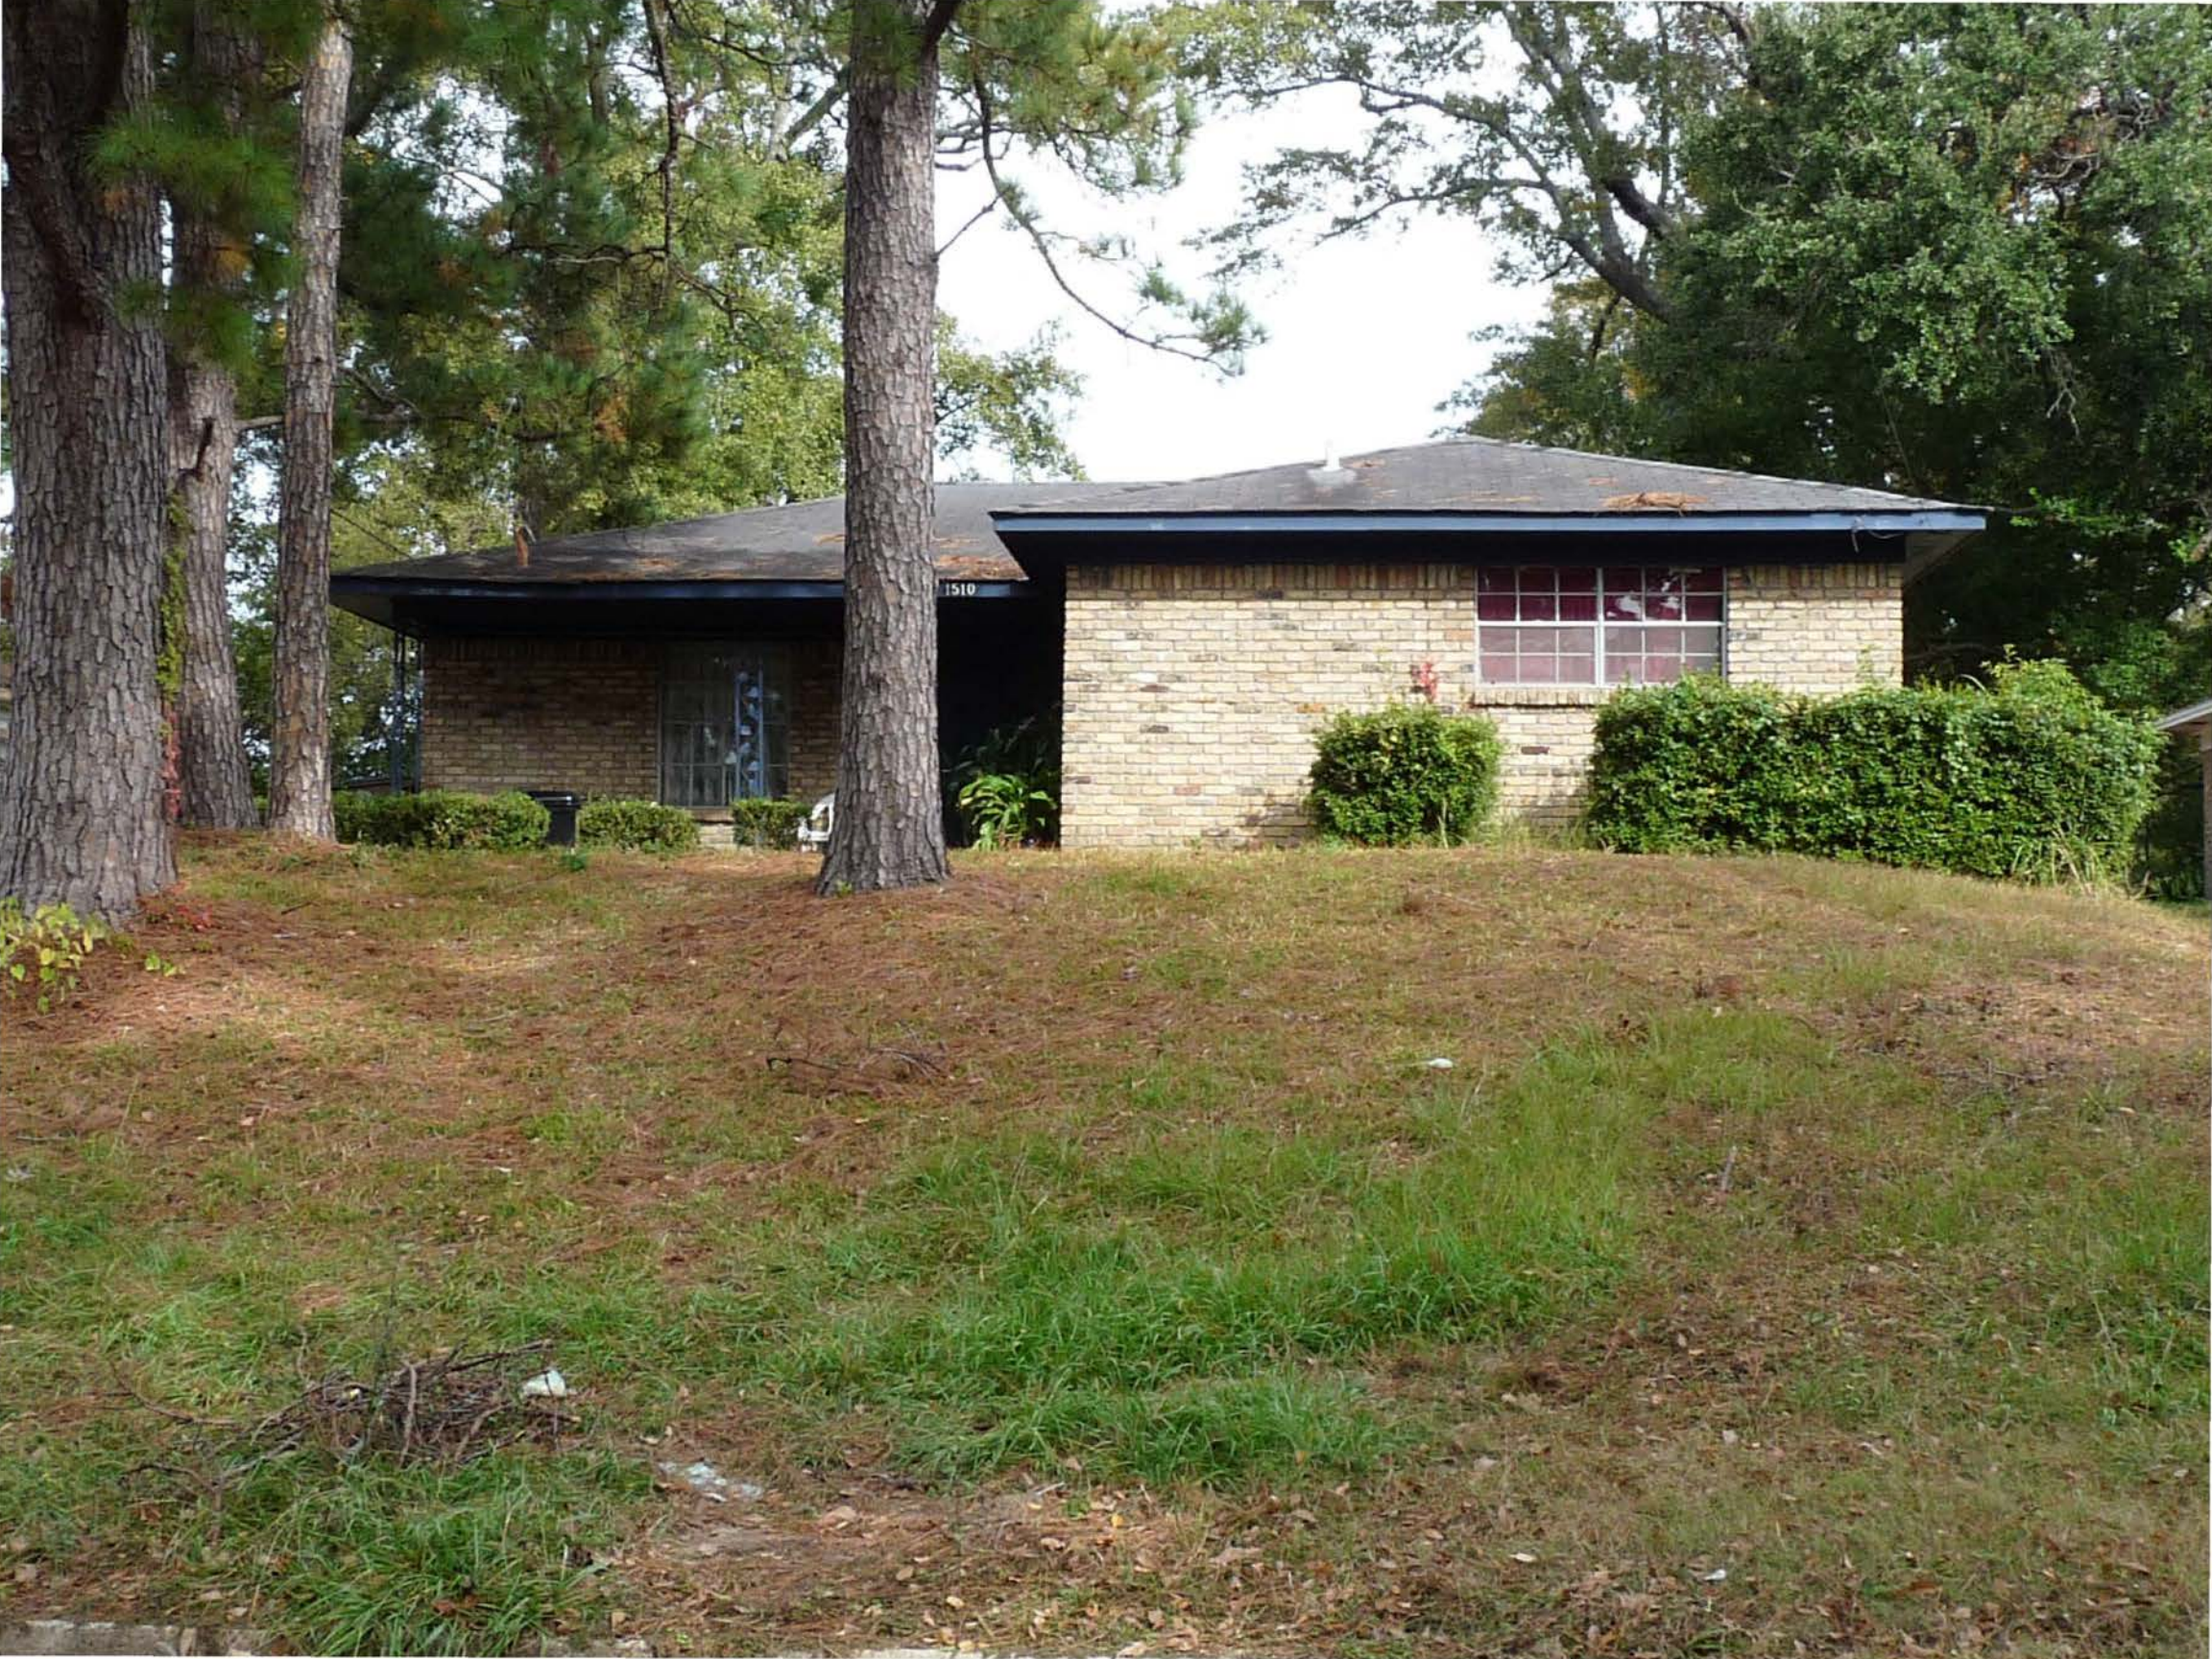
68. 1510 Center Street. Circa 1965. 1 story brick veneer L-shaped Ranch style house with hip roof, raised concrete foundation, two bay façade, entrance at projecting hip roofed ell, paired metal frame 6/6 windows. Photo# 00019. NC
