UNITED STATES DEPARTMENT OF THE INTERIOR
NATIONAL PARK SERVICE
NATIONAL REGISTER OF HISTORIC PLACES
PROPERTY PHOTOGRAPH FORM

1. NAME		
COMMON	AND/OR HISTORIC	NUMERIC CODE. (Assigned by GPO)
Cumberland and Oxford Canal		23/005
2. LOCATION		
STATE	COUNTY	TOWN
Maine	Cumberland	Standish, Windham, Gorham & Westbrook
STREET AND NUMBER		
From: Sebago Lake Basin To: Conant Street		
3. PHOTO REFERENCE		
PHOTO CREDIT	DATE	NEGATIVE FILED AT
U.S. Dept. of Agriculture Soil Conservation Service	May 2, 1964	Joel W. Eastman University of Me. Portland-Gorham
4. IDENTIFICATION		
DESCRIBE VIEW, DIRECTION, ETC.

COMMON: Cumberland and Oxford Canal

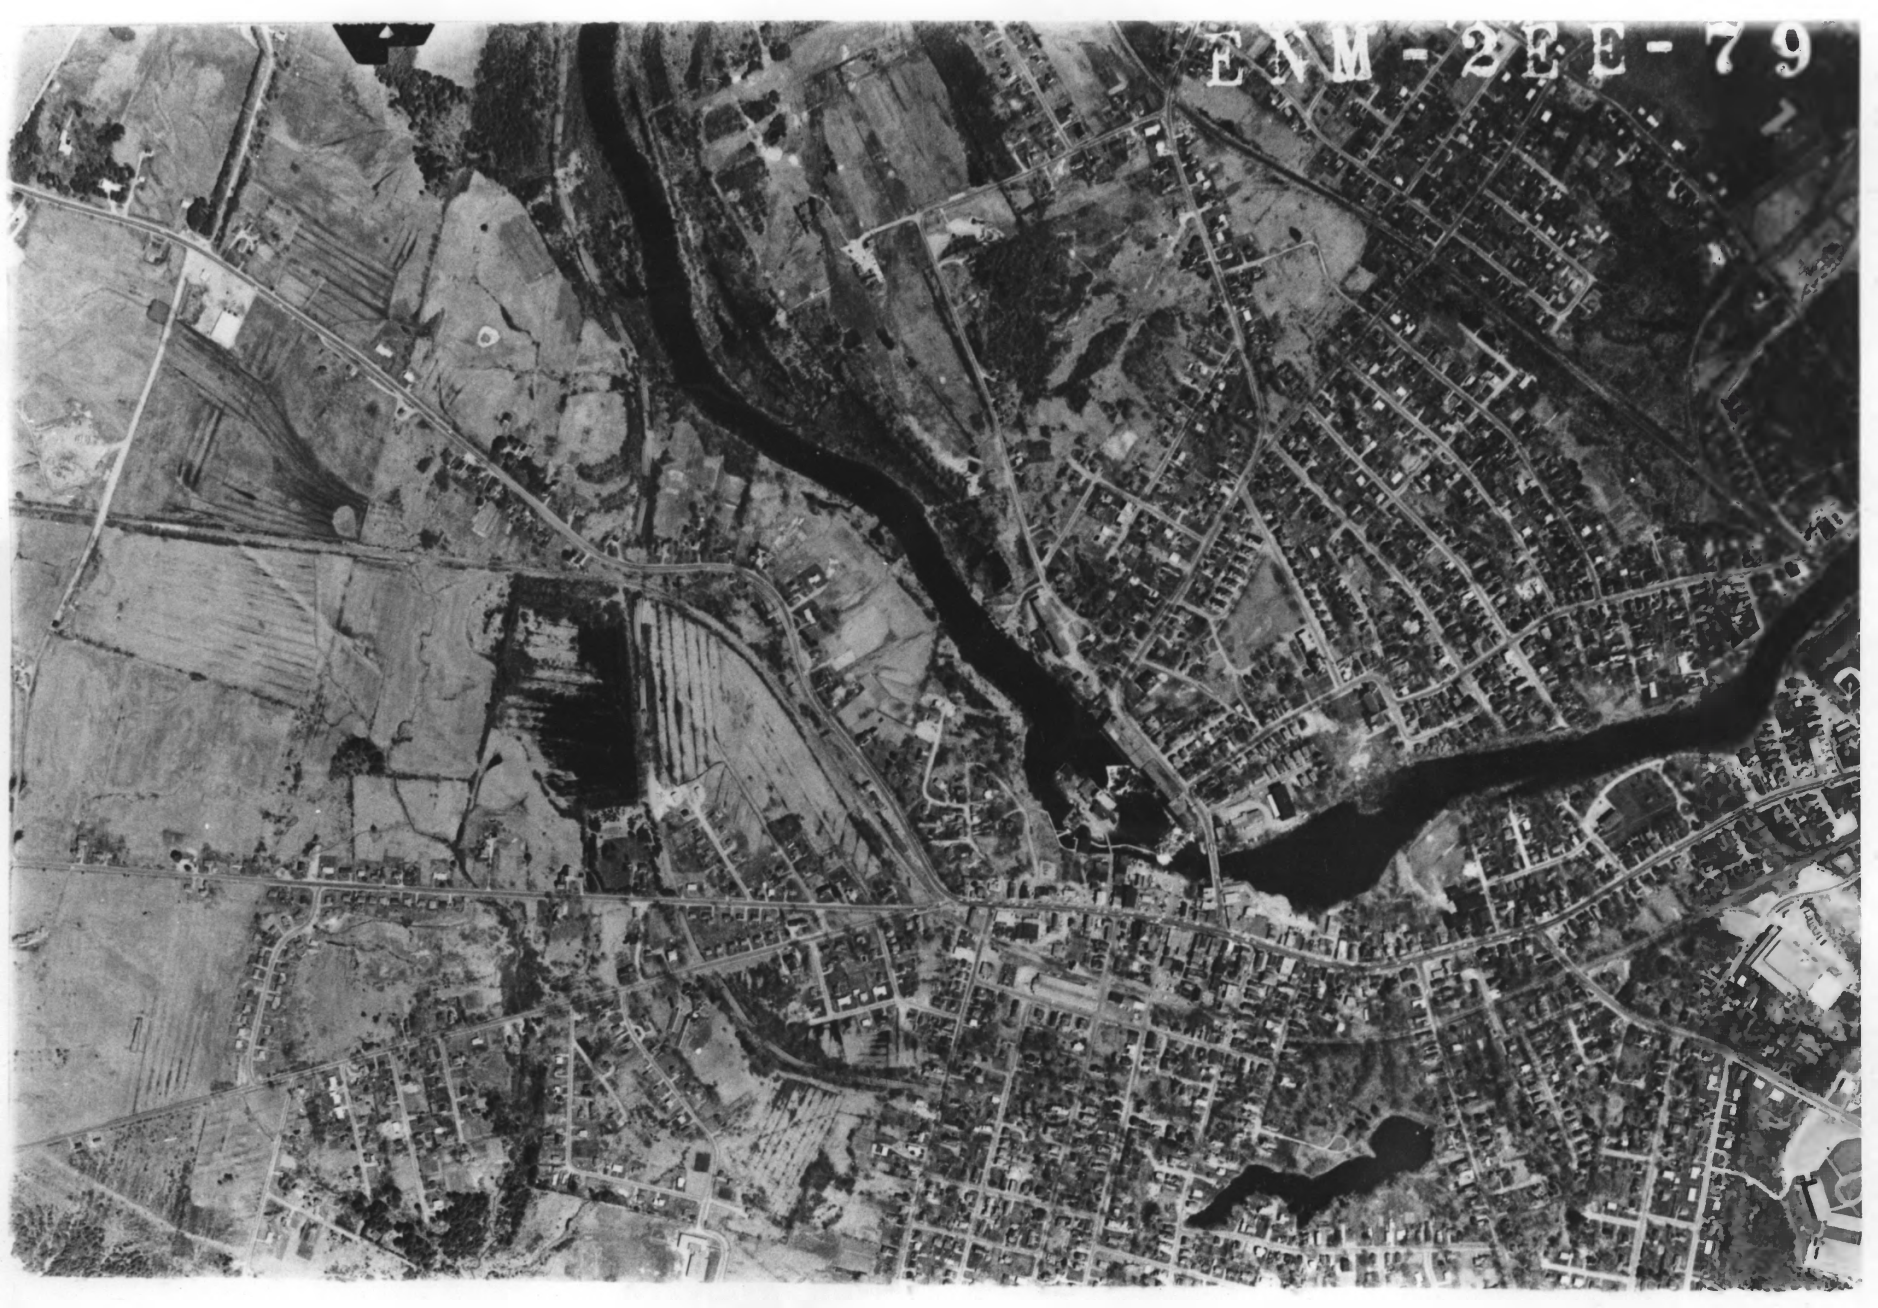
Photo #1: Air view of the canal in Westbrook. The canal can be seen running south and then leaving the river. It has been covered by route 25 (now Conant Street), but is visible again south of the highway, curving into the residential area of the city where it has been largely obliterated.

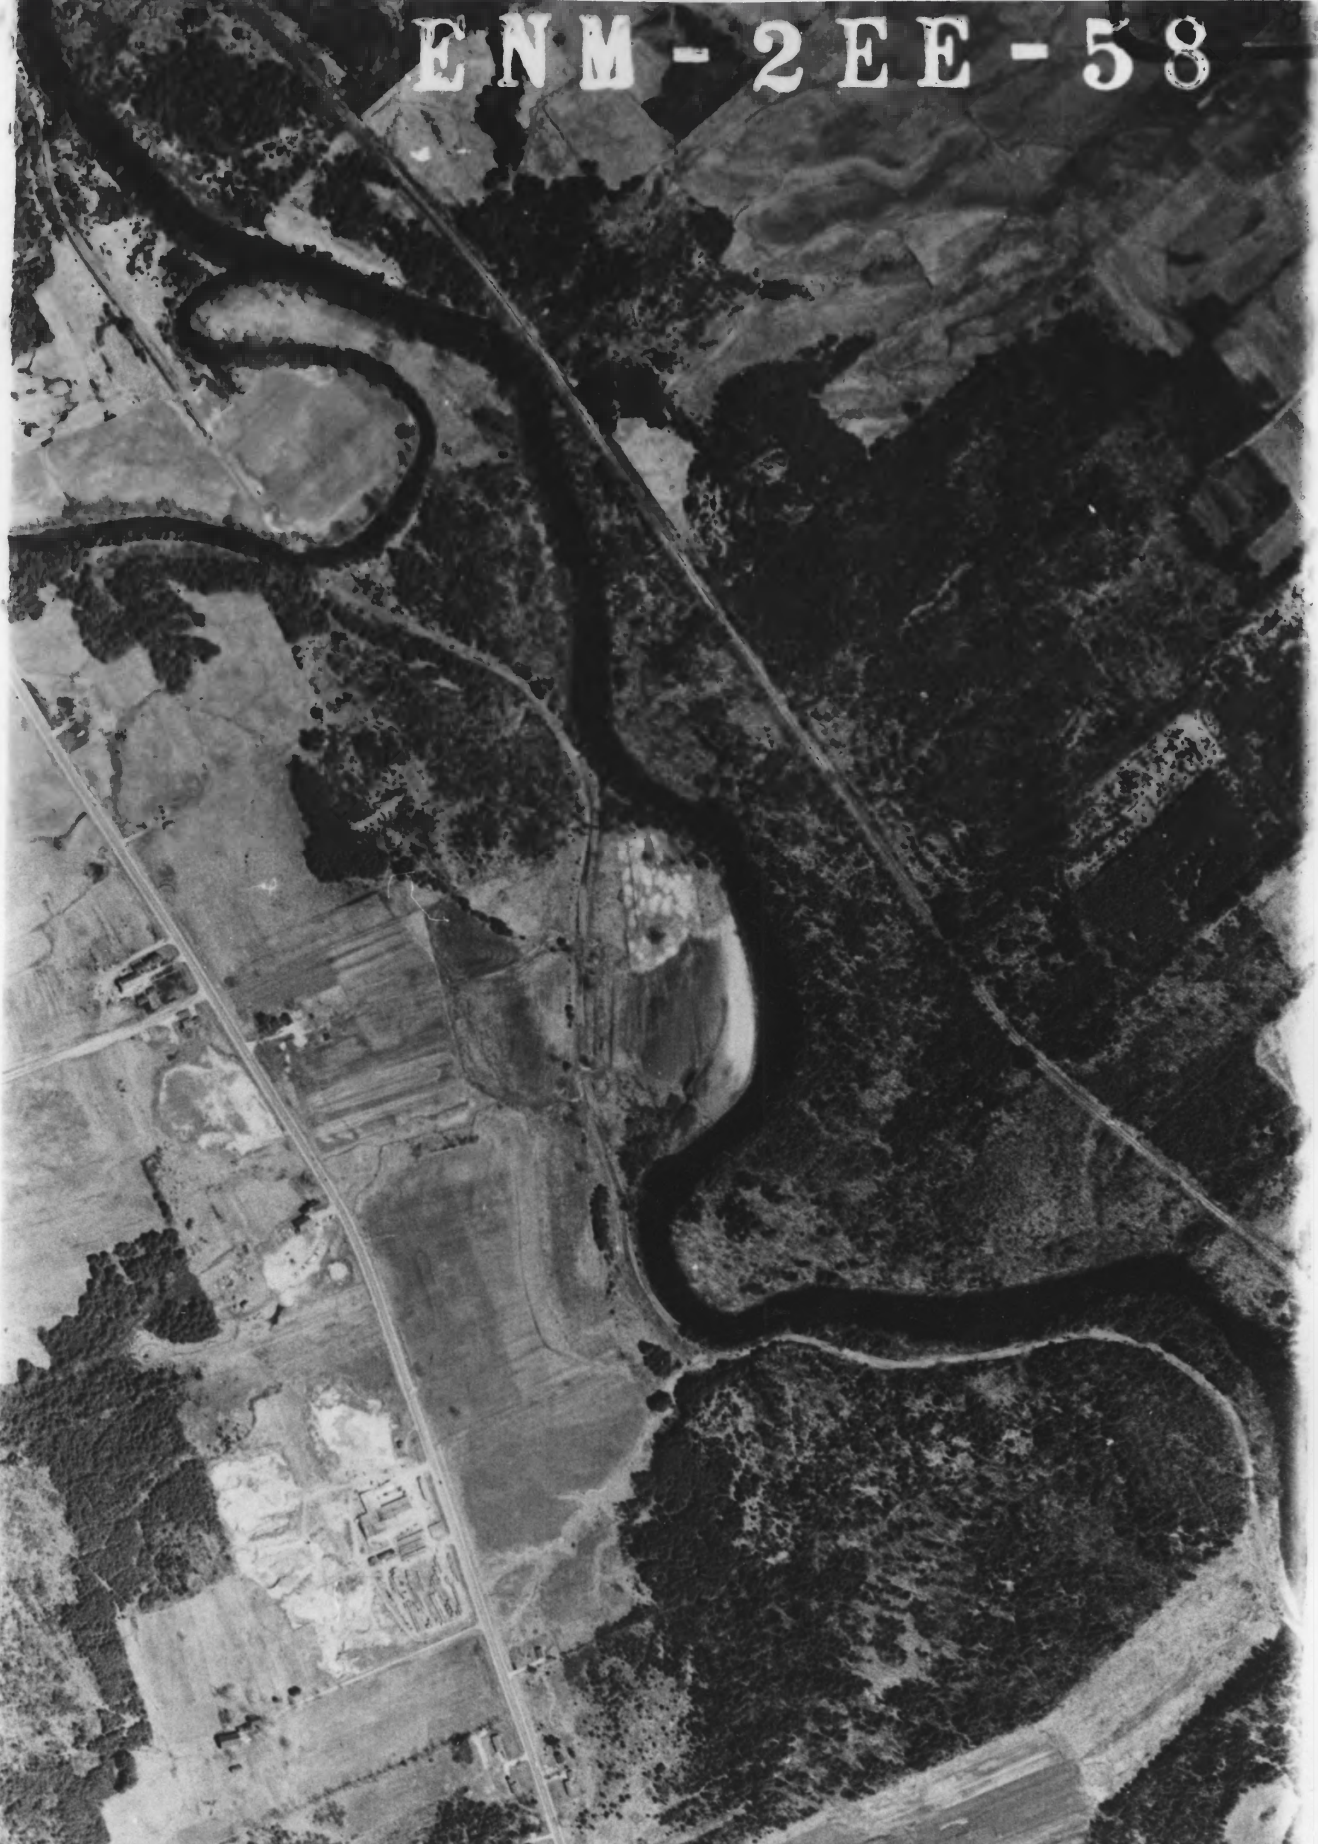
Photo #2: Close-up air view of the section of the canal from the Little River to a point near the Westbrook city line. With the exception of a small section just above the Little River which has been destroyed, this portion of the canal, called the "Long Level" because of the absence of locks, has survived in excellent condition due to its relative inaccessibility.

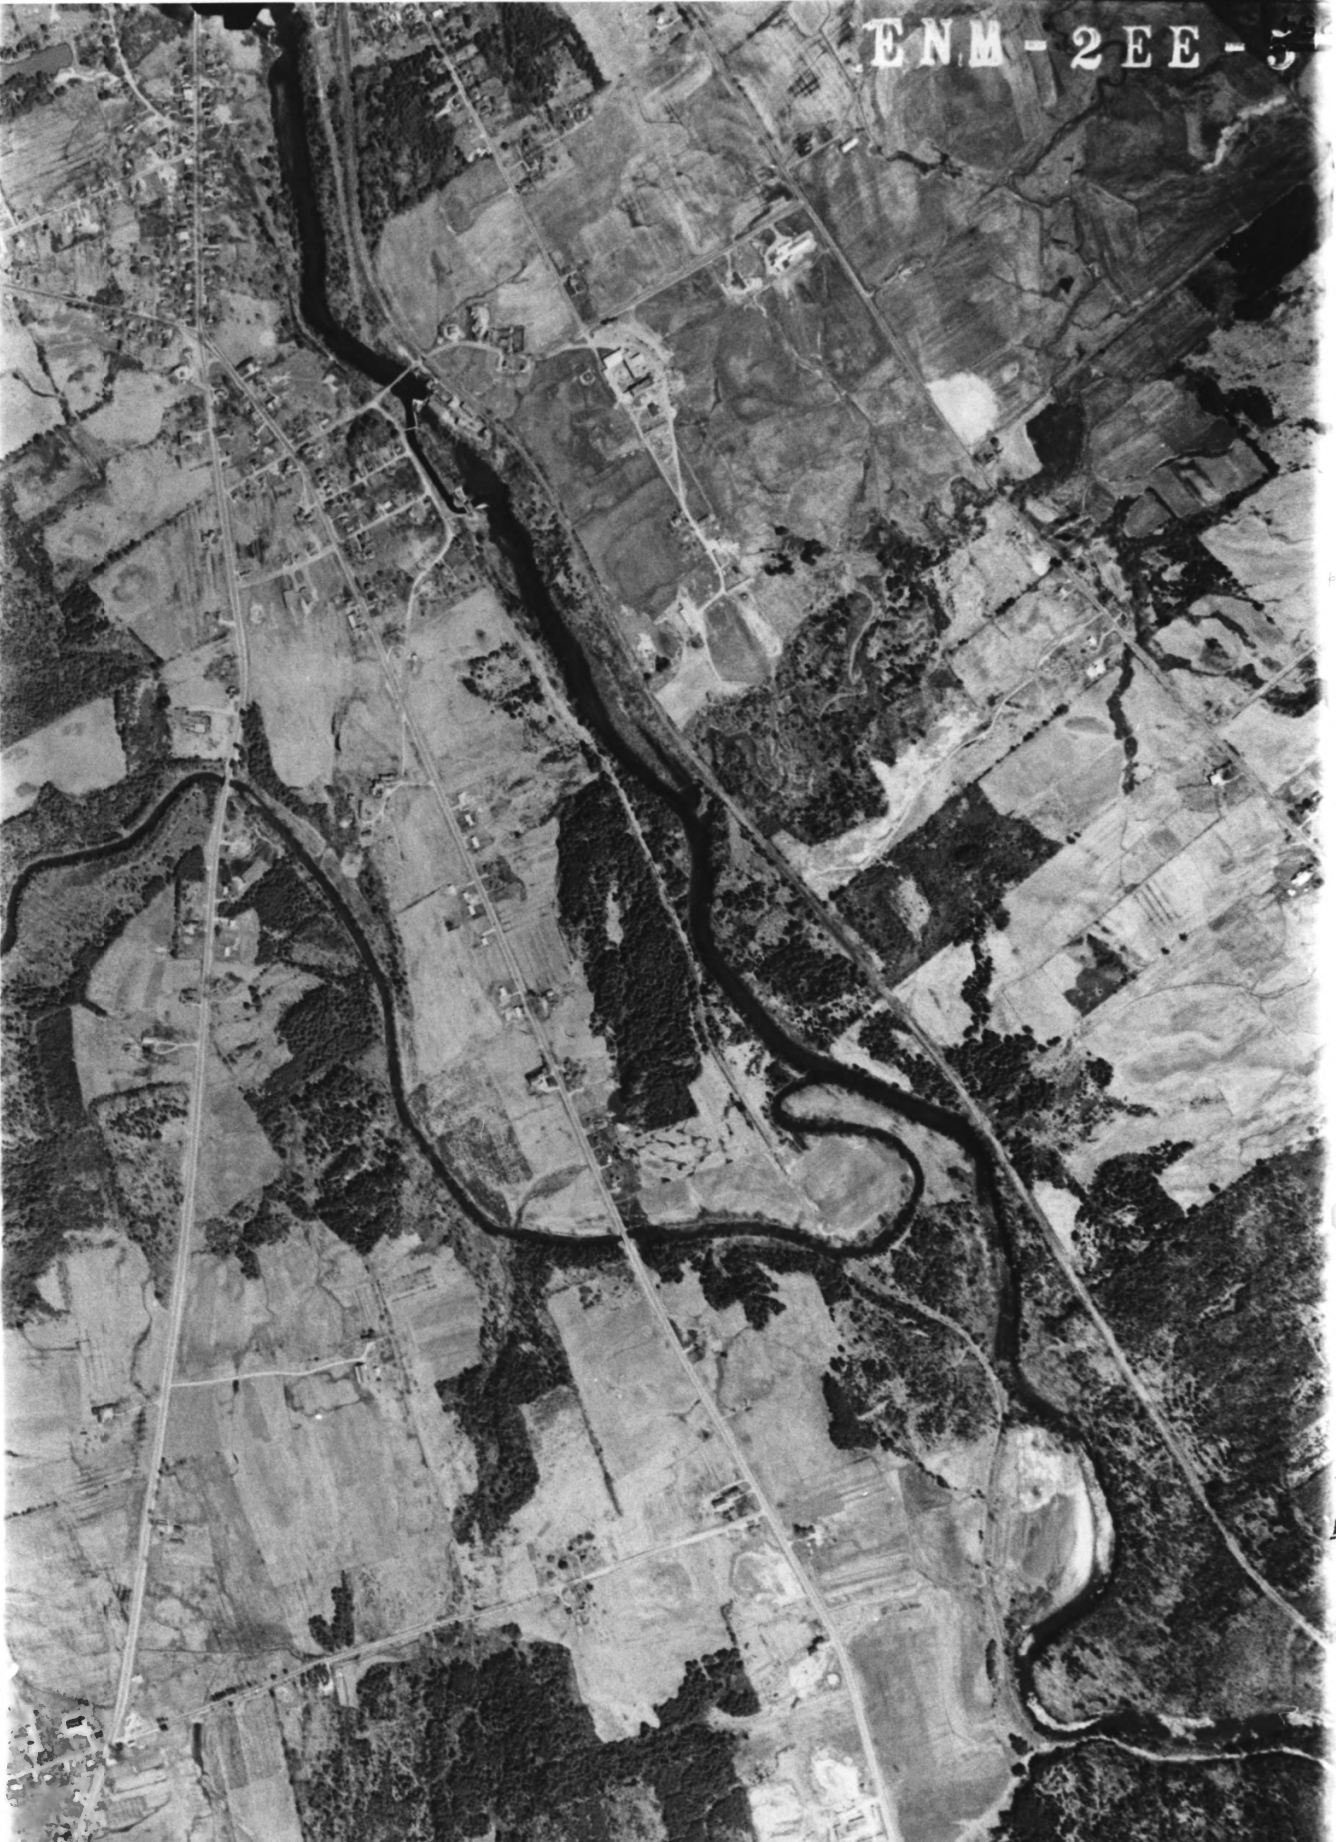
Photo #3: Air view of the canal from Little Falls (South Windham) to a point near the Westbrook city line. The canal is visible just east of the main street of the village. The section of Malison Falls just below has been rebuilt and used to supply water to a power station. The stonework of the aqueduct over the Little River, in the center of the photo, still remains.

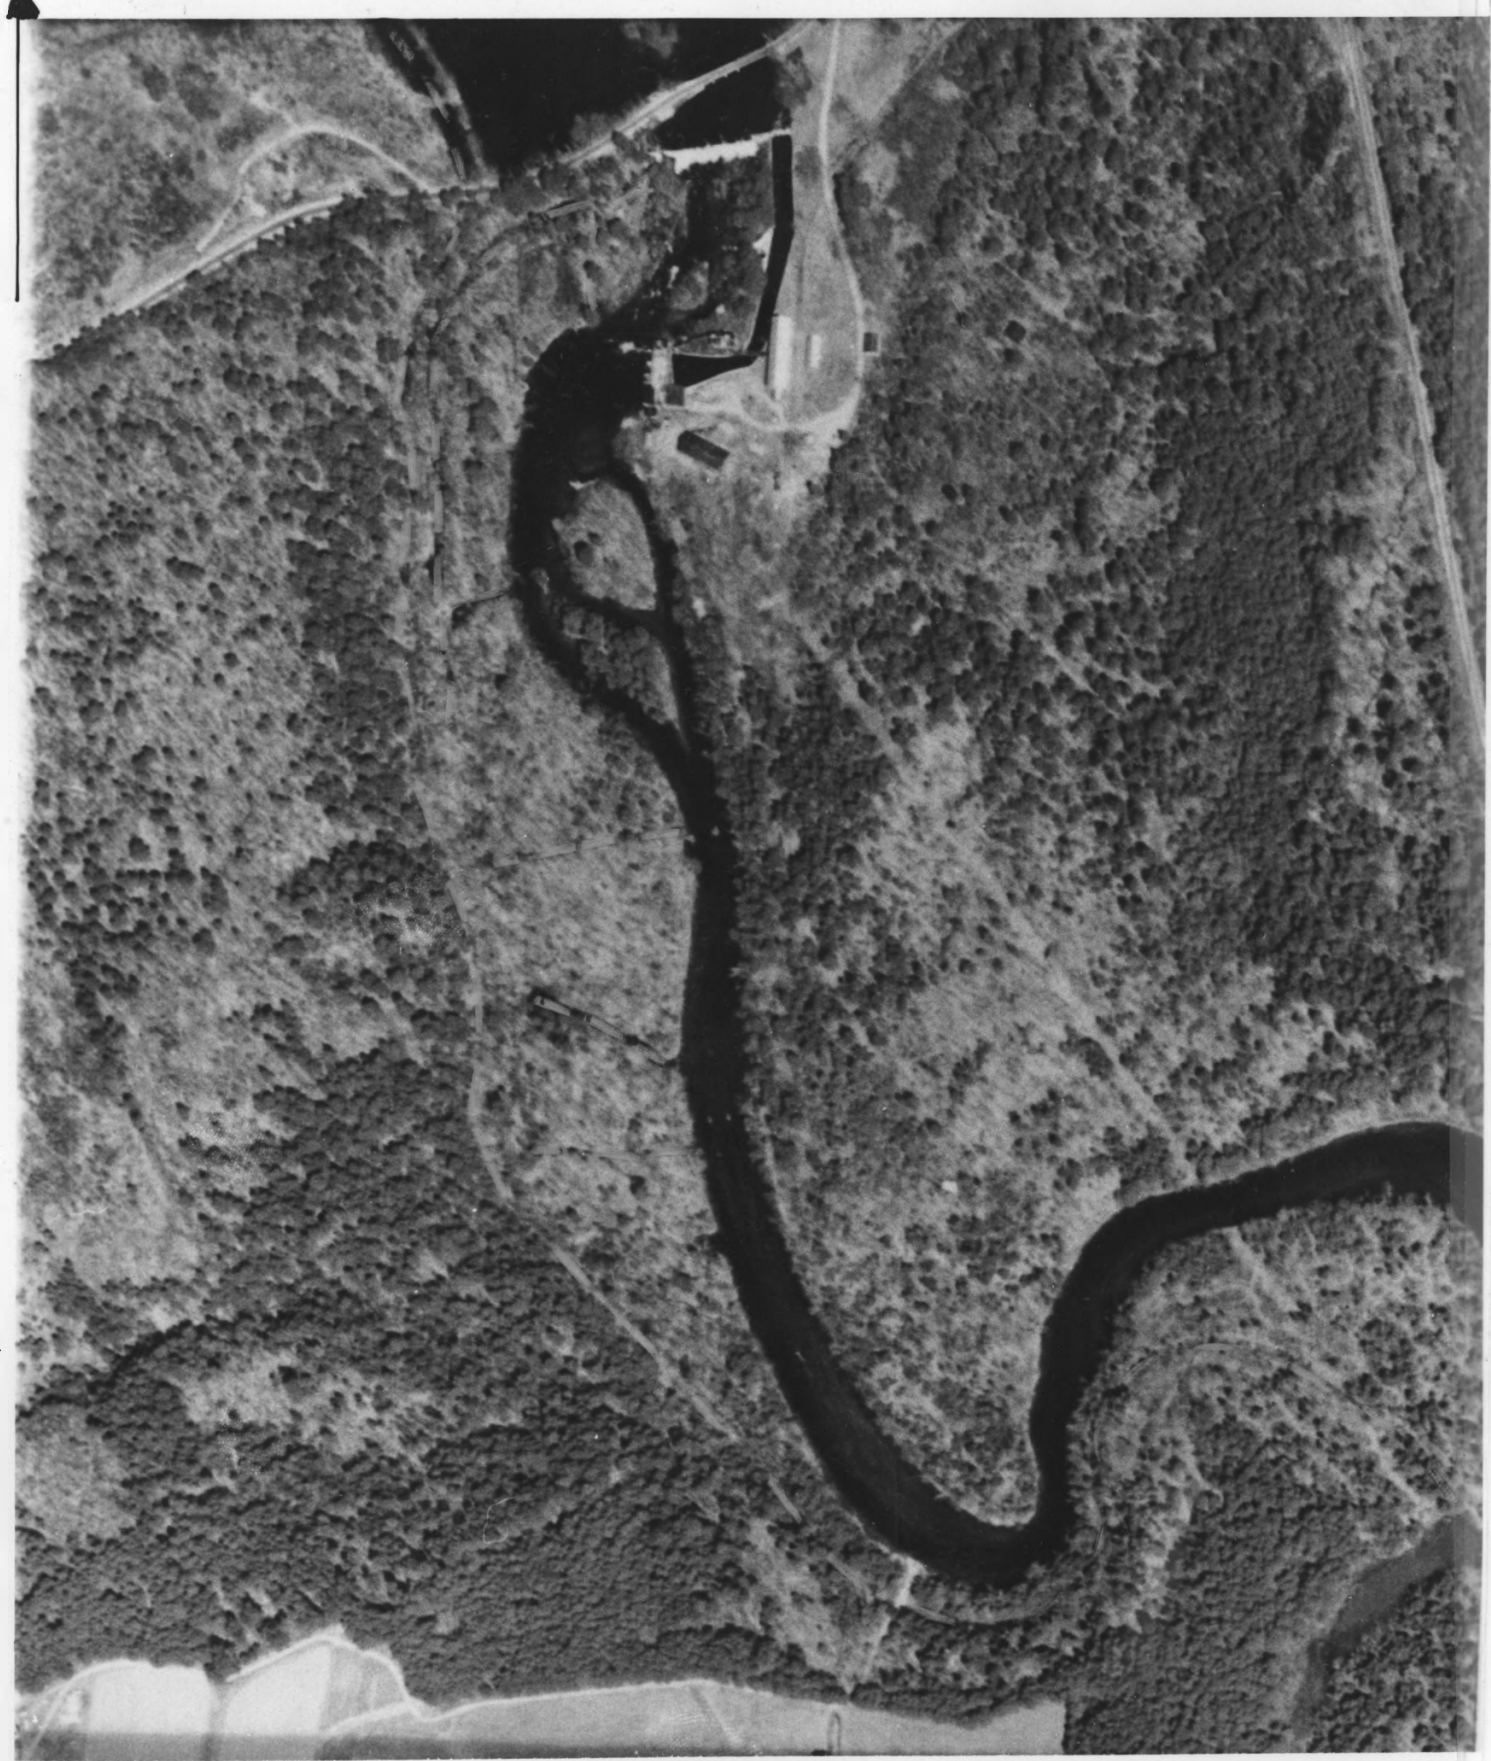
Photo #4: Air view of powder mill complex, (Oriental Powder Mill). Cumberland and Oxford Canal, which was used to supply water to many of the individual mills, is visible leaving the pond and then paralleling the river. A mill feeder canal runs from the dam diagonally, connecting with the Cumberland and Oxford Canal. The outlets of the several mills along the canal can be seen running horizontally to the river.

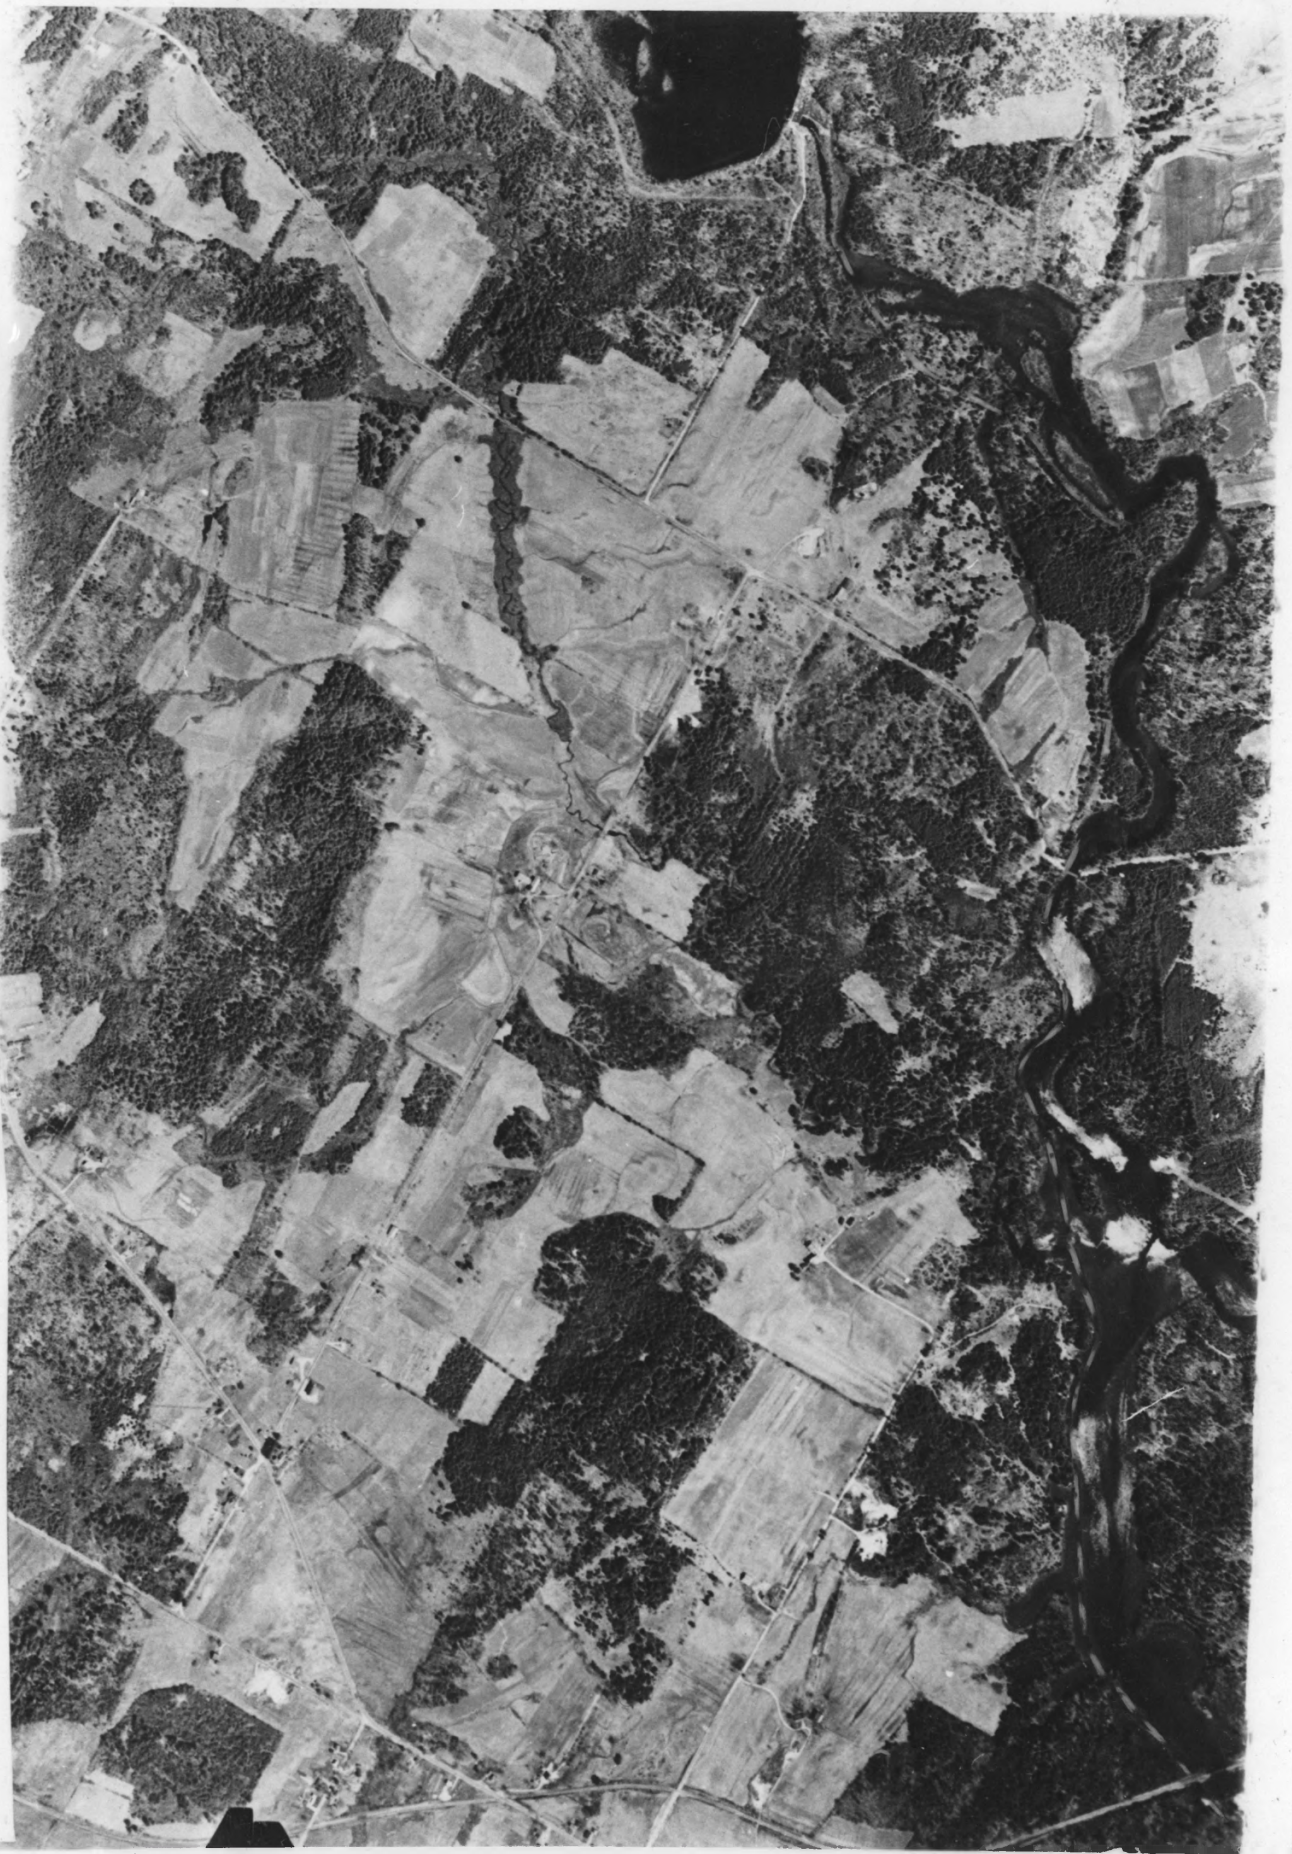
Photo #5: Air view of the canal from Dundee Pond to the Maine Central Railroad bridge. The canal is visible below Dundee Pond running through the woods along the river to the Babb's (Covered) Bridge, where well preserved Lower Kemp Lock, is located. From this point south the canal is again submerged due to the raised height of the river but it is visible in the photo just beneath the surface.

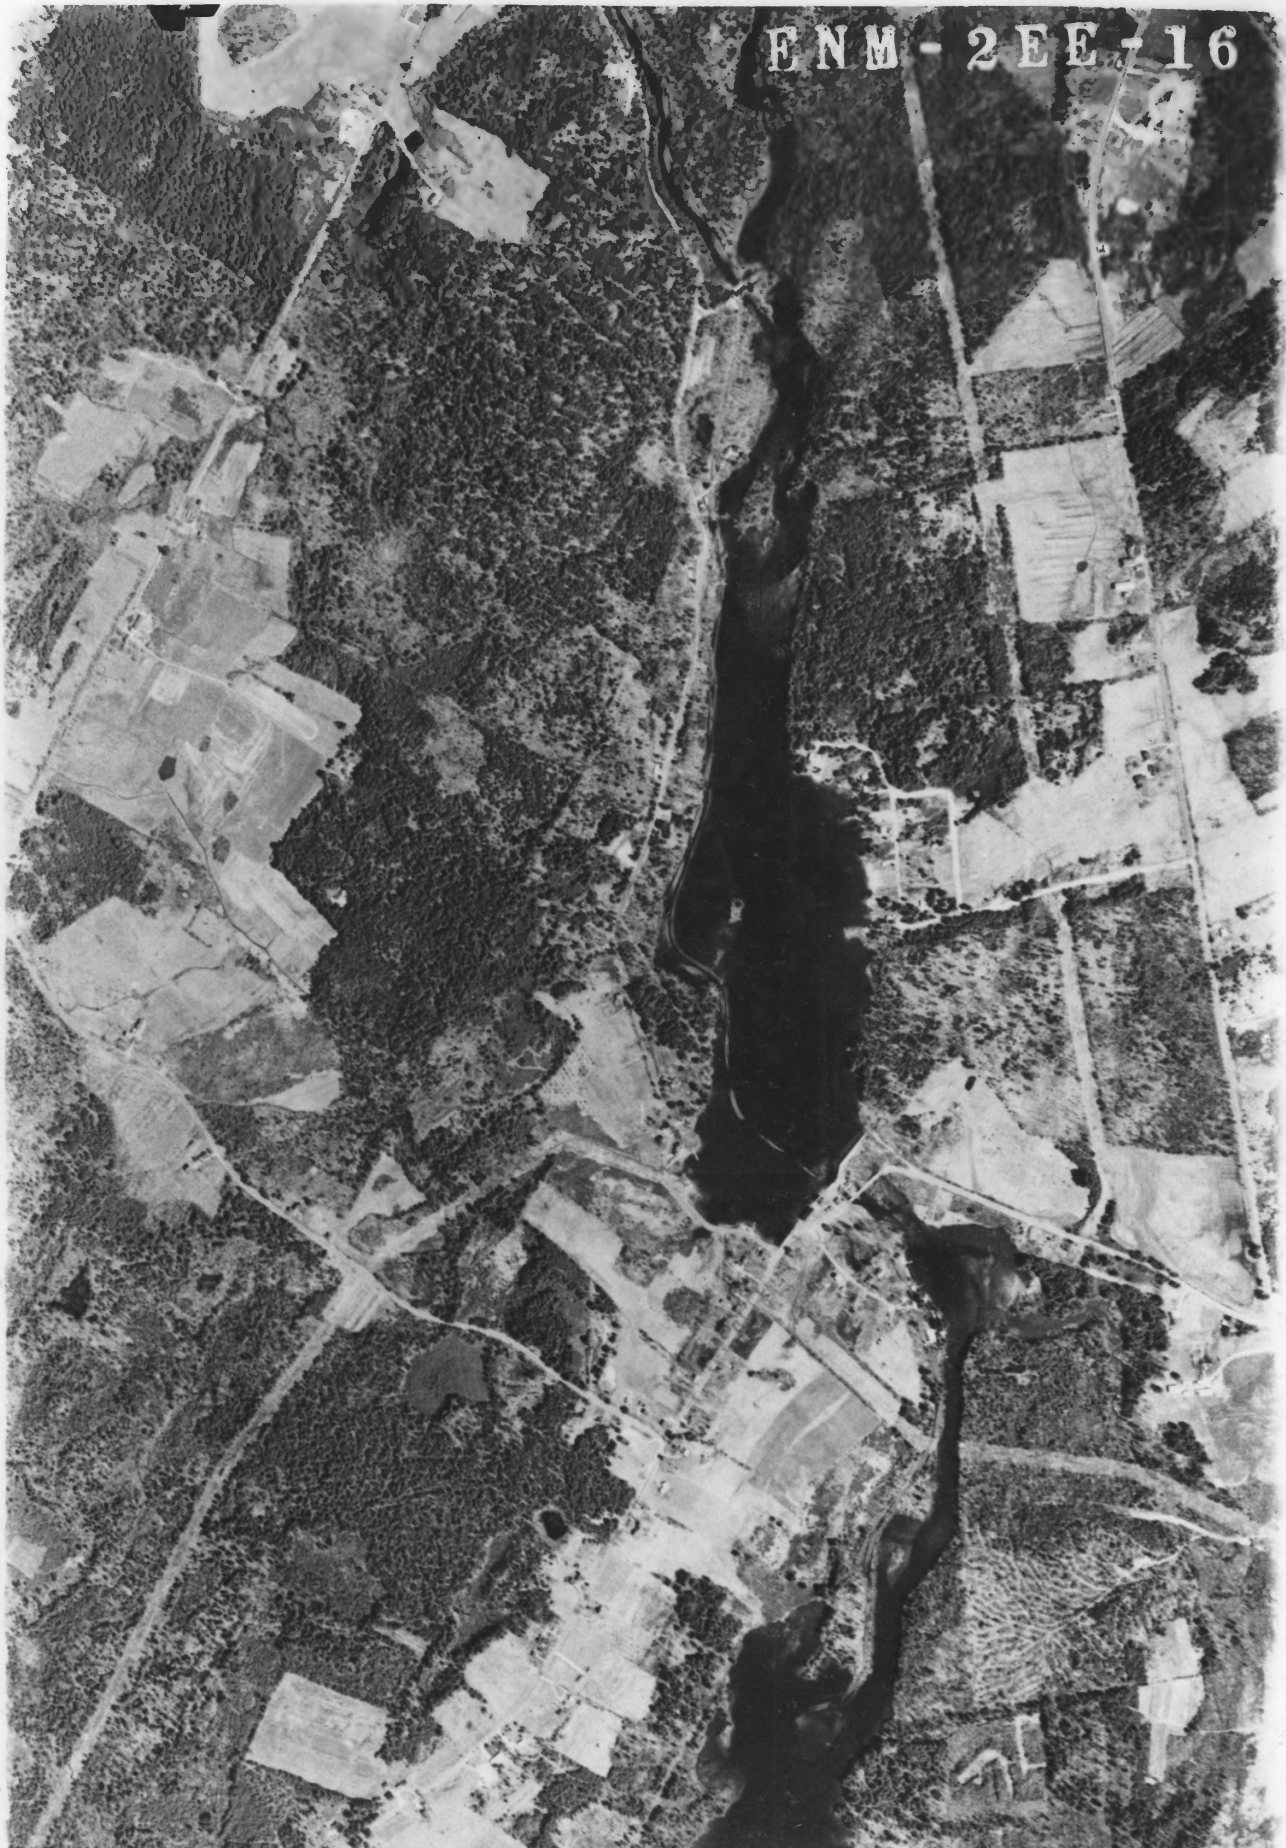
Photo #6: Air view of canal from Eel Weir Canal to Dundee Pond. Remains of canal are visible running south from the dam at the end of the rebuilt section of the canal, now called the Eel Weir Canal, and then entering, running along the edge of, and finally disappearing into a flooded portion of the Presumpscot River called North Gorham Pond. The canal is visible again below No. Gorham dam before disappearing again into Dundee Pond.

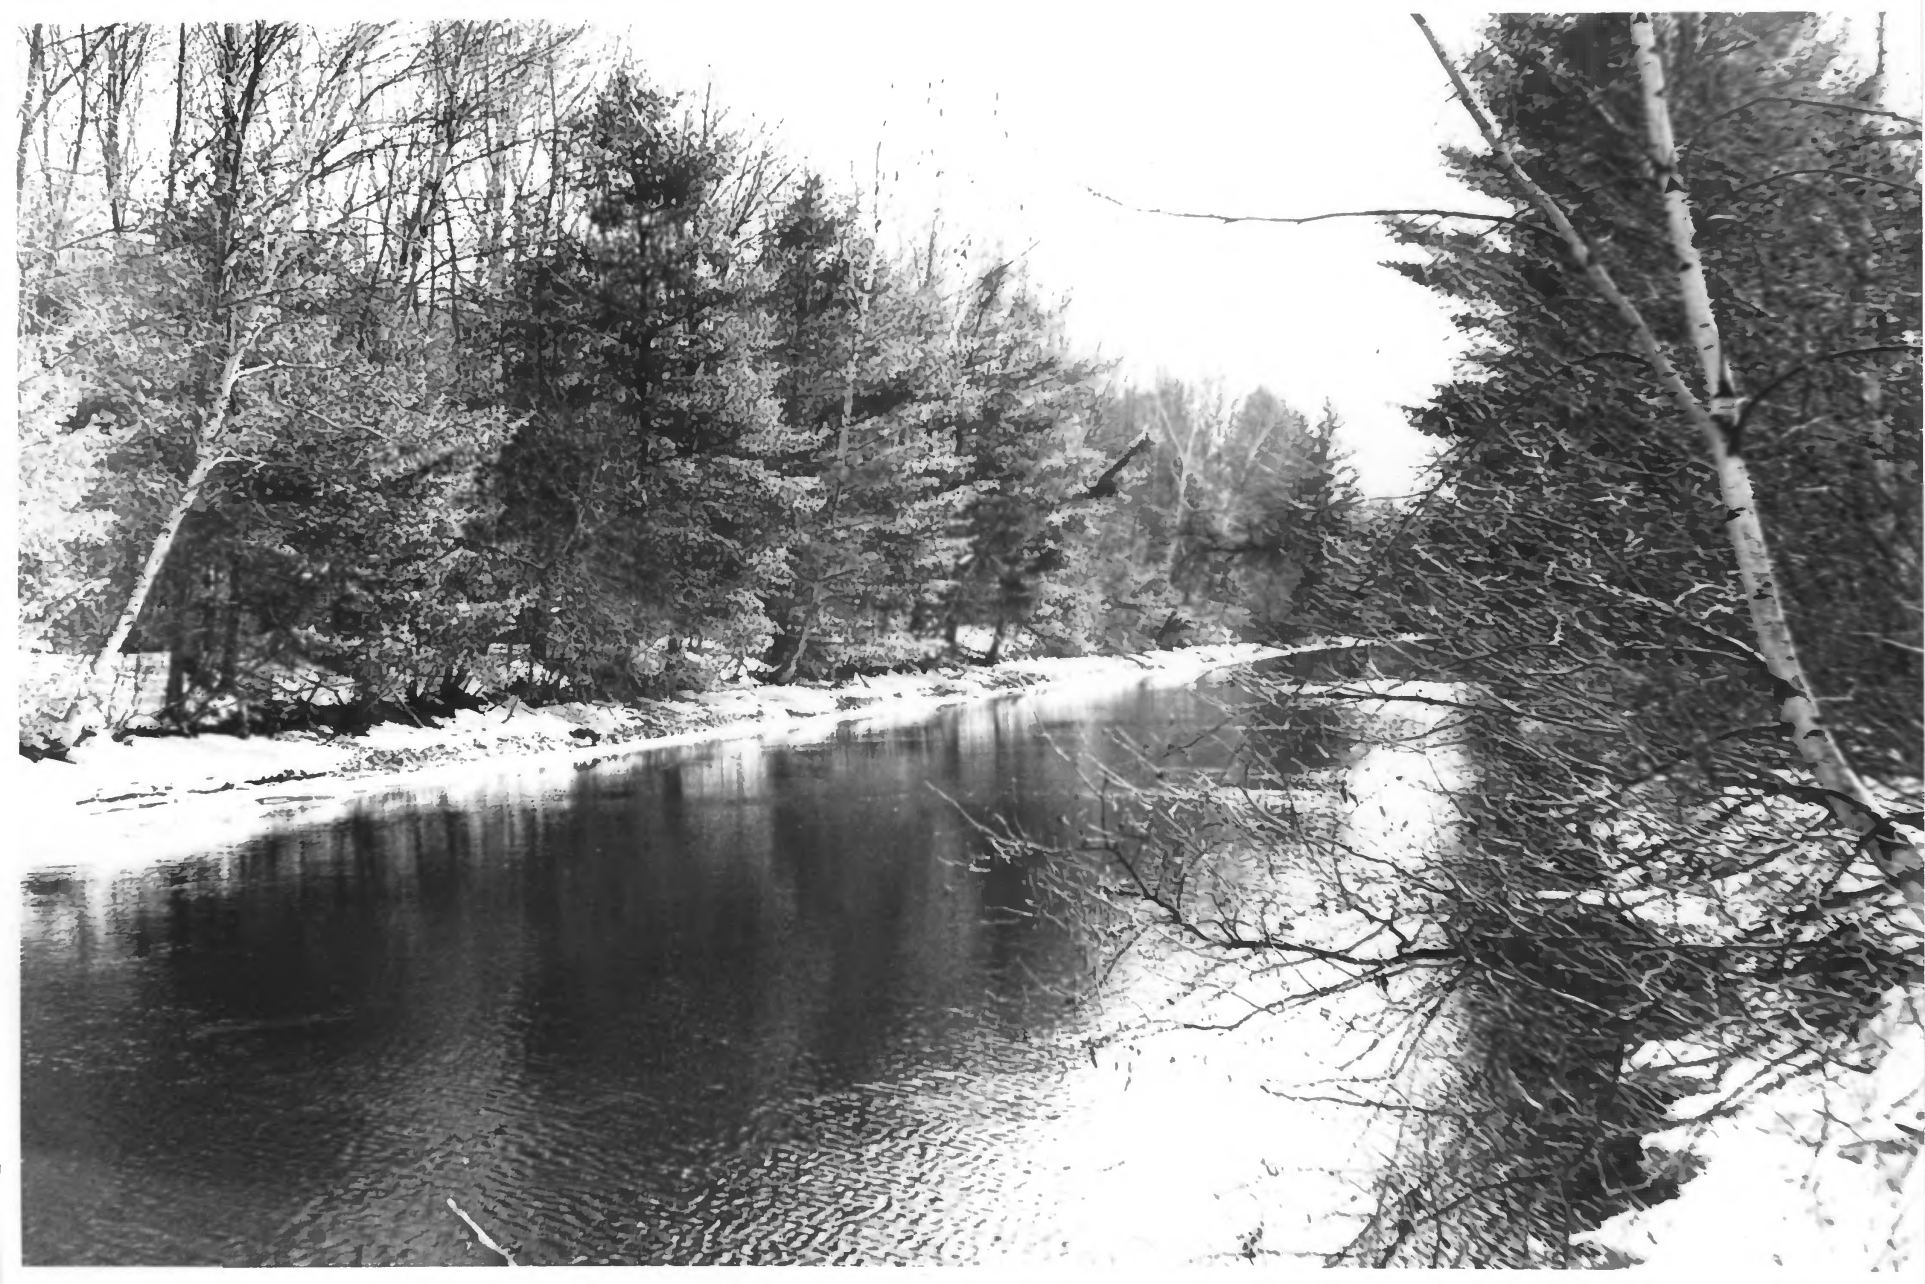
The Cumberland and Oxford Canal between Sebago Lake Basin and the Eel Weir Power Station in Standish. This section has been widened and is now called the Eel Weir Canal. View looking south down canal from the western bank.

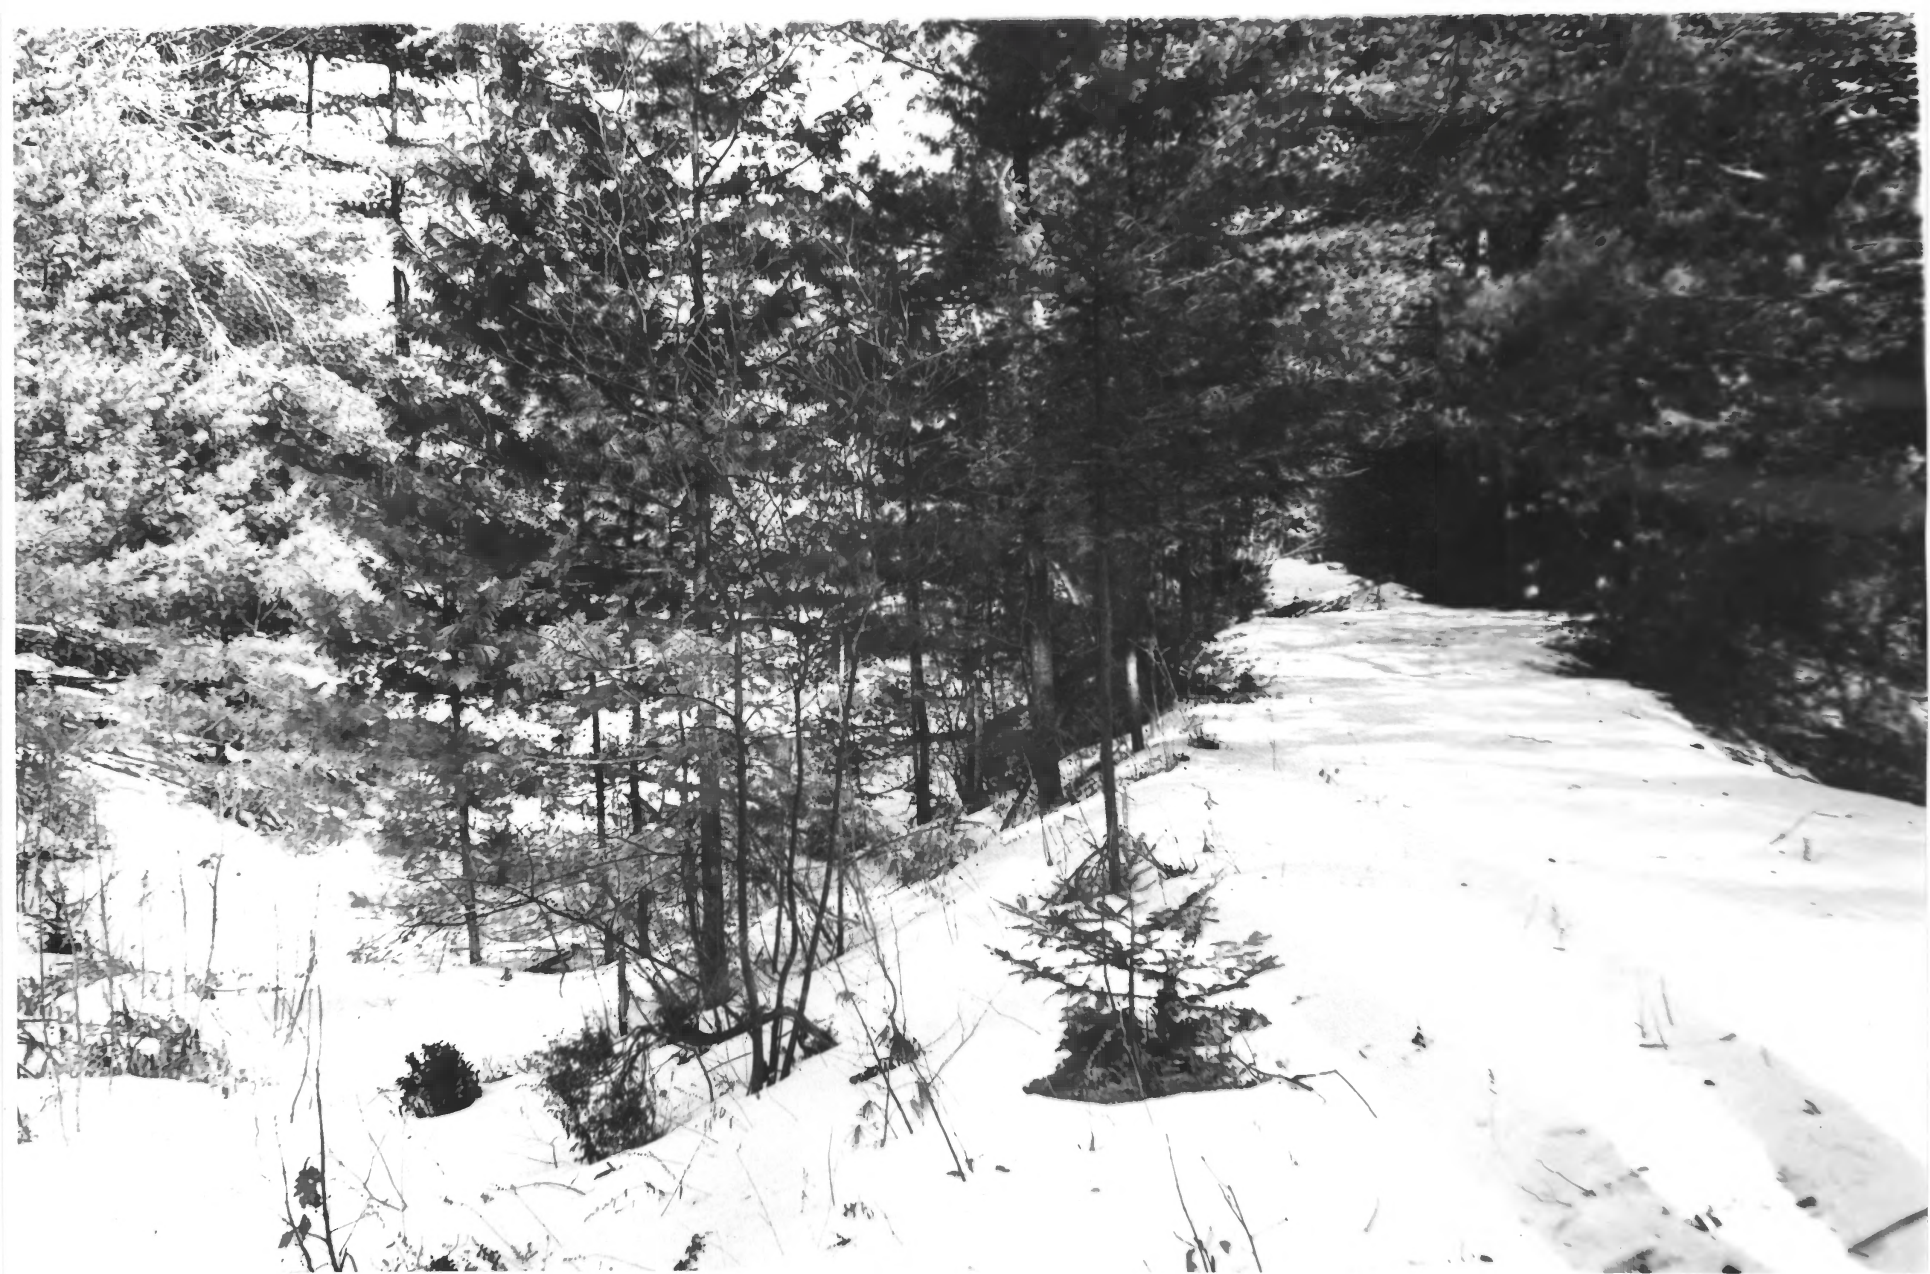
The Cumberland and Oxford Canal bed. View from Hurrell
(Harry Cane) Road at the eastern end of the covered bridge,
looking north up the canal. Tow path on the right.

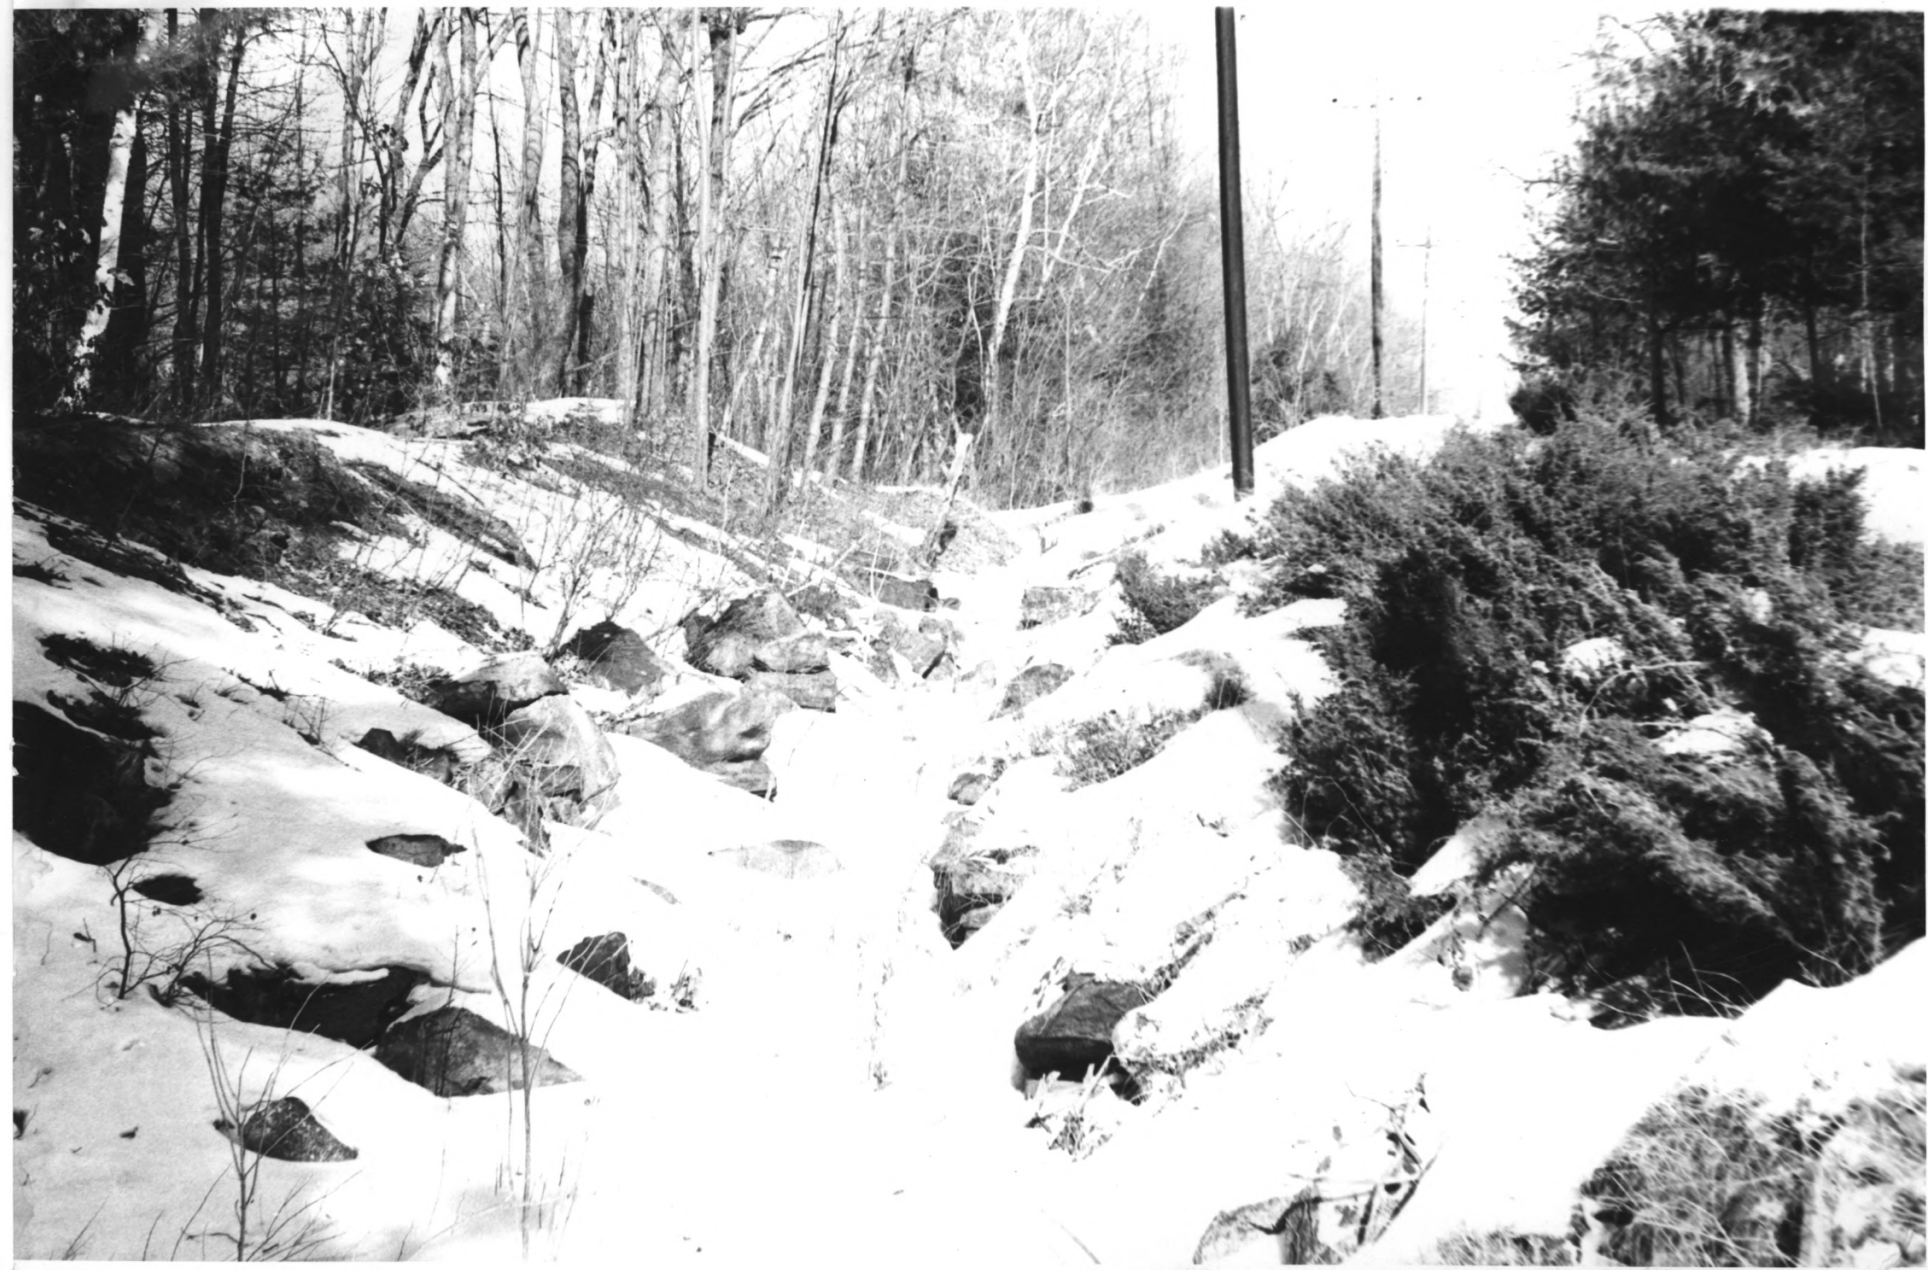
The remains of Blake Lock on the Cumberland and Oxford Canal, on the Standish-Gorham line to the east of Canal Road. View looking north from the lock up the canal bed.
