UNITED STATES DEPARTMENT OF THE INTERIOR
NATIONAL PARK SERVICE
NATIONAL REGISTER OF HISTORIC PLACES
PROPERTY PHOTOGRAPH FORM

1. NAME		
COMMON	AND/OR HISTORIC	NUMERIC CODE. (Assigned by GPO)
Cumberland and Oxford Canal		23/005
2. LOCATION		
STATE	COUNTY	TOWN
Maine	Cumberland	Standish, Windham, Gorham & Westbrook
STREET AND NUMBER		
From: Sebago Lake Basin To: Conant Street		
3. PHOTO REFERENCE		
PHOTO CREDIT	DATE	NEGATIVE FILED AT
U.S. Dept. of Agriculture Soil Conservation Service	May 2, 1964	Joel W. Eastman University of Me. Portland-Gorham
4. IDENTIFICATION		
DESCRIBE VIEW, DIRECTION, ETC.

COMMON: Cumberland and Oxford Canal

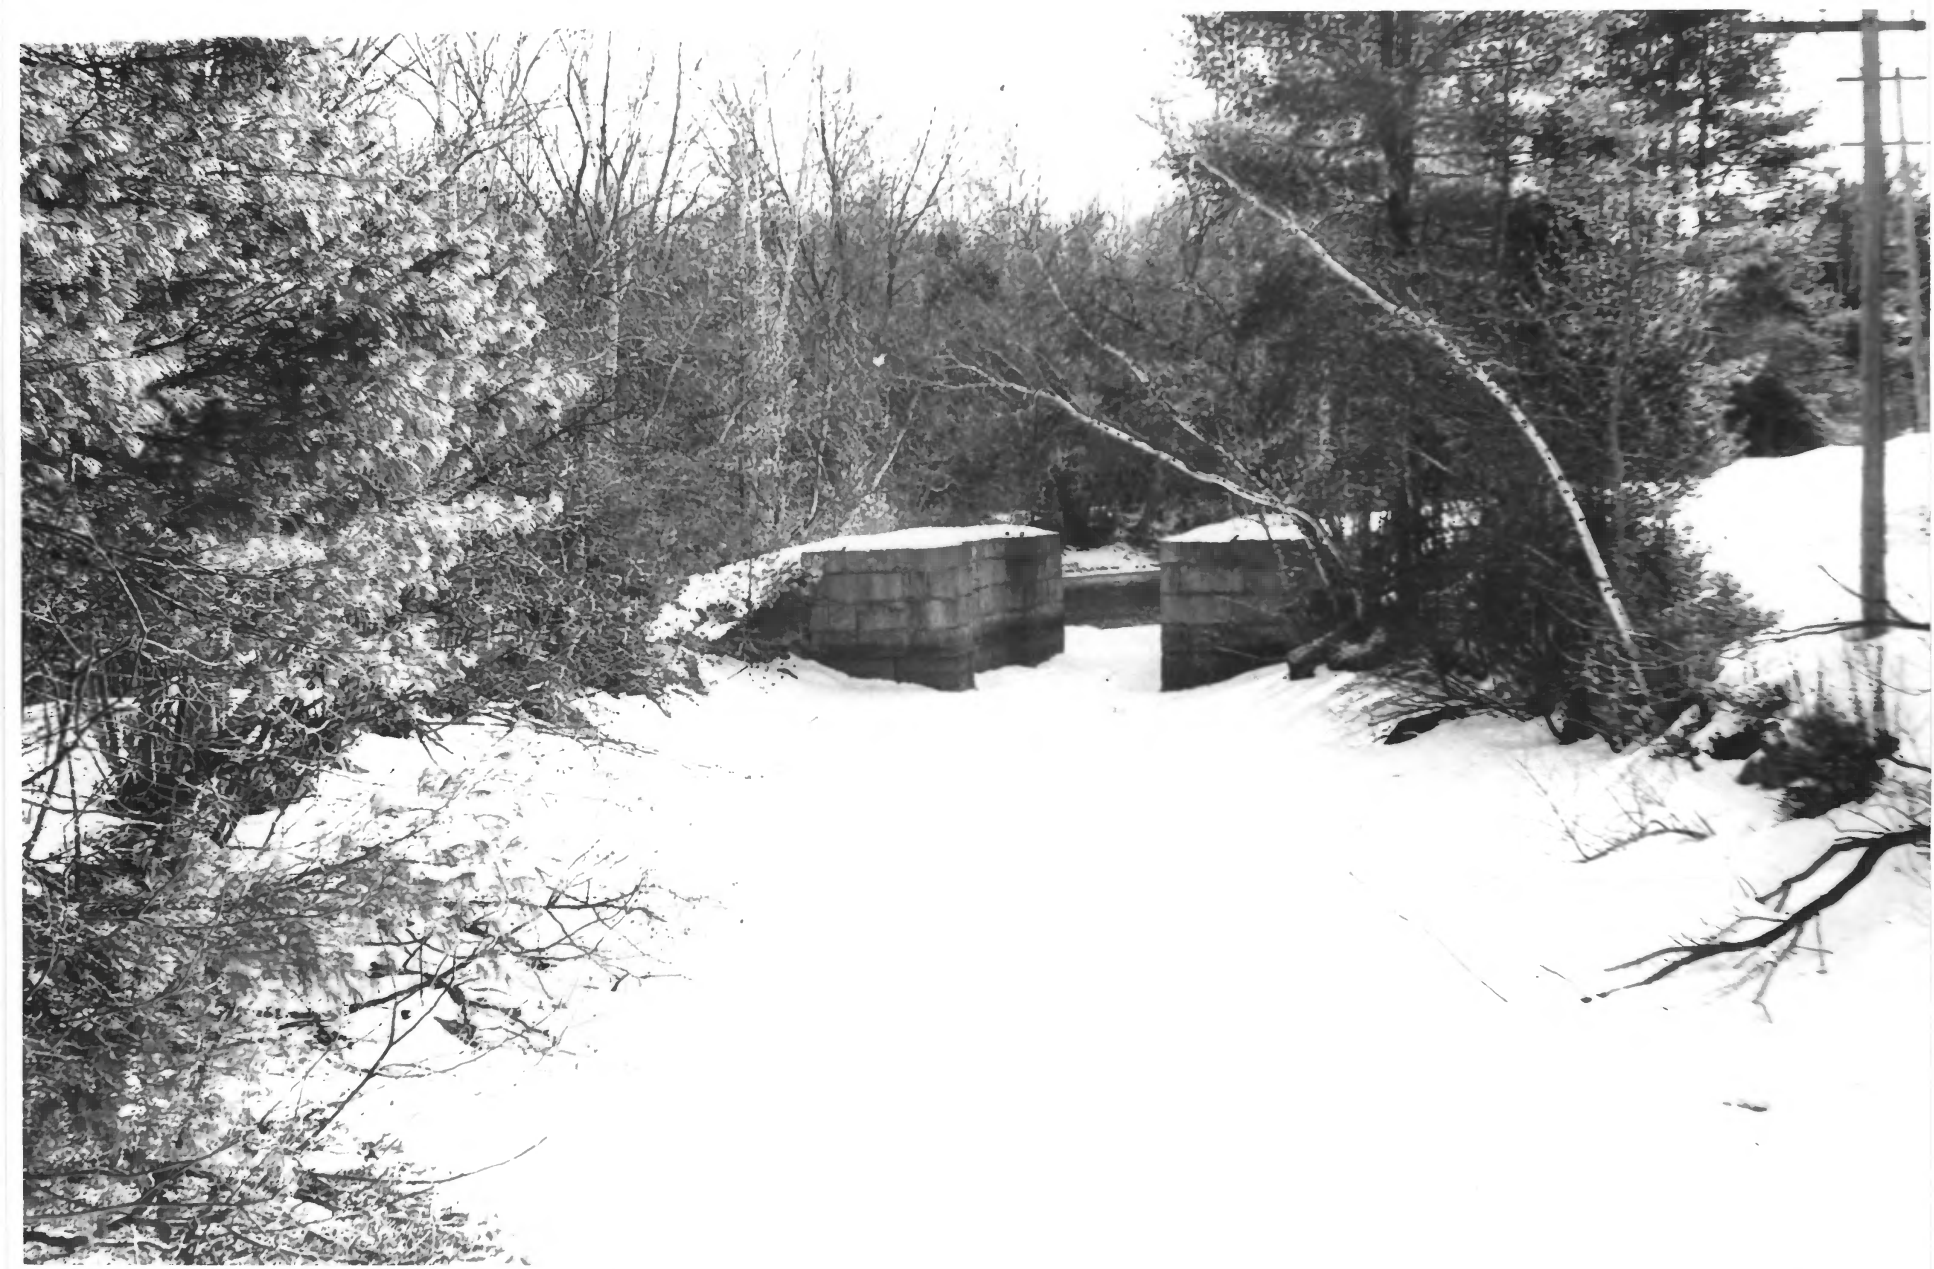
Wescott Lock on the Cumberland and Oxford Canal at the foot of Sebago Lake Basin. View looking south down the lock at the stonework of the southern end. Curve in the stonework shows where the wooden gate swung.

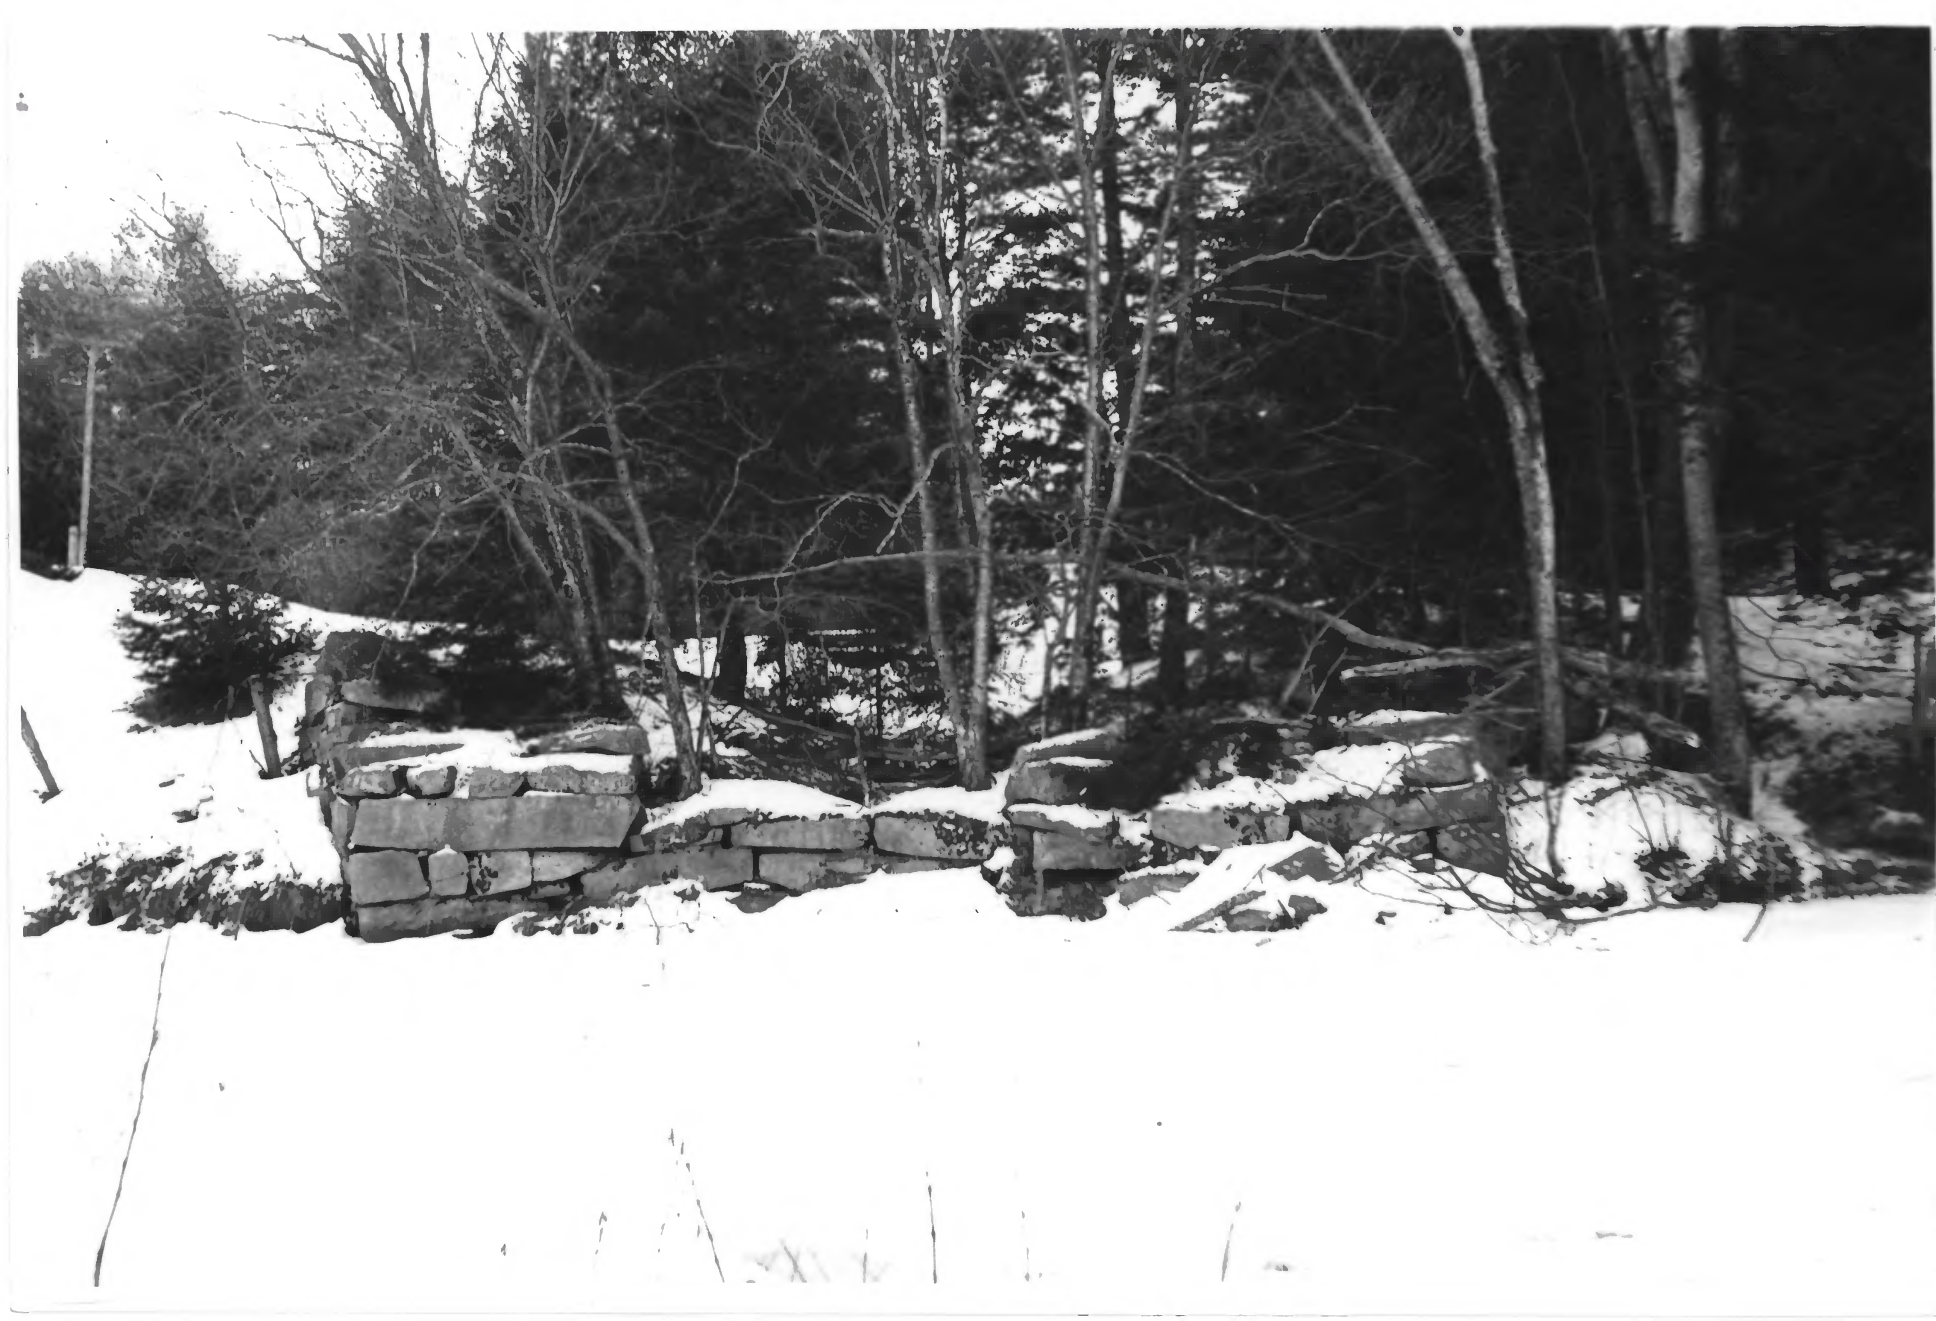
Stonework end support of the aqueduct which carried the Cumberland and Oxford Canal over the Little River in Gorham. View from the northern bank of the river looking southeast at the canal bed on the opposite bank.

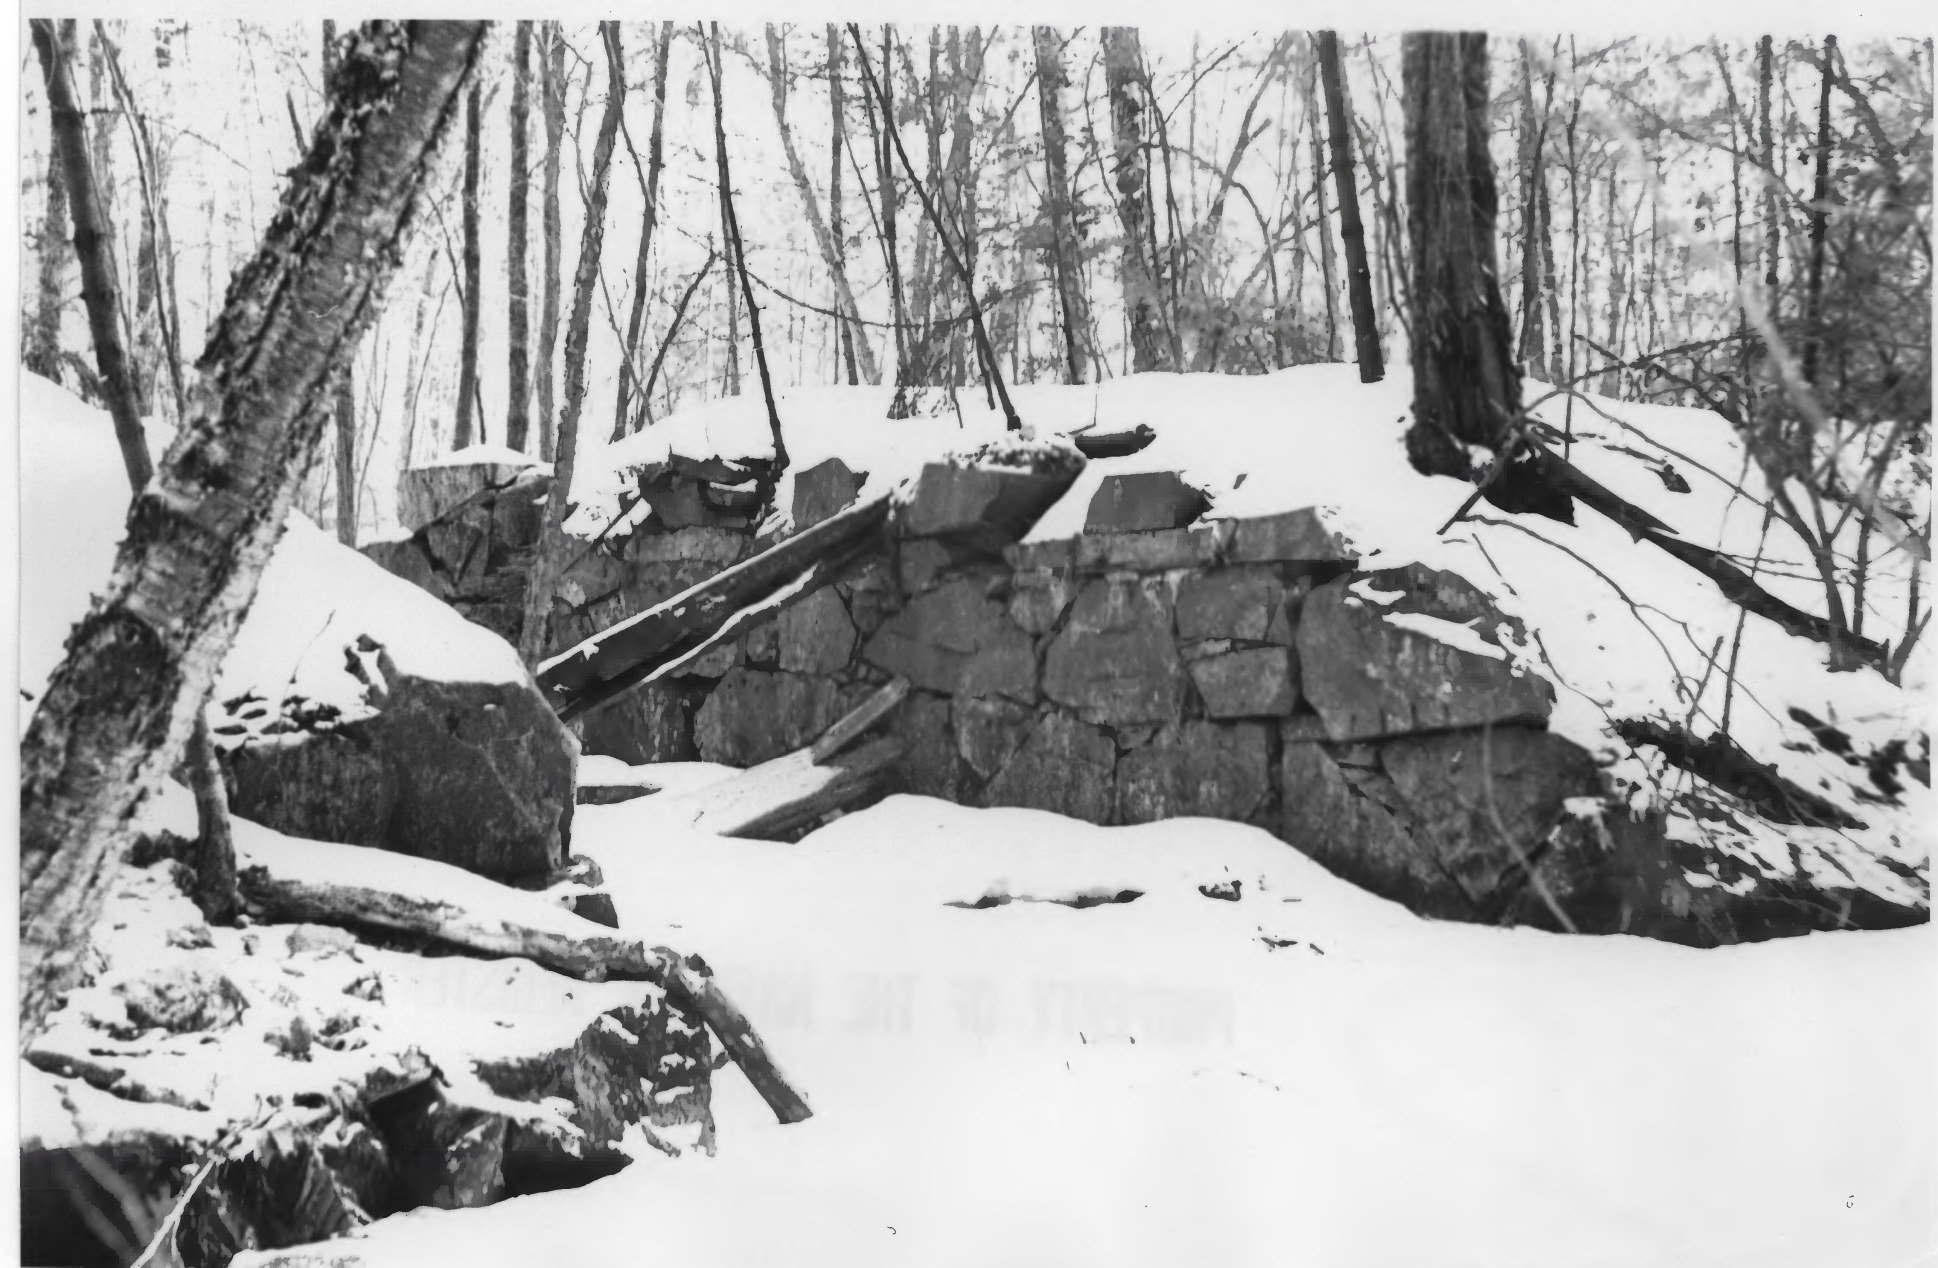
Sluiceway opening in the tow path of the Cumberland and Oxford Canal, at the former Gambo Falls mill complex below Newhall Road. View from the canal bed looking southeast at the southern side of the remaining stonework.

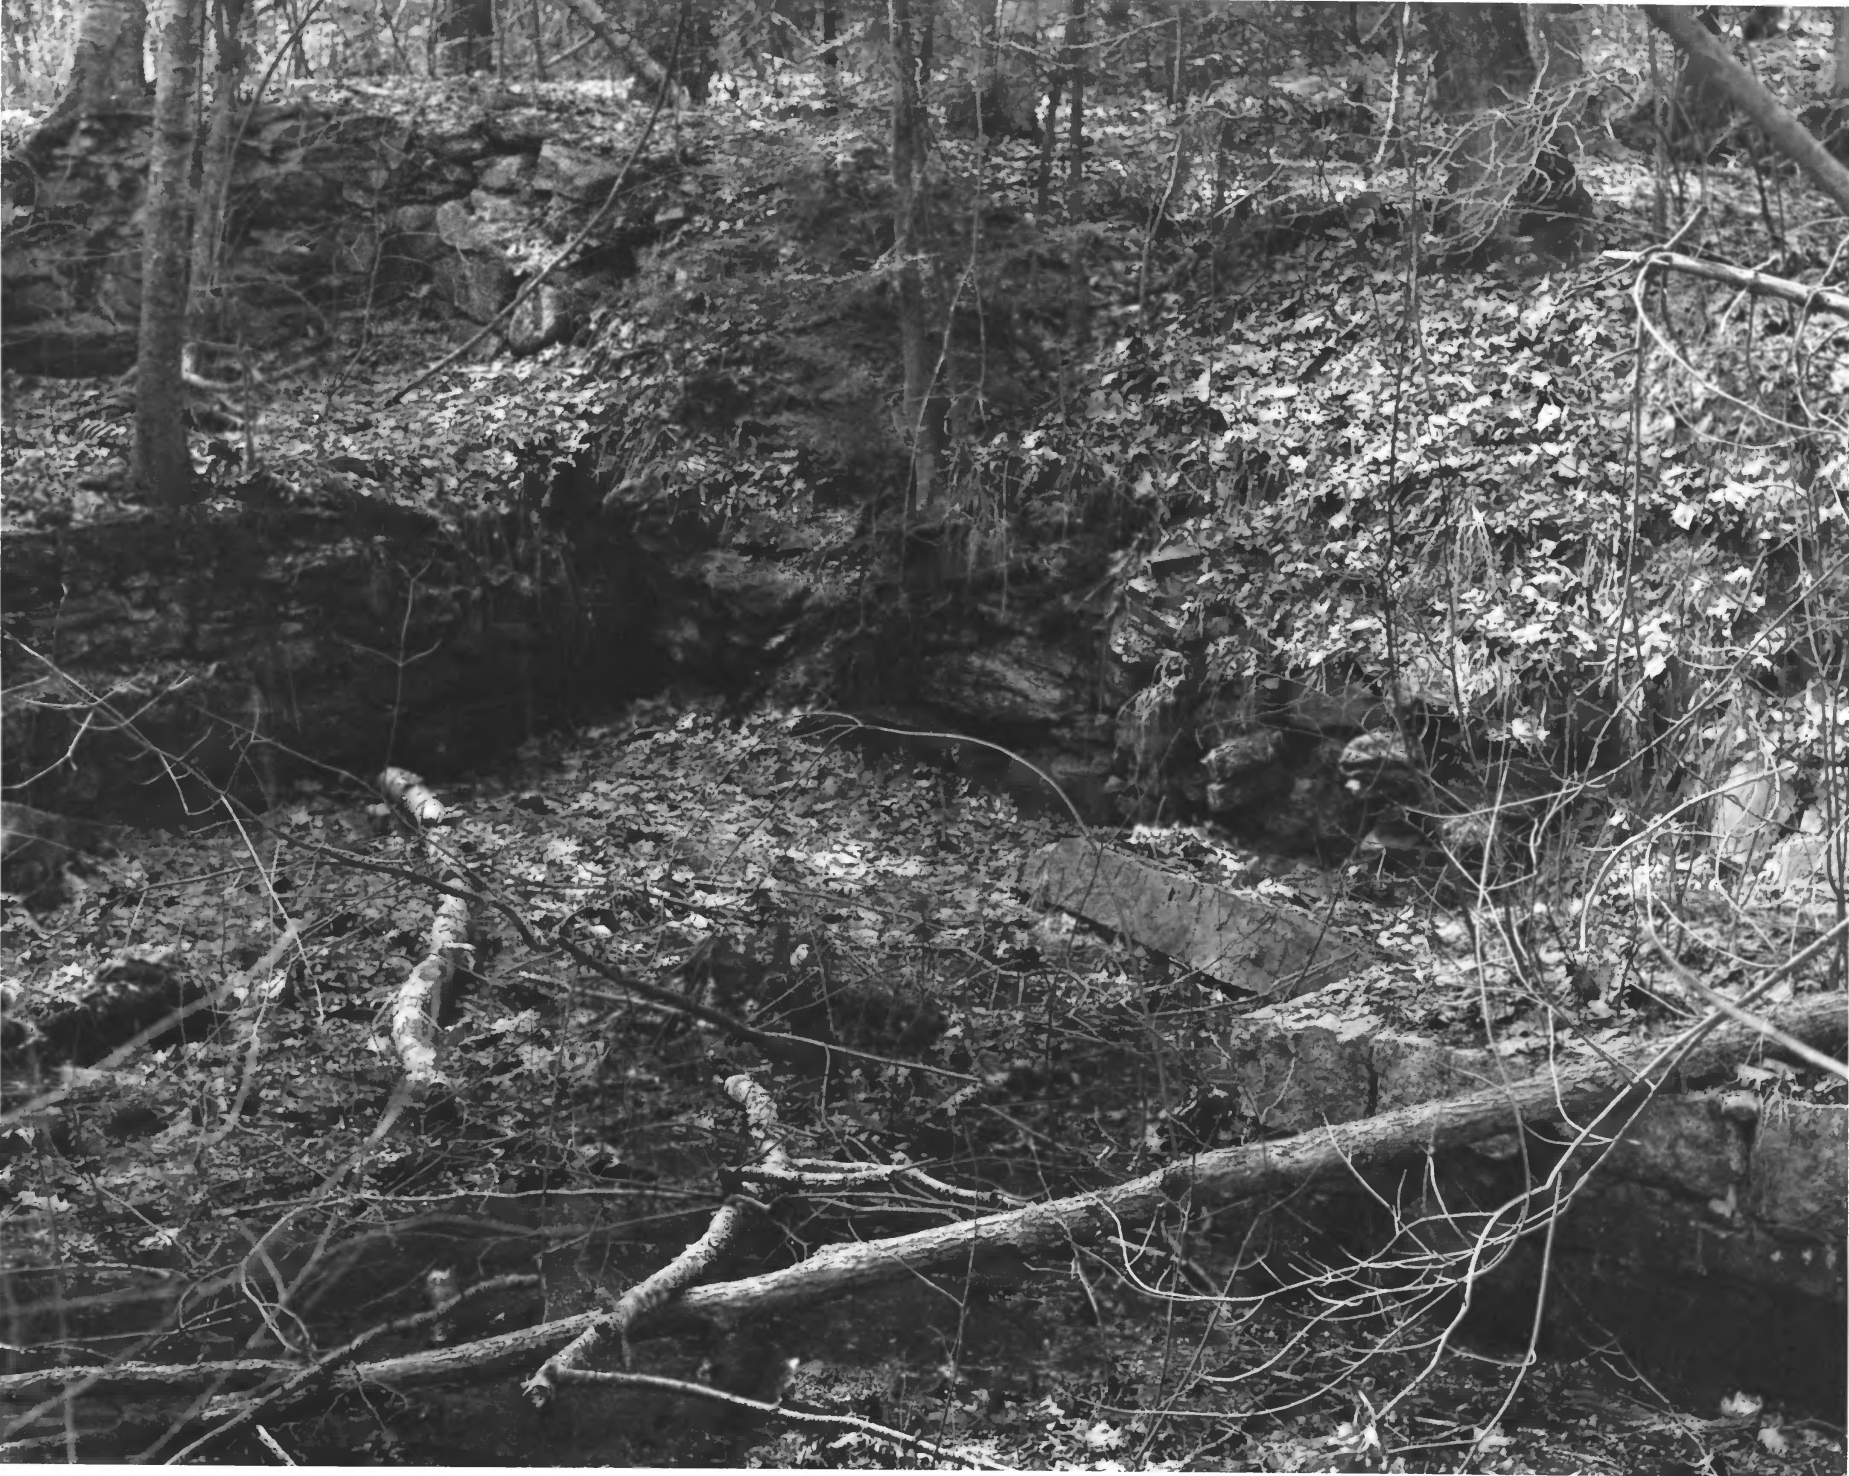
The foundation of one of the various mills
in the complex.

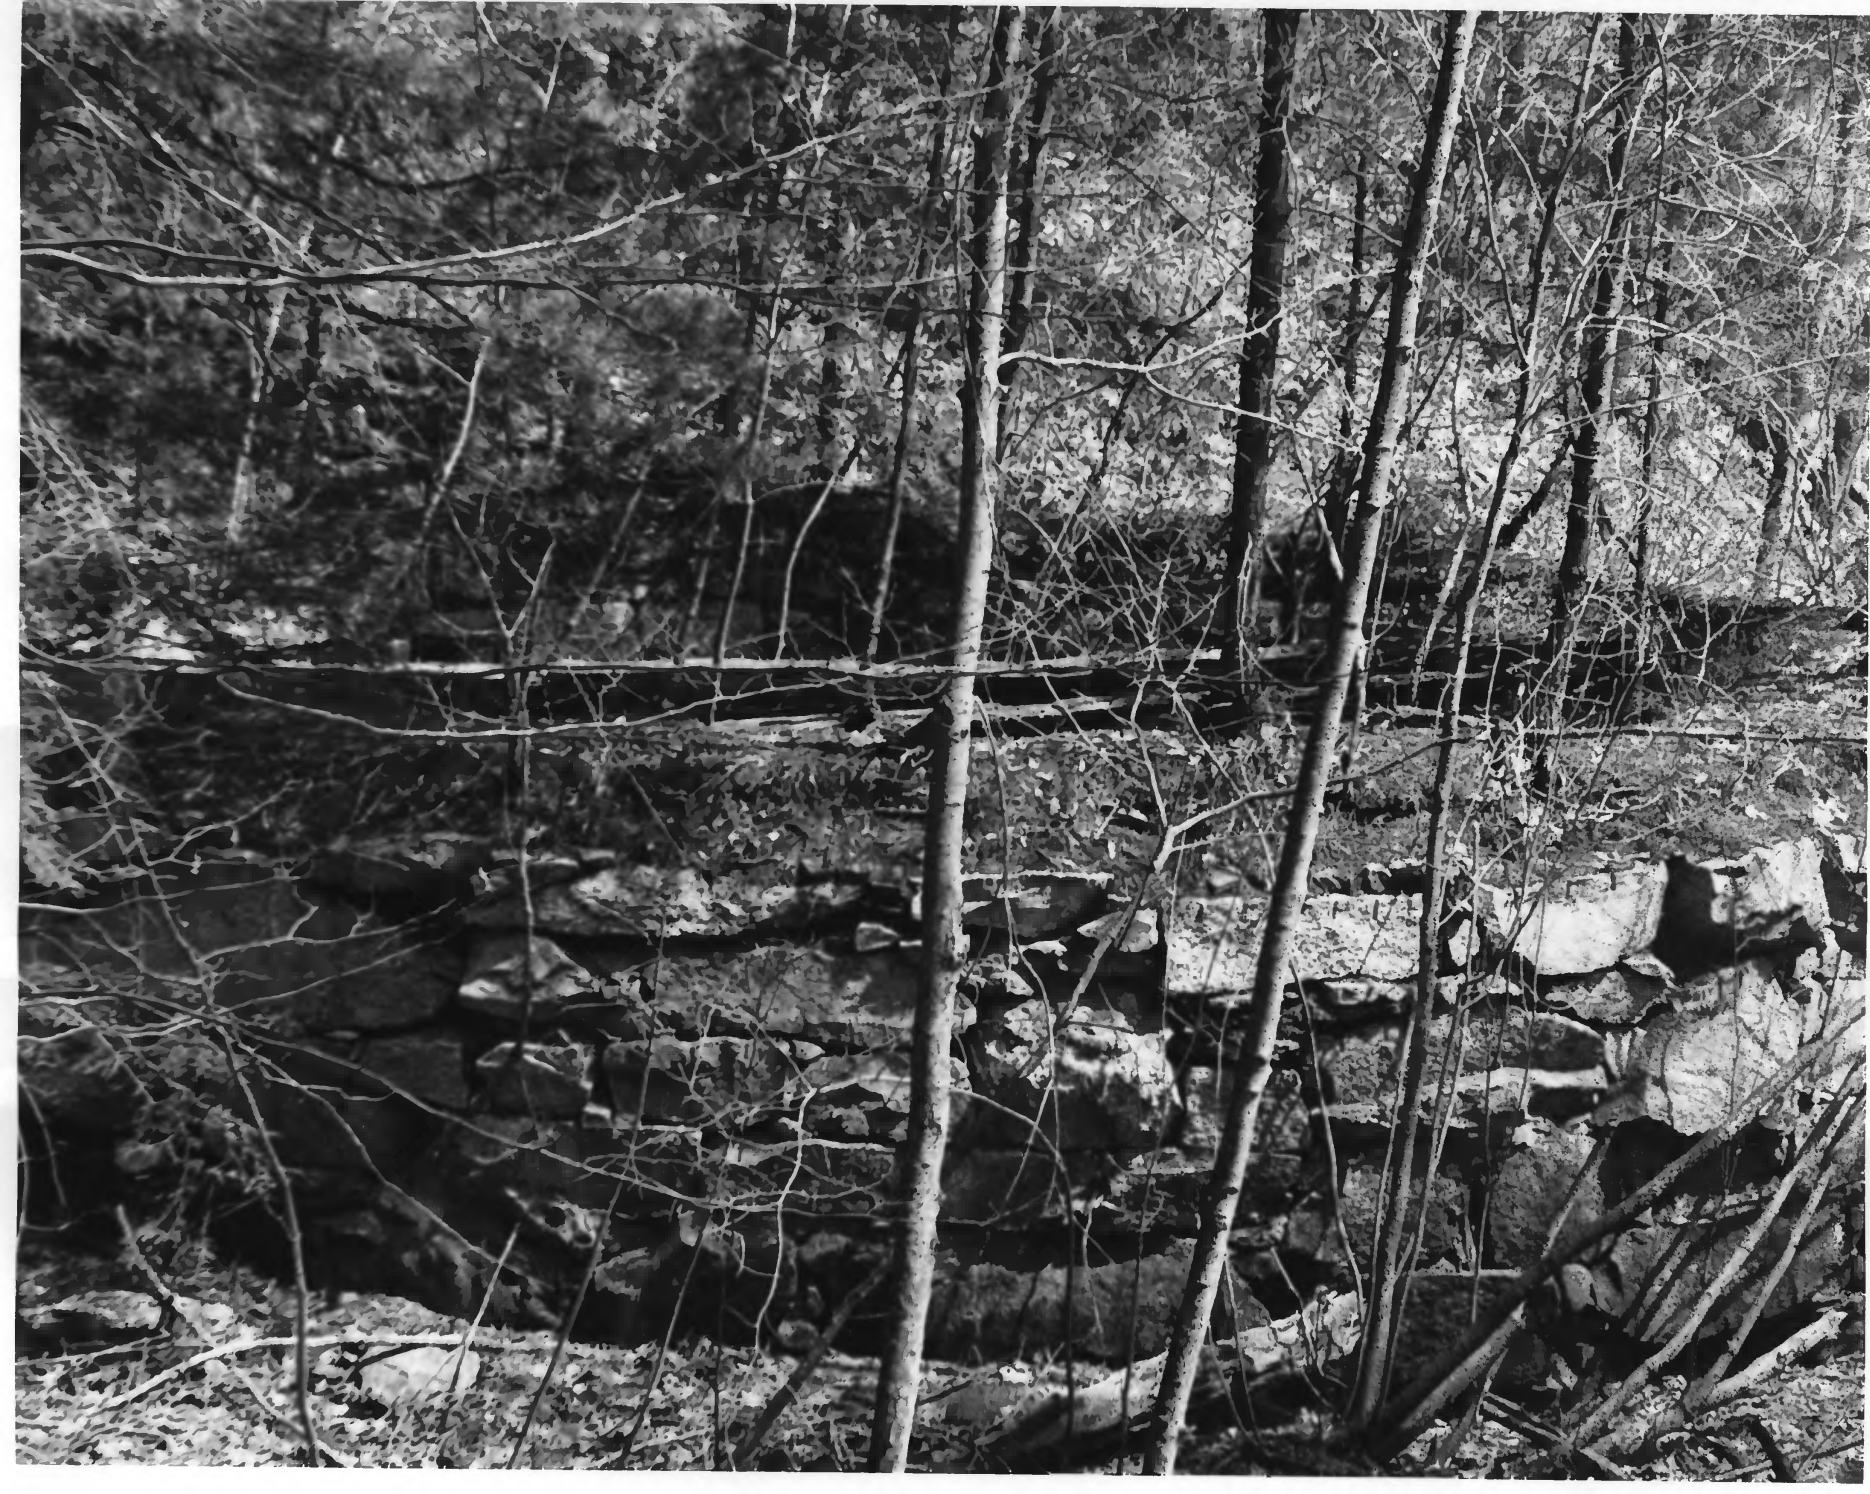
The foundation for a horizontally-set mill wheel which was used during the compounding stage of production.
