National Register of Historic Places Registration Form

historic name Nordby Farmstead

city or town Genesee, Idaho N/A vicinity

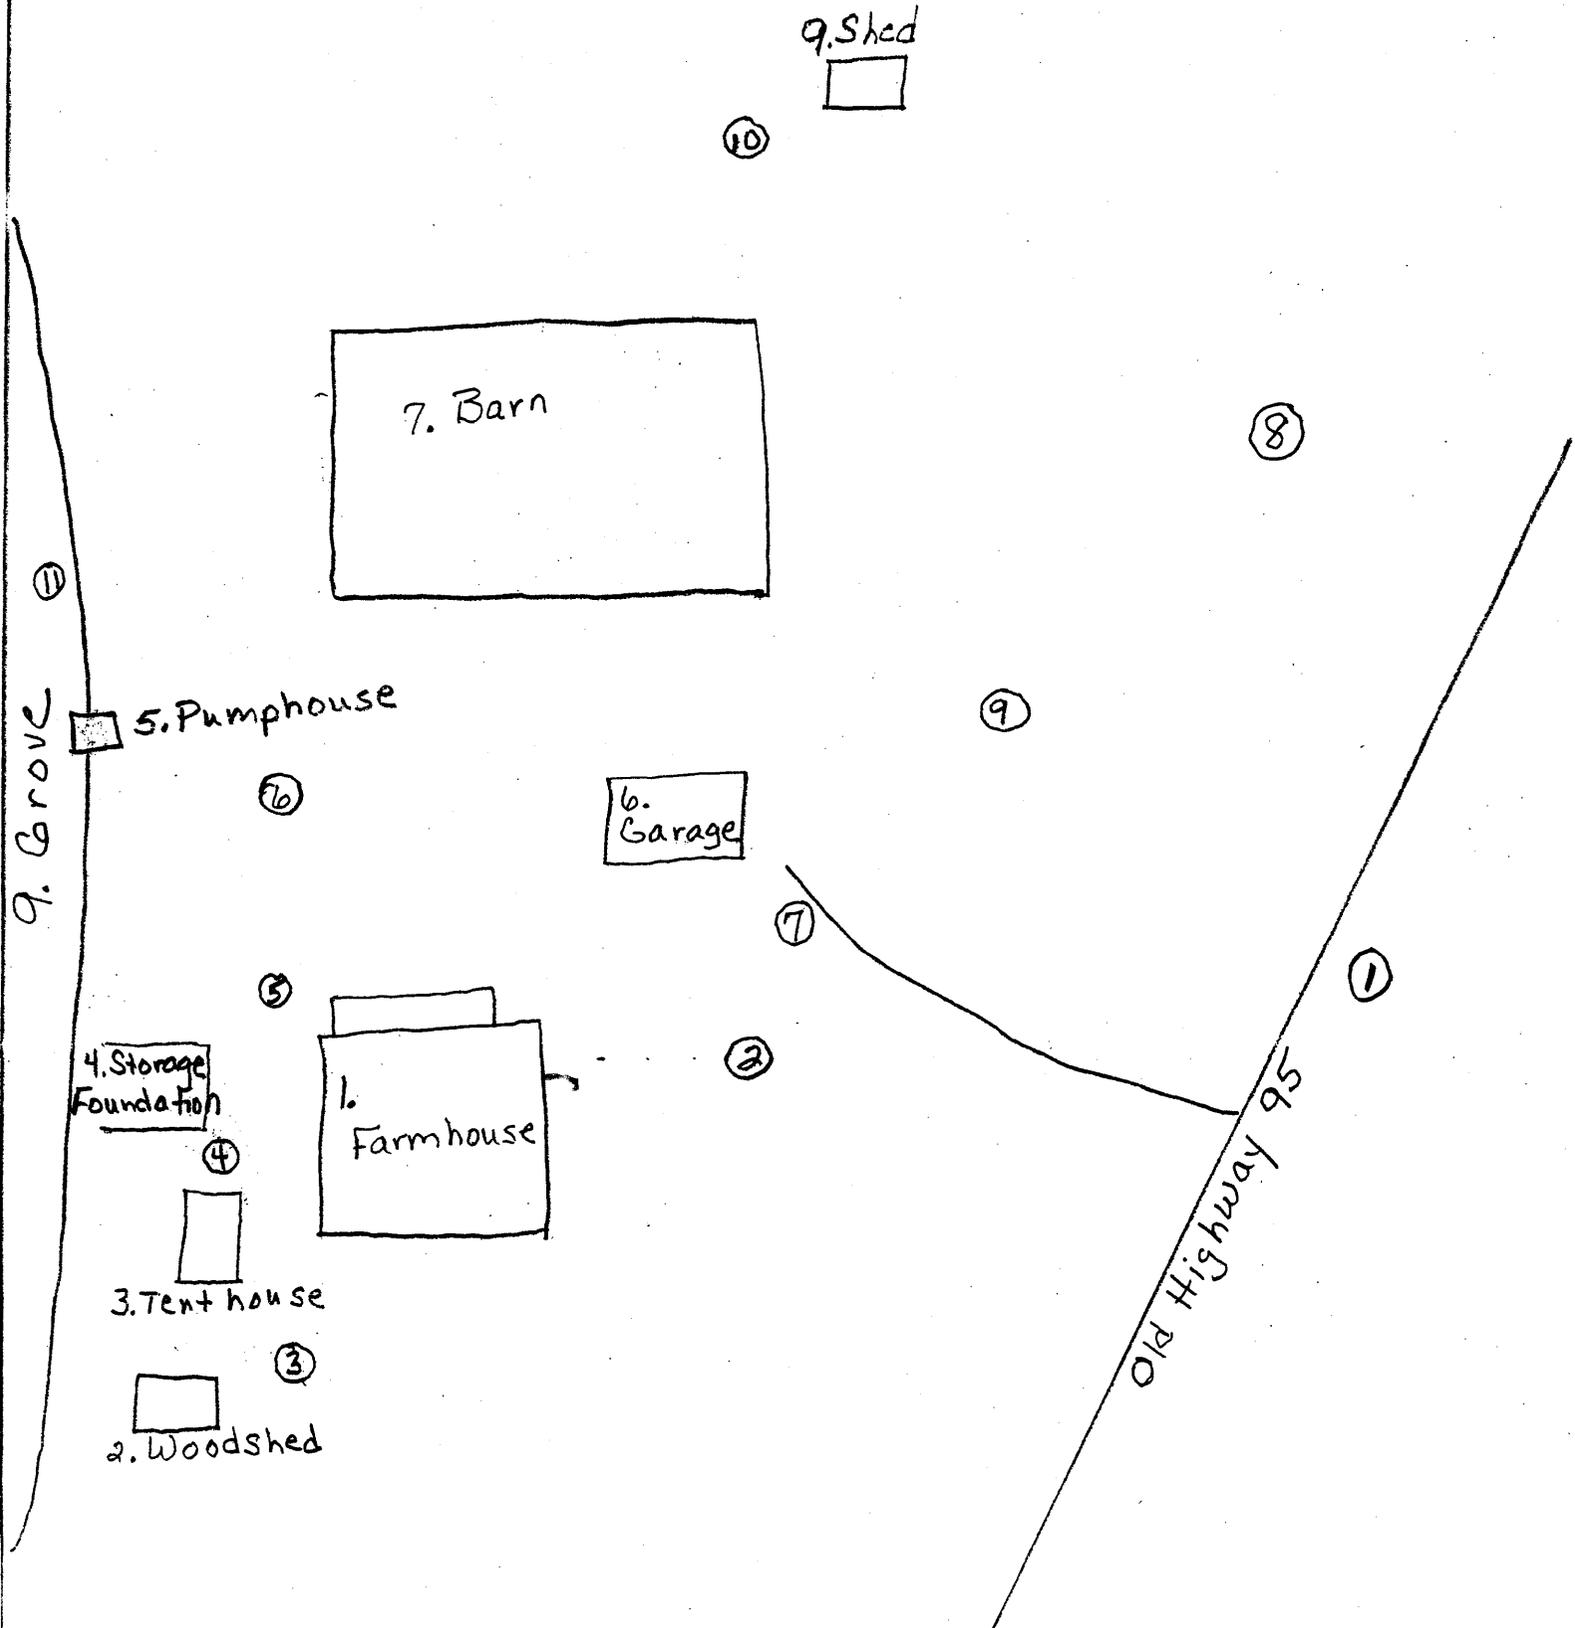
Nordby, Rudolph and Mildred, Farmstead

Photograph Vantage Points ○
