FORM B - BUILDING

Town Rehoboth  
Address 13 Gorham Street  
Historic Name The Anawan Club Clubhouse

Address 15 Gorham Street

Historic Name Anawan Club Caretaker's  
House

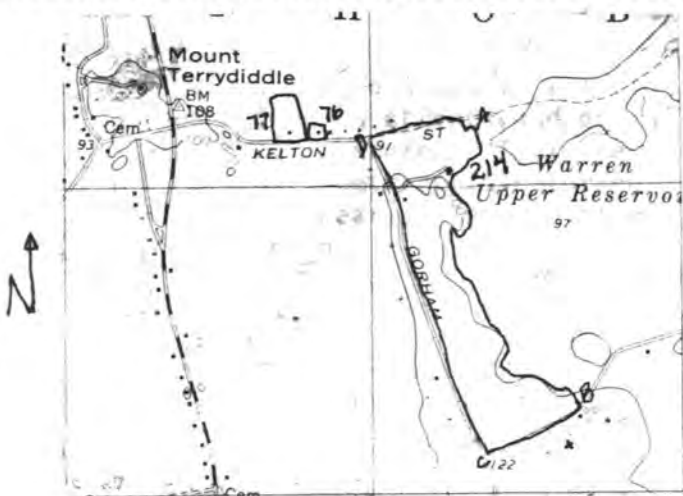
Style log cabin

Exterior wall fabric cedar logs

Setting well off road on the edge of  
Bad Luck Reservoir, surrounded by  
woodland

The Anawan Club Clubhouse is a unique and outstanding local example from this period of the vernacular log cabin form common to hunting and logging camps of northern New England. In plan, the one-story main portion contains a single large room with two

massive fieldstone exterior end chimneys; a small service ell extends to the rear end and a porch across the front directly overlooks Bad Luck Reservoir. It is constructed of cedar logs cut from an adjacent swamp and hewn by hand. In addition to its primary architectural importance, the Anawan Club Clubhouse stands as the only known local precedent for log cabin residential architecture currently popular in Rehoboth.

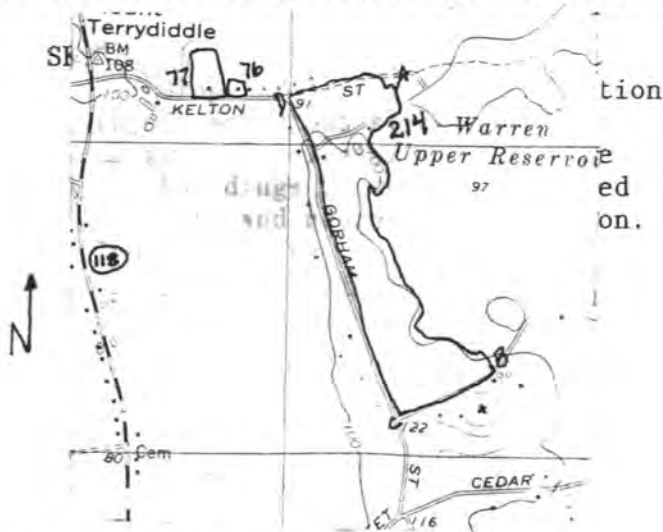
Style Georgian

Exterior wall fabric clapboard

A modest one-story cottage, following the traditional five-bay center chimney plan, the Anawan Club Caretaker's House is a well-preserved example of this vernacular form. It retains the bulk of its original exterior and interior features, including period fireplace panelling, doors and hardware.

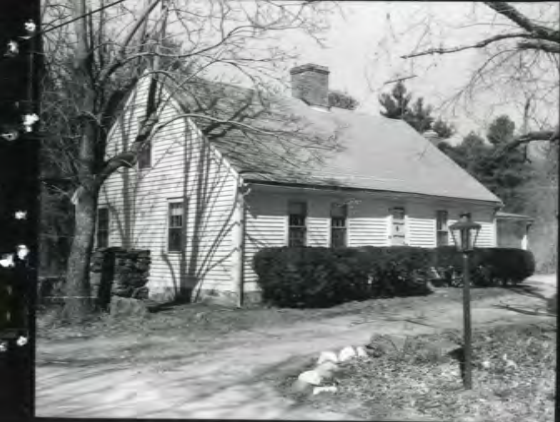
RAHS # ~~75~~  
75

Angewandte Club Cretaceous House

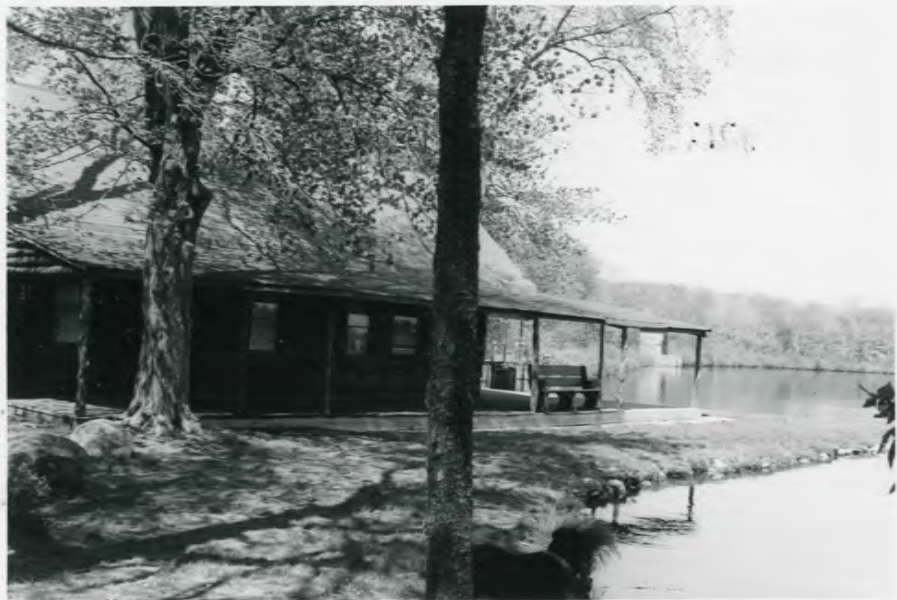
#214

ANAWAN CLUB

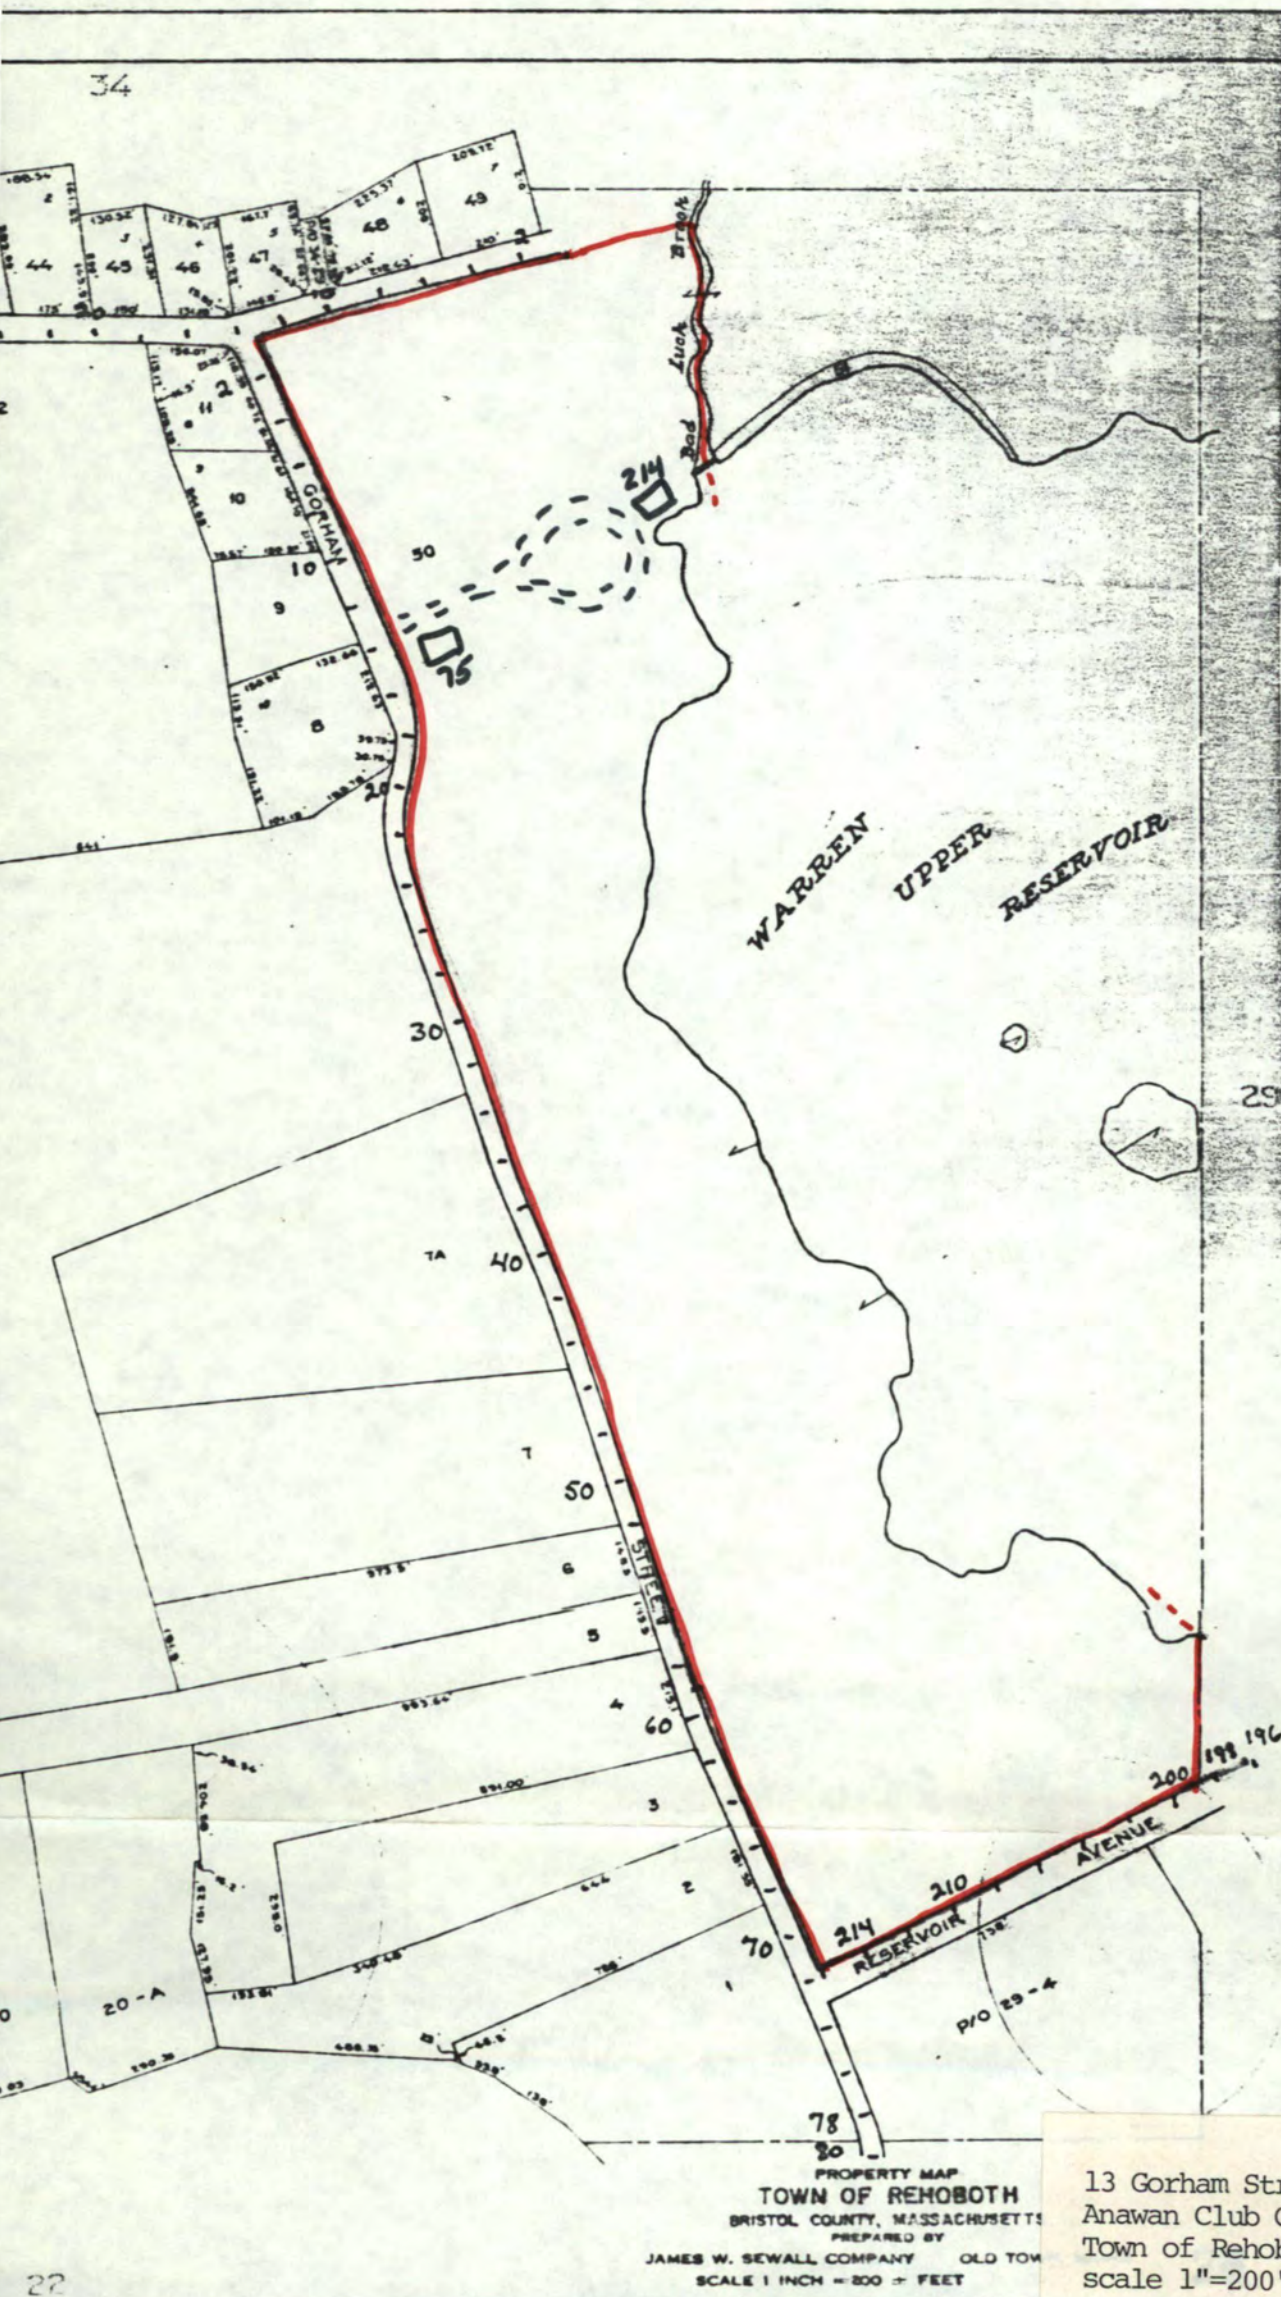
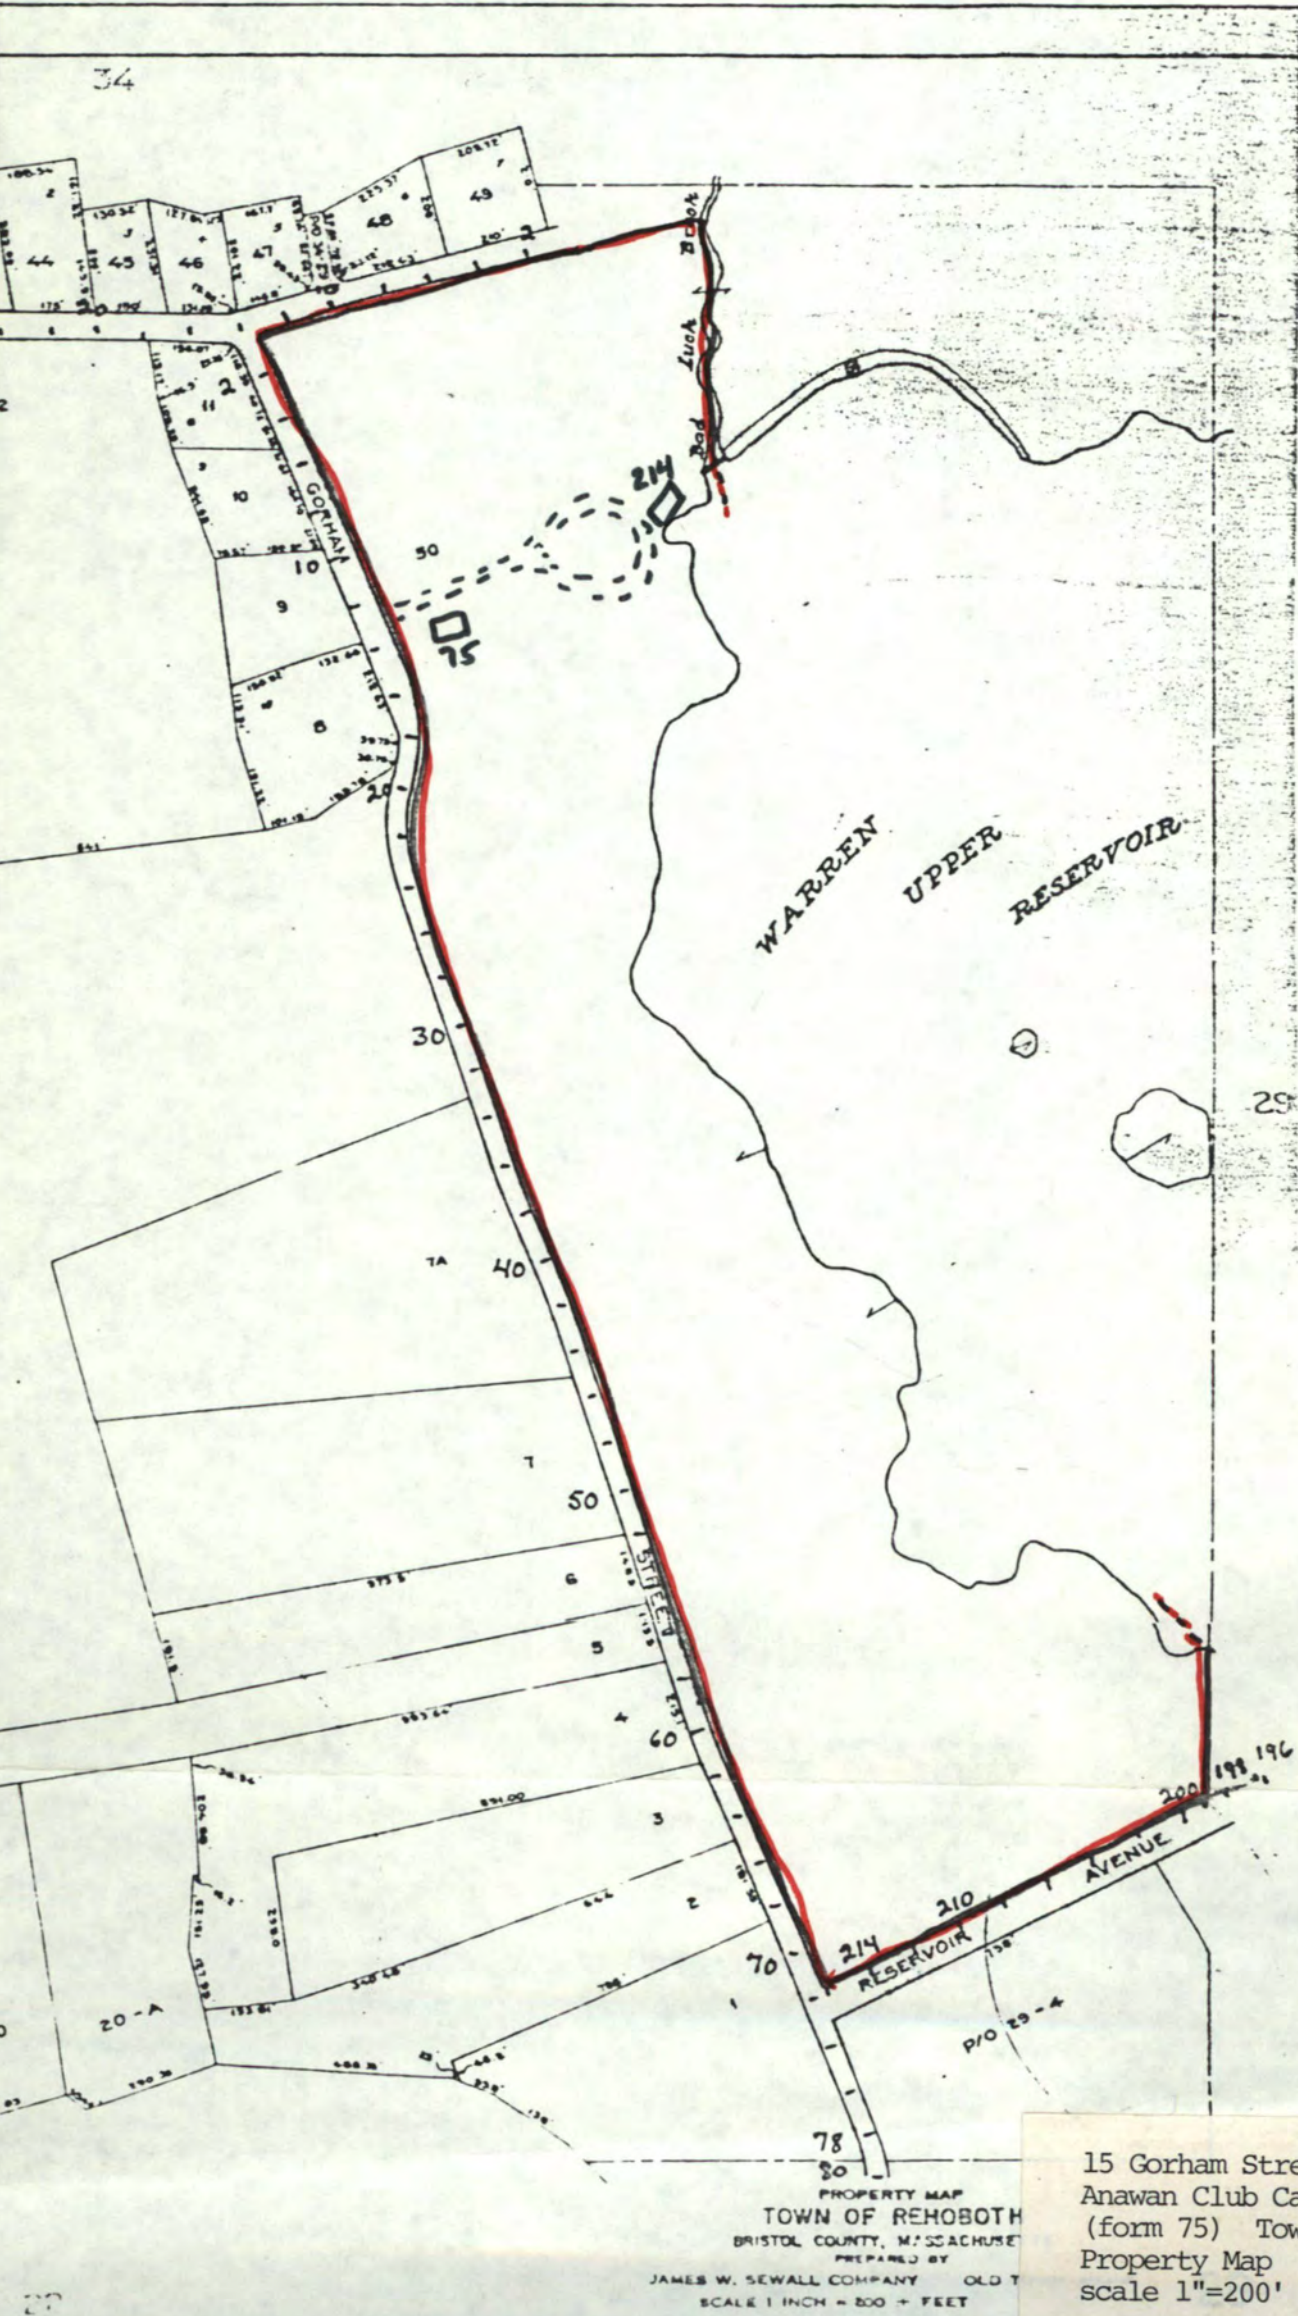
15 Gorham Street  
Anawan Club Caretakers House  
(form 75) Town of Rehoboth  
Property Map 1978  
scale 1"=200'
