**NATIONAL REGISTER OF HISTORIC PLACES
REGISTRATION FORM**

historic name Carolina Cadillac Company Building

street & number 304 East Market Street not for publication N/A

Carolina Cadillac Company Building
Guilford County, North Carolina

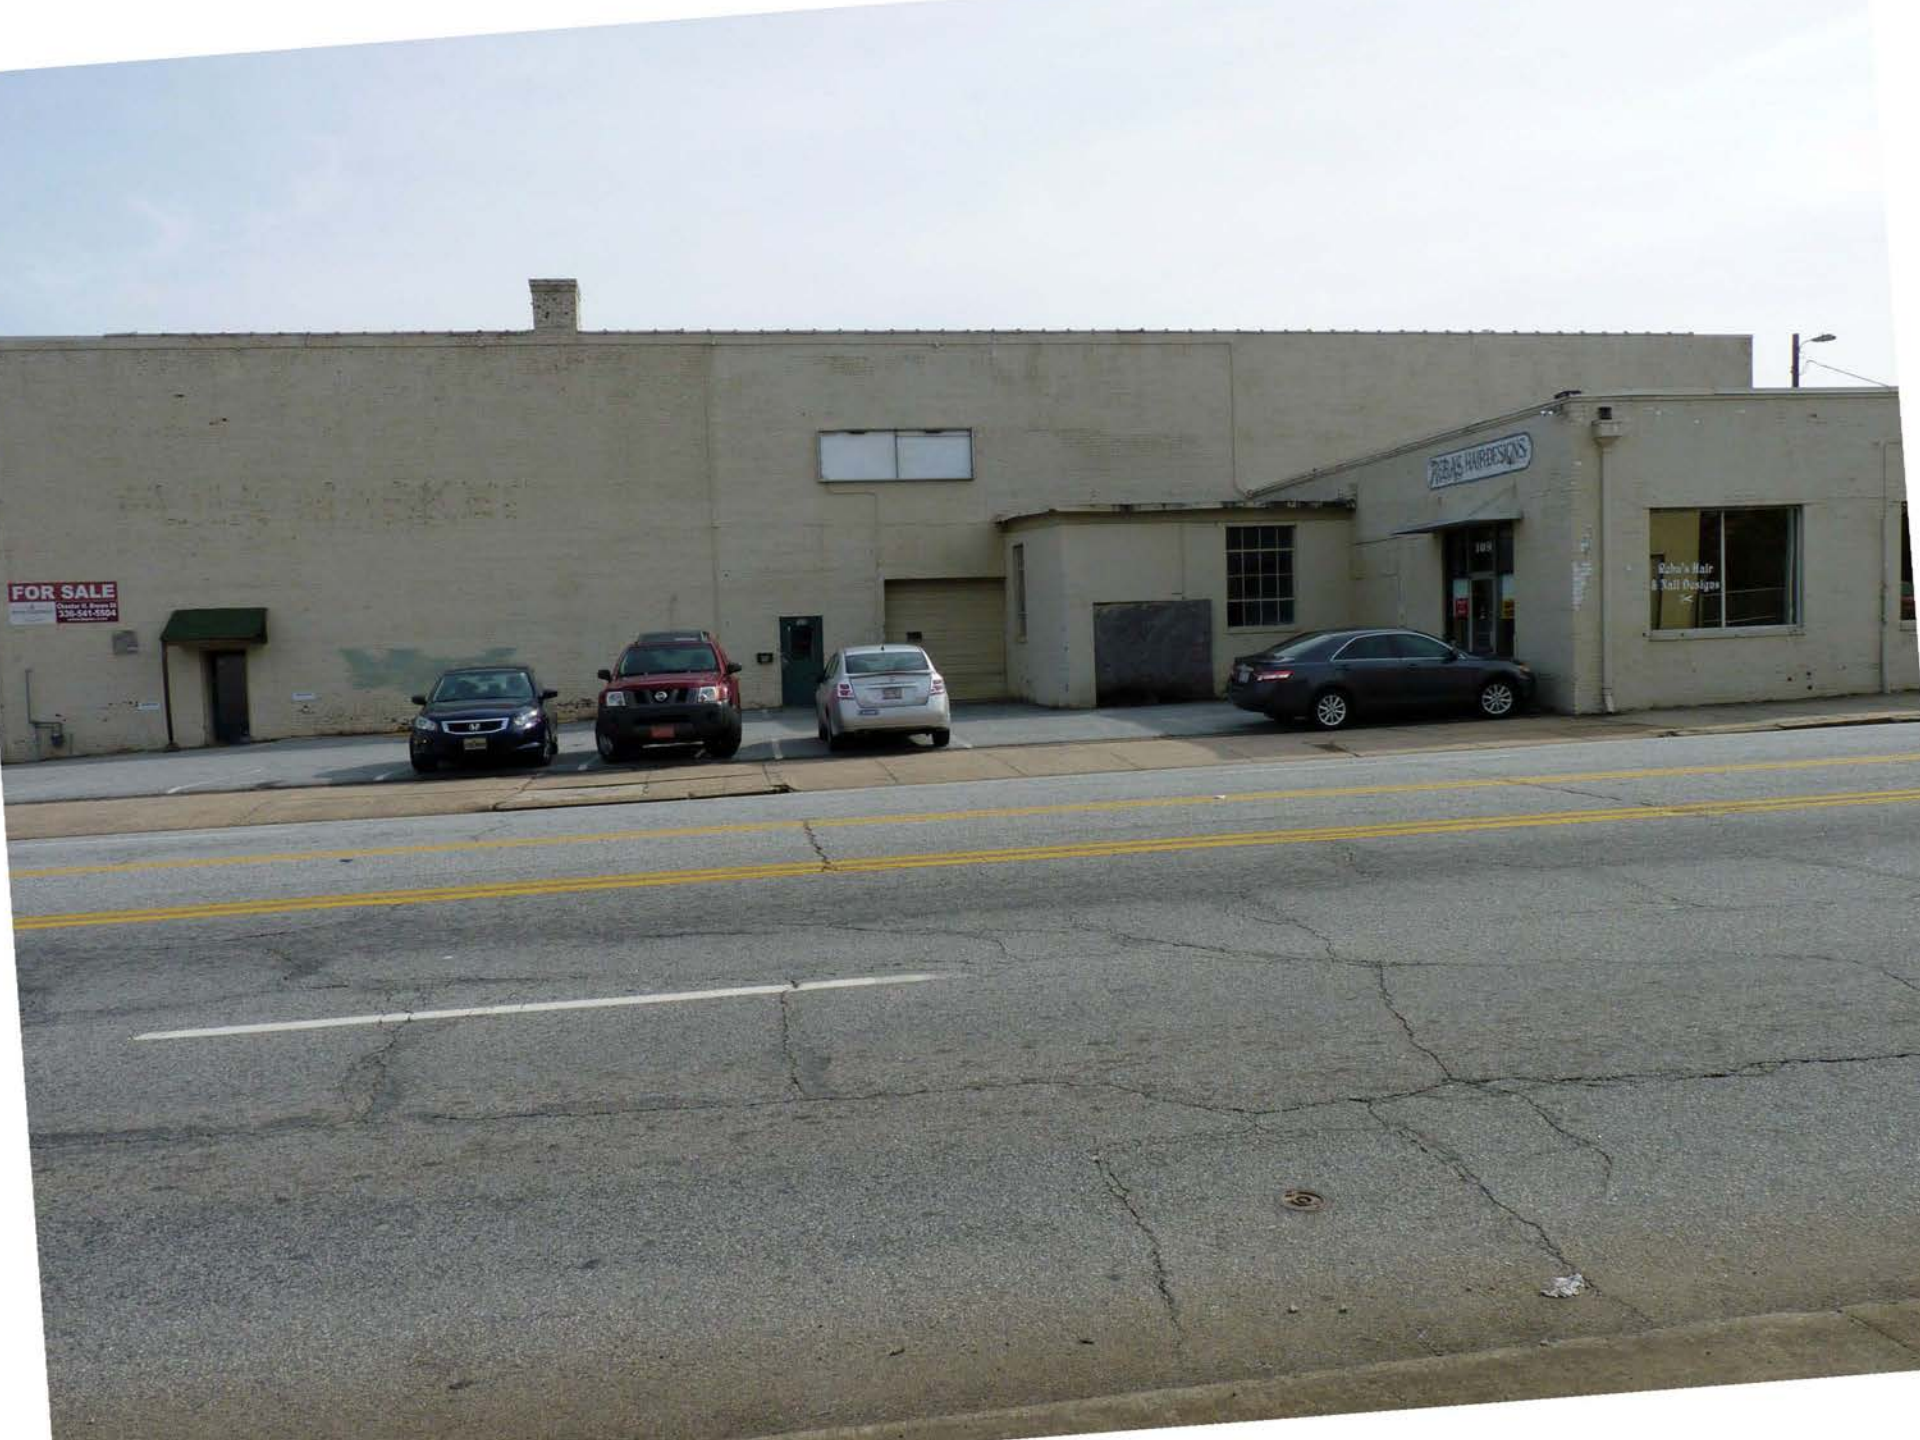
- 1: North and west elevations (façade); camera looking southeast
- 2: West elevation; camera looking east
- 3: South elevation; camera looking north
- 4: South elevation of 1940 addition; camera looking north
- 5: Interior – showroom and staircase; camera looking south
- 6: Interior – loft overlooking showroom; camera looking west
- 7: Interior – mezzanine level; camera looking west
- 8: Interior – garage; camera looking southwest
- 9: Interior – garage; camera looking south
- 10: Interior – garage; camera looking north

The Carolina Cadillac Company Building is a remarkably intact example of early twentieth-century Commercial Style architecture with several Mission Revival-style embellishments. Although the building was painted a cream color in the late 1950s or early 60s, documentary photographs reveal that the brick was unpainted up to that time. The facade is divided into three bays by four slightly recessed, stuccoed, rectangular piers. Diamond-shaped panels, formerly inset with terra cotta, are set near the top of the four piers, as well as in the upper wall of the façade. Central glass doors and flanking plate-glass windows are surmounted by the original small-paned Luxfer glass transoms. In addition, three sets of triple, multi-paned, casement, wood-framed windows remain intact at the second level of the façade. The original, decorative, metal awning is suspended over the entrance. A new pent style roof has recently been added to the upper wall of the façade. The new roof, which replicates the original pent roof, is composed of copper tiles and is supported by scrolled wood brackets, painted green. The roof line features a central shaped pediment topped with terra cotta coping.
