National Register of Historic Places
Registration Form

historic name Uptown Cuba Historic District

Uptown Cuba Historic District
Crawford County, MO
Historic & Architectural Resources of Cuba, Missouri

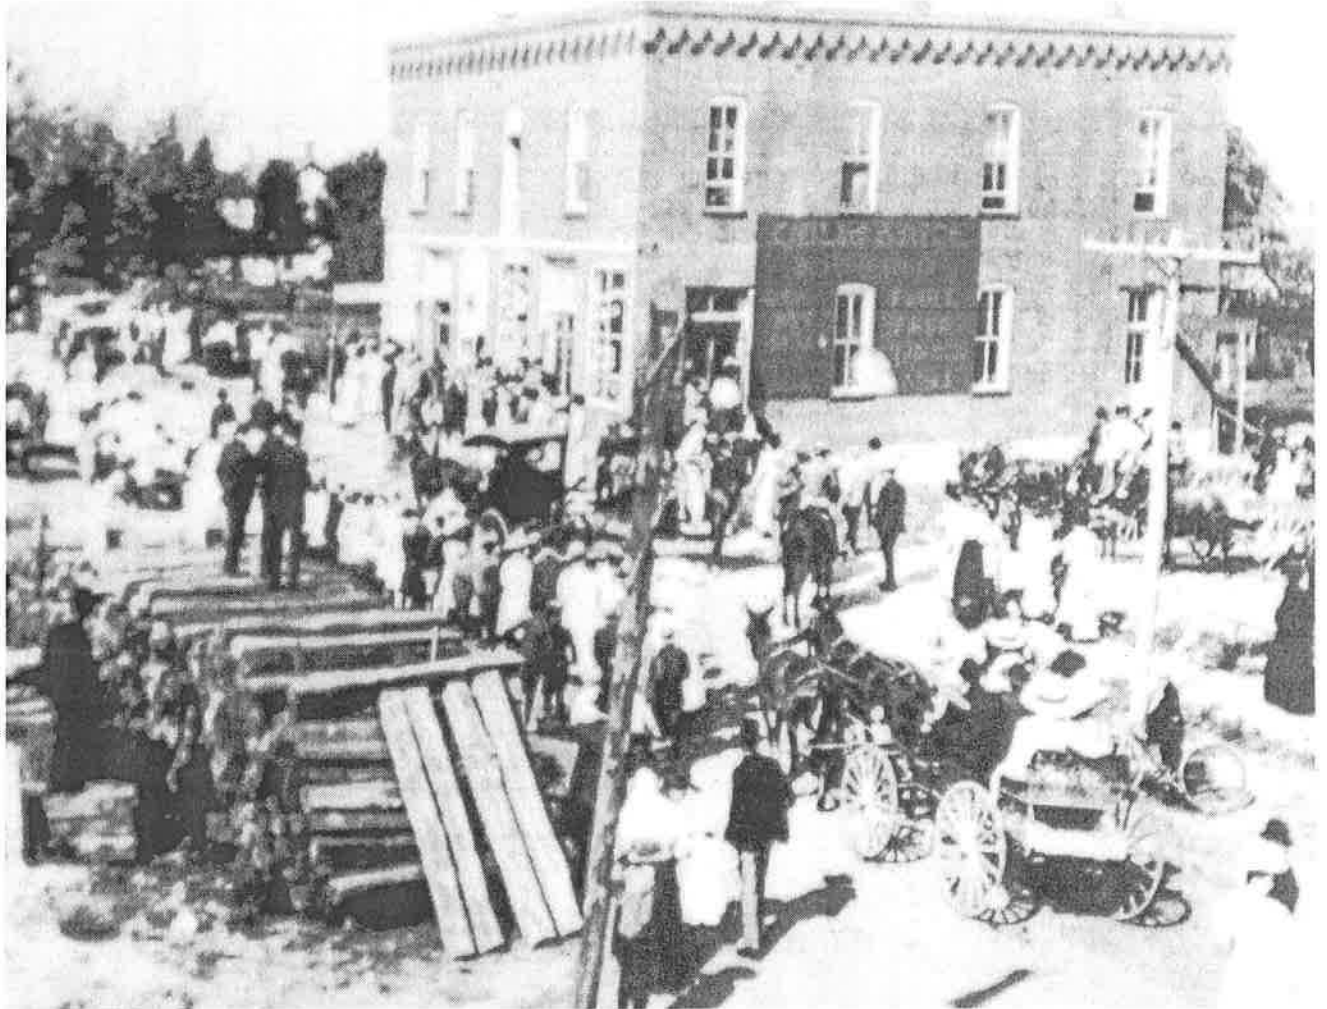
Fig. 2 This view along West Main Avenue looks across South Smith Street and show the c. 1885 Kinder Building on the corner but not the 1897 Hotel Grand which was eventually built beside it to the west. The railroad ties indicate that some manner of rail construction project was on-going at the time. [Crawford County Historical Society]

607 West Main Avenue; c. 1885; contributing; Figs. 1, 2

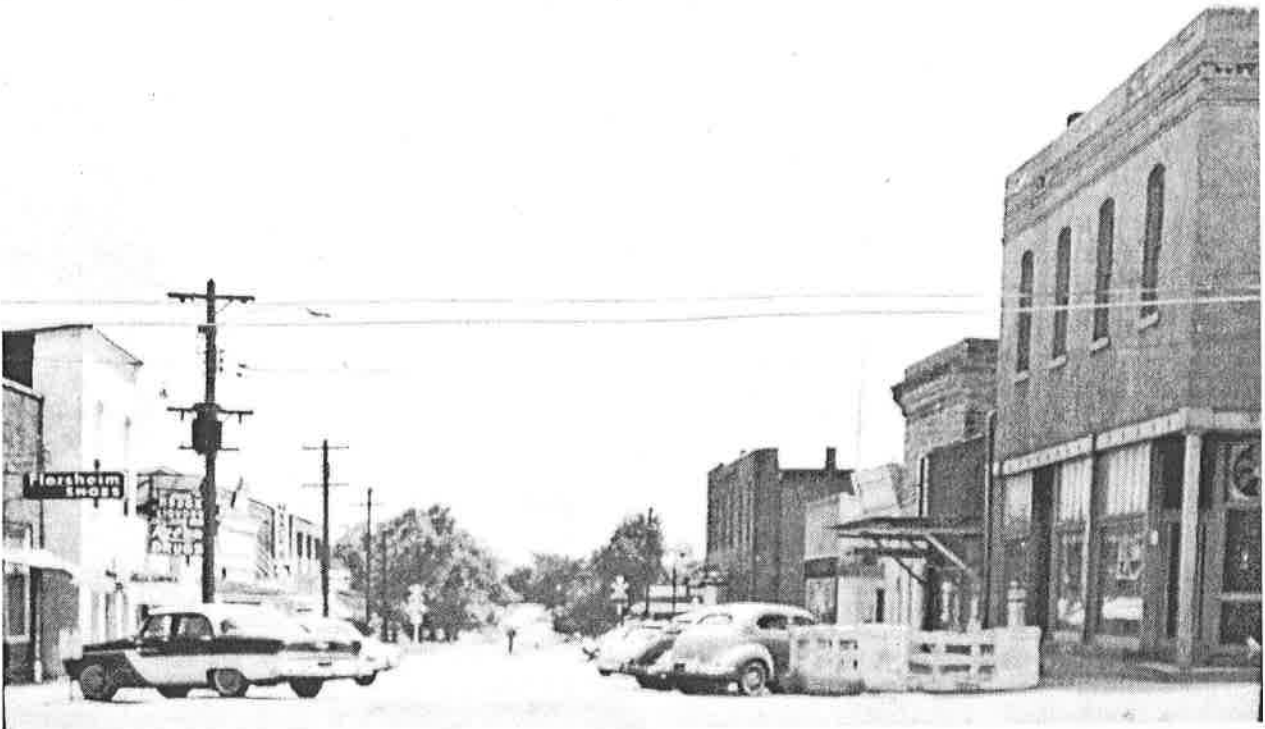
Fig. 3 This 1950s view of South Smith Street looks southward from West Washington Boulevard and shows the People's Bank/Masonic Hall on the right corner. [Crawford County Historical Society]
