### National Register of Historic Places Registration Form

Historic name U.S. Inspection Station—Calais (Ferry Point), Maine  
Other names/site number Calais Inspection Station; Ferry Point Inspection Station

*U.S. Inspection Station—Calais, Ferry Point Washington  
County, Maine*

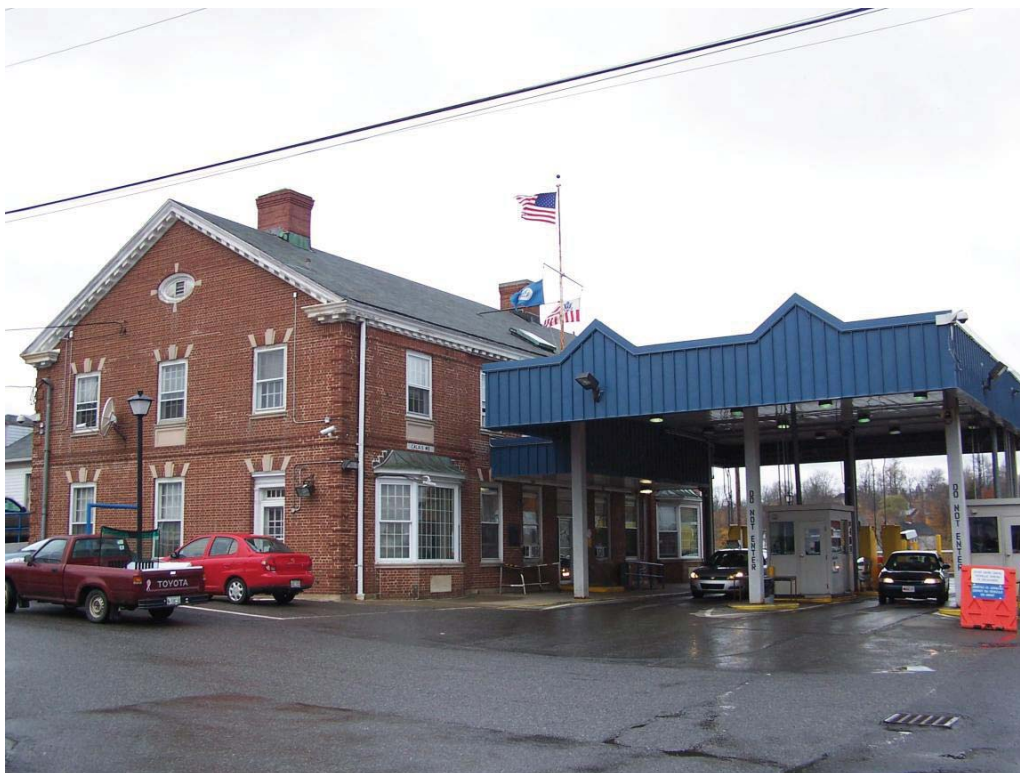
*Photo number:* ME\_WashingtonCounty\_BorderStation1.tiff

*Description of view:* front and side elevation, view: northeast

The 2-story Inspection Station is clad in English bond brickwork, was designed in the Colonial Revival style, and was built in a rectangular plan. The roof is side gabled, and is clad in asphalt shingles. Two large brick chimneys with corbelled caps are present at either end of the ridgeline. The front elevation consists of 7 bays and features a centrally located entrance. This doorway consists of a classically detailed wood surround with a 5-light transom. Set within the doorway are a pair of wood doors, each leaf having 6 lights at the top and a panel below. At the first level, the 2 bays of windows on either side of the entrance are 12/12 wood windows. These windows, like many on the building, have aluminum storms. There are brick jack arches above these and all other window openings on all facades. Centered within this jack arching is a marble keystone. On either end of the jack arching are additional marble keystones at a similar inward slant as the jack arching. Rounded concrete sills and concrete aprons underscore all of these windows. At either end bay of the first level front elevation, are protruding tripartite bay windows of aluminum frame with press-on muntins. Copper seam canopy roofs are located above each of these bay windows. Within the center base of each bay window is a marble plaque. The marble plaque at the northernmost bay is a commemorative plaque for the building, noting that the construction year of the station building was 1935.

The second level of the front elevation inspection station features a rosette window in the center bay framed in soldier course brickwork, and double layer marble keystones within the cardinal points. The rosette window itself features a leaded pattern of semi-circles. The second level windows are 8/8 double hung and are underscored by simple marble sills. Between the first and second level, across all elevations, is a 2-course protruding brick string course. Running directly above the header of all second level windows is a continuous brick soldier course enclosed in running headers above and below. Directly above this is dentil molding, topped by an ogee style cornice molding that runs continuously across all four elevations. Brick quoining is present at all 4 corners of the building.

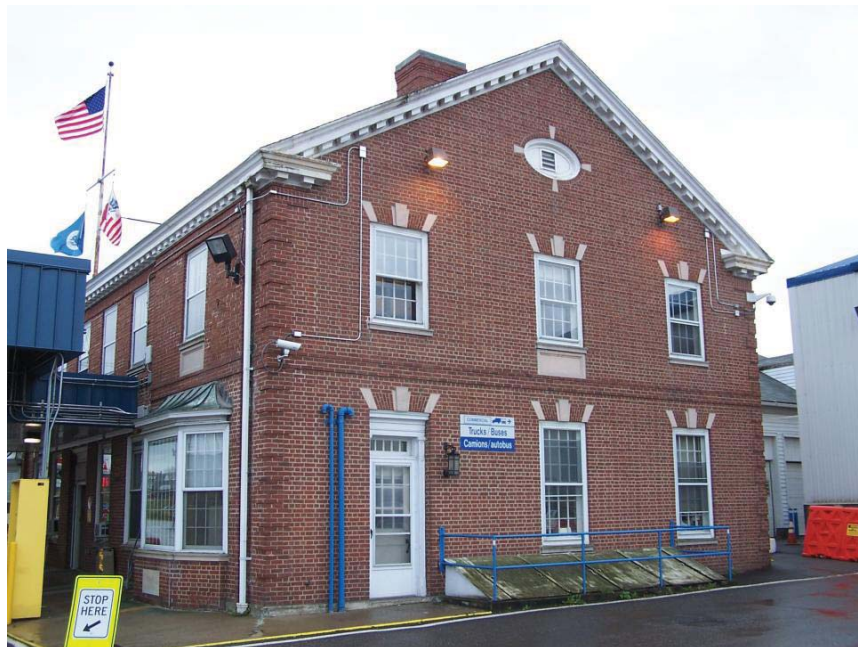
*Photo number: ME\_WashingtonCounty\_BorderStation2.tiff*

*Description of view: east side elevation, view: northwest*

The Ferry Point side elevations are identical. Both elevations are three bays wide. The first level along each side features two bays with 12/12 wood windows similarly detailed to those already mentioned at the front elevation. The front-most of the three bays at the first level side elevations features a classically detailed entry. The entry is framed by square shaped, paneled, engaged colonettes at the sides, and a 5-part transom window topped by a molded entablature. The doors are wood panel with 9-unit wood frame glazing in the upper portion. A lantern style hanging light fixture is located adjacent to each entry. The upper level of each side elevation features three bays of 8/8 wood frame double hung windows with similar crown work as that mentioned at the front elevation. At each side elevation, an inset marble plaque with simple molded framing underscores each upper level center window. The gable end is present at each side elevation. Each gable end is underscored by gable returns with dentil molding and ogee cornice

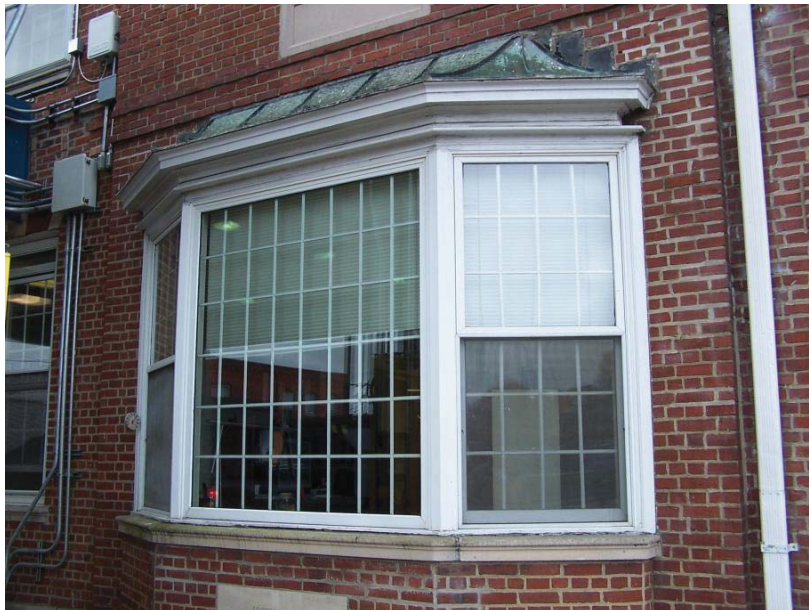
*Photo number:* ME\_WashingtonCounty\_BorderStation3.tiff

*Description of view:* front elevation bay window, view: northwest

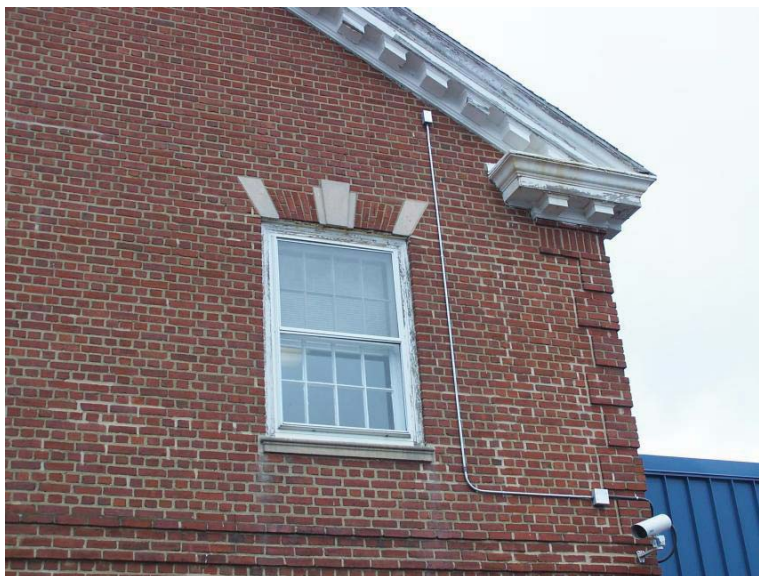
*Photo number:* ME\_WashingtonCounty\_BorderStation4.tiff

*Description of view:* side elevation window detail of quoining and dentil molding, view: east/southeast

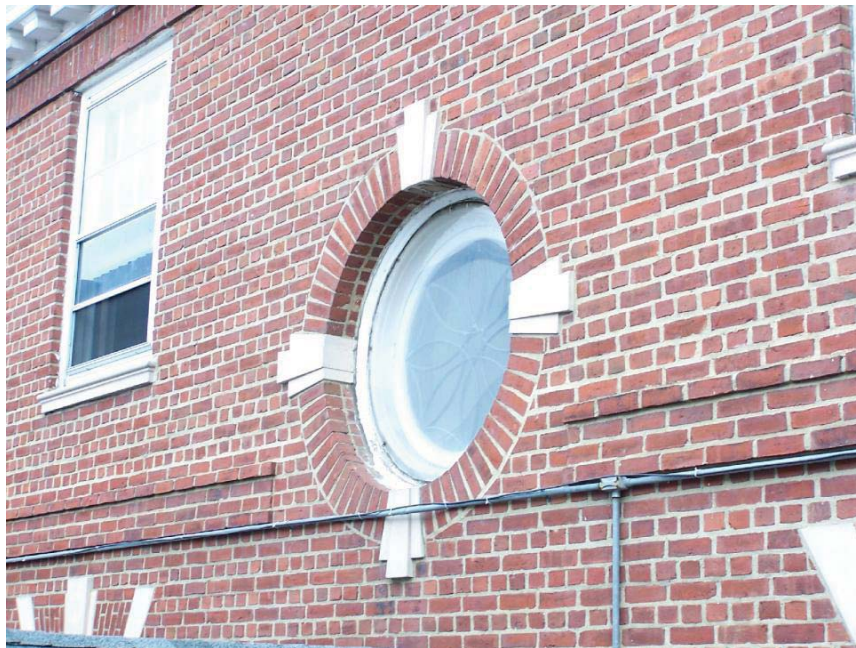
*Photo number:* ME\_WashingtonCounty\_BorderStation5.tiff

*Description of view:* rear elevation, rosette window, view: southeast

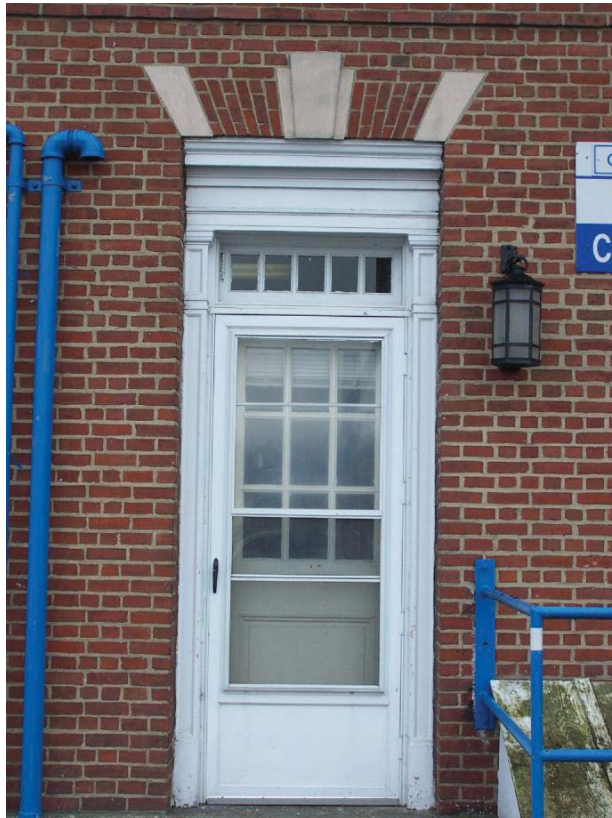
U.S. Inspection Station – Calais, Ferry Point  
Washington County, Maine  
*Photographer:* David Greenwood, Jones & Stokes  
*Date of photograph:* October 2006  
*Negative:* GSA  
*Description of view:* west elevation entry door, view: east  
*Photo number:* ME\_WashingtonCounty\_BorderStation6.tiff

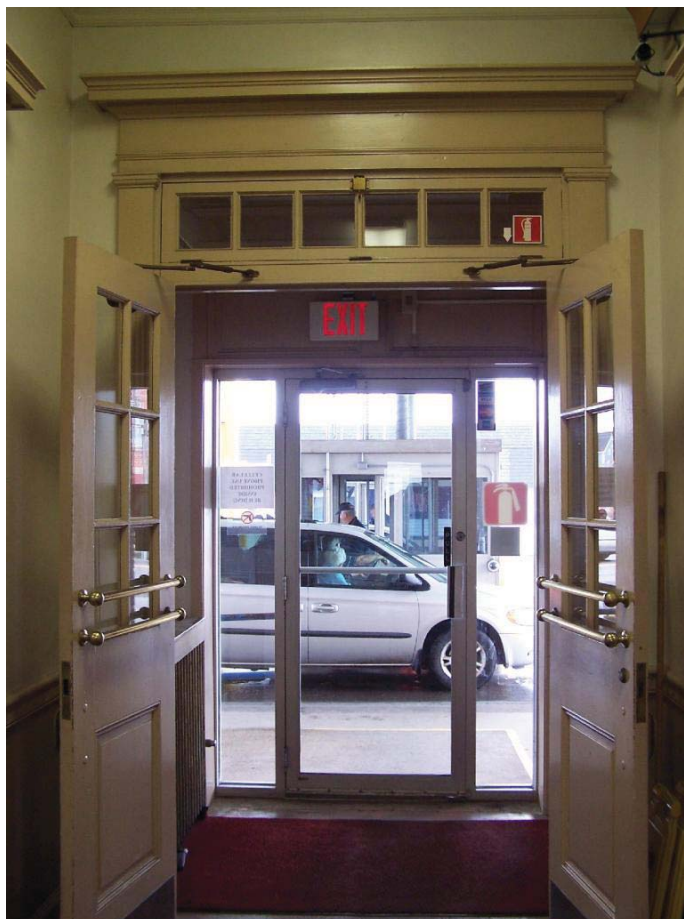
*Photo number:* ME\_WashingtonCounty\_BorderStation7.tiff

*Description of view:* interior entry doors, view: south

Immediately inside the central hall are a second set of original entrance doors. Each of these doors is wood and features a lower panel topped by 6-light glazing. The original brass handle crossbar hardware is still present. Above these doors is a 5-pane, wood frame transom window. This whole entry program is topped with a large entablature. At each end are engaged, classically detailed square colonettes. This entry program is highly similar to those on the side elevations. Various entrances off the hall are similarly trimmed albeit with 3-light rather than 5-light transoms. The two service desks at the first level, one for Customs and one for Immigration, which are original, are five panels each and are of stained wood, which is remarkably rare among all the Inspection Stations within this Multiple Property Submission (MPS). The stairwell to the second level features wainscoting with decorative molding, and a large rosette window is present within it. Triglyph patterned chair railing is also present in the interior.

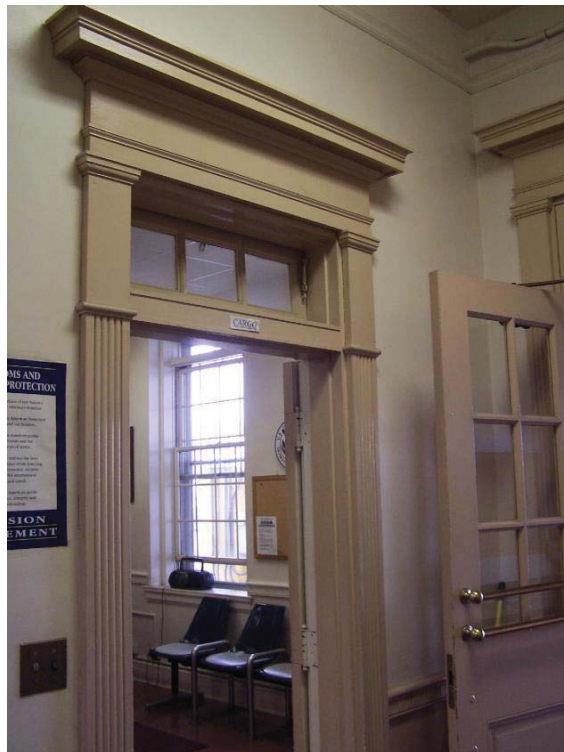
*Photo number:* ME\_WashingtonCounty\_BorderStation8.tiff

*Description of view:* standard office entry, view: south/southwest

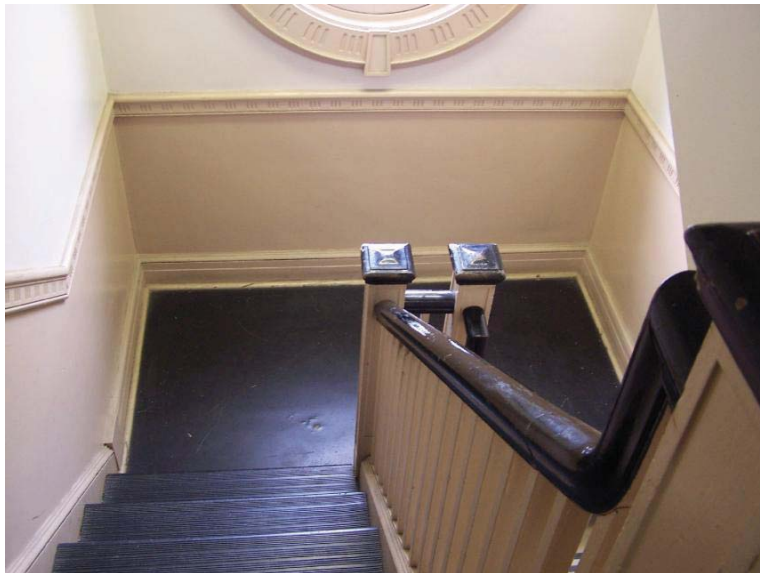
*Photo number: ME\_WashingtonCounty\_BorderStation9.tiff*

*Description of view: stairwell, view: north*

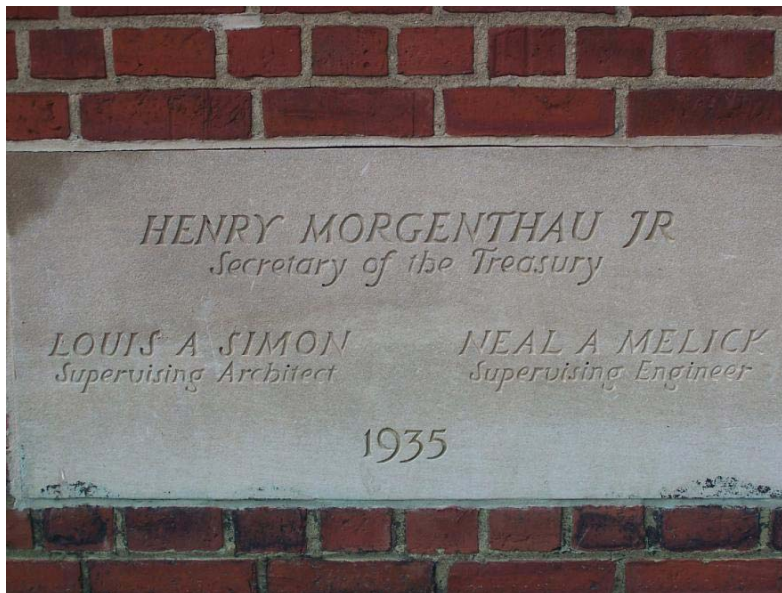
*Photo number:* ME\_WashingtonCounty\_BorderStation10.tiff

*Description of view:* front elevation, commemorative plaque, view: north

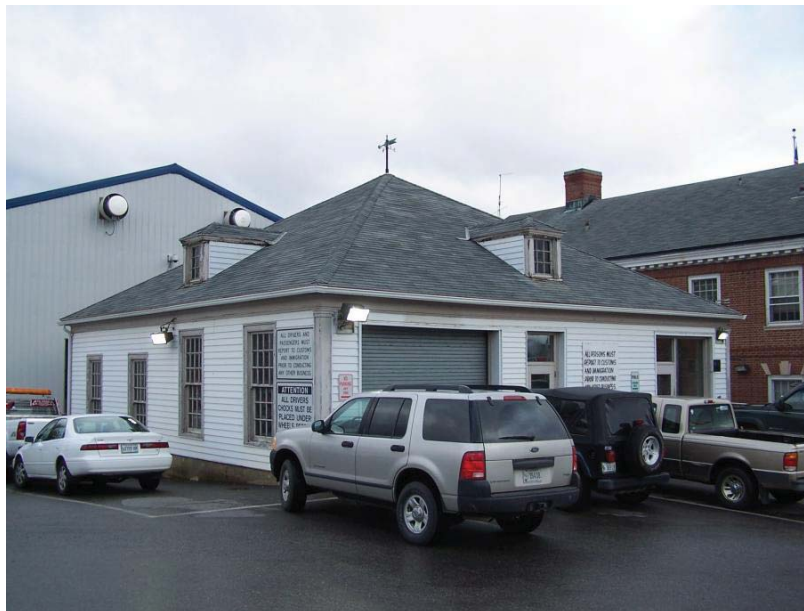
*Photo number:* ME\_WashingtonCounty\_BorderStation11.tiff

*Description of view:* inspection garage, view: southeast

A pyramidal roofed, square plan garage, and restroom facility is also located on the property to the rear of the station. Built ca. 1936, the garage is the second contributing building on the property. Four bays per side, this building is on a concrete foundation, features wood clapboard siding, classically detailed square colonettes at the corners, and multiple 12/12 wood double hung windows with simple wood plank trim. The roof is clad in asphalt shingle and is underscored with continuous molded fascia. In the middle of each run of the roof is a hipped gable dormer with a 9-light wood window and engaged colonette detailing. Clapboard cladding is present at the cheeks of each dormer. Above the face and cheeks of each dormer is wood cornice molding. At the apex of the roof is a metal weathervane with an arrow design. The garage bay in this building appears to have been expanded, and now features a metal roll-up door. The entry program features a glass transom, which although was likely an original feature has been replaced. Other entry bays appear to have been modernized with the additions of aluminum framing and new glazing units.

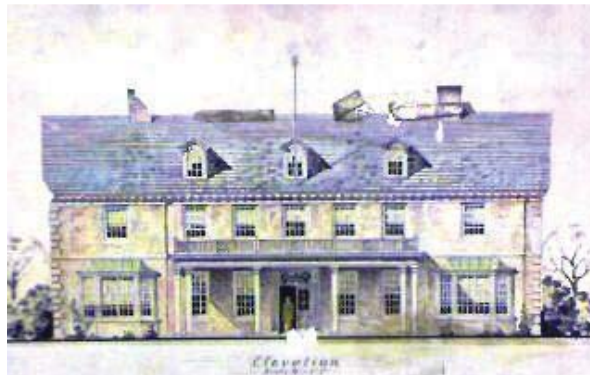
*Description of view: front elevation*

Some window units replaced at front of building. The original porte-cochere was replaced with one larger in scale and incompatible in style. The original slate roof is replaced with asphalt shingles. Although the original rendering shows 3 dormers at the front elevation, based on available research there is no evidence that these dormers were originally constructed.
